HOUSING RECONSTRUCTION AND RETROFITTING AFTER THE 2001 KACHCHH, GUJARAT EARTHQUAKE

Elizabeth A. HAUSLER, Ph.D.¹

SUMMARY

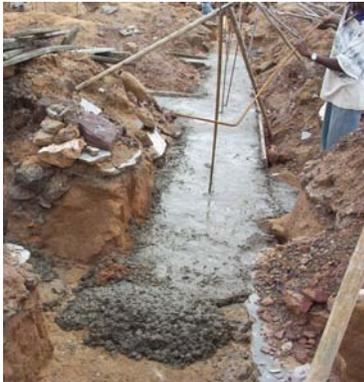
the sand into the voids between the cobbles. In practice, this procedure rarely fills the voids completely. The support matrix consists simply of the cobbles themselves, which are often rounded and in poor contact with each other and the base of the excavation. Thus a competent support matrix is not formed, leaving the foundation vulnerable to differential settlement under the static load of the walls, which is especially problematic for brittle masonry and earth construction. A tenet of foundation construction in seismic regions is that the foundation should be able to span soft spots so that settlement occurs uniformly; yet this approach *creates* soft spots. Plus, foundations should be connected horizontally to reduce shear forces induced in the structural elements resting upon the foundation. Further, differential settlement due to static and seismic loads is unlikely to be restricted by the unreinforced concrete layer.

Fig. 2. Unreinforced concrete base layer for strip footing, with vertical steel bars

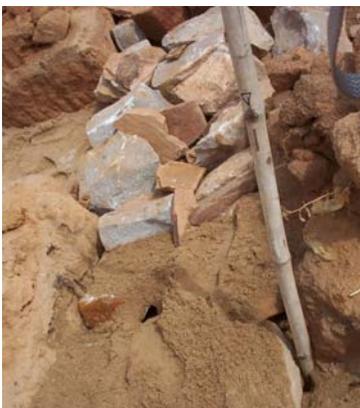
Both foundation approaches allowed by the guidelines were commonly used (see Figs 2-5). In the latter option, the cobbles are laid out, covered with loose sand (Fig. 4), and flooded with water so as to slurry

The practice of placing cobbles in loose sand was defended as a form of base isolation. Some engineers and architects maintained that a frictional interface existed between the cobble/sand layer and the unreinforced concrete such that sliding would occur, reducing the energy transmitted to the walls. However, it is physically very unlikely that sliding of the unreinforced concrete layer could take place relative to cobble/sand foundation because the concrete is confined on all sides by the ground, and the masonry wall up to the plinth band is confined in its interior by backfill for the floor. Thus the structure from the unreinforced concrete layer on up is not free to slide relative to the cobble/sand layer.

Fig. 4. Random cobble foundation covered with loose sand

Further research is required to illustrate the potential for and impact of differential settlement under static and seismic conditions for the foundation approach using cobbles flooded with loose sand. This foundation practice is prevalent throughout India (INTERTECT [20]), and a low-cost alternative should be identified and tested, such as manually crushed, angular hardcore. The level of energy dissipation provided by the common and proposed approaches should be quantified so that the benefits of a reduction in energy transfer can be weighed against the consequences of settlement.

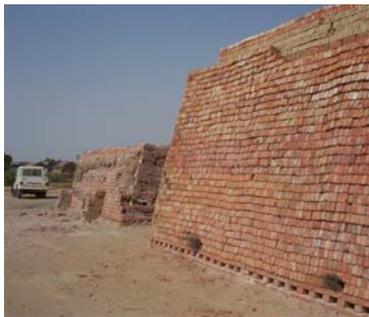
made in coal-fired outdoor kilns as shown in Fig. 7. This process does not burn the brick uniformly. Crushing strength of country-fired bricks varies from 0.3-6 MPa (3-60 kg/cm²).

Fig. 7. Kiln for country-fired brick production

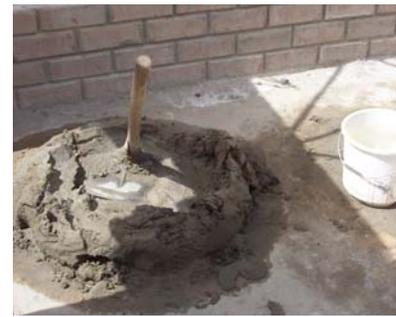
The potential lack of compatibility between the mortar and masonry units may be offset by the quality of the mortar as put in the wall. Mechanical mixers are non-existent in rural Kachchh for low-rise housing construction; instead, mortar is mixed on the ground by hand (Fig. 9). Dry materials are mixed together in a pile that is formed into a circular berm with a hollowed out center portion where water is added. Mixing takes place by gradually pulling in material from the sides. In this process, some of the material on the sides is hydrated for a longer time, producing variations in strengths and consistency.

Fig. 9. Typical mortar mixing

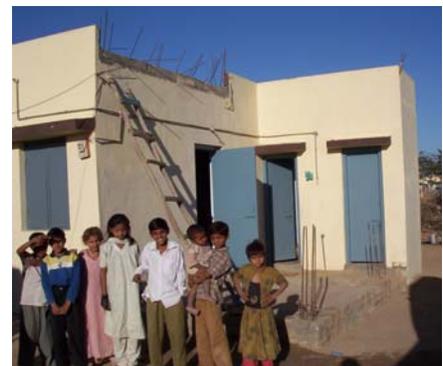
Houses should be structurally capable of supporting extensions, additions, and modifications with inexpensive and locally available skills and materials. If a structure is built with a flat roof, it is likely that a second story will be added as the family expands (Fig. 13). Many foundations for one-story structures with flat roofs were not designed with the possibility of a second story in mind.

Fig. 13. Flat roofed house with preparations for second story

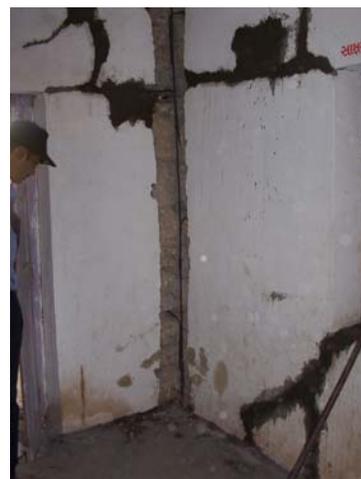
Fig. 15. Vertical bar with shear connectors

In practice, the holes that were made for the shear hooks were very large. Also, in order for this technique to be effective, the concrete should be placed under pressure, or a non-shrink grout used. Neither technique was observed in the field.
