Fig 1. Collapsed westernmost spans of four-span, reinforced concrete arch bridge at Xiao Yu Dong. IMG0047.

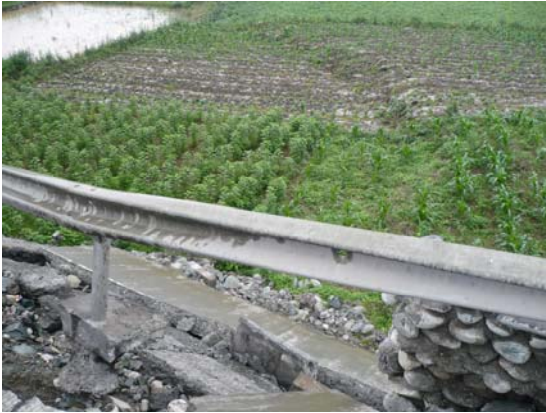
Fig 2. Permanent ground displacement, south side of bridge looking south, curved but trending NNW. West side moved up approximately 1.2m relative to east side. Possible extension to west. IMG0395

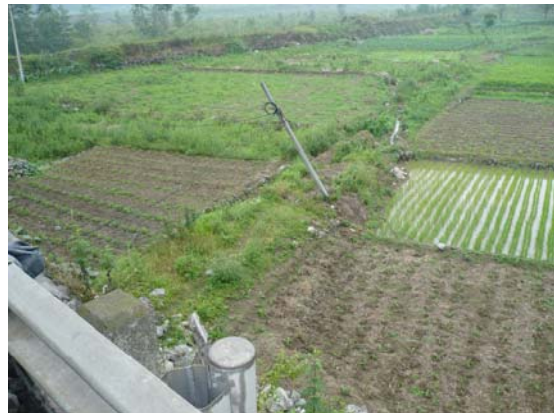
Fig 5. Continuation of surface expression of fault rupture on the north side of bridge, strike NNW. IMG0396

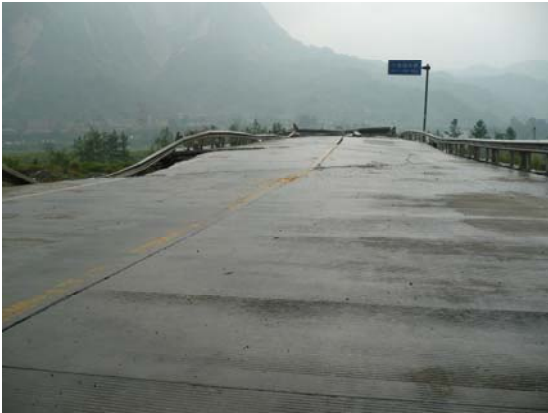
Fig 6. Heave in east bridge approach, looking west. Crack is consistent with NNW-trending ground scarp. IMG0012

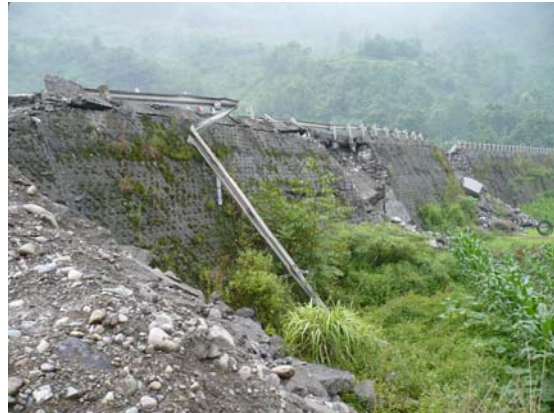
Fig 7. South side of east approach, looking ENE. IMG0015

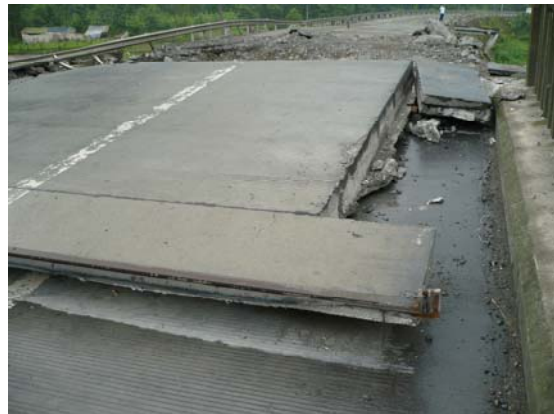
Fig 9. Displacement of road deck from east approach on top of first span, offset by over 3m west and twist to the north. Looking East. IMG0414

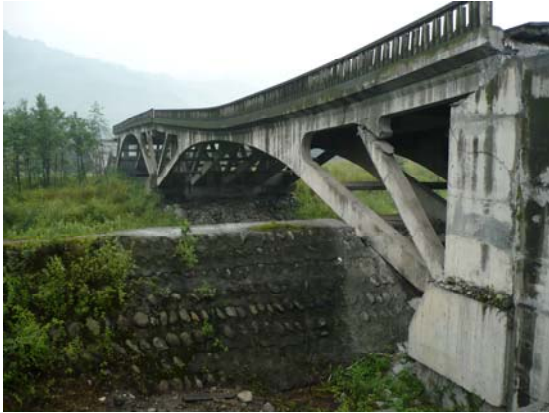
Fig 10. Easternmost span, east approach and abutment have moved west and/or arch has expanded due to fracture in RC elements. IMG0014

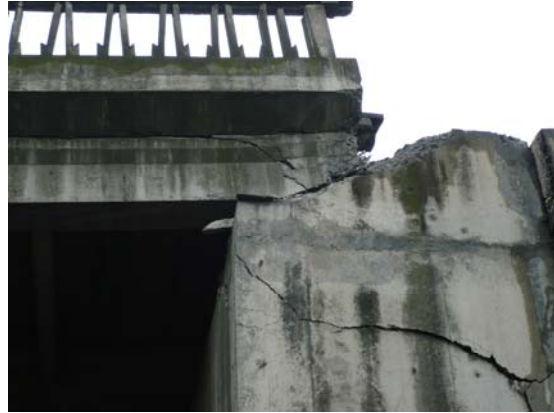
Fig 11. Relative displacement of east abutment and deck of easternmost span. IMG0020

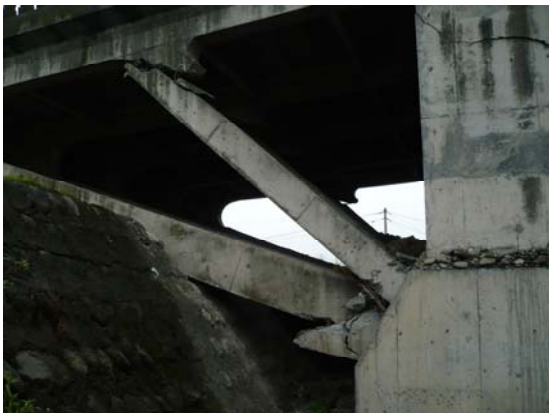
Fig 12. Fracture in spandrel elements. IMG0018

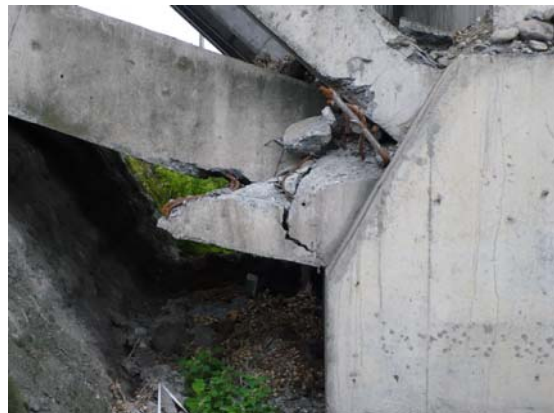
Fig 13. Fracture at connection between arch and abutment. IMG0019

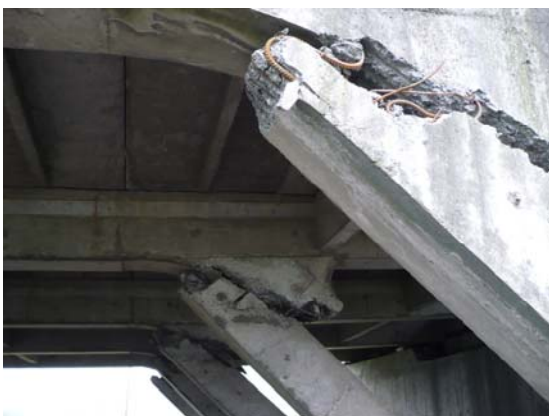
Fig 14. Spandrel element fractures. IMG0030

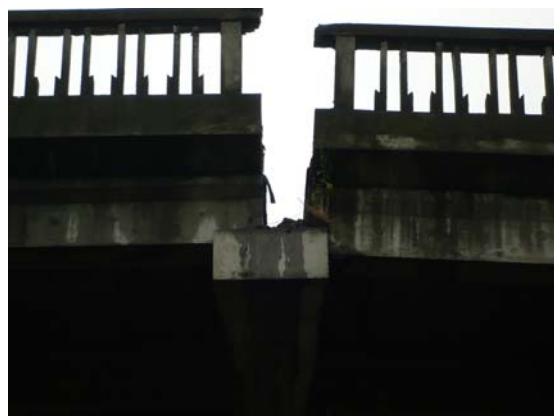
Fig 15. Horizontal displacement of easternmost span (right) to the east. IMG0031

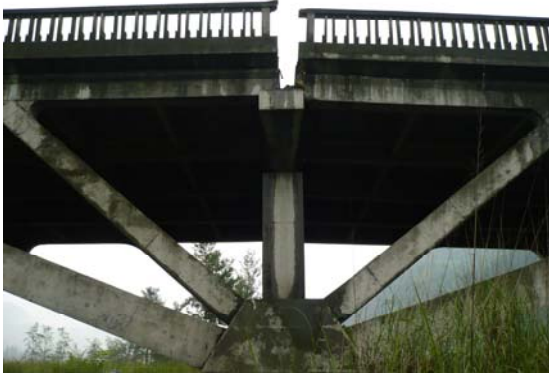
Fig 16. No damage to 2nd span from the east (shown at left). IMG0032

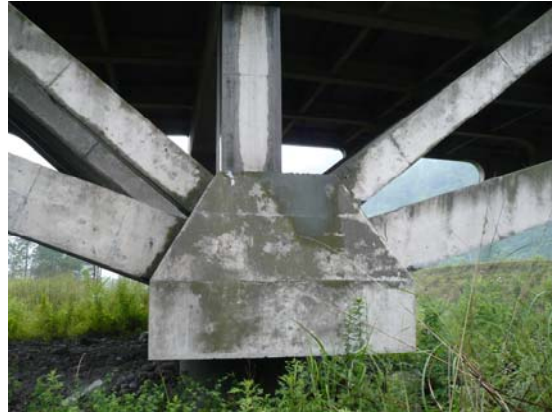
Fig 17. Spandrel supports, between 1st and 2nd spans from the east. IMG0033

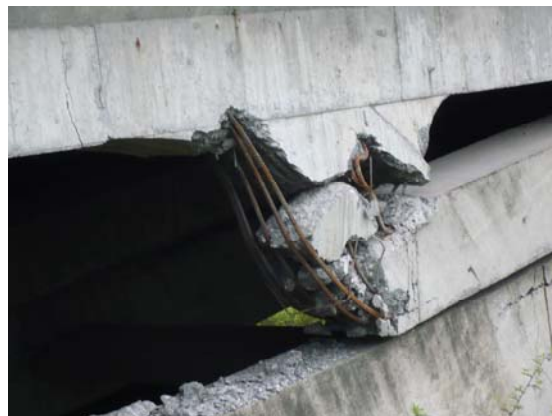
Fig 21. Fracture at spandrel connection, note lack of concrete confinement. IMG0041

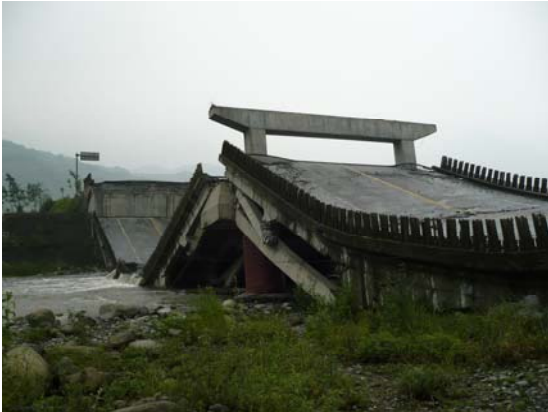
Fig 22. Collapsed 3rd and 4th spans. IMG0039

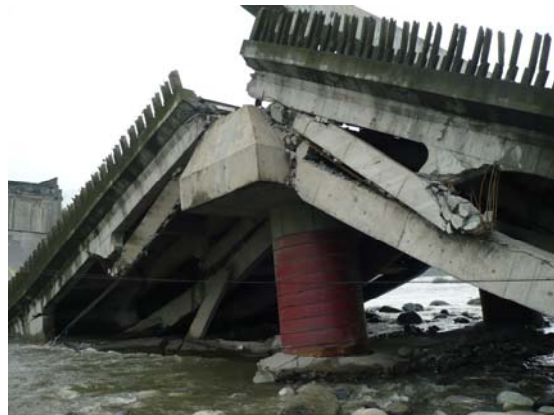
Fig 23. Pier between 3rd and 4th spans, not clear if pier displacement caused the collapse, or the pier was pushed west by the collapsing deck. IMG0048

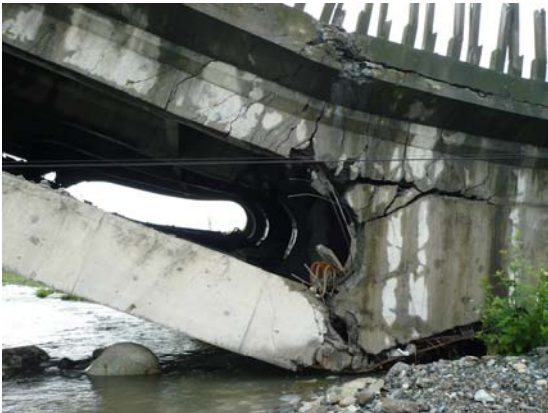
Fig 24. Damage at top of arch, 3rd span. IMG0053

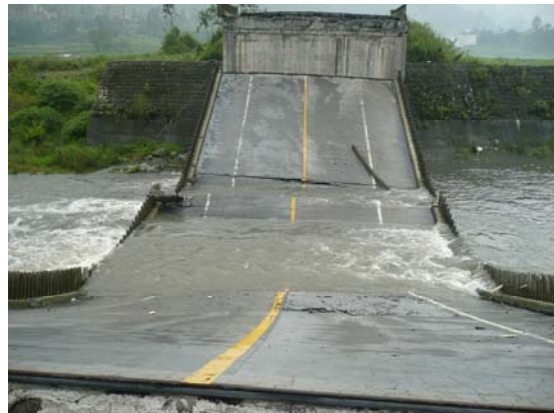
Fig 25. View of collapsed 4th (westernmost) span, from 3rd span. 4th span displaced south relative to west approach. IMG0057
