**April 25, 2015 – GORKHA EARTHQUAKE, NEPAL**

**Surveyed May 5-19, 2015  
Report Released May 31, 2015**

## Build Change Post-Disaster Reconnaissance Report

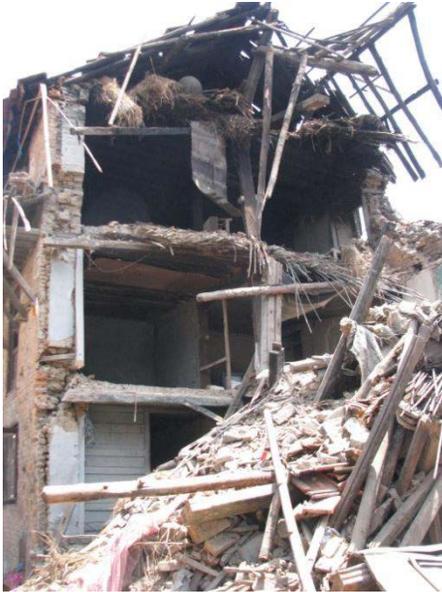
*Figure 2. Housing damage in Bungamati.*

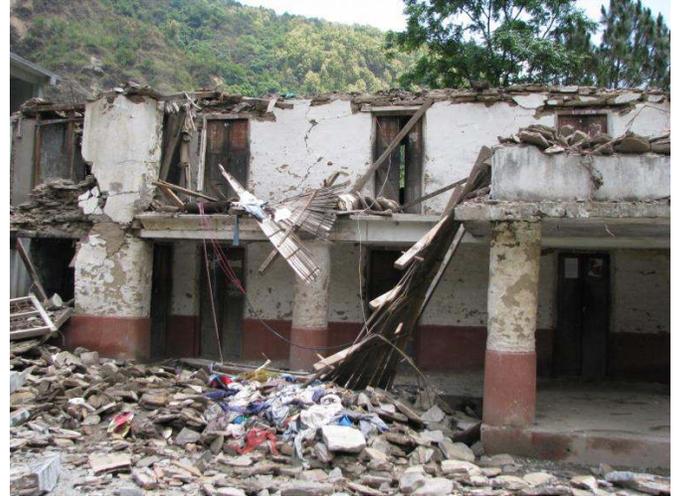
*Figure 3. Damaged school in Mahakal, Sindhupalchok.*

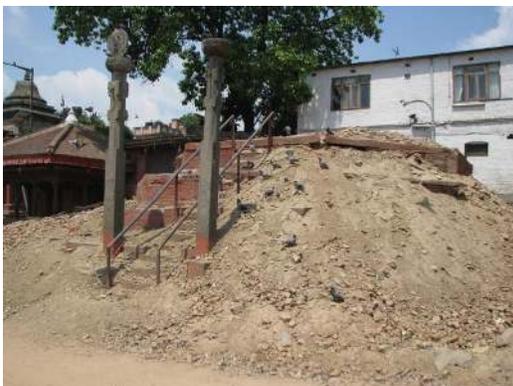
*Figure 4. Destruction at UNESCO site in Kathmandu Durbar Square.*

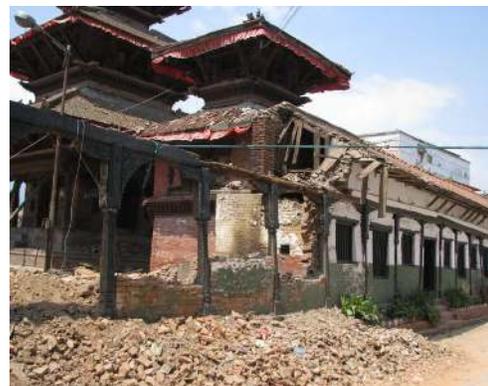
*Figure 5. Destruction at UNESCO site in Kathmandu Durbar Square.*

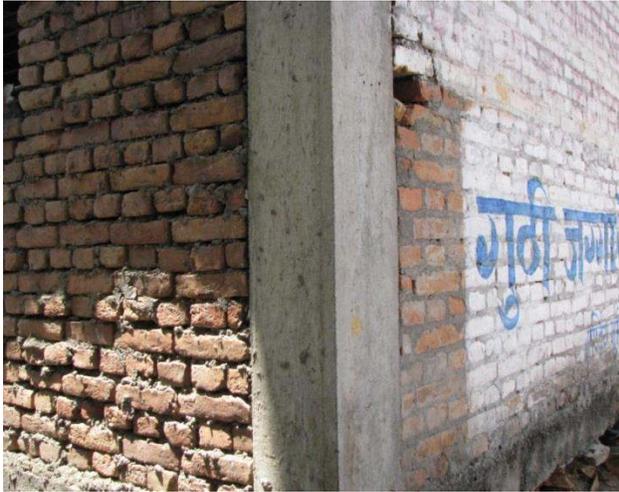
Figure 13. Note mortar finishing on exposed side wall versus mortar finish on “out of sight” back wall, Chautara.

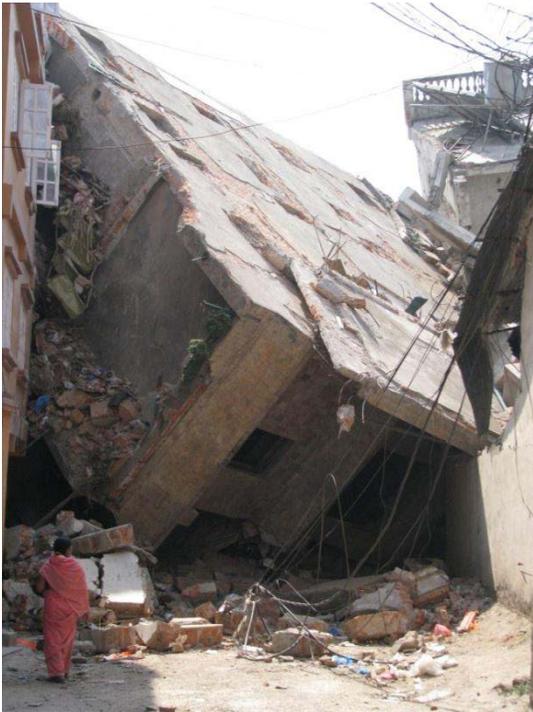
Store front/soft story failures were more common at recent construction where the concrete columns at the ground level would fail at the column top or bottom joints. Often, after a failure of one or more ground story concrete columns, the upper portion of the structure would remain intact as the building fell over to one side (See Figures 34 – 36 for examples of this failure).

*Figure 34. Soft story failure, Kuleswor.*

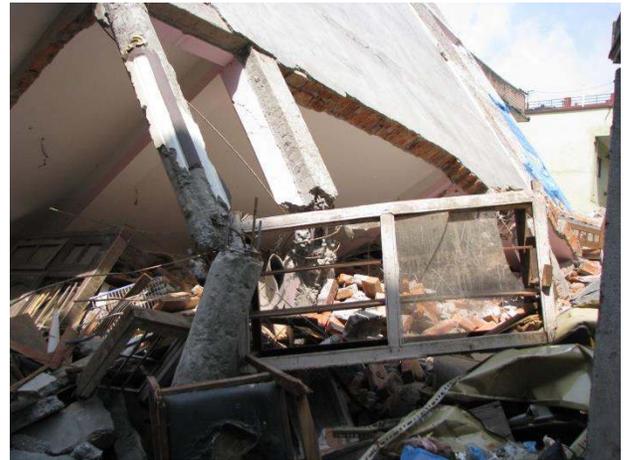
*Figure 35. First story column failure, Balkhu.*

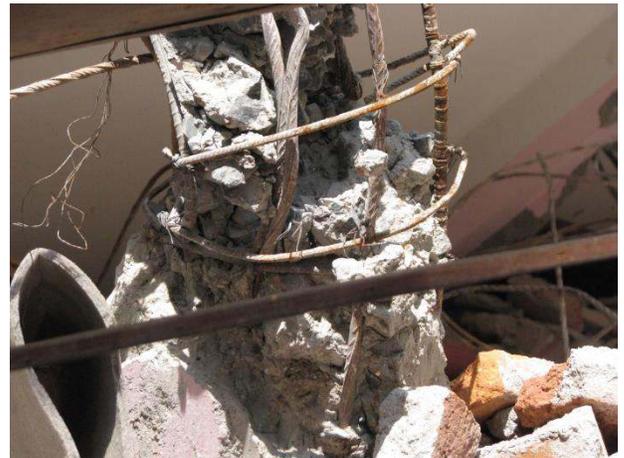
*Figure 36. Close up of Figure 35 column failure, Balkhu.*

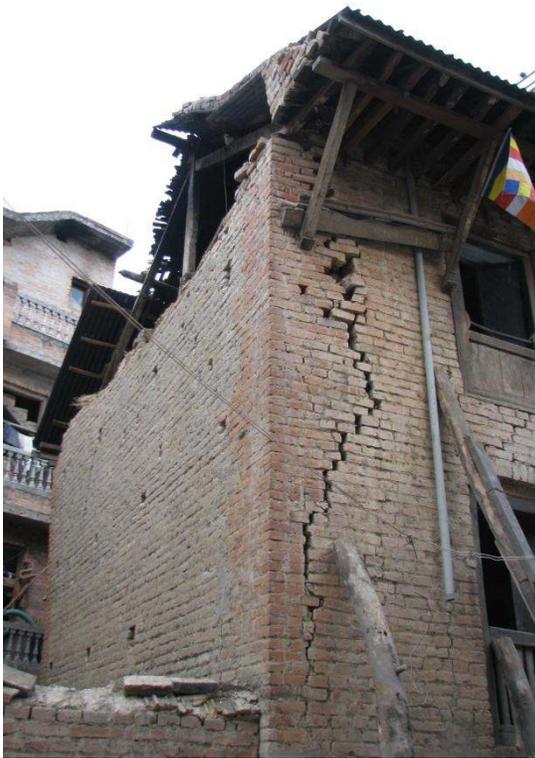
At older construction that did not utilize concrete frames, there was a substantially higher rate of failure and collapse, particularly at the wall corners and gable roof ends. There is no reinforcement tying perpendicular walls together at the corners. While the low ends of the roofs are supported by masonry walls, and the timber roof framing often runs into the wall, the gable wall ends had no ties or bracing back to the roof framing, and were frequently a source of initial collapse.

*Figure 37. Gable wall failure & corner separation, Khokana.*

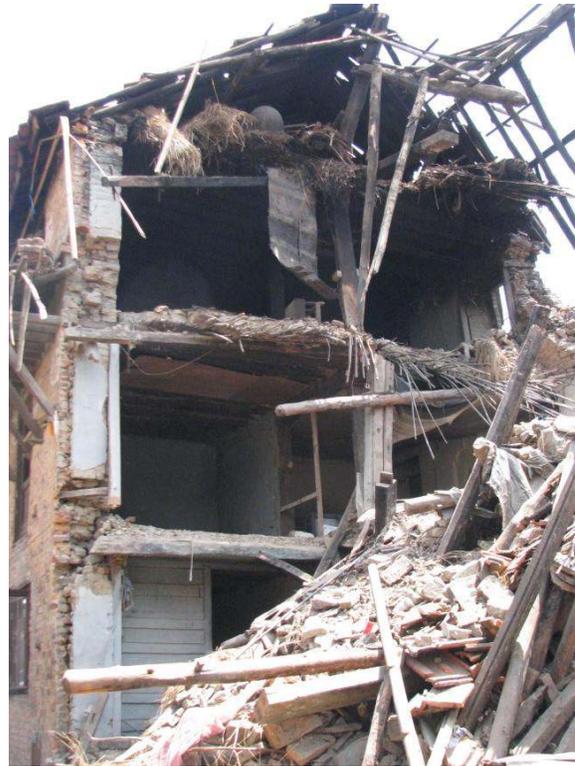
*Figure 38. End wall collapse, Bungamati.*

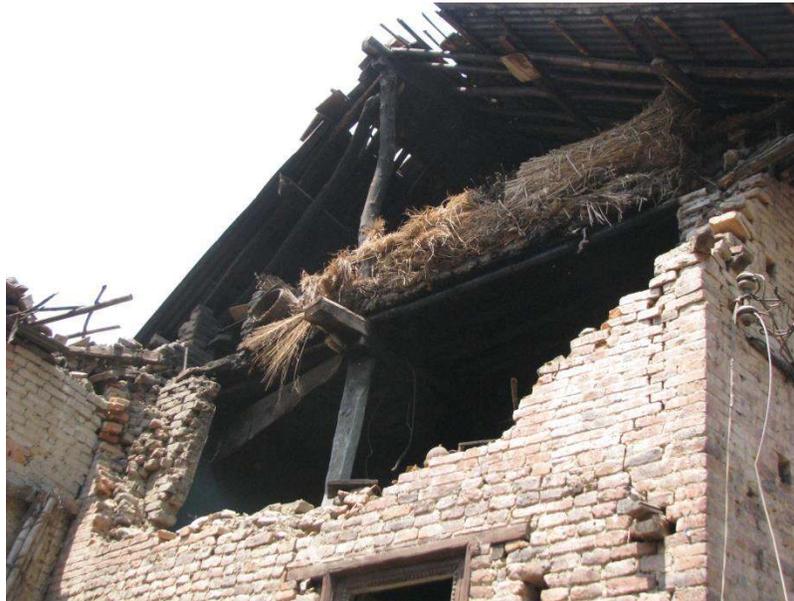
*Figure 39. Collapsed end wall at gable, Bungamati.*

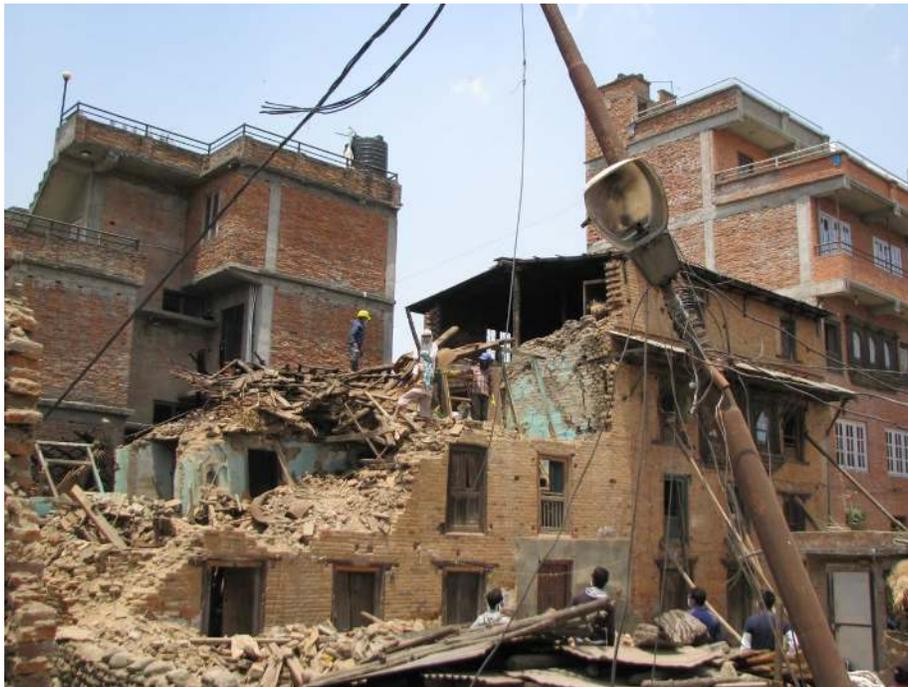
*Figure 40. Unconfined masonry collapse. Note undamaged infilled frame in background, Khokana.*

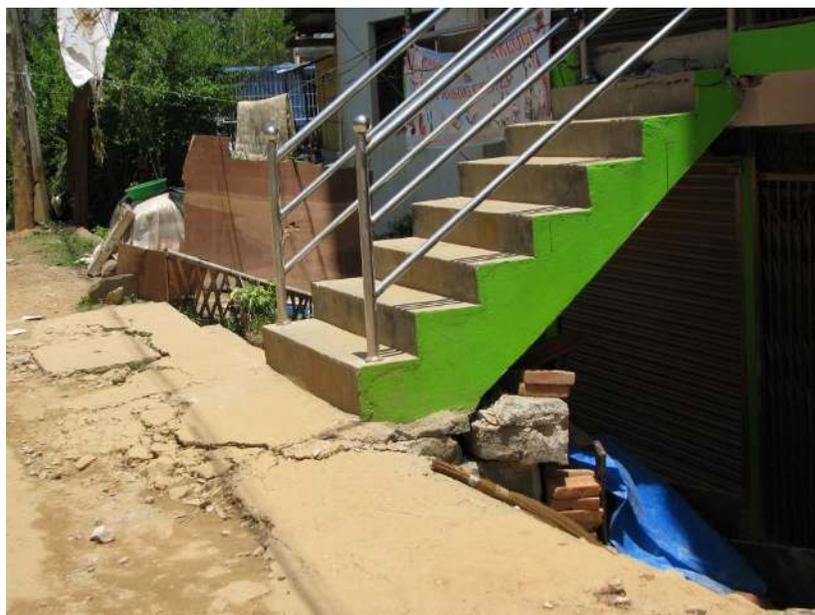
Cracking along entire front side at the base of buildings located above the steep hillsides was often clearly evident even where no other building damage was noted. Where hillside building failures did occur, it often appeared to be due to inadequate ties to a foundation or partial lower level, or a lack of a solid foundation – such as the use of stone rubble for foundations. The presence of buildings lower on the hillside, below the upper buildings, prevented closer observation to try to determine whether the damage observed was actually due to foundation slippage or failure, or damage to lower hillside columns or walls.

*Figure 41. Evidence of foundation shifting at front of building (bottom of stair), Chautara.*

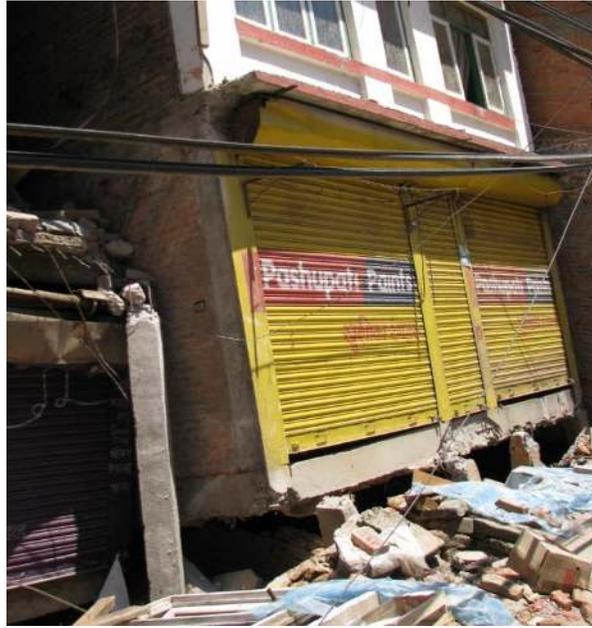
In more urban hillside areas, such as Chautara, in the Sindhupalchok district, landslides due to earthquake ground motion combined with inadequate foundation systems appeared to be the major cause of building failure and collapse. The age of construction varies greatly, with materials ranging from unconfined stone masonry with mud mortar at older buildings to concrete frame with brick infill and cement masonry. But regardless of construction type and age, a lack of adequate foundations for the steep hillside sites contributed to many of the collapsed and damaged structures.

*Figure 42. Foundation/lower level failure on hillside, Chautara (See Figures 43 & 44 for column failure details).*

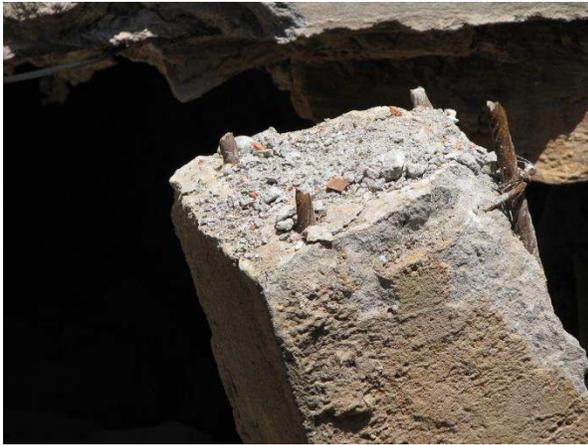
*Figure 43. Foundation column failure, Chautara.*

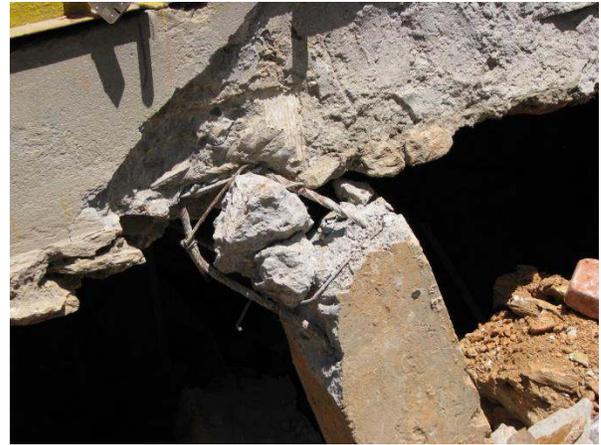
*Figure 44. Foundation column failure, Chautara.*

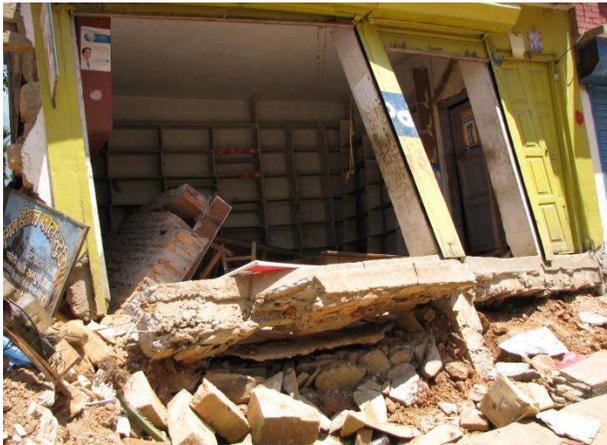
*Figure 45. Foundation failure, Chautara.*

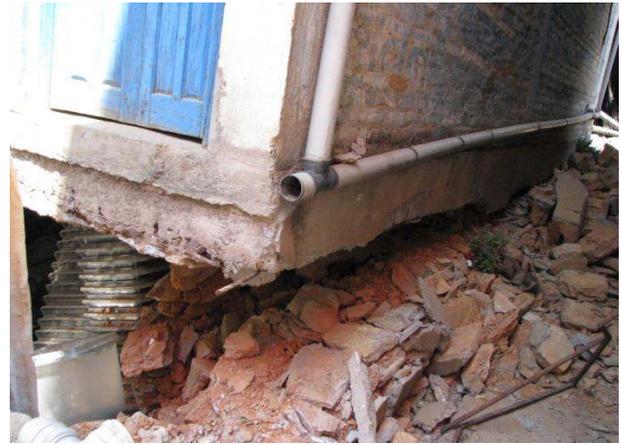
*Figure 46. Foundation failure, Chautara.*

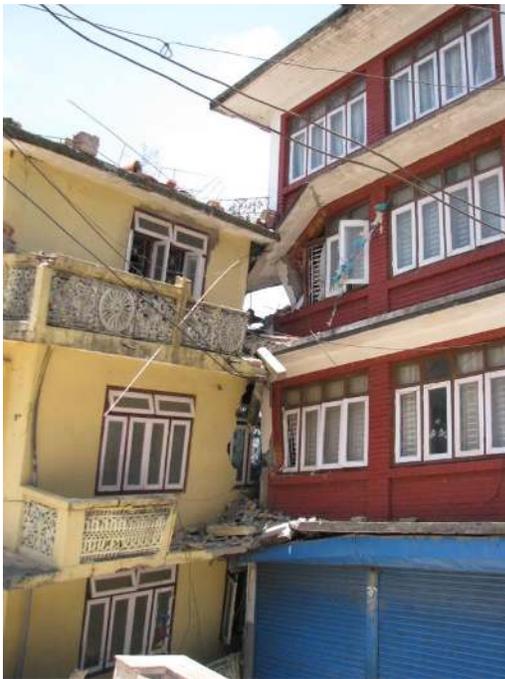
Other causes of damage and/or collapse were related to masonry wall failure, pounding by adjacent buildings, and collapse of adjacent structures onto a building (See Figures 47 – 49 below).

*Figure 47. Damage due to adjacent building collapse, Chautara.*

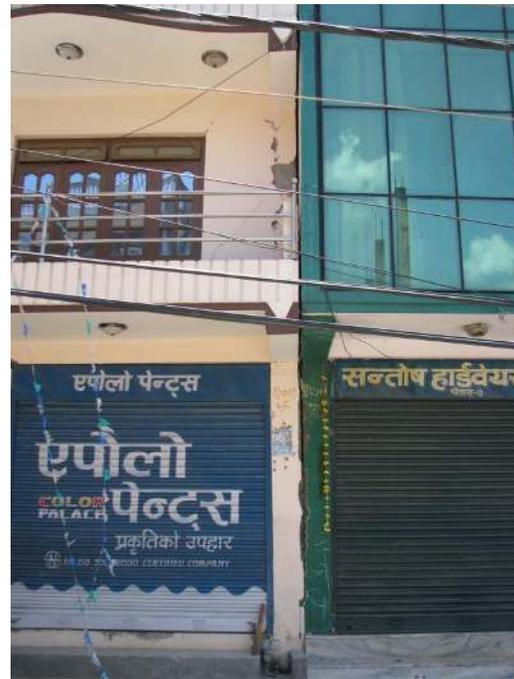
*Figure 48. Pounding damage, Chautara.*

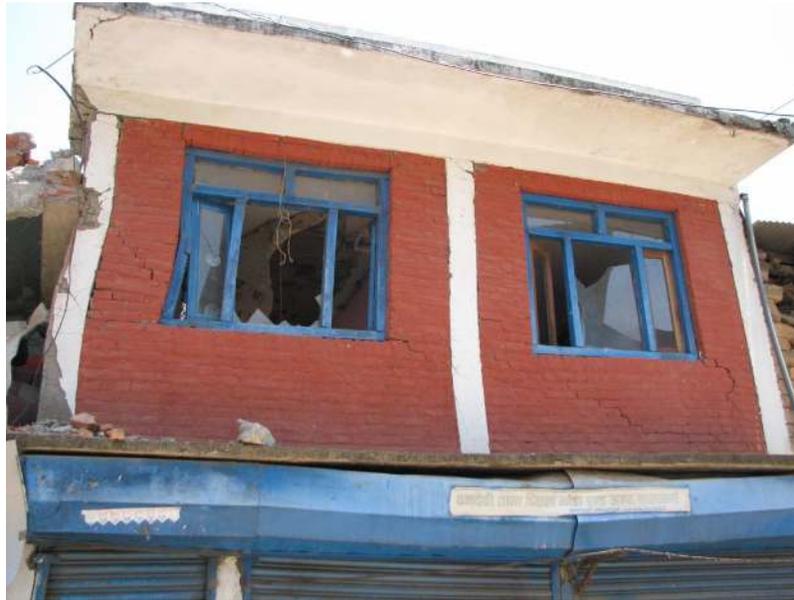
Figure 49. Damage due to pounding and collapse of adjacent building, Chautara.

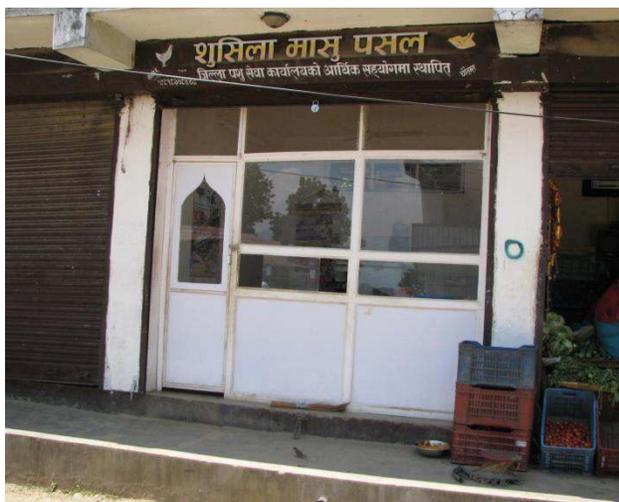
Figure 50. Green tagged structure, Chautara.

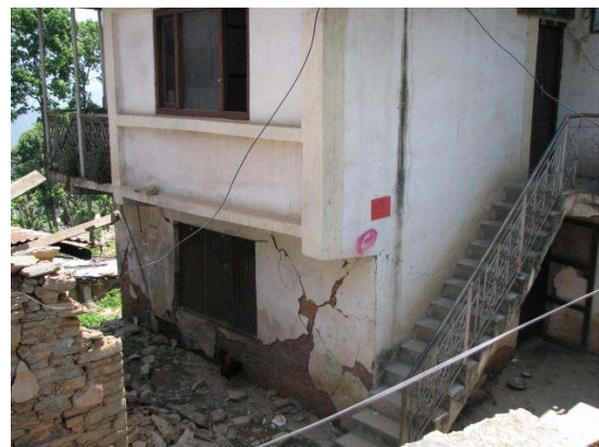
Figure 51. Red tagged structure with placard, Chautara.

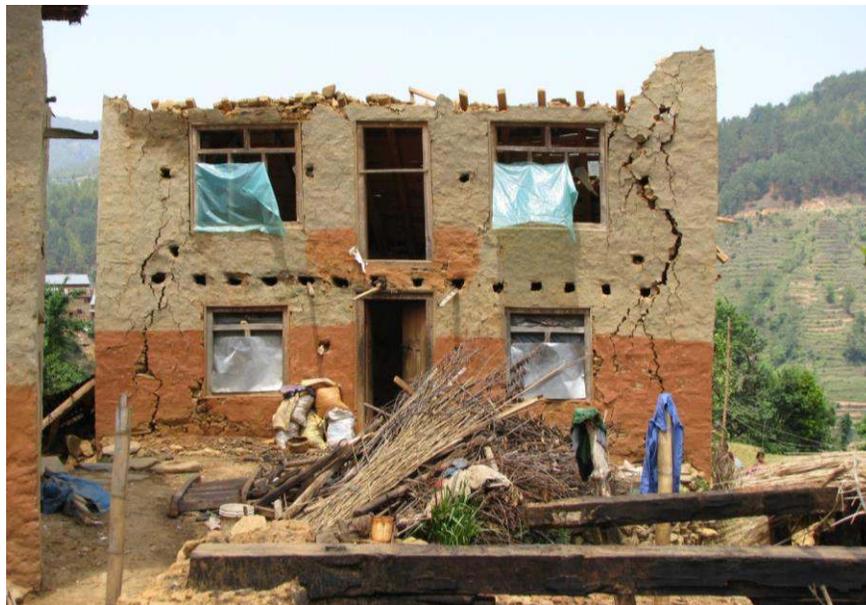
In the remote, rural hillside areas, most of house construction consists of stone masonry with mud mortar. These homes suffered the greatest amount of damage. Like unconfined brick masonry, wall corners and gable walls collapsed first. Without having even header courses to tie the width of the wall masonry together, and dried mud mortar that can be crushed to dust between fingers, the stone masonry walls disintegrated easily when subjected to the lateral earthquake forces. With the random layout nature and varying shapes and sizes of stone masonry, X-cracking was not frequently observed, or clearly visible, in these buildings.

Figure 53. Severely damaged stone masonry home with randomly shaped rocks, Thula Gaun.

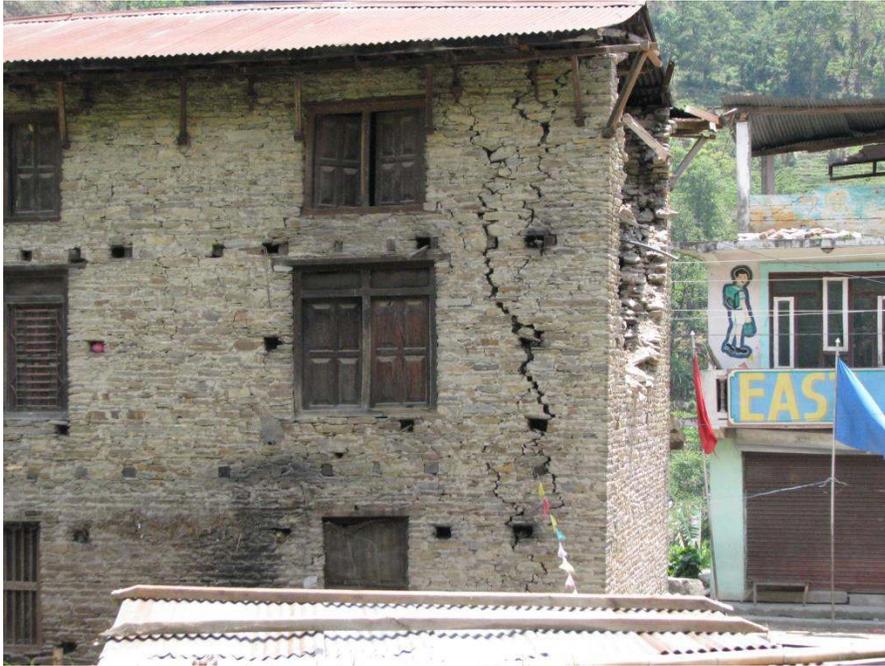
Figure 54. Damaged stone masonry with small cut stones, Mahankal.

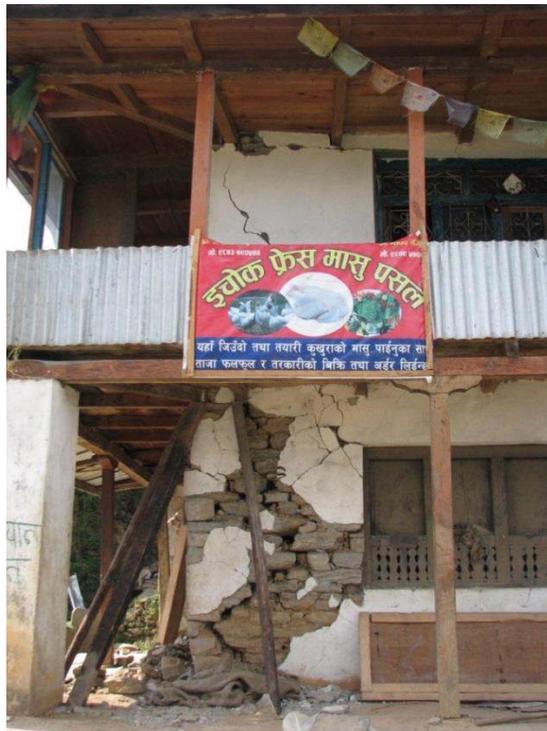
Figure 55. Large cut stones in damaged stone masonry, with plaster over stonework, Ichok.

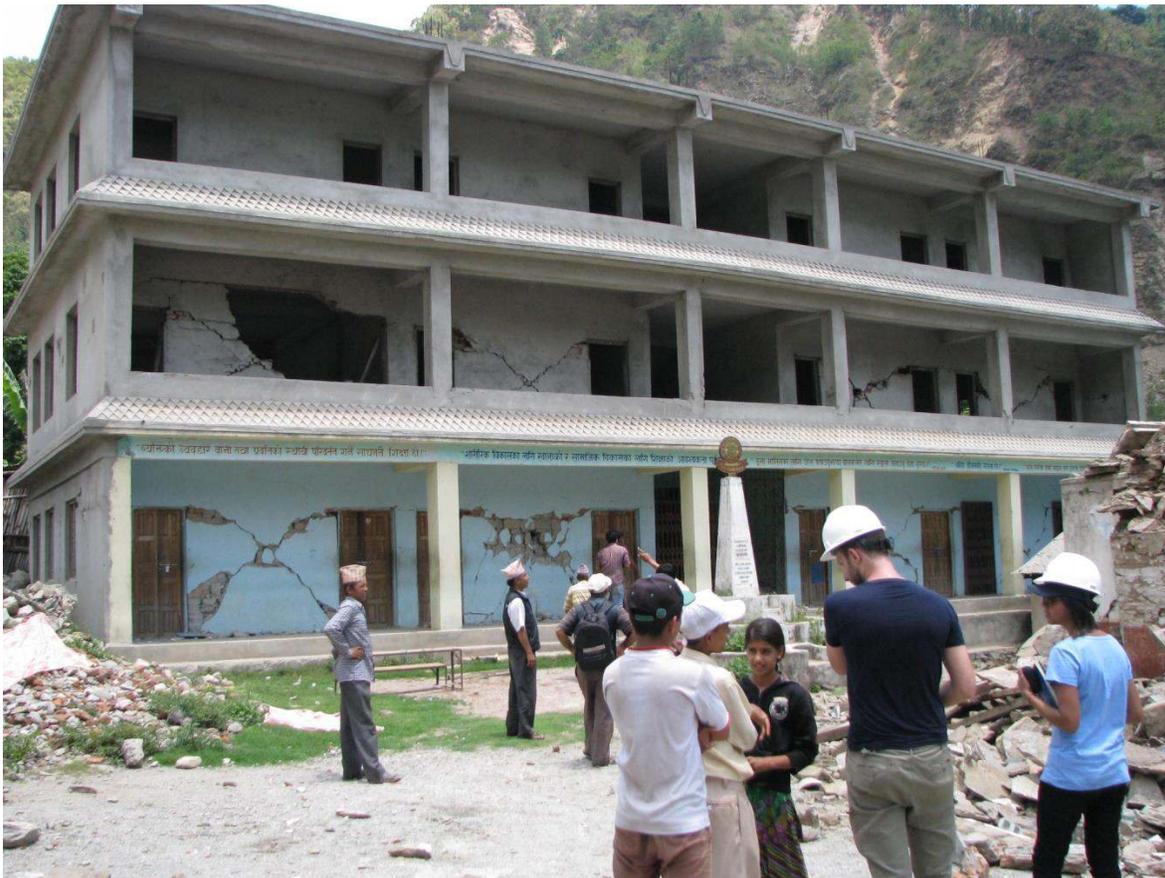
The Shree Saraswati Higher Secondary School in Mahankal has only one structure that may be able to be retrofit and repaired for use again. This was a 3-story concrete frame structure, consistent with the type of building being constructed in recent years at most other school sites. The structure is about 3 years old and took about 3-4 years to build, being built one story at a time as funding was available. The infill at the first, ground level story is a combination of stone and brick. The upper 2 stories both have brick infill. There is evidence of significant lateral movement – shear cracking of the infill and wacking of doorframes (See Figure 57). There was severe concrete spalling at the interior stairs, with cracking at the stair to floor landing joints that left exposed, making the stairs to the upper levels unsafe (See Figures 58 and 59).

*Figure 57. 3-story concrete frame Shree Saraswati School structure with shear cracking at infill walls, Mahankal.*

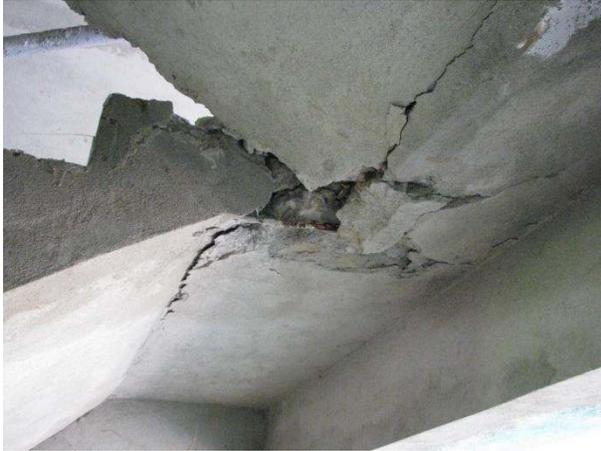
*Figure 58. Concrete cracking at stair floor landing.*

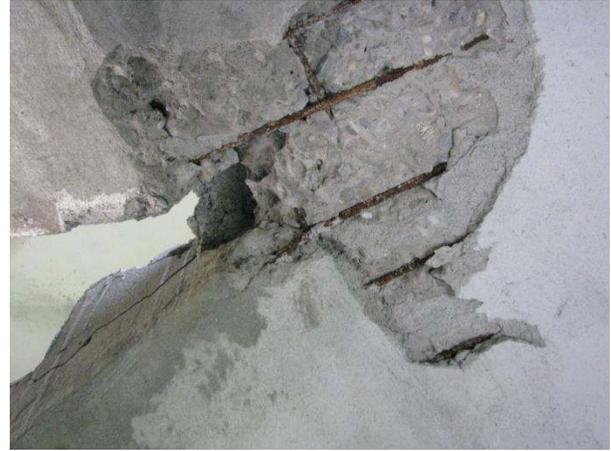
*Figure 59. Close-up of stair landing spalling, Mahankal.*

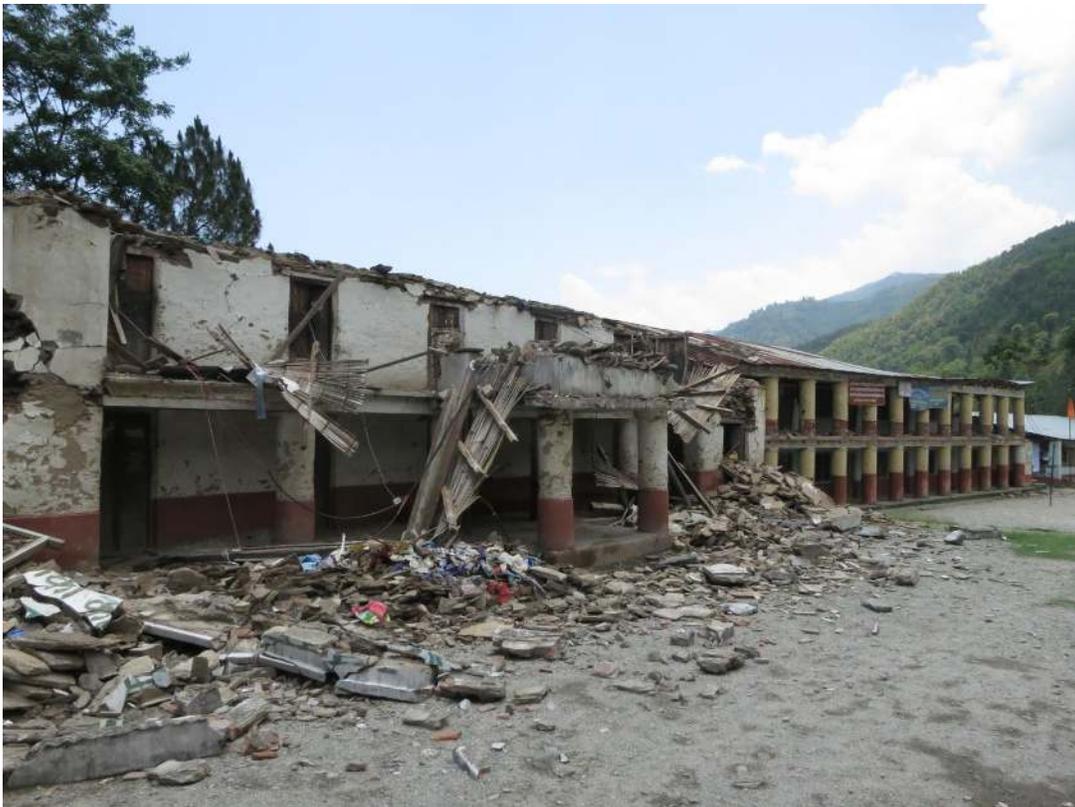
*Figure 60. Heavily damaged structures, 50 and 35 years old (left to right), at Shree Saraswati School, Mahankal.*

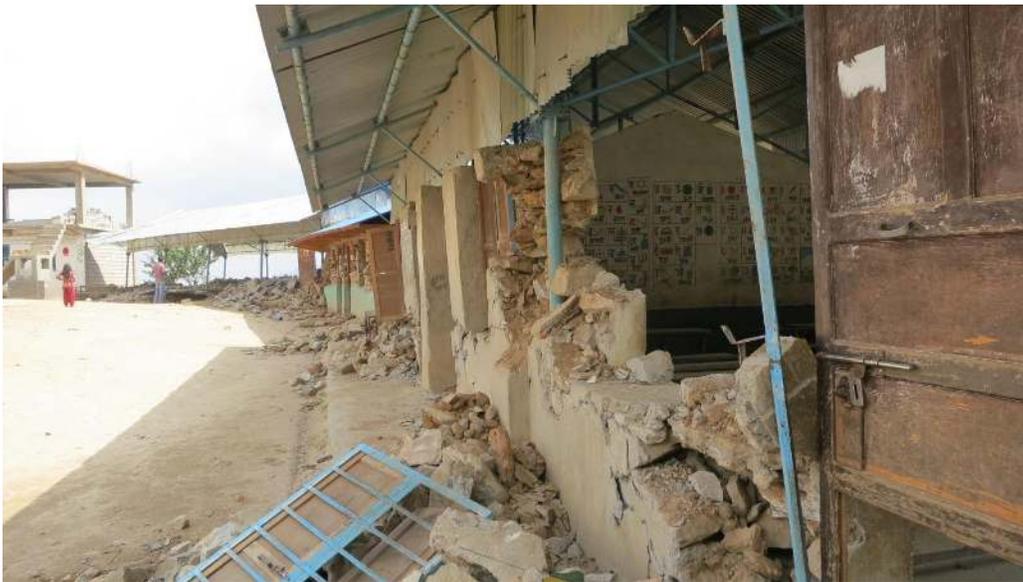
A multi-structure school in the remote village of Ichok also suffered similar damage as the Mahankal school. The older stone masonry structures had severe damage with most walls partially collapsed in the single story structures, although the steel supported and framed roof structures were still standing. Collapse of the walls appeared to be primarily due to out-of-plane failure of the unreinforced stone masonry. A newer two-story concrete frame structure was damaged primarily at the unfinished upper story. If the upper story were removed, the two lower story classrooms could be used again (See Figures 62 and 63).

*Figure 61. Damaged single-story structures at school, Ichok.*

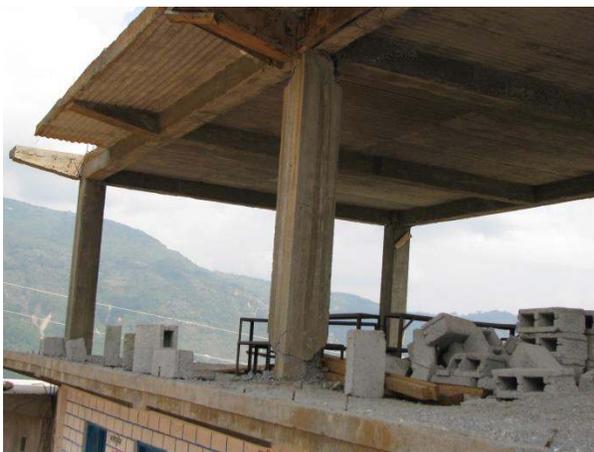
*Figure 62. Unfinished second story of school, Ichok.*

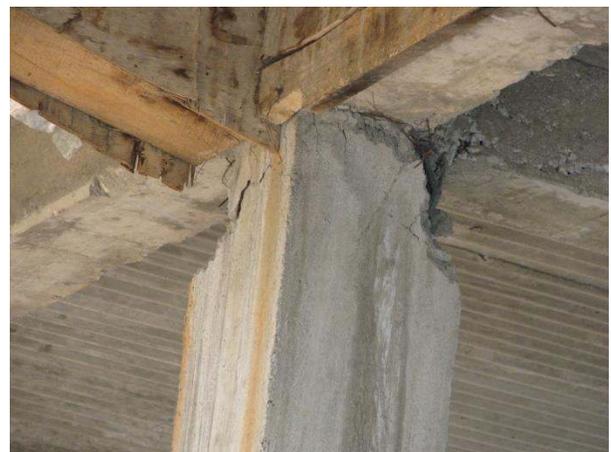
*Figure 63. Beam-column connection damage, Ichok.*

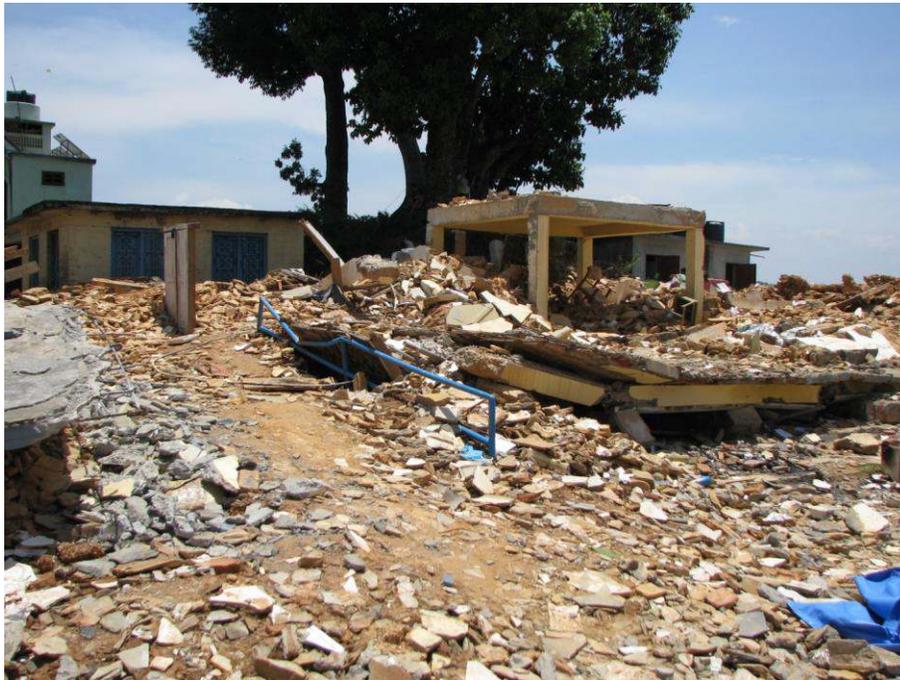
Most schools observed had similar damage types. Typically, the more recent concrete frame buildings showed evidence of shear cracking in the infill and damage at beam-column joints, while older stone masonry structures typically had wall failure and collapse, for the same reasons as previously discussed for other buildings. A school observed in Chautara had been entirely reduced to piles of rubble. The only discernable sign of a building was a door still standing in the middle of a rubble pile, as seen in figure 64.

*Figure 64. Collapsed school buildings, Chautara.*

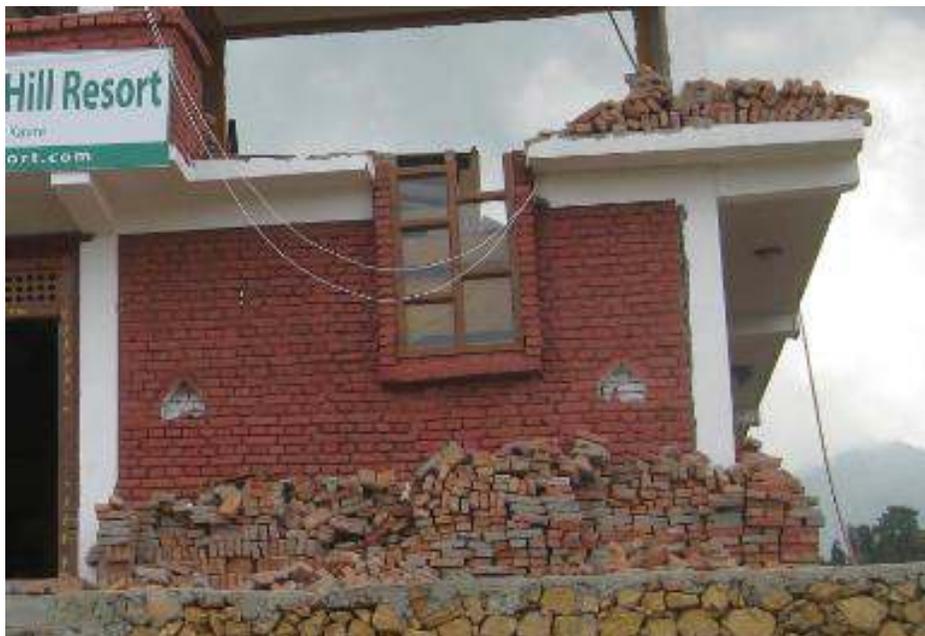
*Figure 65. Construction of non-continuous, non-code complying beam at stairway of hotel structure in rural area, Thula Gaun.*
