April 25, 2015 – GORKHA EARTHQUAKE, NEPAL

**Report Released May 31, 2015
Updated October 1, 2015**

Build Change Post-Disaster Reconnaissance Report

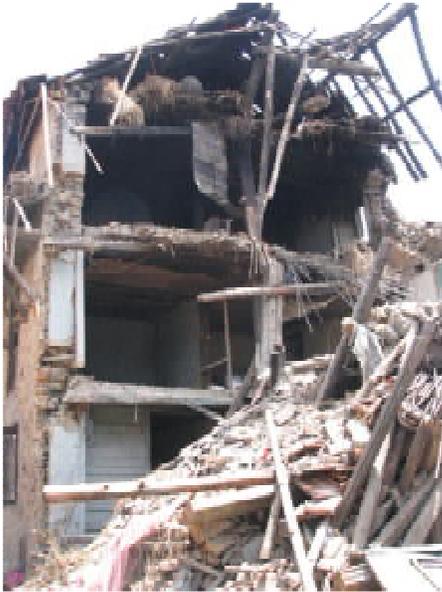
Figure 2. Housing damage in Bungamati.

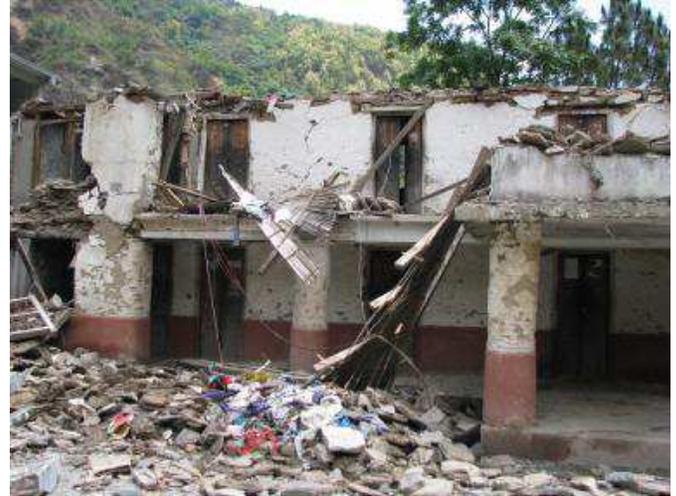
Figure 3. Damaged school in Mahakal, Sindhupalchok.

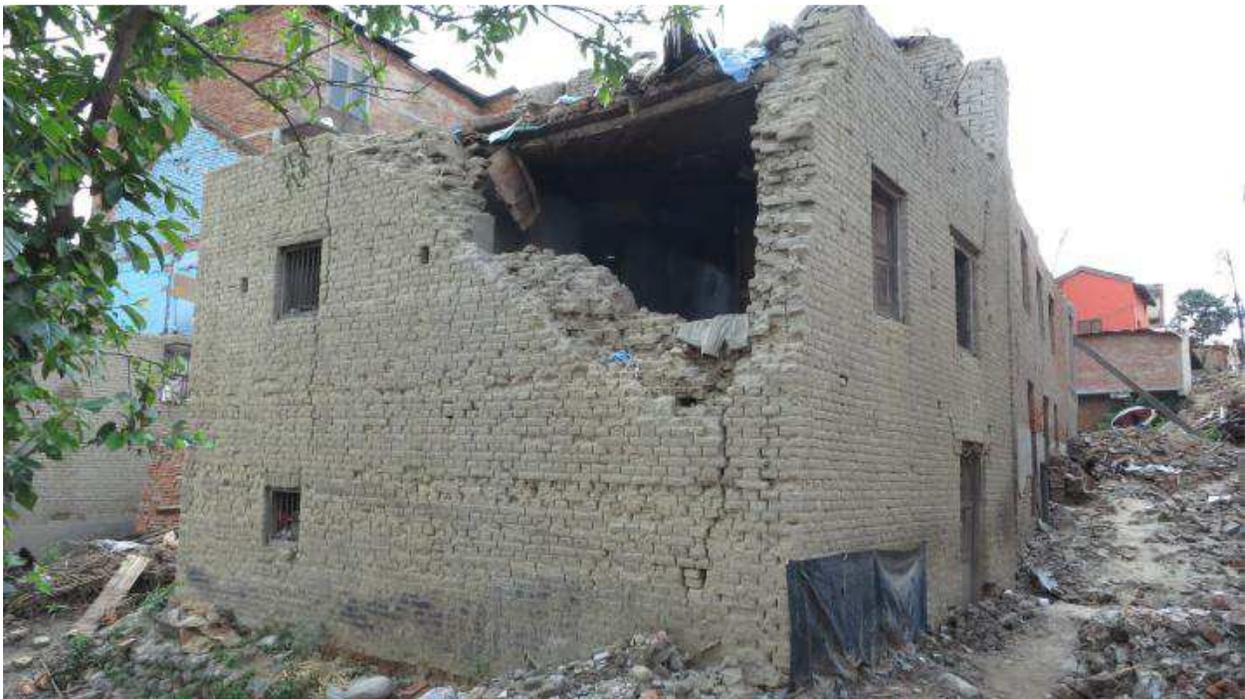
In some areas, unfired brick was used for construction, see Figure 23 and 24. As observed in Sankhu, unfired brick is typically paired with mud mortar, like adobe construction, creating a weak wall in comparison to fired brick with cement mortar.

Figure 24 Damaged unfired brick and mud house in Sankhu

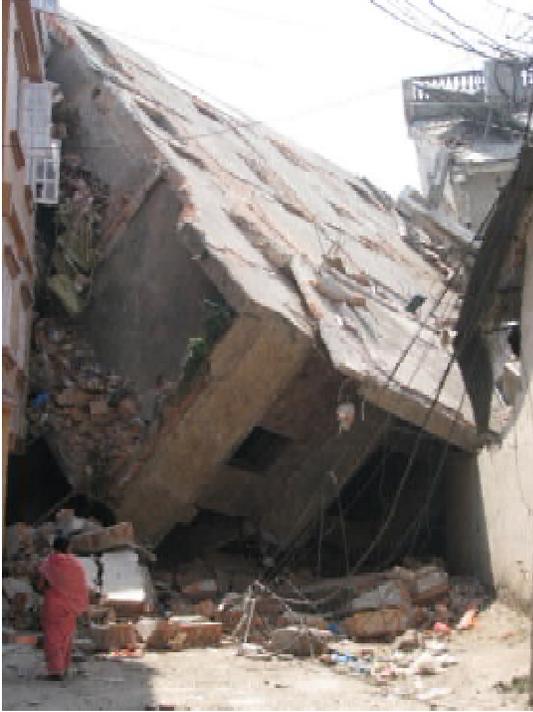
Store front/soft story failures were more common at recent construction where the concrete columns at the ground level would fail at the column top or bottom joints. Often, after a failure of one or more ground story concrete columns, the upper portion of the structure would remain intact as the building fell over to one side (See Figures 41 – 43 for examples of this failure).

Figure 41. Soft story failure, Kuleswor.

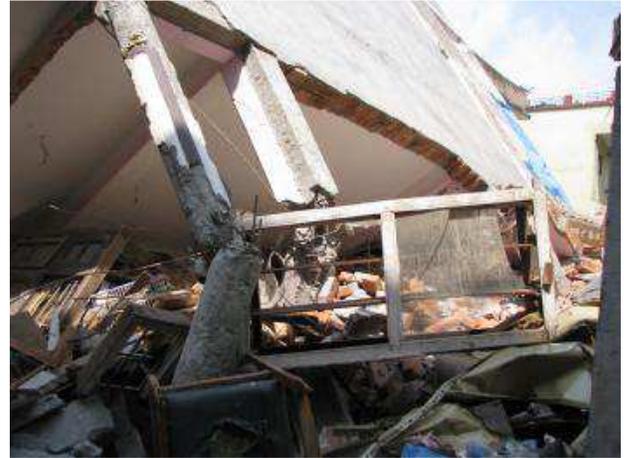
Figure 42. First story column failure, Balkhu.

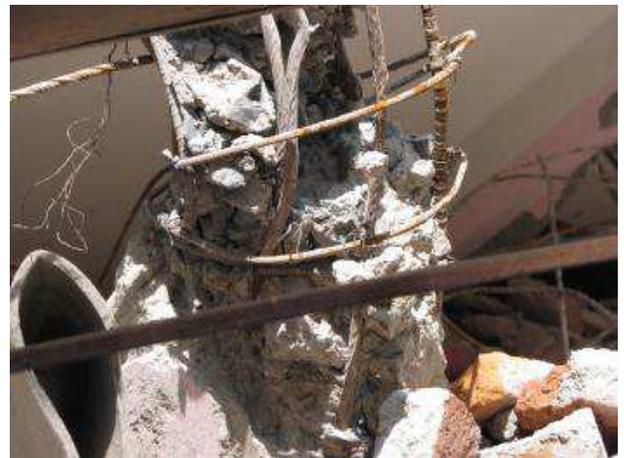
Figure 43. Close up of Figure 35 column failure, Balkhu.

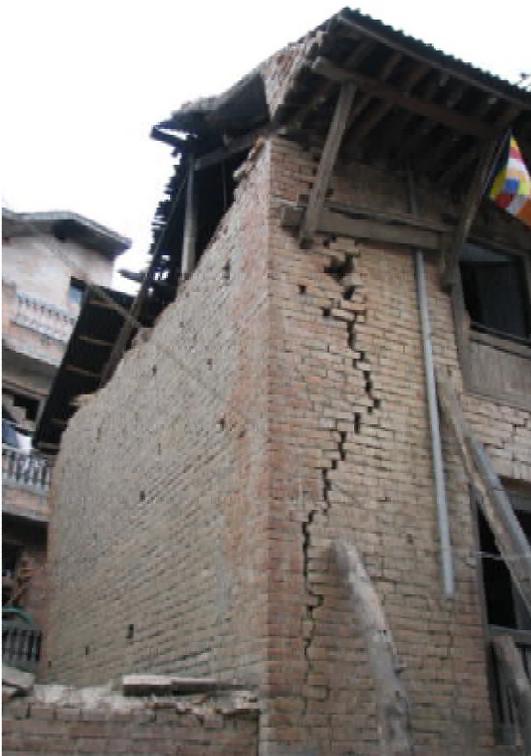
At older construction that did not utilize concrete frames, there was a substantially higher rate of failure and collapse, particularly at the wall corners and gable roof ends. There is no reinforcement tying perpendicular walls together at the corners. While the low ends of the roofs are supported by masonry walls, and the timber roof framing often runs into the wall, the gable wall ends had no ties or bracing back to the roof framing, and were frequently a source of initial collapse.

Figure 44. Gable wall failure & corner separation, Khokana.

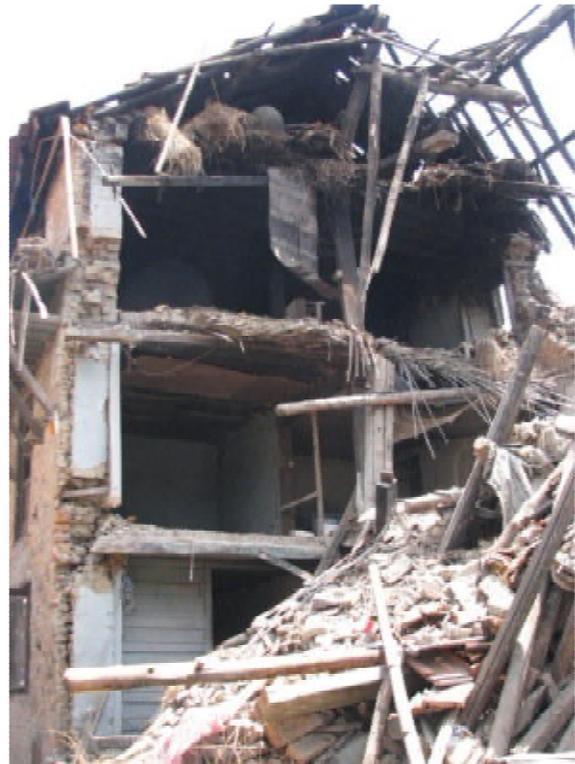
Figure 45. End wall collapse, Bungamati.

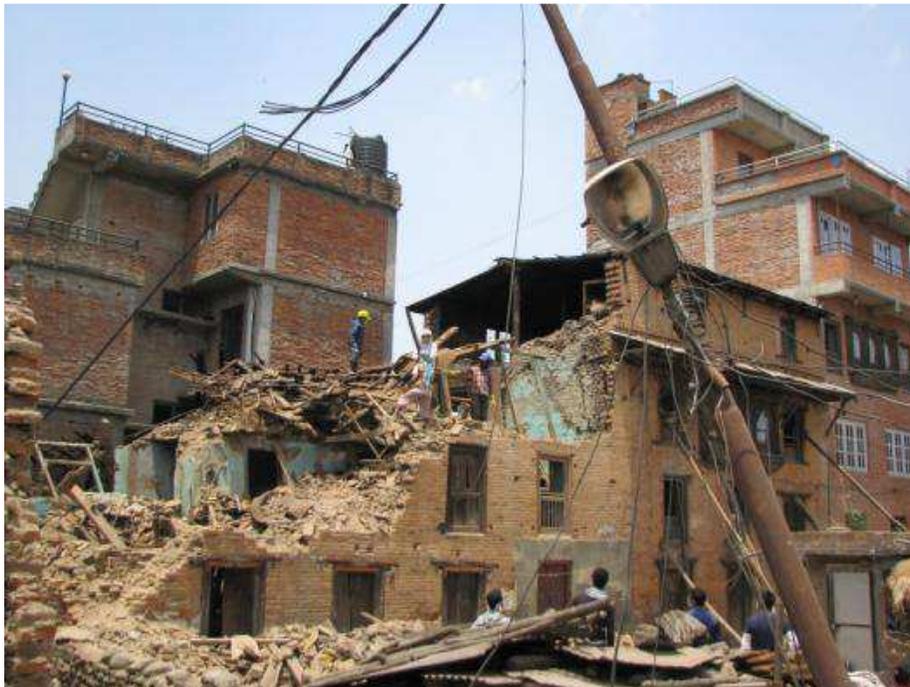
Figure 47. Unconfined masonry collapse. Note undamaged infilled frame in background, Khokana.

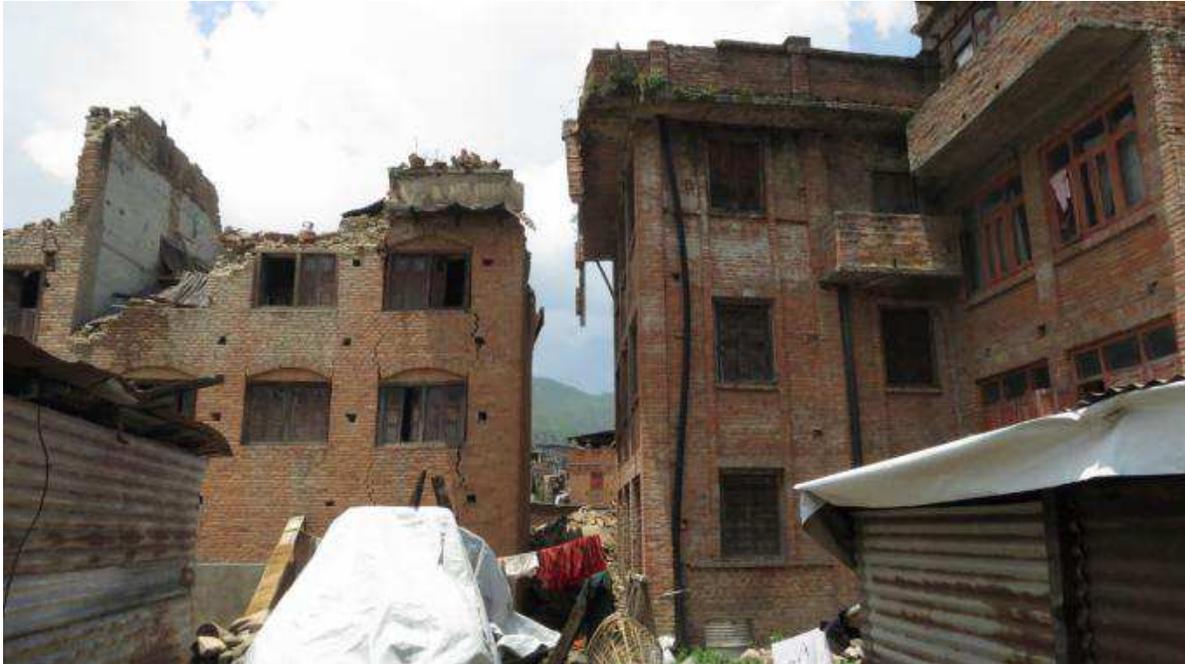
In Sankhu, many of the buildings were constructed of unreinforced masonry. Some buildings were constructed with brick and mud mortar, while others were constructed with brick and cement-based mortar. The buildings utilizing cement-based mortar clearly performed better than those with mud. This could be observed in relatively similar (with the exception of the

Figure 48. Sankhu - Both buildings are 3-4 stories, with wood floors and fired brick walls. The building on the left utilized mud mortar and sustained significant damage, while on the right the building used cement mortar and had no observable damages.

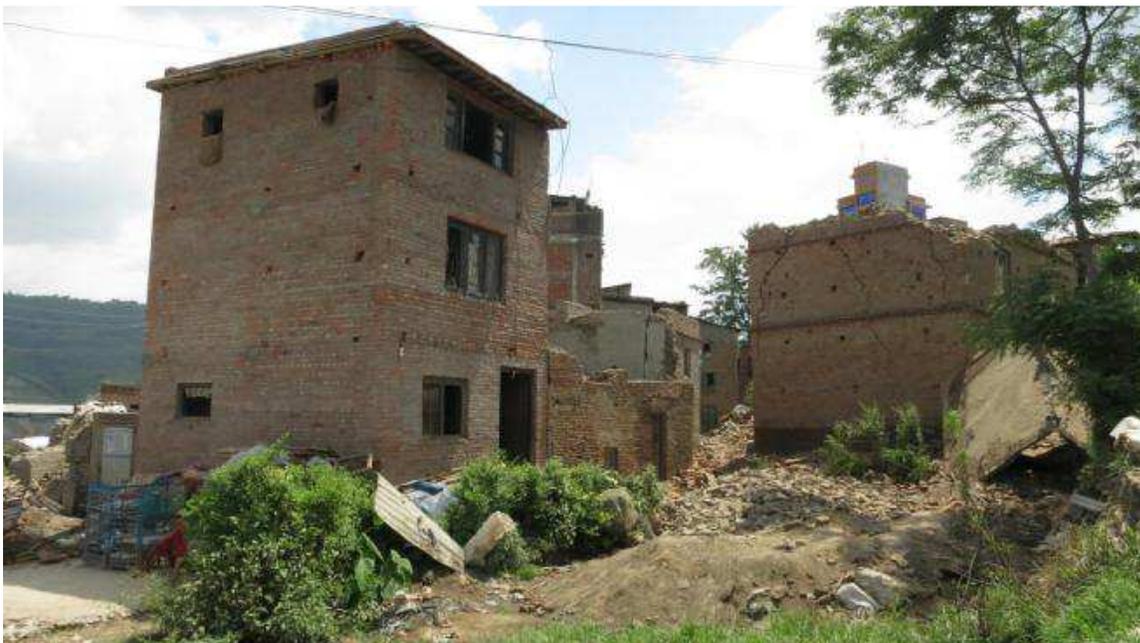
Figure 49. Sankhu – Left side three-story building used cement mortar and had minimal damage, center one-story and right two-story used mud mortar and suffered significant damage.

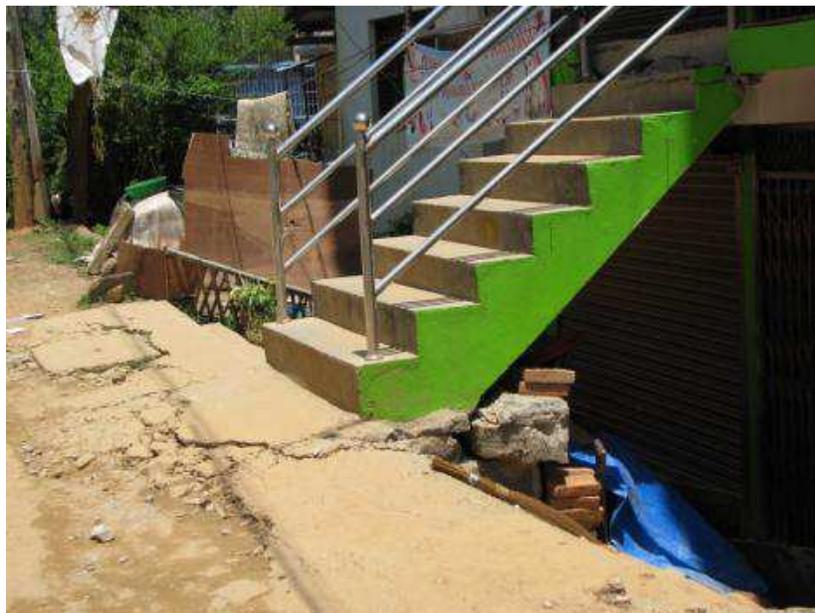
Cracking along entire front side at the base of buildings located above the steep hillsides was often clearly evident even where no other building damage was noted. Where hillside building failures did occur, it often appeared to be due to inadequate ties to a foundation or partial lower level, or a lack of a solid foundation – such as the use of stone rubble for foundations. The presence of buildings lower on the hillside, below the upper buildings, prevented closer observation to try to determine whether the damage observed was actually due to foundation slippage or failure, or damage to lower hillside columns or walls.

Figure 50. Evidence of foundation shifting at front of building (bottom of stair), Chautara.

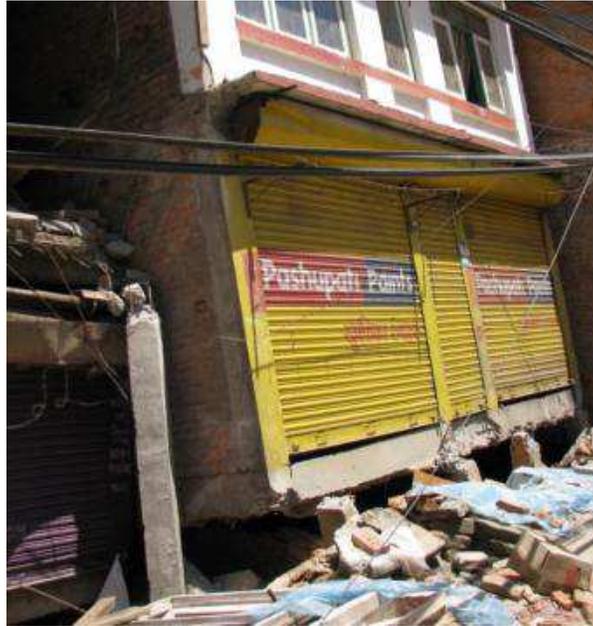
In more urban hillside areas, such as Chautara, in the Sindhupalchok district, landslides due to earthquake ground motion combined with inadequate foundation systems appeared to be the major cause of building failure and collapse. The age of construction varies greatly, with materials ranging from unconfined stone masonry with mud mortar at older buildings to concrete frame with brick infill and cement masonry. But regardless of construction type and age, a lack of adequate foundations for the steep hillside sites contributed to many of the collapsed and damaged structures.

Figure 51. Foundation/lower level failure on hillside, Chautara (See Figures 52 & 53 for column failure details).

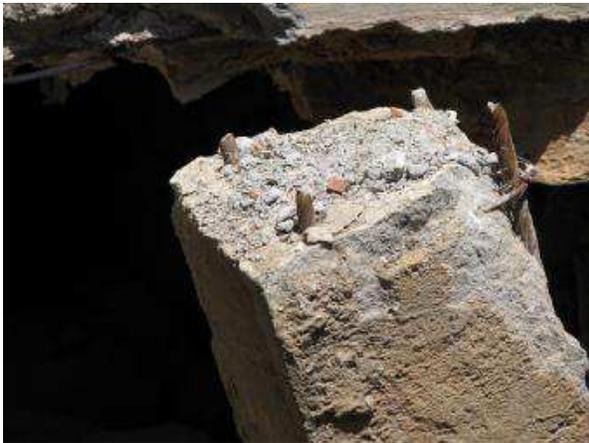
Figure 52. Foundation column failure, Chautara.

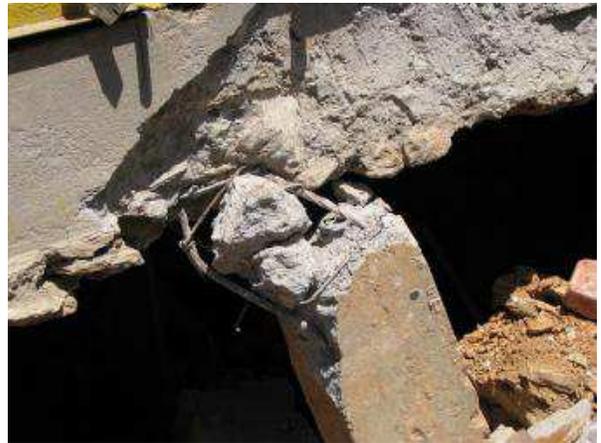
Figure 53. Foundation column failure, Chautara.

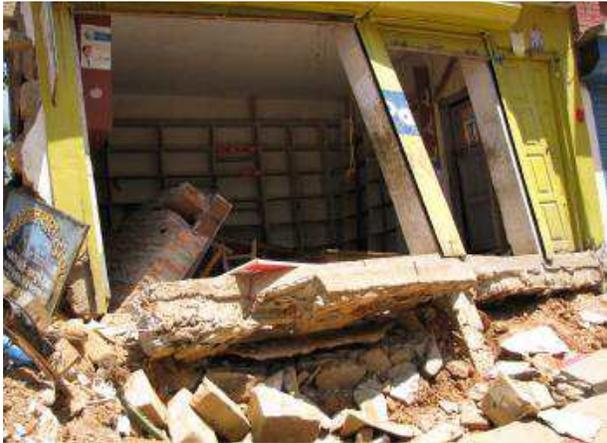
Figure 54. Foundation failure, Chautara.

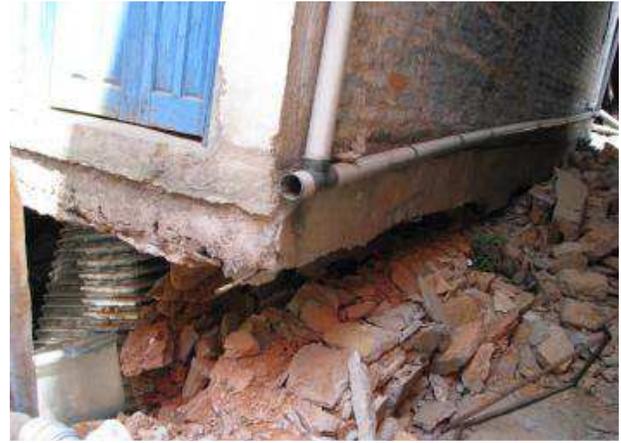
Figure 55. Foundation failure, Chautara.

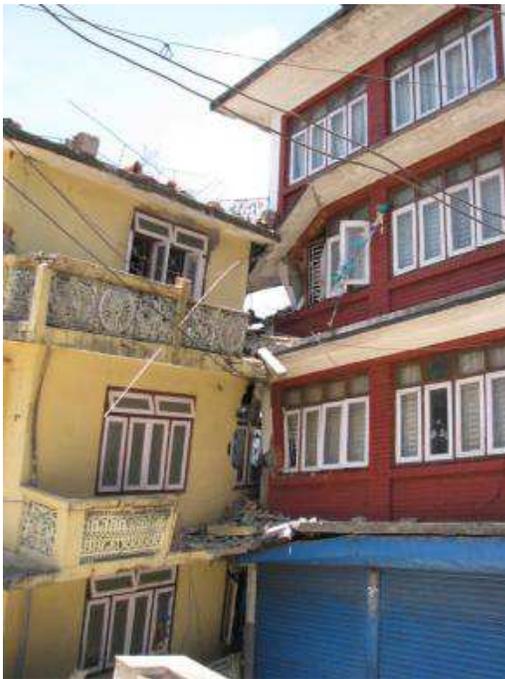
Figure 56. Damage due to adjacent building collapse, Chautara.

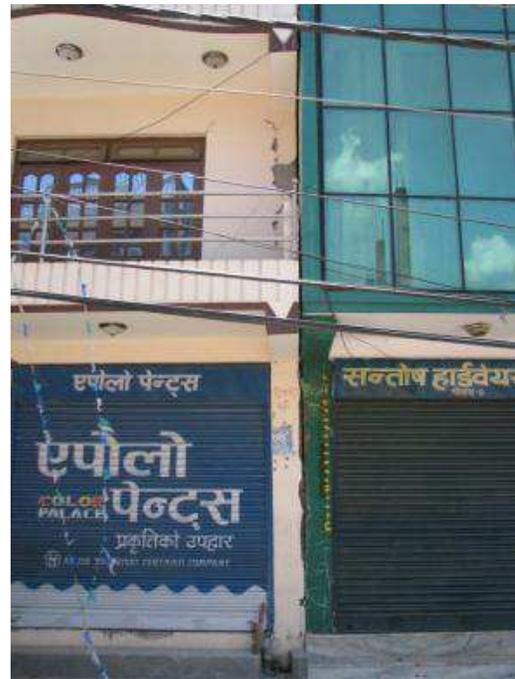
Figure 57. Pounding damage, Chautara.

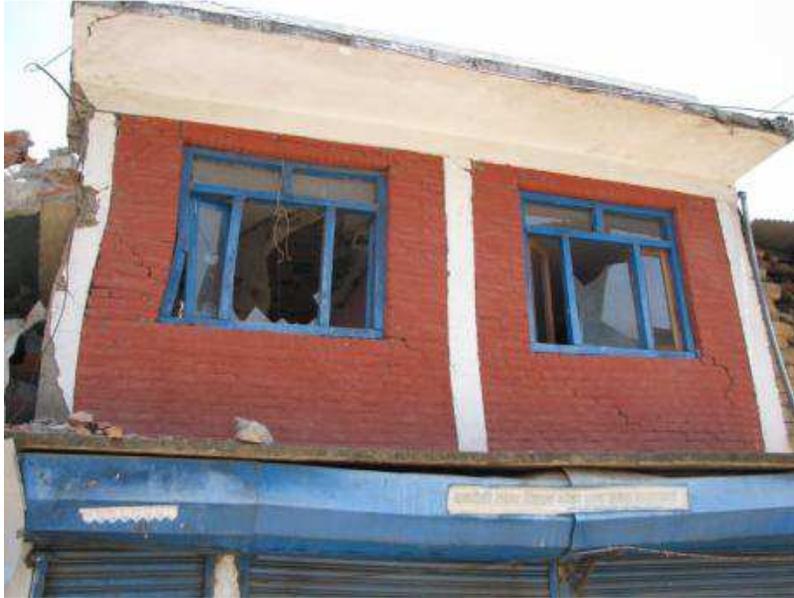
Figure 58. Damage due to pounding and collapse of adjacent building, Chautara.

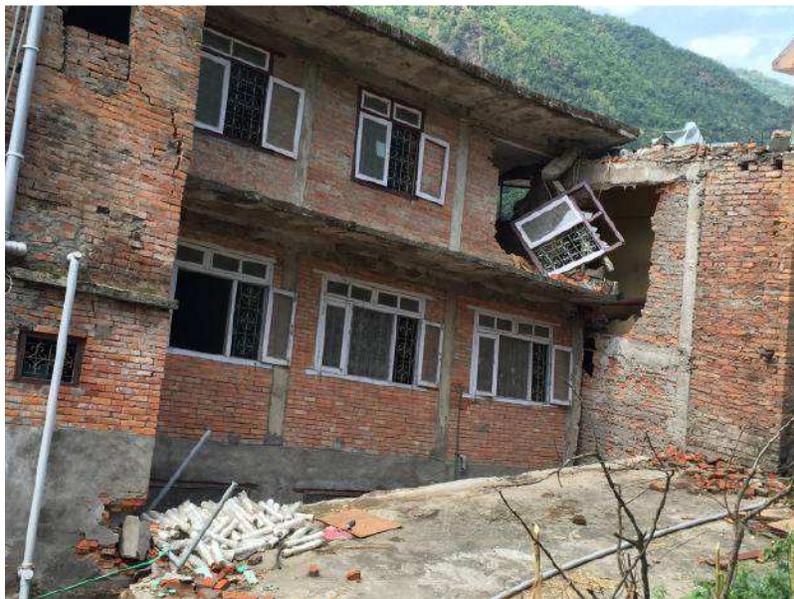
Figure 59. Damage due to collapse of adjacent building, Lamosanghu.

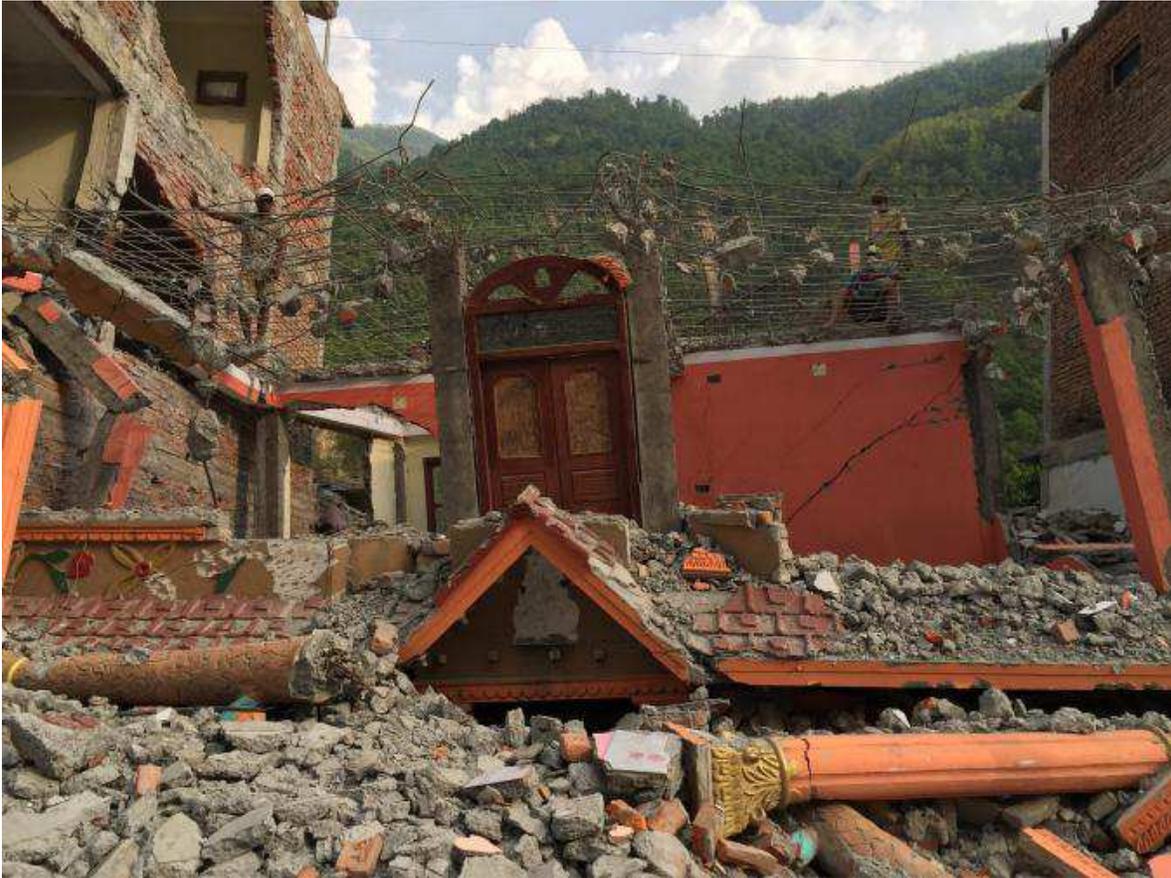
Figure 60. Demolition of collapsed building. Note damage to adjacent building caused by building collapse, Khadichaur.

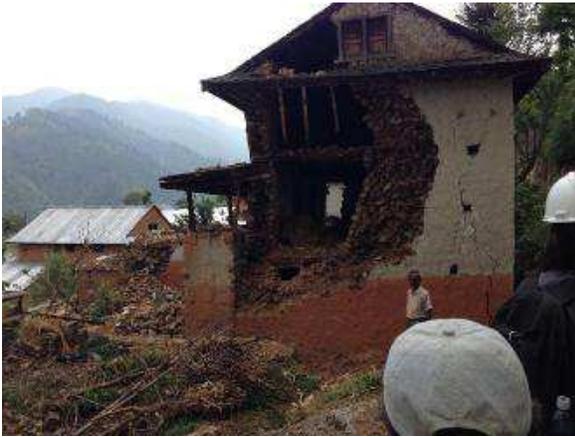
Figure 64. Damaged two story house in Mahankal Chaur

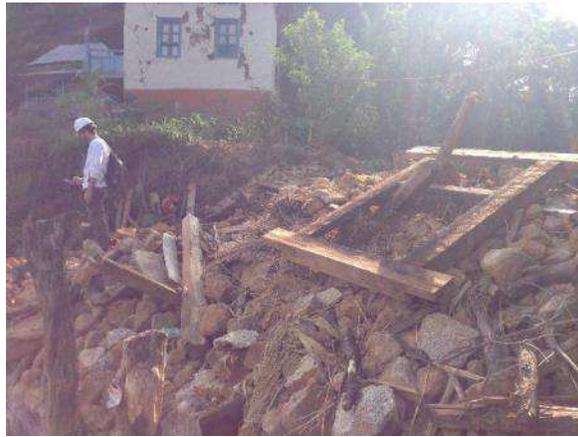
Figure 65. Complete collapse of house, Dhungharka

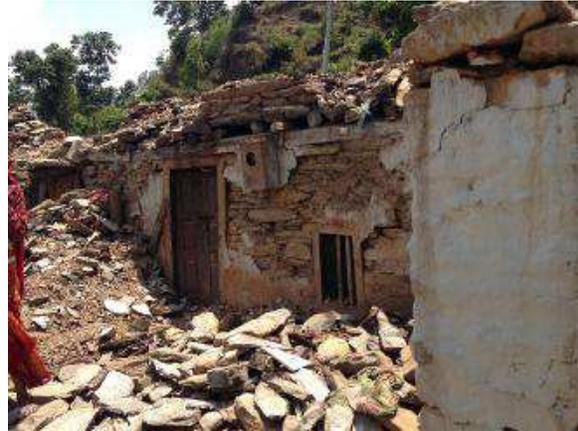
Figure 68. Collapsed house in Ramche

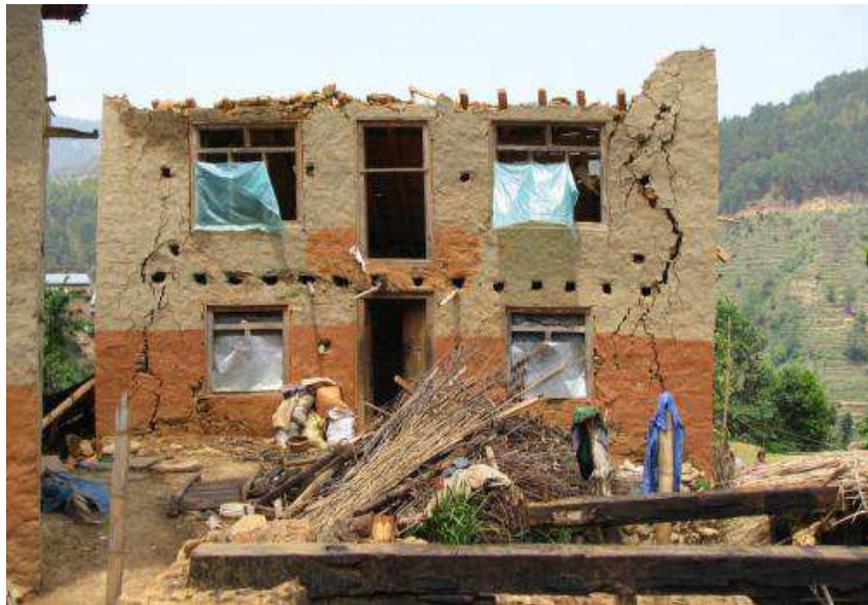
In the remote, rural hillside areas, most of house construction consists of stone masonry with mud mortar. These homes suffered the greatest amount of damage. Like unconfined brick masonry, wall corners and gable walls collapsed first. Without having even header courses to tie the width of the wall masonry together, and dried mud mortar that can be crushed to dust between fingers, the stone masonry walls disintegrated easily when subjected to the lateral earthquake forces. With the random layout nature and varying shapes and sizes of stone masonry, X-cracking was not frequently observed, or clearly visible, in these buildings.

Figure 69. Severely damaged stone masonry home with randomly shaped rocks, Thula Gaun.

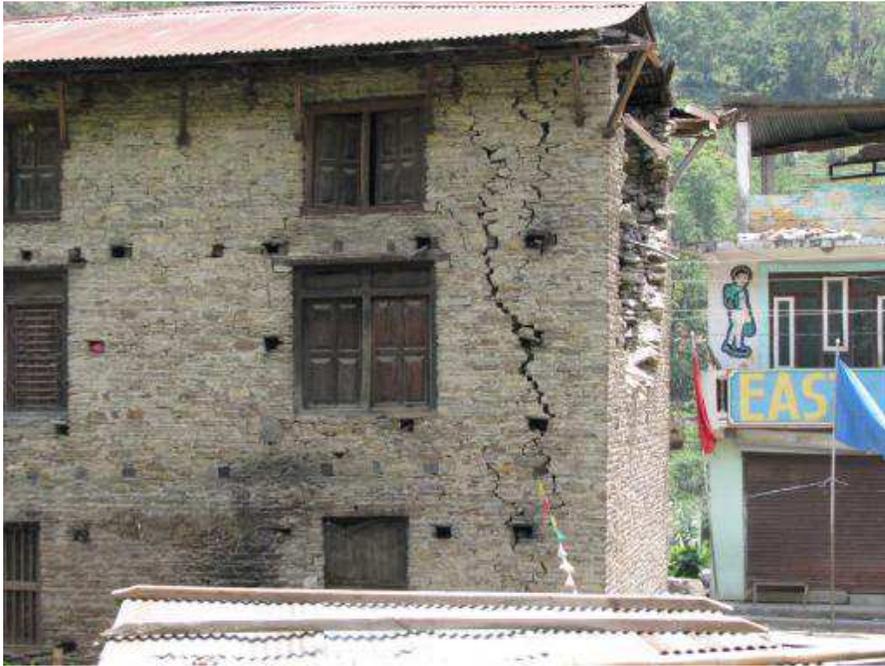
Figure 70. Damaged stone masonry with small cut stones, Mahankal, Sindhupalchok.

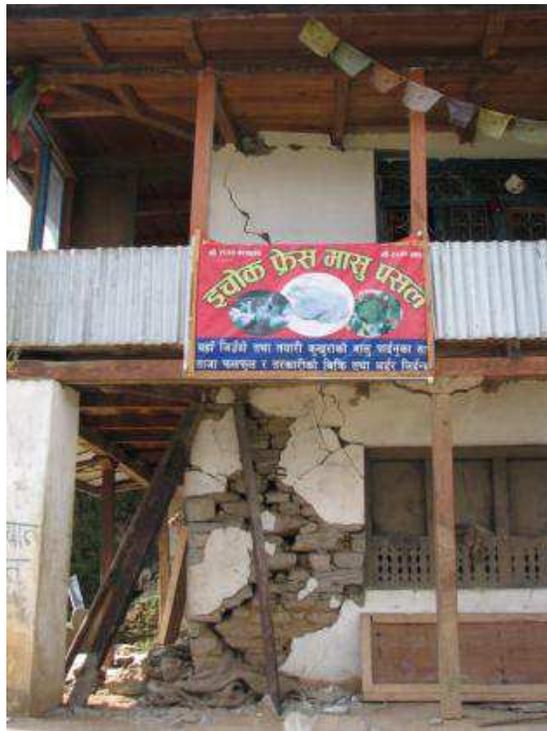
Figure 71. Large cut stones in damaged stone masonry, with plaster over stonework, Ichok.

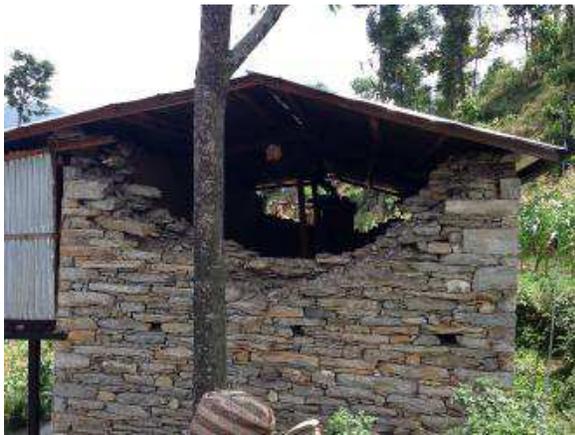
There were many cases of out of plane stone wall failures in the rural villages, likely due to a number of deficiencies in the configuration and construction of the walls. The typical floor plan had masonry exterior walls but with limited internal cross walls. Internal cross walls can provide important out-of-plane support to the exterior walls and also increase the lateral strength of the house. The wood-framed floors are not specifically built stiff enough or well-connected enough to provide adequate resistance for bracing two-story walls out-of-plane. Therefore walls may have been effectively unbraced over the full two-story height, leading to slender walls that are more likely to collapse. The masonry walls were commonly missing ties and bands that help the unreinforced stone masonry span out-of-plane and transfer loads to the foundation in-plane. The absence of bands can lead to early failure of the wall in-plane and especially out-of-plane.

Figure 73. Out of plane wall failure, Ramche VDC

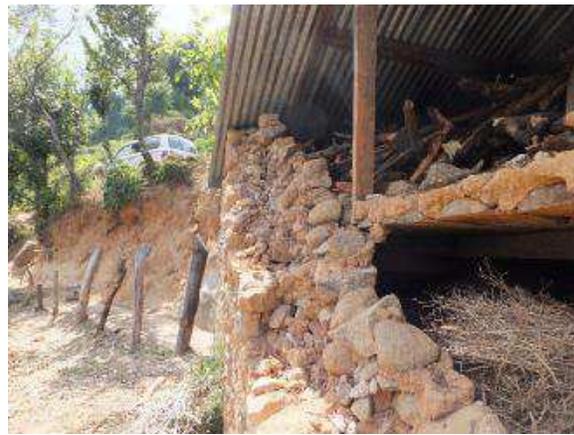
Figure 74. Out of plane wall failure, Dhungharka VDC

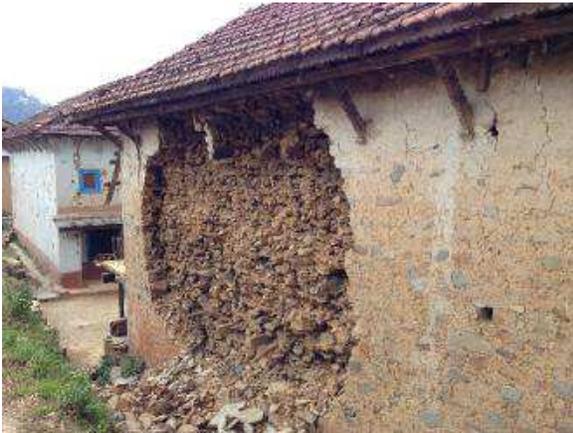
One of the primary failure modes for the walls was the delamination of the interior or exterior wall faces. This failure mode is due to the typical construction technique of building the walls with stone masonry on the inside and outside faces and filling the void between the two faces with rubble or debris. Through stones that would tie together the inside and outside faces and prevent delamination were not used in any of the houses that were observed.

Figure 75. Delaminated wall failure, Chalal Ganeshthan VDC

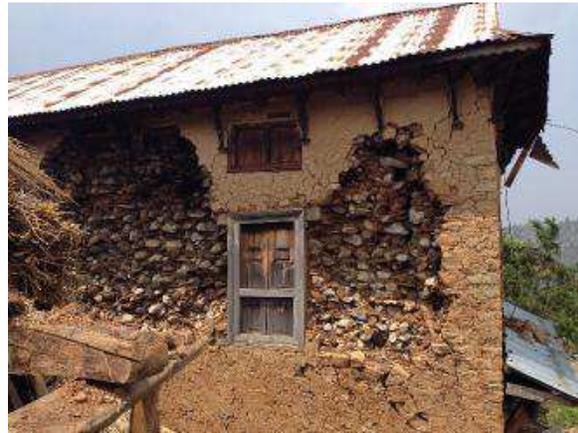
Figure 76. Delaminated wall failure, Mahankal Chaur VDC

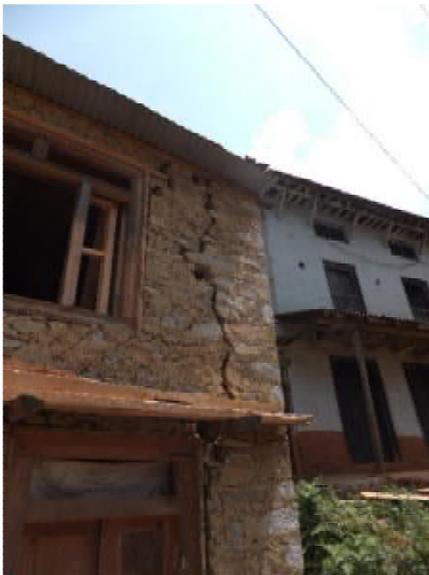
It was common for stone walled houses to have small holes in the walls. The homeowners explained that the holes were created when the walls were built to support temporary scaffolding used by the builders to construct the walls. It is standard practice for the holes to be left in place, in part to allow for scaffolding to be installed to build vertical additions to the house or to make repairs to the wall. There were cases where cracks in the walls either formed in or propagated through these holes, especially at holes that were adjacent to building corners.

Figure 77. Cracks through holes in walls, Dhungharka VDC

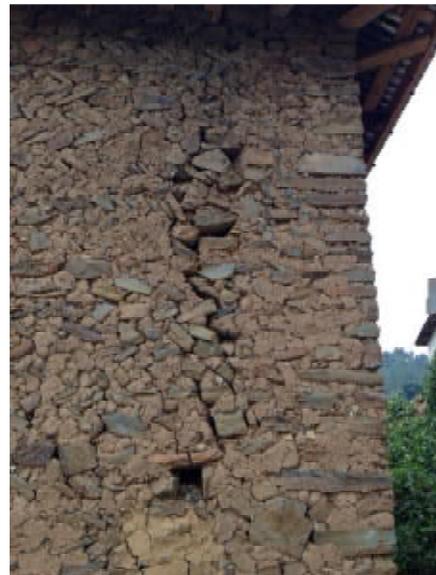
Figure 78. Cracks through holes in walls, Chalal Ganeshthan VDC

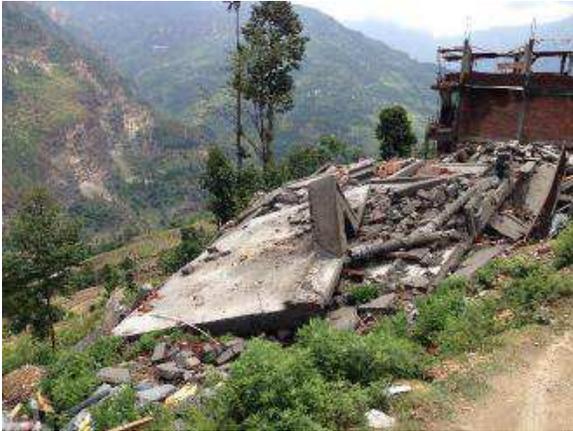
In many cases, houses built on slopes did not have the appropriate configuration required to support the house during the earthquake. There were many houses built on hillsides that suffered major damage or collapse because the foundation was undermined by the soil underneath them sliding away. In Maneshwor, for example, the houses that were on the slope

suffered significantly more damage than those built just across the street but away from the slope.

Figure 79. Collapsed house on a hillside, Maneshwor VDC

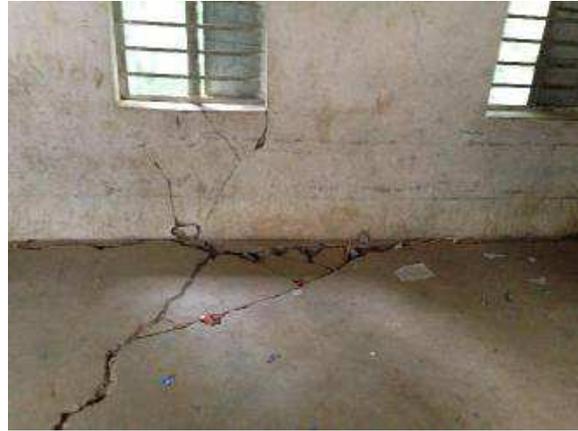
Figure 80. Undermined foundation slab in school, Chyasingkharka VDC

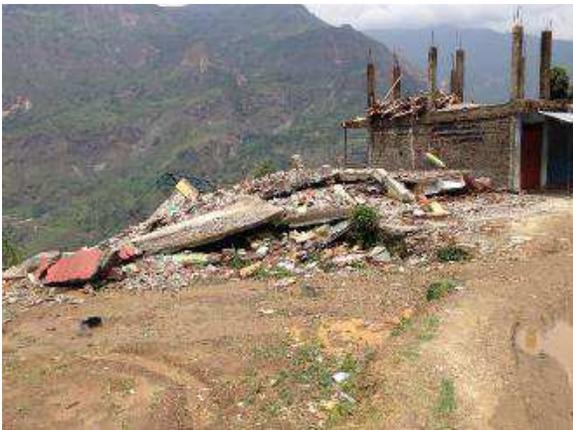
There were many houses in Maneshwor constructed with concrete frames with brick infill and there was a significant amount of damage to those houses. In addition to the collapses due to undermined foundations, weak story collapses and damage to brick infill walls were common. There was much less damage to concrete frame houses in the Kavrepalanchok villages. However, there was relatively fewer concrete frame houses in these villages compared to Maneshwor. In Chalal Ganeshtan, for example, concrete frame and brick housing was mostly limited to a cluster of houses at the center of the village. These houses sustained little to no visible damage.

Figure 81. Collapsed concrete frame house, Maneshwor VDC

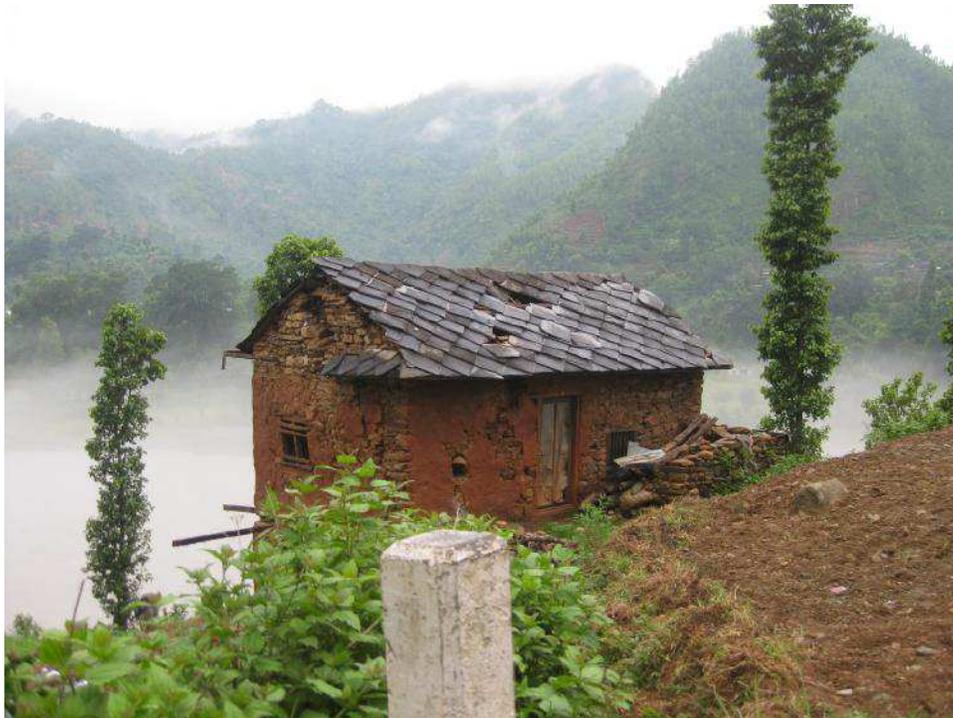
Figure 85. Example of a typical damaged stone and mud house with slate tile roof, Lachyang.

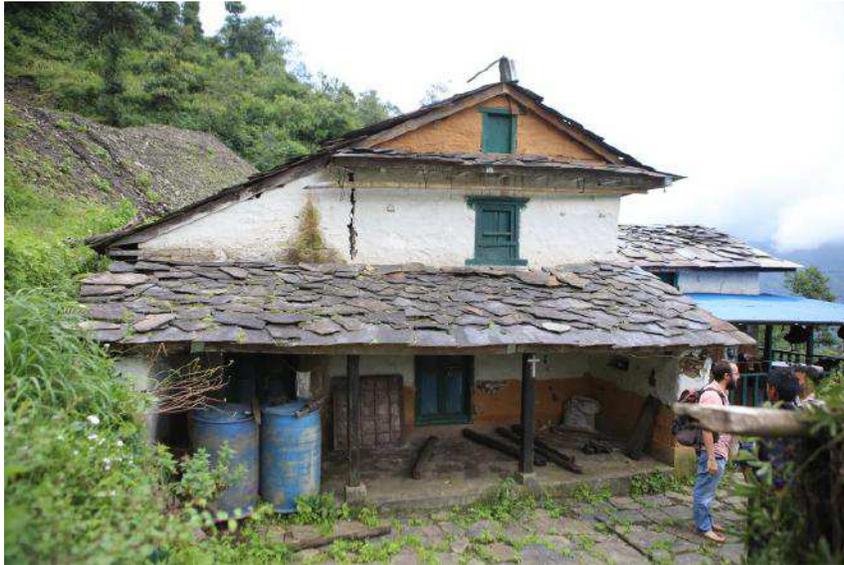
Figure 89. Typical house in Ragani constructed from stone and mud, damaged

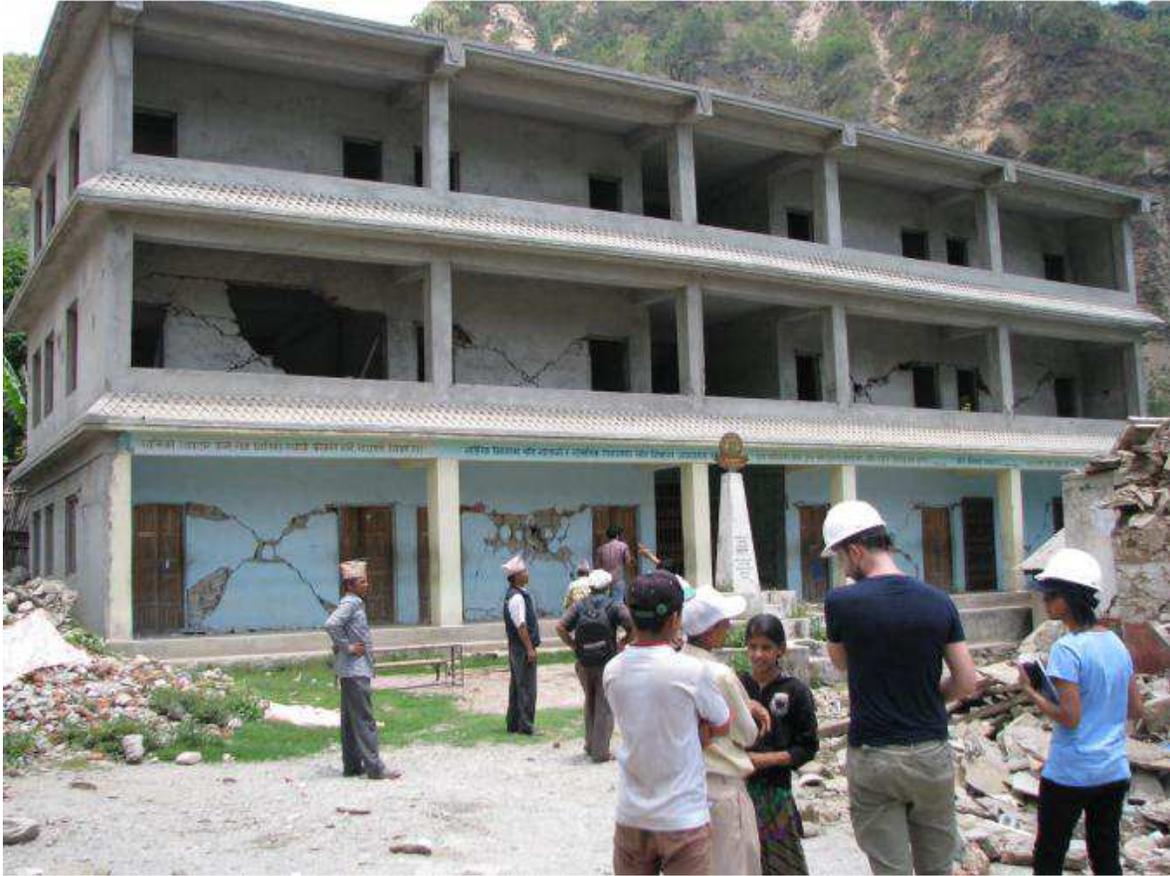
The Shree Saraswati Higher Secondary School in Mahankal has only one structure that may be able to be retrofit and repaired for use again. This was a 3-story concrete frame structure, consistent with the type of building being constructed in recent years at most other school sites. The structure is about 3 years old and took about 3-4 years to build, being built one story at a time as funding was available. The infill at the first, ground level story is a combination of stone and brick. The upper 2 stories both have brick infill. There is evidence of significant lateral movement – shear cracking of the infill and wacking of doorframes (See Figure 94). There was severe concrete spalling at the interior stairs, with cracking at the stair to floor landing joints that left exposed, making the stairs to the upper levels unsafe (See Figures 95 and 96).

Figure 94. 3-story concrete frame Shree Saraswati School structure with shear cracking at infill walls, Mahankal.

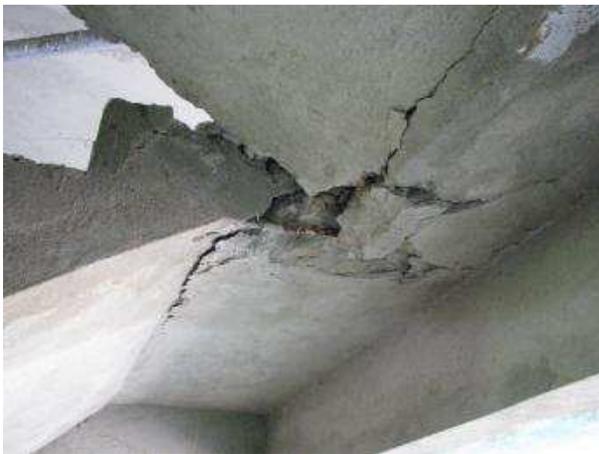
Figure 95. Concrete cracking at stair floor landing.

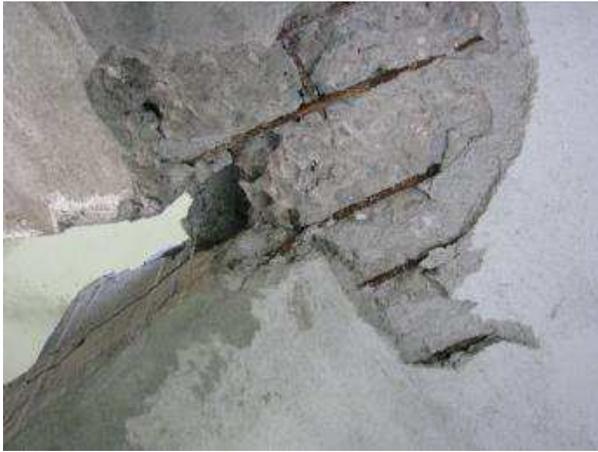
Figure 96. Close-up of stair landing spalling, Mahankal.

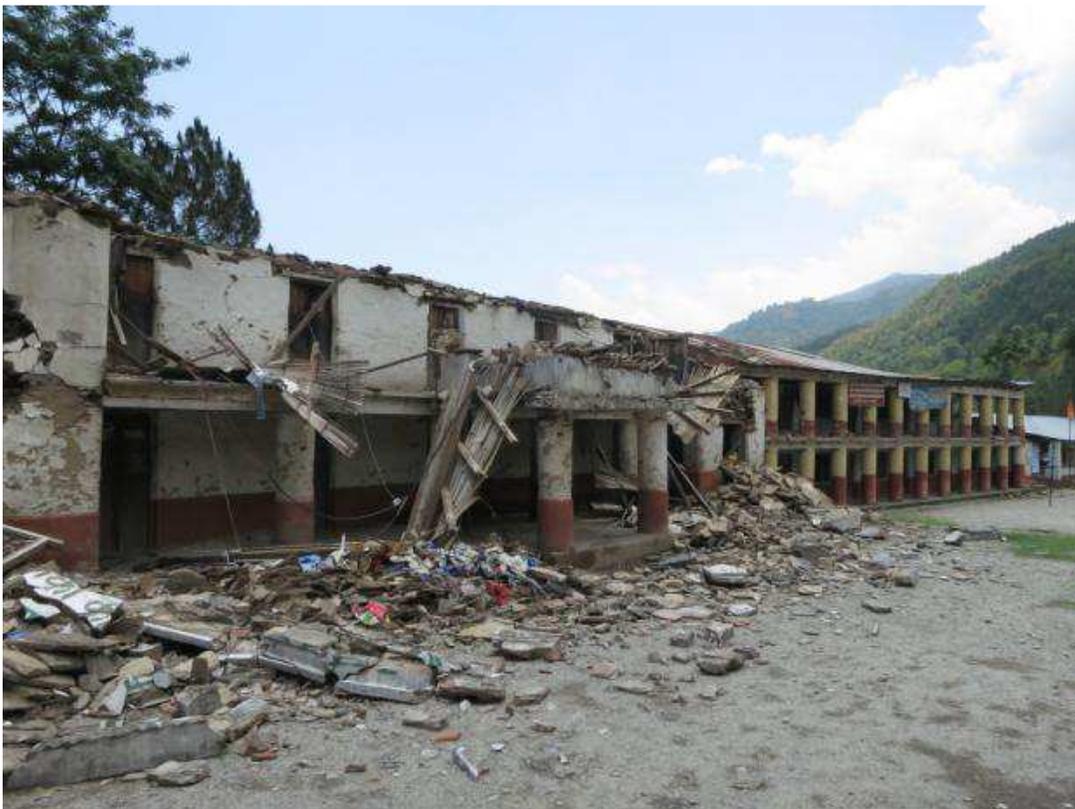
Figure 97. Heavily damaged structures, 50 and 35 years old (left to right), at Shree Saraswati School, Mahankal.

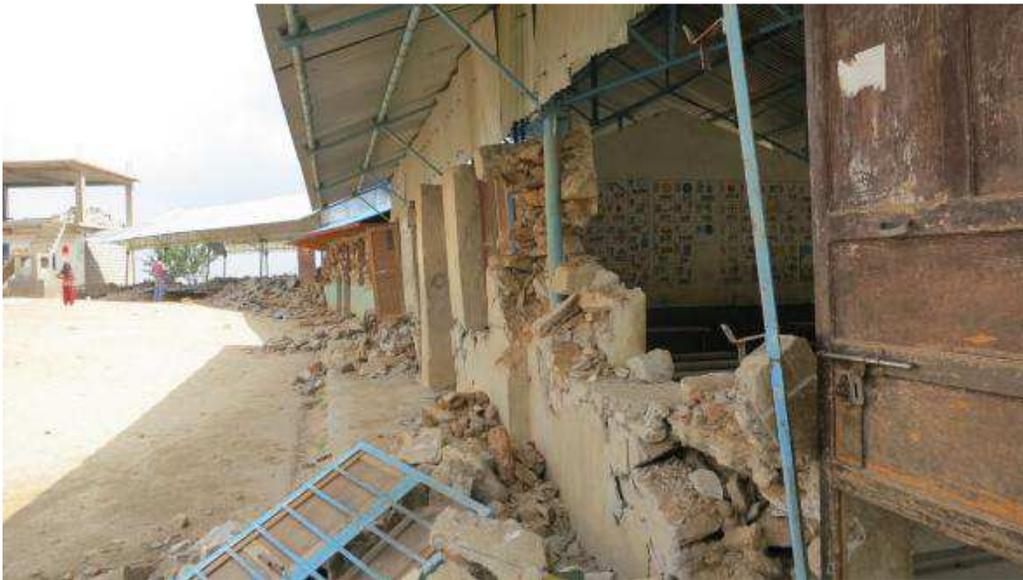
A multi-structure school in the remote village of Ichok also suffered similar damage as the Mahankal school. The older stone masonry structures had severe damage with most walls partially collapsed in the single story structures, although the steel supported and framed roof structures were still standing. Collapse of the walls appeared to be primarily due to out-of-plane failure of the unreinforced stone masonry. A newer two-story concrete frame structure was damaged primarily at the unfinished upper story. If the upper story were removed, the two lower story classrooms could be used again (See Figures 99 and 100).

Figure 98. Damaged single-story structures at school, Ichok.

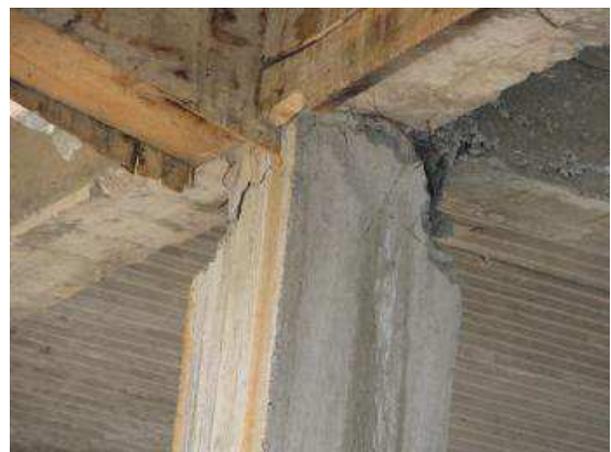
Figure 100. Beam-column connection damage, Ichok.

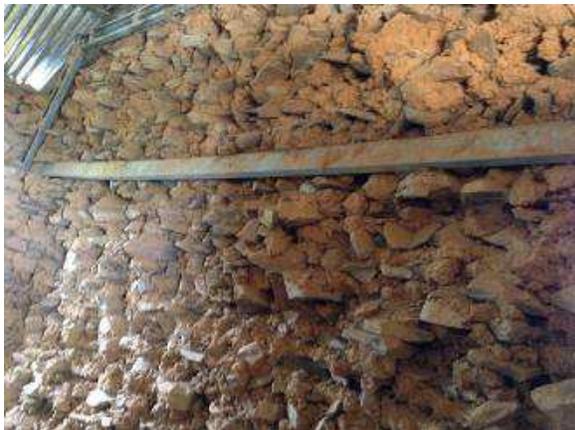
Figure 101. Delaminated stone masonry wall in school, Chalal Ganeshthan VDC

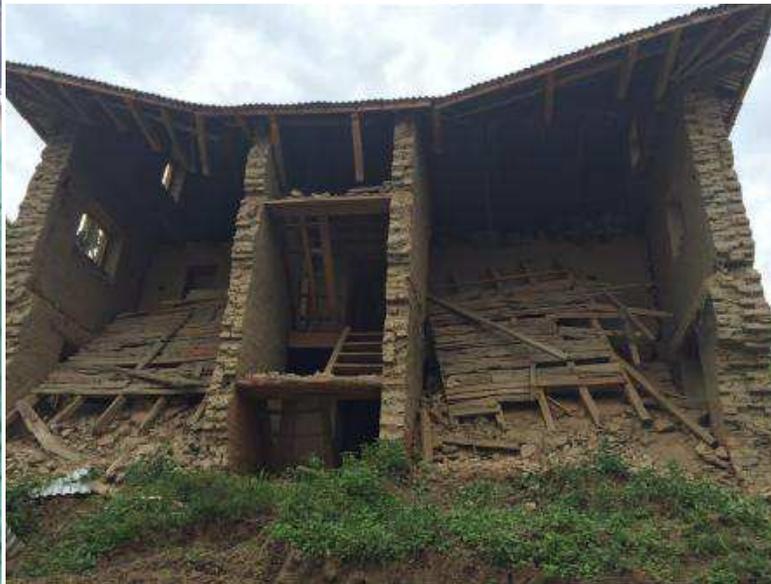
Figure 110. Partially collapsed adobe house in Devi Chaur
