April 25, 2015 – GORKHA EARTHQUAKE, NEPAL

**Report Released May 31, 2015
Updated October 1, 2015**

Build Change Post-Disaster Reconnaissance Report

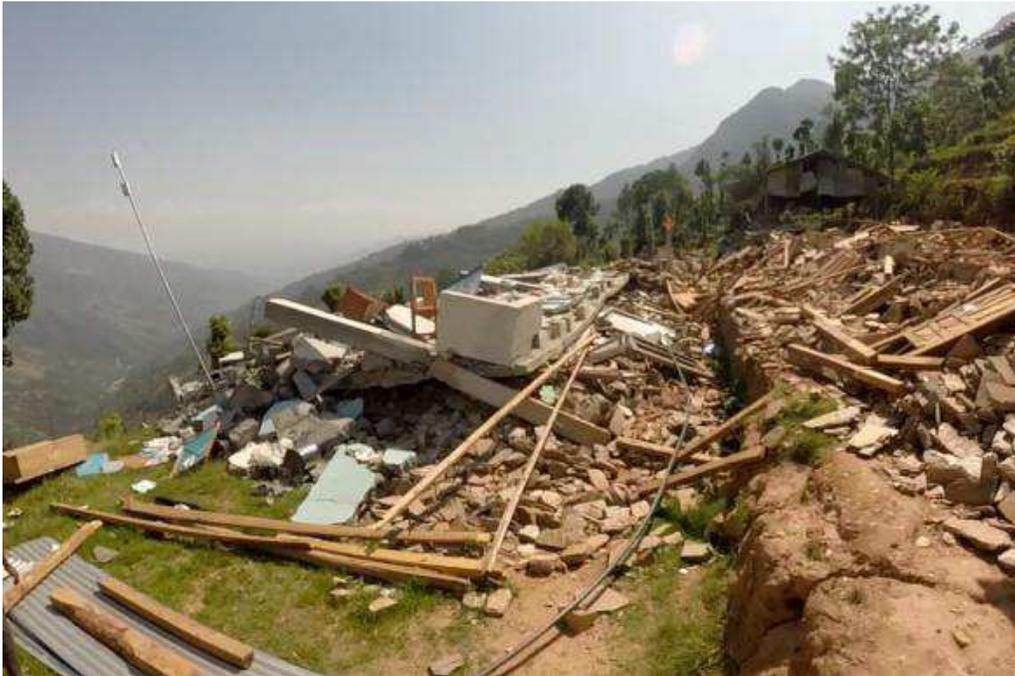
Figure 111. Completely collapsed two-story concrete frame with infill school, Baruwa

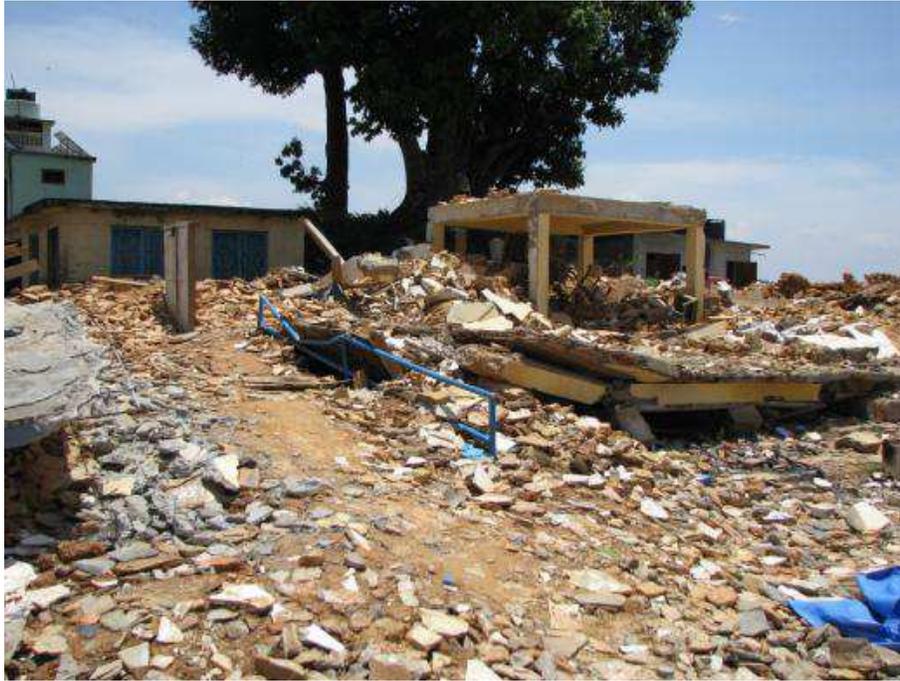
Figure 112. Collapsed school buildings, Chautara.
