APRIL 16, 2016 - MUISNE, MANABI EARTHQUAKE, ECUADOR

Surveyed May 01-06, 2016

Build Change Post-Disaster Reconnaissance Report

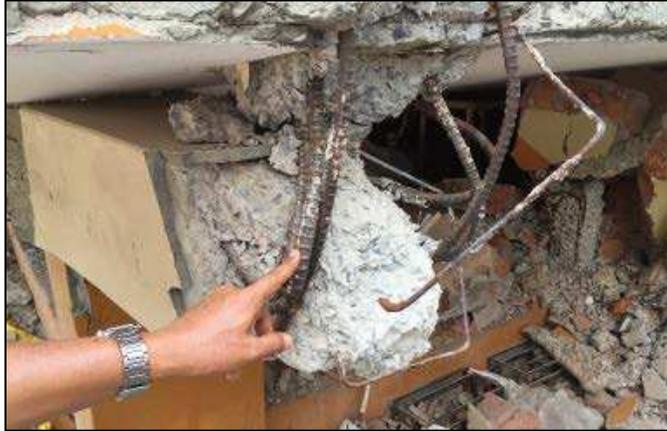
In reinforced concrete frame elements, the rebar for longitudinal reinforcing was usually ½” diameter ribbed bars, and for transverse reinforcing, like stirrups and ties, it was usually ¼” diameter smooth bars. (Fig. 26)

Figure 26. Typical reinforcing exposed in damaged column, Tarqui, Manta

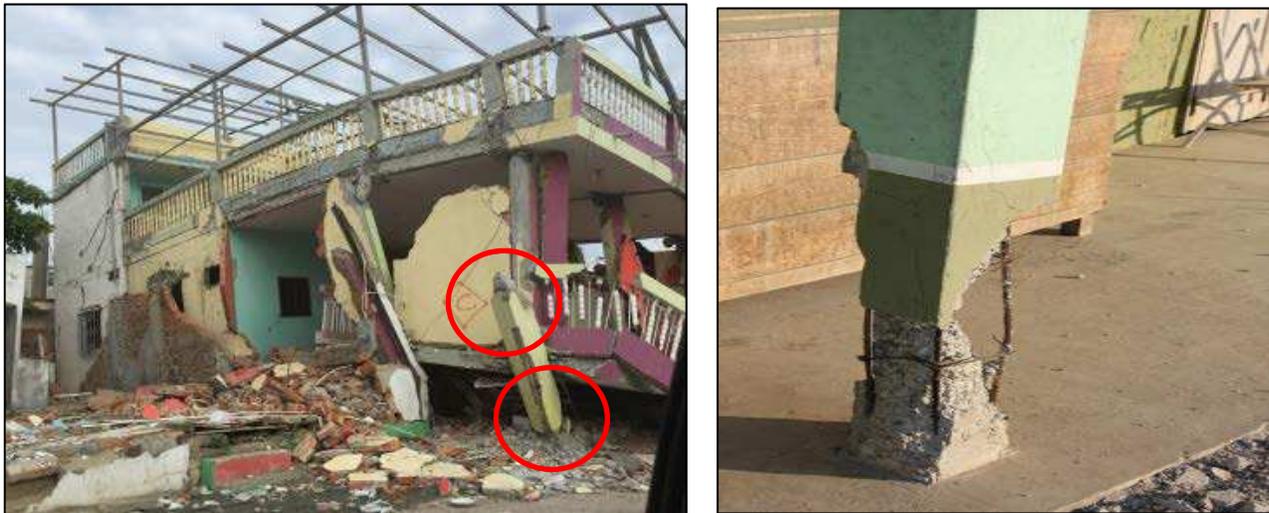
- Description:
Concrete frame column damage was observed in many concrete frame buildings – from single story to multi-story (Fig. 28). Typically, damage was localized at the base or top of the column due to flexural demands. Column damage was much more common than frame beam damage. The damage observed varied from cracking and spalling of the concrete cover in the column, to complete deterioration of the concrete core or fracture of the reinforcing bars.

Figure 28. Non-ductile column failure in multi-story building, Manta (left) and single-story building, Jama (right).

- Possible Causes:
The failure of the columns can be attributed to several possible causes that may apply to different cases observed. These frames may be undersized for the demands required. Additionally, it was common for the slab to be integrated with the beam, increasing the capacity of the beam significantly and thus forcing failure in the column, which would be relatively weaker than the beam (Fig. 29). It was also observed that many of the failed columns did not have what would be considered “ductile” reinforcing details – such as closely spaced stirrups (many were spaced 12” more apart instead) or 135° hooks at the stirrups (many had short 90° hooks instead) – so that the resulting non-ductile frame columns were more susceptible to failure in the earthquake and unable to resist the drift demands. Additionally, in some cases, the reinforcing at damaged columns was severely corroded, which may have caused microcracking or weakening of the surrounding concrete, early fracture of the longitudinal bars, or breakage of the stirrups leaving the concrete core unconfined and weaker. The placement of infill walls may have unintentionally

- Possible measures for improvement:
For new construction, concrete frame buildings with infill should use reinforced concrete frame elements that are adequately proportioned for the required demands and use ductile detailing as required by current building codes. The use of corroded reinforcing steel or aggregates and water that may increase corrosion of the steel should be avoided. Proper concrete cover should be provided, and increased in corrosive environments, such as locations close to the ocean. Additionally, the placement and use of masonry infill panels should be considered to contribute to the rigidity of the structure as appropriate and be accounted for accordingly.

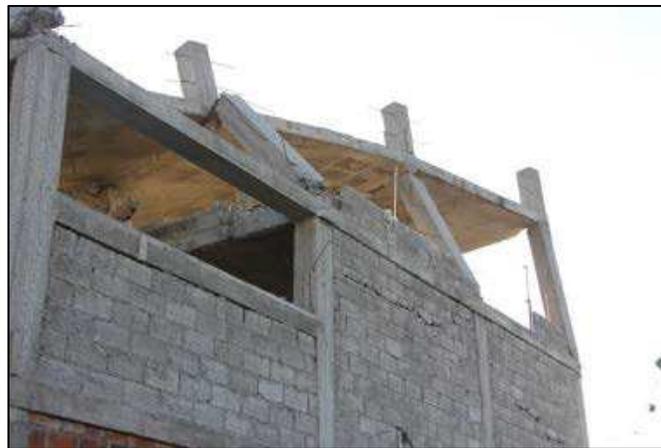
Figure 29. Failure of vertical elements near the column-beam joints, Jama.

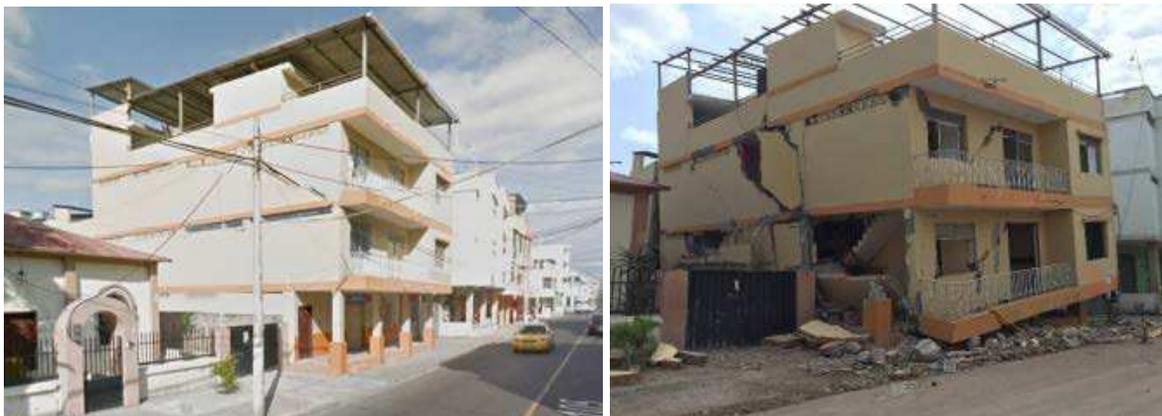
- Description:
Soft-/weak-story failures were observed as collapse of a story, typically the ground floor, of multi-story concrete frame with infill buildings (Fig. 30). In most cases, the collapsed level was where the damages were concentrated in the structure and the remaining levels were left with relatively less damage (Fig. 31).

Figure 30. Before (left, source: Google Street View) and after (right) earthquake, Tarqui, Manta.

- Possible Causes:
Soft-story and weak-story failures can occur when one level is significantly less stiff or less strong, respectively, than the adjacent levels. Because of the degree of damage, it is difficult to discern from a collapsed building whether the stiffness or strength or a combination of both contributed to the failure. Soft-stories can be caused by taller ground floor heights, more open ground floors such as in mixed use buildings, set-back ground floors such as in overhang conditions, and other configurations causing the lower level to be more flexible and less stiff than upper levels. Weak stories can be caused by similar configurations or also by construction detailing, such as inadequate splicing at a level, or a change in construction materials quality at a certain level.

- Possible measures for improvement:
Avoid or correct soft and weak story problems in new and existing construction. This can be done by addressing the cause of the soft or weak story, such as

- Strengthening the lateral force resisting system in locations where inadequate detailing or where a change in material quality may have created a weak point. This strengthening would need to be performed without creating new large discontinuities in stiffness.

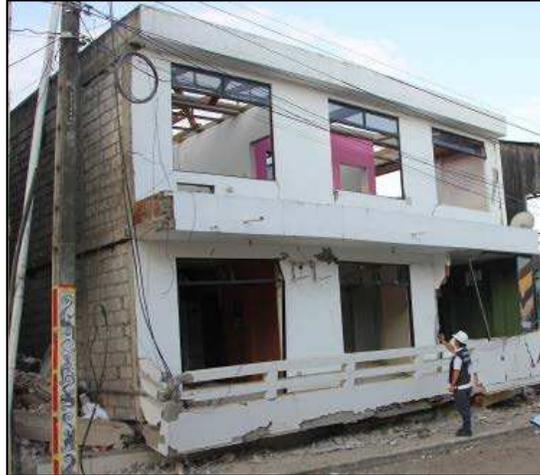
Figure 31. Ground floor collapsed due to soft/weak story failure, Jama.

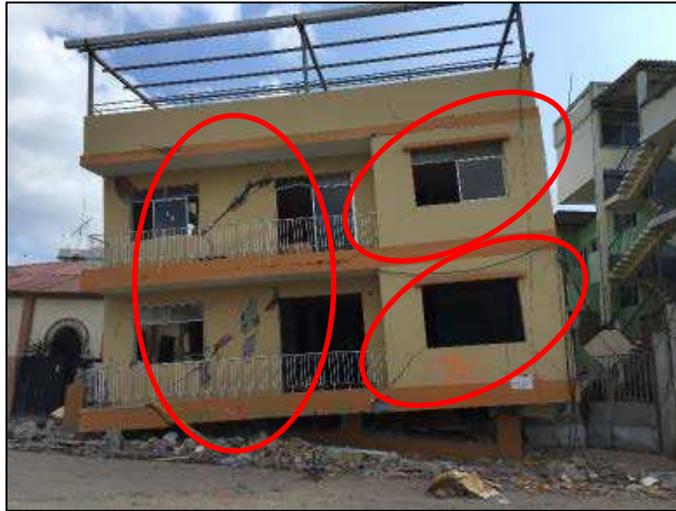
- Description:
Diagonal cracking of masonry infill due to in-plane shear loading was observed (Fig. 32 and Fig. 33). Cracks also tended to initiate at the corners of windows and doors in panels with openings. This types of damage rarely appeared to lead to the collapse of the wall, unless combined with out-of-plane failure or failure of the adjacent frame elements.

Figure 32. In-plane masonry infill wall cracking, Tarqui, Manta

- Possible Causes:
Diagonal cracking in masonry wall due to in-plane shear loading is not unusual and can be a more ductile damage condition than others. In-plane failure can be attributed to the low resistance of masonry units and joint mortar, large openings in the wall without confinement, or a lack of sufficient shear walls for lateral resistance.
- Possible measures for improvement:
To reduce the incidence of in-plane shear cracking and failure, several approaches can be taken, such as: reduce the size of openings to increase the length of shear walls, provide confinement (reinforcing) around openings in each wall panel, increase the amount of shear walls in each direction by infilling more bays, ensure good quality mortar and bricks are used. When increasing

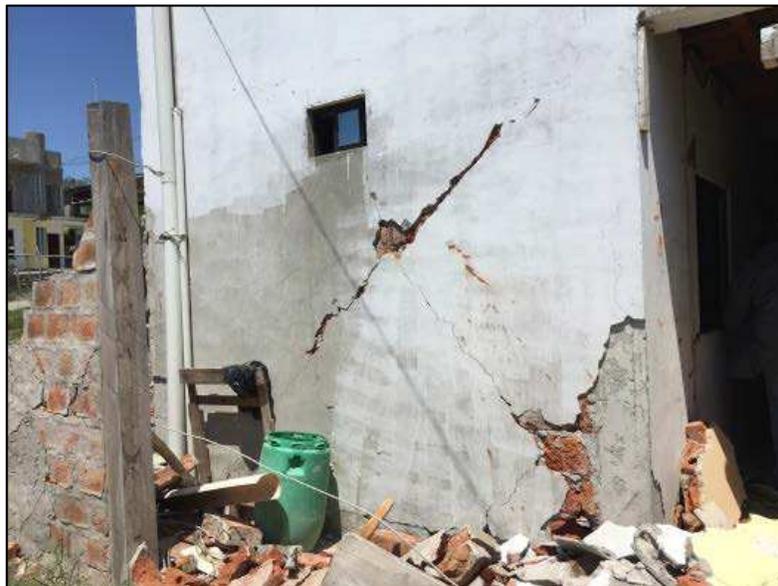
Figure 33. In-plane cracking at end wall, Canoa

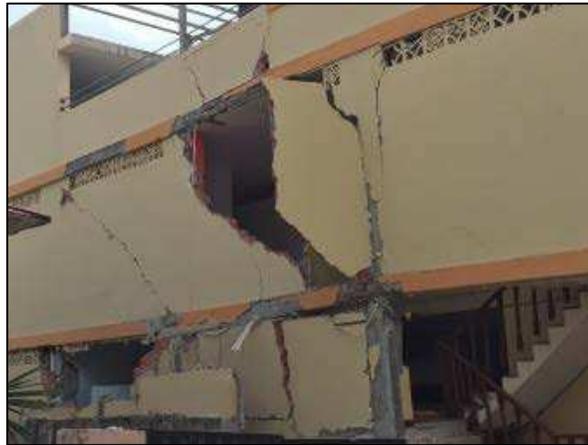
- Description:
In concrete frame buildings, out-of-plane failure was less common than in other building types described below. Typically, out-of-plane masonry failure in concrete frame buildings was accompanied by one of the following conditions: severe in-plane cracking of the panel, poor connection to the frame, particularly at the top (Fig. 34), or lack of a frame beam such as at the top of a building where a temporary light-weight roof had been built prior to completion of the concrete frame (Fig. 35).

Figure 34. Out-of-plane failure of masonry walls. Perforated block/vent at wall panel connection to slab. Manta

- Possible Causes:
Out-of-plane wall failure seemed to be caused by the following conditions: slender walls (thin side-stacked brick spanning full wall height) infilling large panels, large spans between perpendicular bracing elements such as walls or frames, poor connection of the infill to the underside of slab due to window or perforated block at interface, lack of bracing at top of walls such as not diaphragm or ring beam, failure of rebar dowels between the wall and column (in some cases due to corrosion), and out-of-plane failure after excessive in-plane cracking.

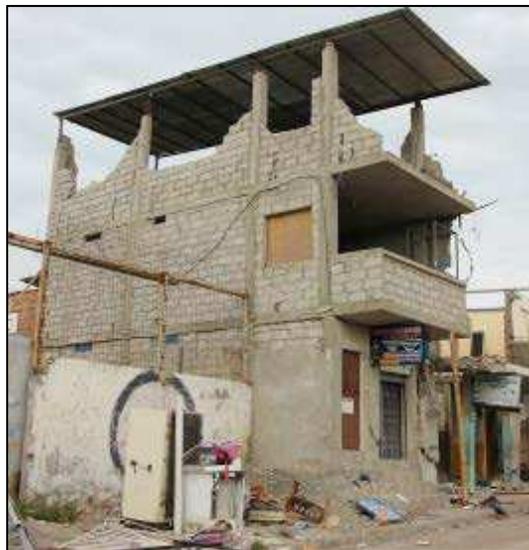
Figure 35. Out-of-plane failure of masonry walls. Lack of ring beam or diaphragm at roof. Manta

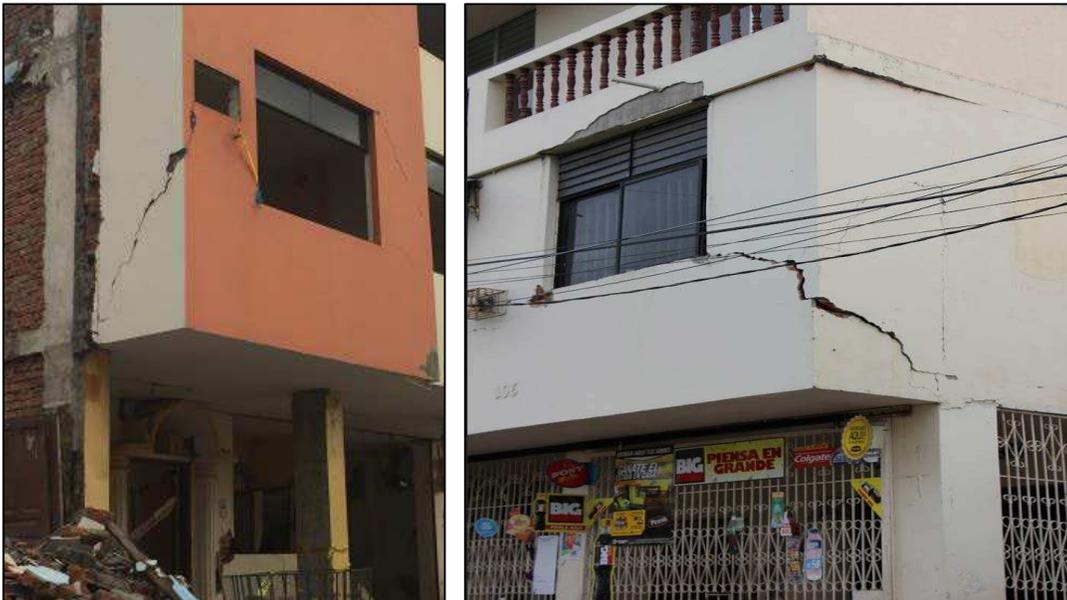
- Description:
Wall failure at overhangs, diagonal cracking (Fig. 36).

Figure 36. Failure at the overhangs, Manta

- Possible Causes:
Discontinuity of vertical load caused stress concentrations at the overhangs and increase of flexibility, leading on cracking of overhanging walls and slabs.

- Possible retrofitting measures:
Make walls continuous from foundation to roof, design walls as non-structural elements by providing the proper confinement and tying directly to the slab.

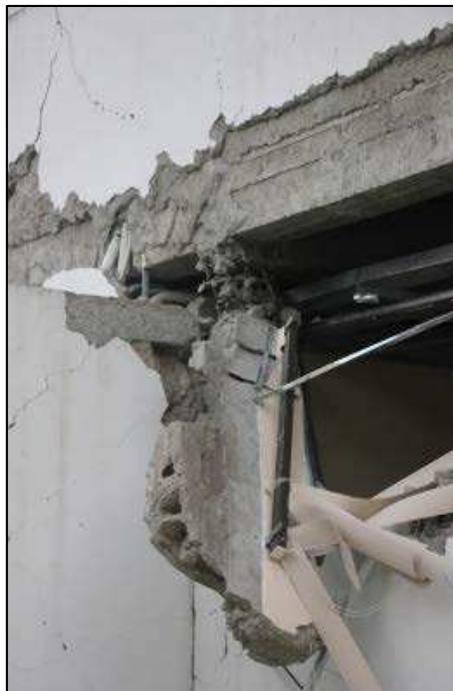
- Description:
Significant damage to the portion of a column left unrestrained by adjacent structural elements, such as masonry infill, which restrain other portions of the column during an earthquake. This was only observed in a limited number of locations (Fig. 37).

Figure 37. Short Column failure. Outside Canoa

- Possible Causes:
It's caused by lateral restriction of partial height of the column or the construction of short columns within the building, leading to shear concentration along such short effective length. A short column has large stiffness and during earthquakes attracts higher value of earthquake induced forces.
- Possible measures for improvement:
This can be fixed by avoiding columns which are restrained over part of the height, either by providing lateral restriction of the column's free length (over the full height), or eliminating the lateral restriction of the partial height of the column.

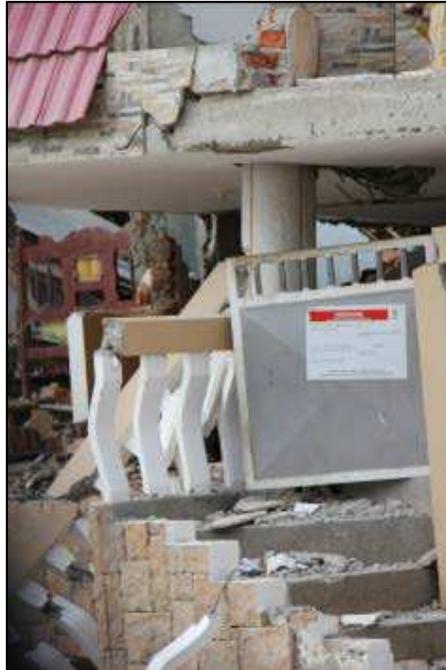
- Description:
This type of damage was mainly observed in locations where partial or full story collapse occurred and was observed in very limited numbers. The column “punched” through the slab above where the reinforced concrete slabs was subjected to high localized forces, such as at column support points.

Figure 38. Punching Shear failure / Red Tagged house, Manta.

- Possible Causes:
Collapsing slabs due to column failure would impact the lower portion of the column and produce localized concentration of forces that may have caused this type of damage. Additionally, the concrete frames were often built with shallow beams that fit within the depth of the slab (flat slab) which reduces the shear capacity of the beam in comparison to deeper beams.
- Possible measures for improvement:
Column failures and thus story collapses should be prevented as noted in the section above on concrete frame failures. Providing deeper frame beams with adequate shear reinforcing along column lies could also help reduce this damage condition.

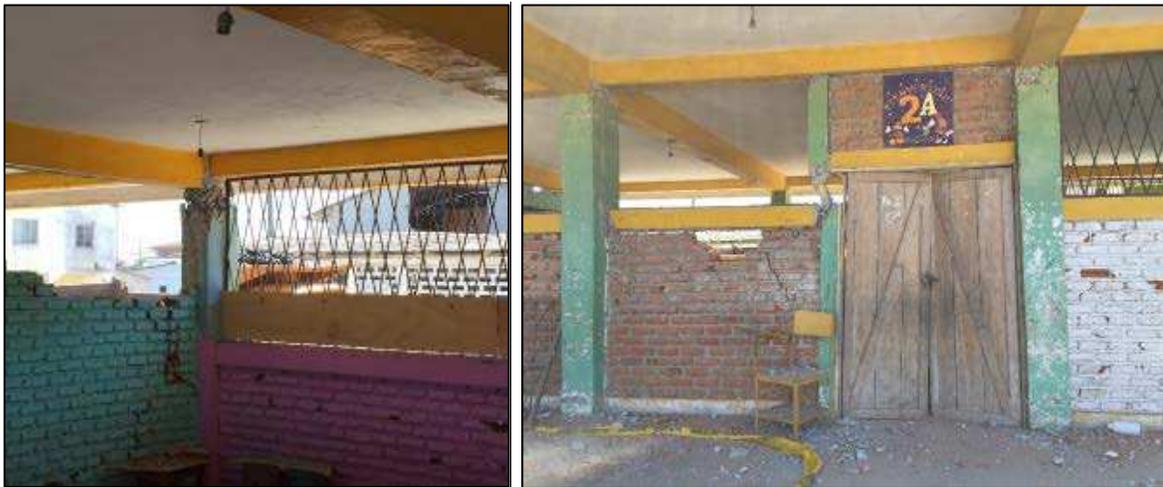
- **Description:**
The damage to the frames observed included cracking of the core concrete and spalling of the cover in the ground floor columns at the base and at the top below the floor beam. In one building, the frame displayed a permanent drift. Damage to the frame beams was not observed.

Figure 39. Column damage in classroom building, Canoa

- **Possible Causes:**
It is hard to determine the cause of the cracking in the frames, potentially there was transverse reinforcing deficiencies, non-ductile joint detailing, or a consequence of construction sequencing (in one frame, cracking appeared to be concentrated at a horizontal cold joint at the top of all columns).
- **Possible measures for improvement:**
Use of modern ductile frame detailing.

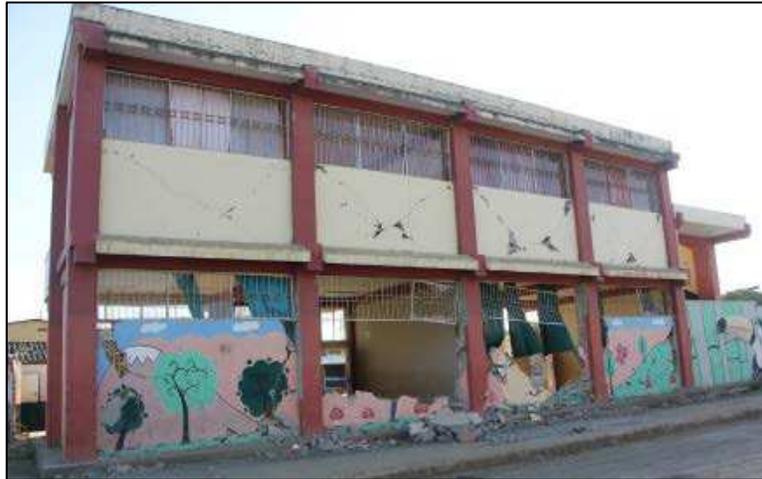
- **Description:**
Diagonal cracking of infill walls (exterior walls and interior partitions) within the reinforced concrete frame.

Figure 40. Cracking and failure of non-structural elements at a school, Jama

- Possible Causes:
Interaction between concrete elements and infill walls, such that the infill walls are active in resisting lateral forces although they may not have been designed to do so.
- Possible measures for improvement:
Separate infill walls from lateral columns and frame beams to isolate the panel in-plane, or account for the infill in the design and construction, including providing adequate connections between the frame elements and infill.

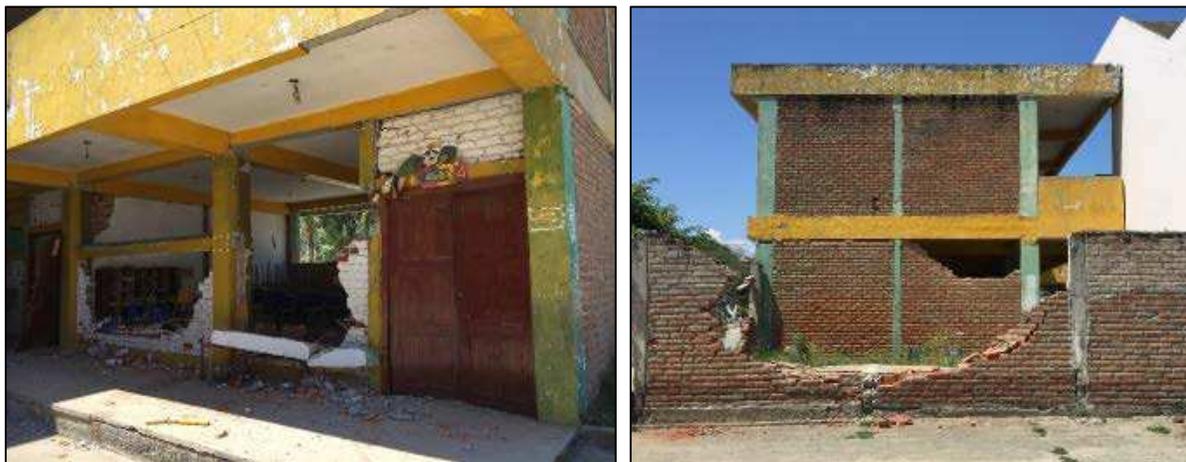
- Description: Out-of-plane failure of masonry infill was observed in a limited number of concrete frame schools. In one case, the reinforced bracing elements for the infill openings also failed, separating from the frame columns at the joint – leaving the masonry unbraced (Fig. 41, left).

Figure 41. Out-of-plane failure of a classroom walls, Canoa

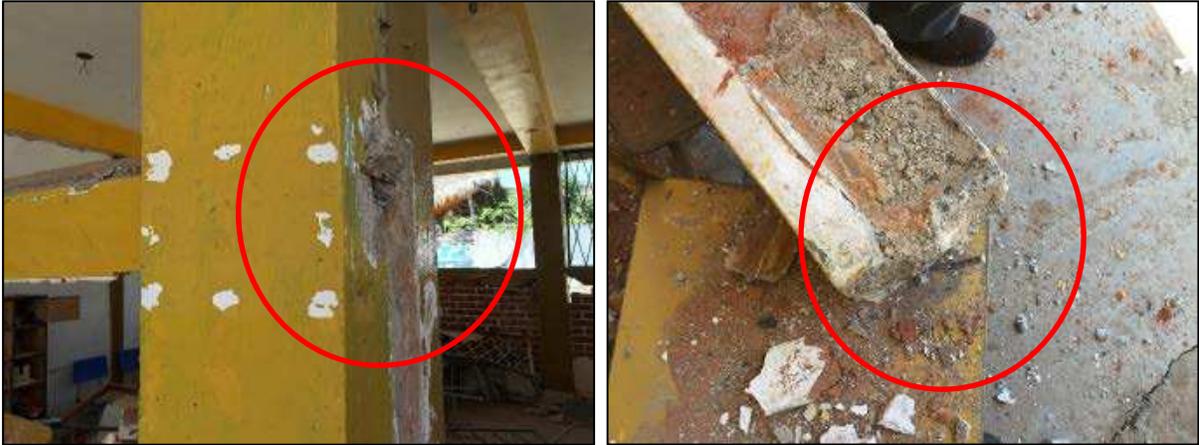
Out-of-plane damages in concrete frame schools appeared to be caused by two main reasons: slender infill walls in large panels that were cracked due to in-plane engagement, and failure of the intermediate confining/bracing elements, either at the connection to the structure (Fig. 42) or due to high deformation demands.

Figure 42. Connection failure of wall panel bracing element, Canoa

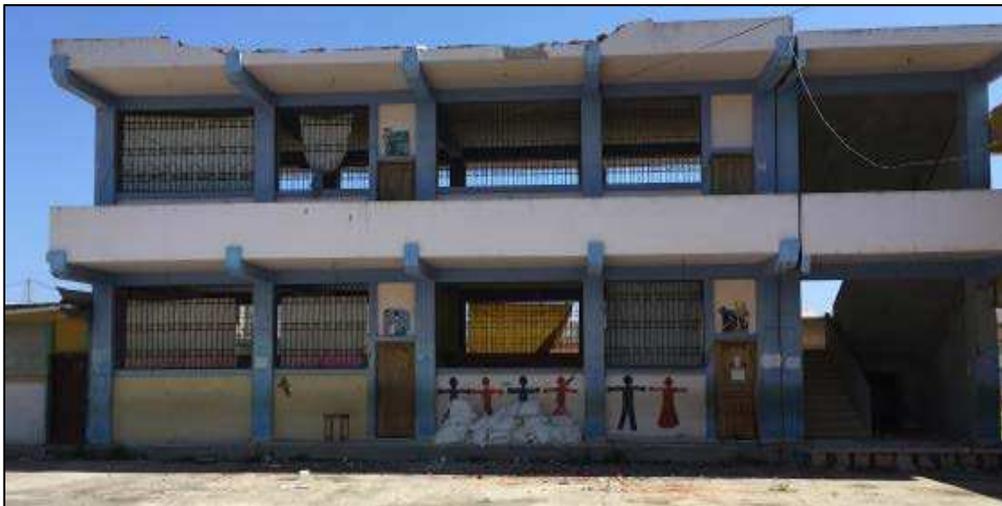
- Description:
Cracking and collapse of masonry roof parapet (Fig. 43). While this does not affect the structure of the building, it could be hazardous to students or others below.

Figure 43. Parapet collapse at a school building, Canoa

- Possible Causes:
Lack of confining or reinforcing elements along the parapet.
- Possible measures for improvement:
Provide confining elements or buttresses in order to reduce displacements and stiffen the parapet wall or avoid the use of unreinforced masonry parapets.

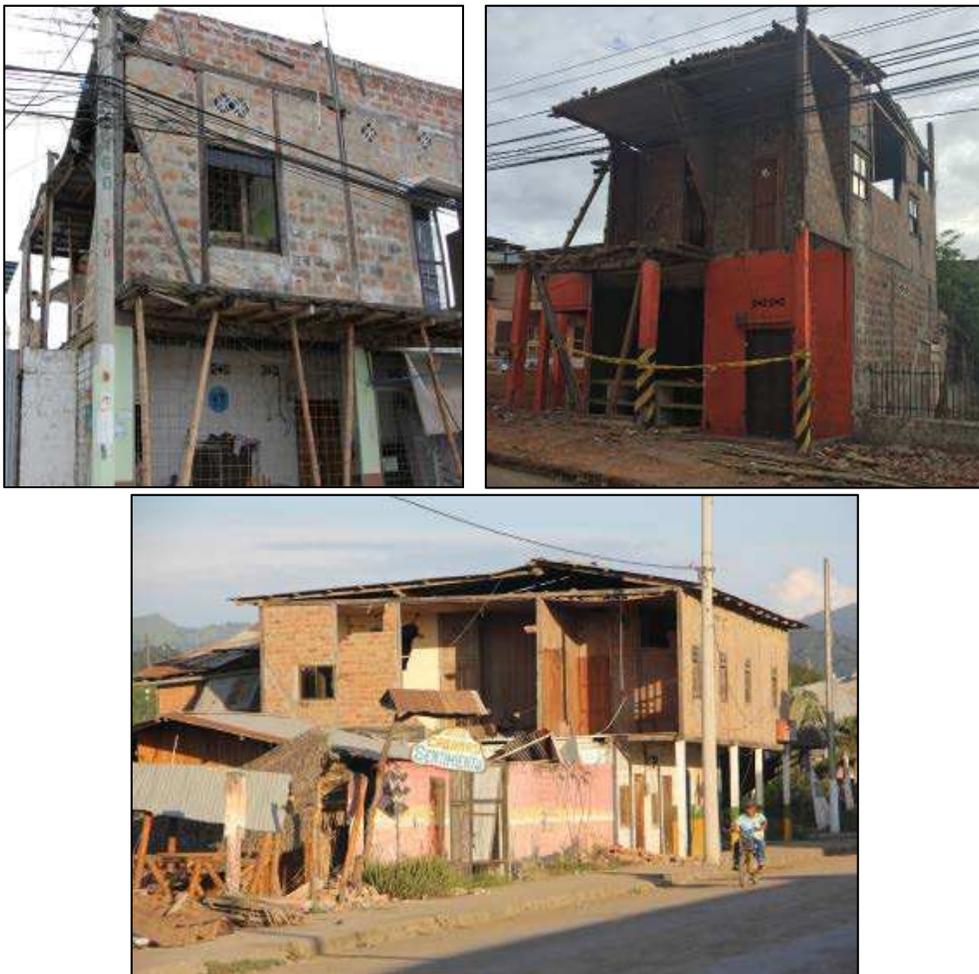
- Description:
One of the most common damages observed for this type of building was the out-of-plane collapse of infill masonry – either individual panels separating from the framing, or full panels, including the framing (Fig. 44).

Figure 44. Failure of infill walls. (Manta, top and Jama, bottom)

- Possible Causes:
Where panels separated or collapsed, this may be due to there being too large of a span for the infill (large spacing of timber elements), or where spans were limited, a lack of good connections between the infill and timber elements. Where panels, including framing collapsed, this may be due to insufficient or deteriorated connections to the cross walls, or insufficient quantity and spacing of cross walls.

- Possible measures for improvement:
Ensure that timber elements are closely spaced to provide adequate bracing and the masonry infill is positively connected to the timber. Wall panels should be braced to perpendicular cross walls of the same construction type, with a positive connection between the panels designed to transfer the loads. The timber should be in good condition, with no signs of decay or infestation and treated to be protected from future deterioration.

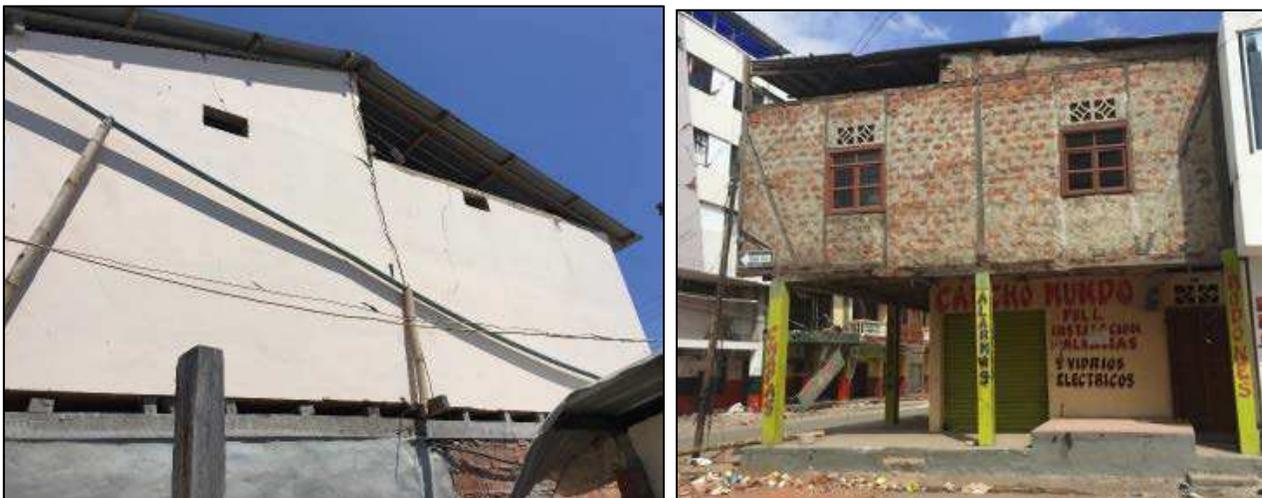
Figure 45. Collapse of infill gable walls, Canoa, left and Manta, right

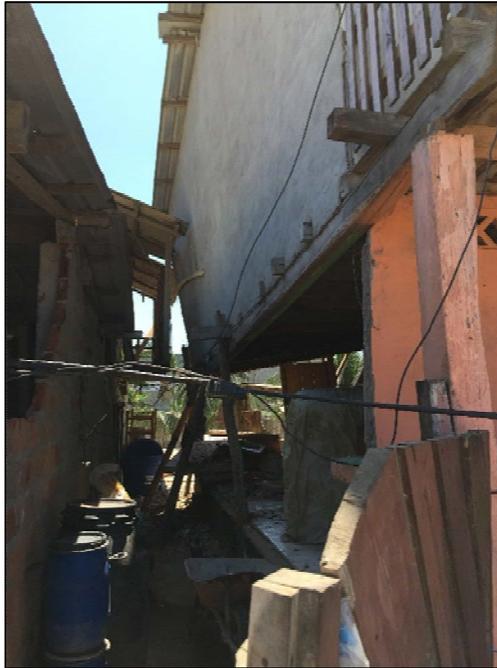
Figure 46. Wood frame connections failure, loss of support, Canoa

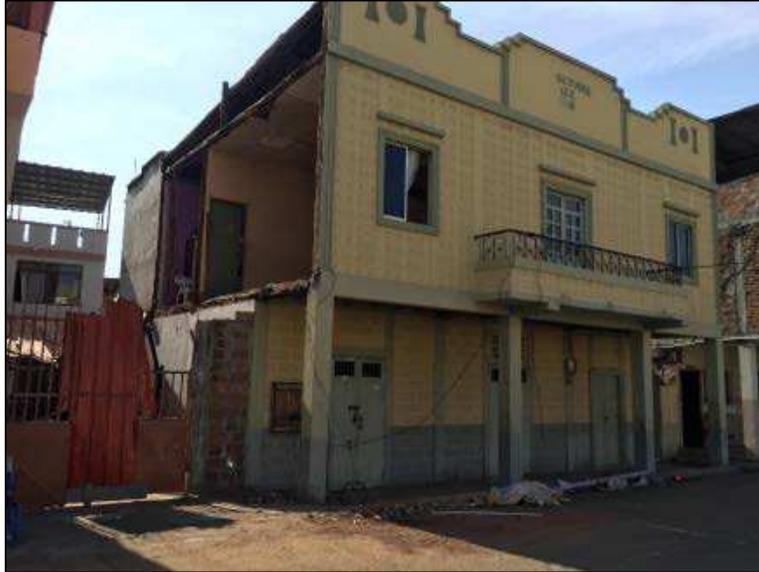
Figure 47. Collapse of wall above decayed floor beam, Los Esteros, Manta

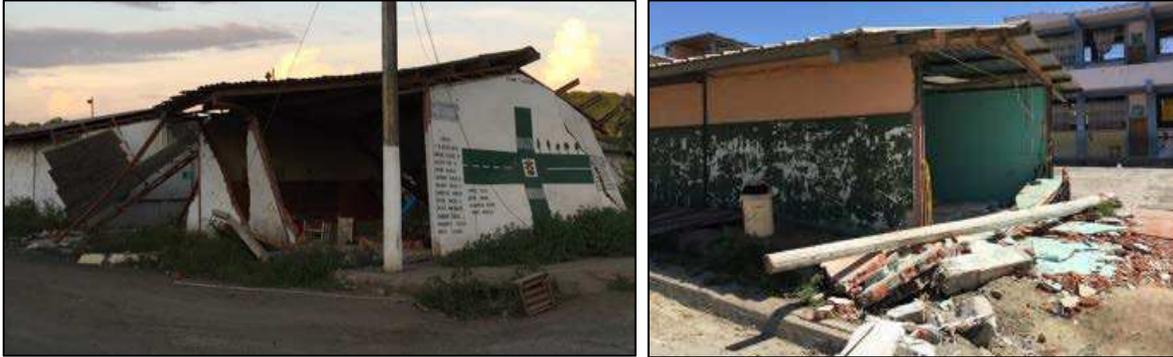
Figure 48. Out-of-plane failure of masonry infill wall in light frame. Jama (left) and Canoa (right)

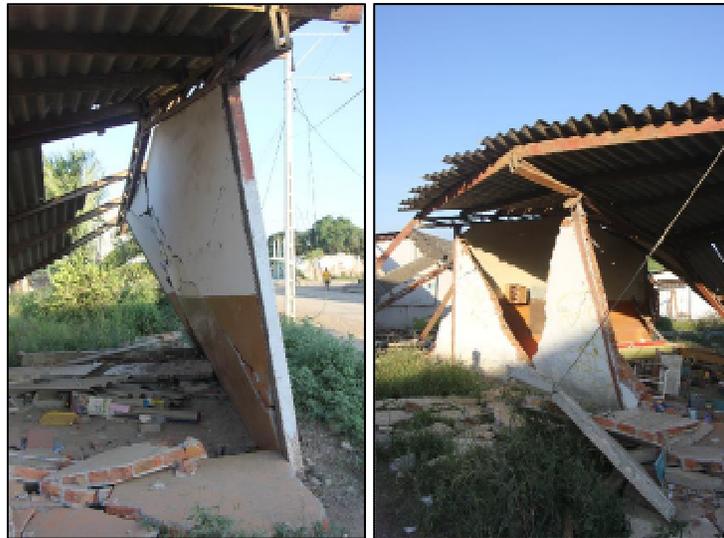
Figure 49. Out-of-plane failure of masonry wall and roof collapse, Jama

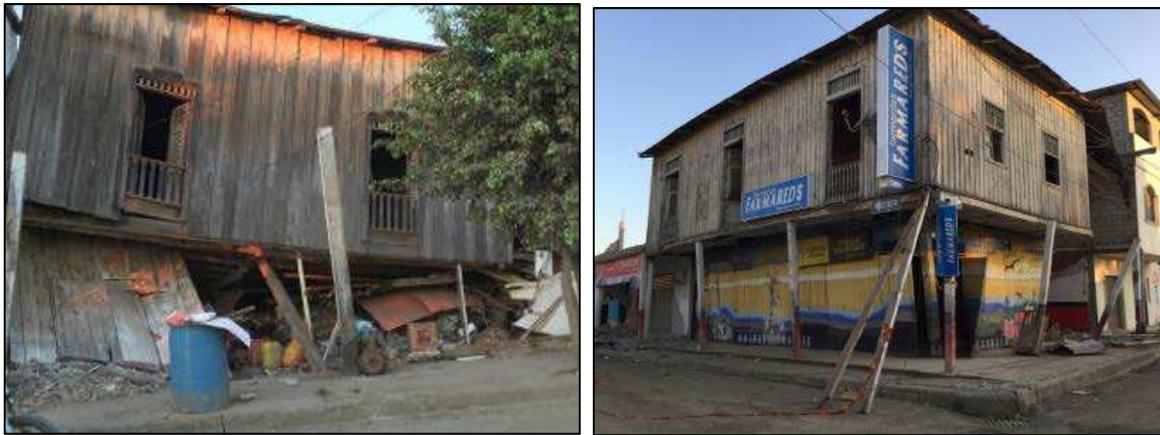
Figure 50. Partial story collapse in timber buildings, Jama

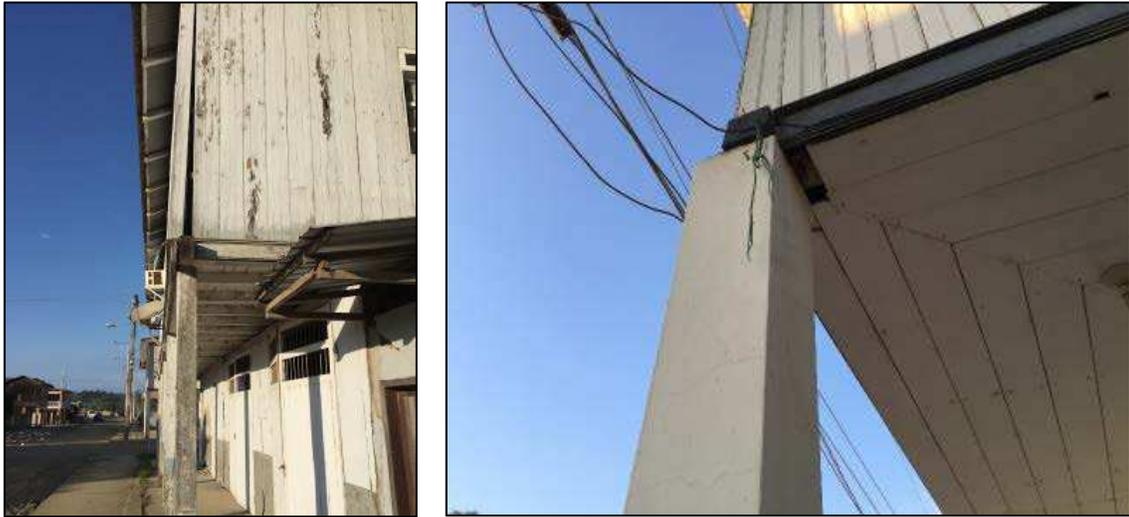
Figure 51. Displacement of posts relative to floor framing, Jama

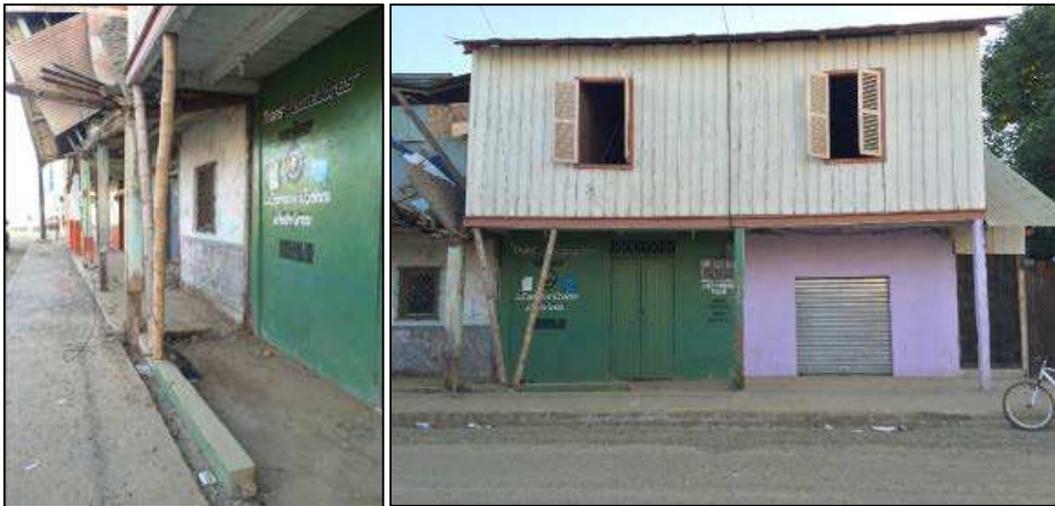
Figure 52. Collapse of timber post, shoring in place, Jama

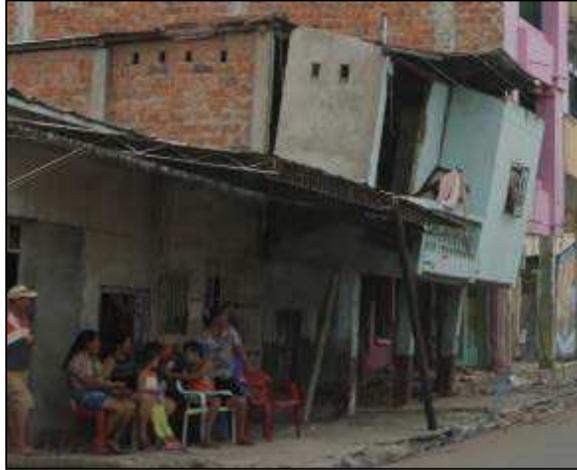
Figure 53. Separation of front façade and overturning, Manta

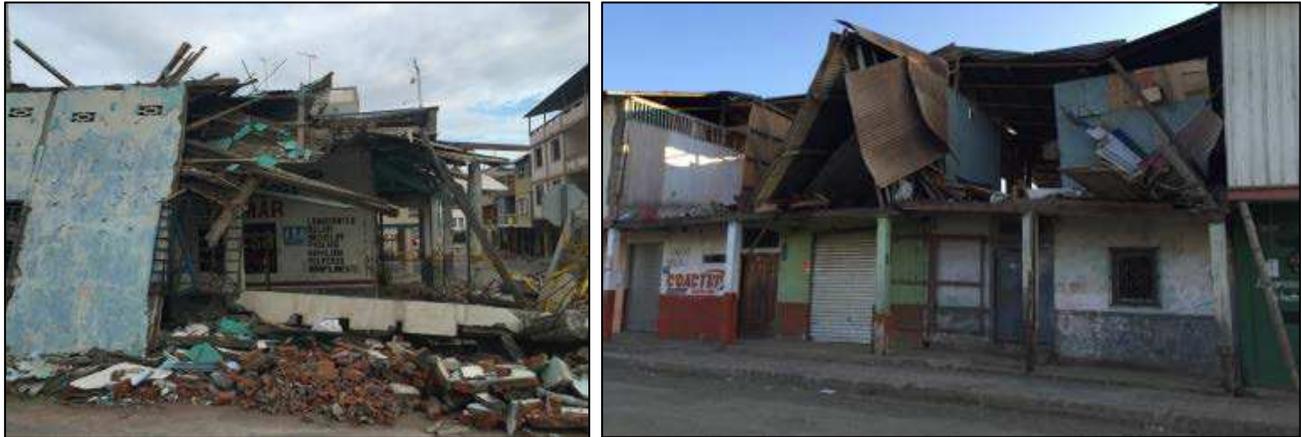
Figure 54. Failure of light-weight walls due to heavier perpendicular walls (Manta, left and Jama, right)

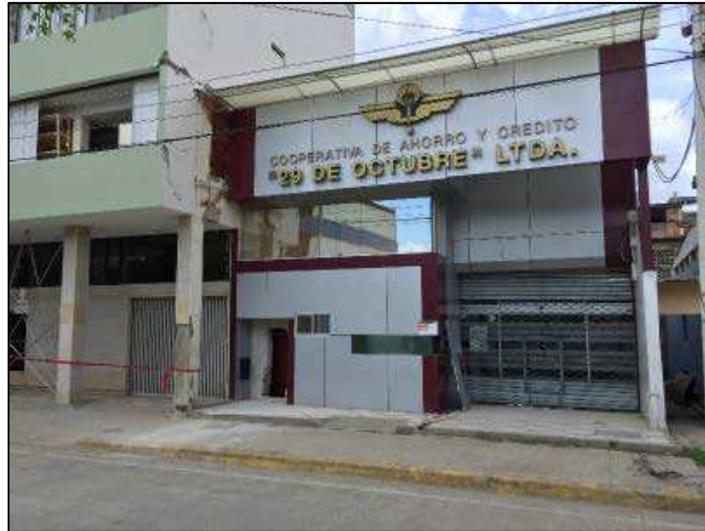
Figure 55. Pounding in adjacent building, Portoviejo

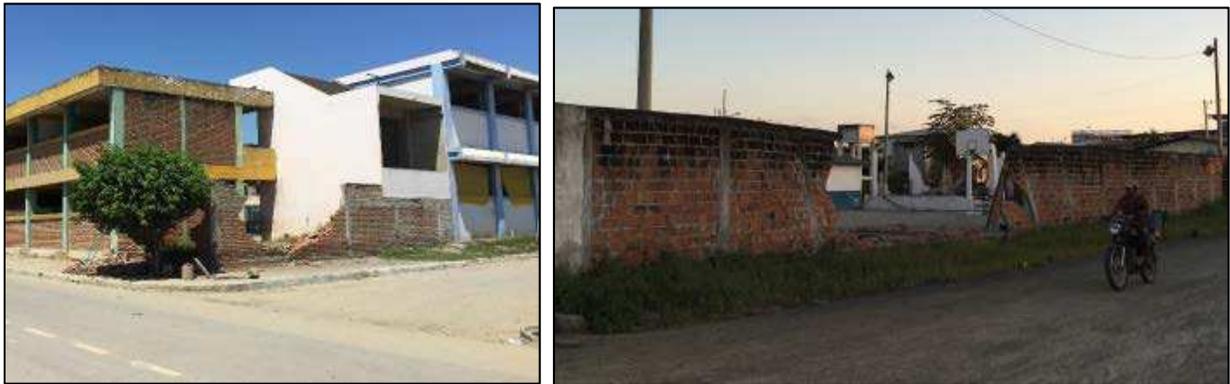
Figure 57. Failure of site walls at schools (Canoa, left and Jama, right)
