Oct 4, 2016 – Hurricane Matthew, HAITI  
Surveyed Oct 25-28, 2016  
Build Change Post-Disaster  
Reconnaissance Report

**BUILD CHANGE**

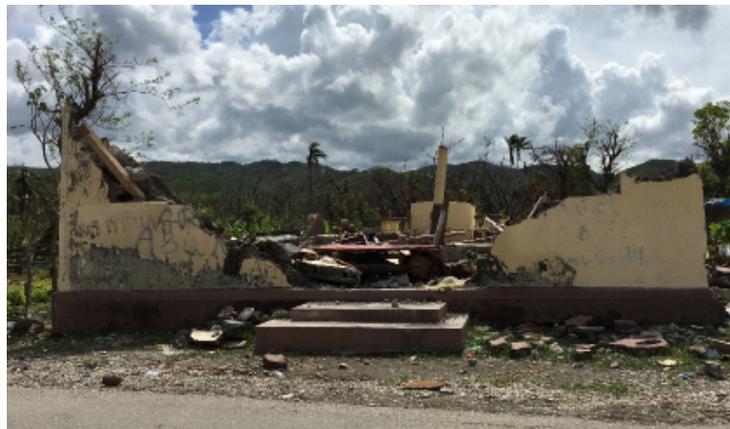
Even if it is hard to understand the exact cause of the collapse we observe severely damaged unreinforced houses possibly due to the failure of the walls prior to roof failure.

*Figure 26 House totally destroyed possibly because of wall failure prior to roof failure*

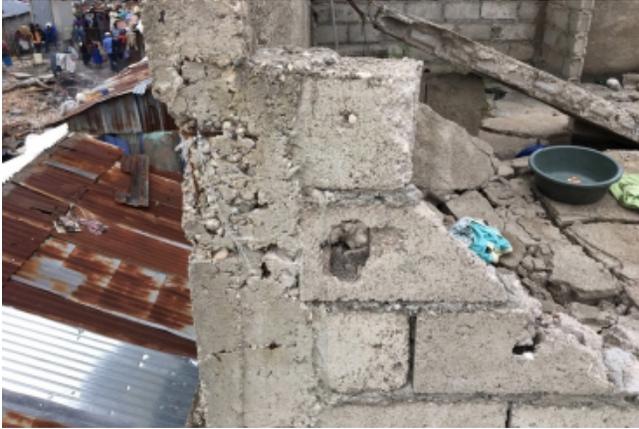
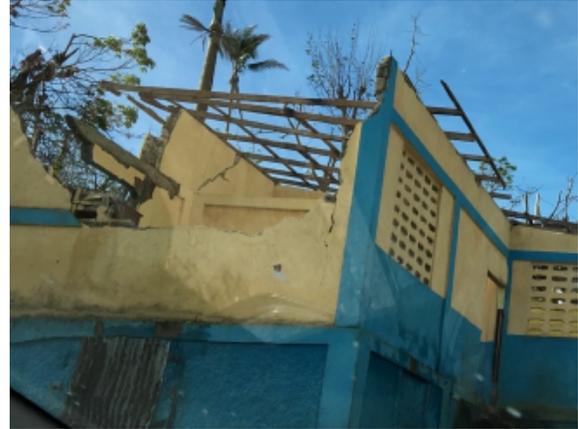
- Description:  
Out of plane failure of masonry wall was observed in many unreinforced masonry building. The damage varies from a couple blocks falling from the top of the wall to total collapse of the wall panel.

Figure 27 Left: Wall collapse due to lack of tothing and intermediate beam  
Right: Tall wall collapsed

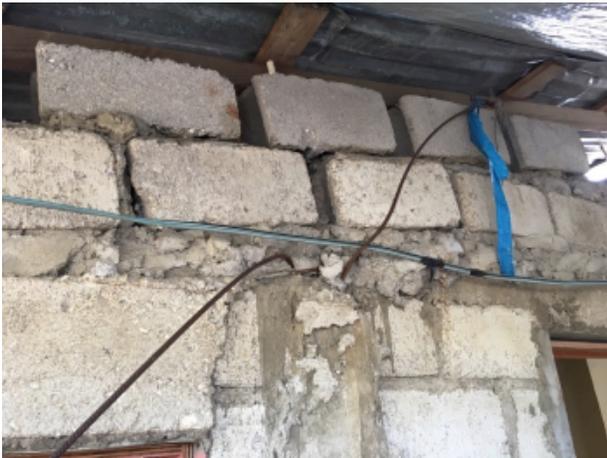
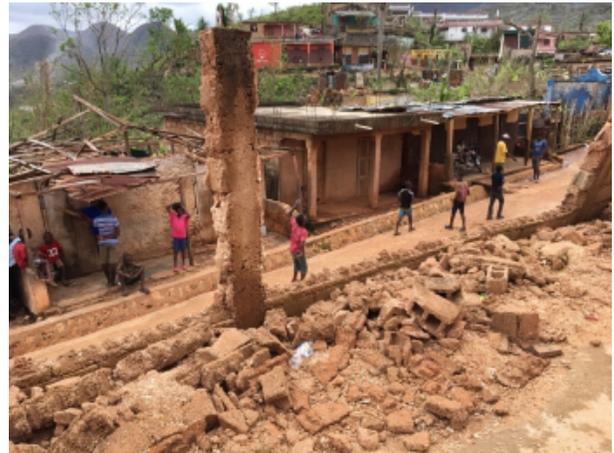
Figure 28 Blocks placed back after the hurricane to replace the roof as the previous ones fell

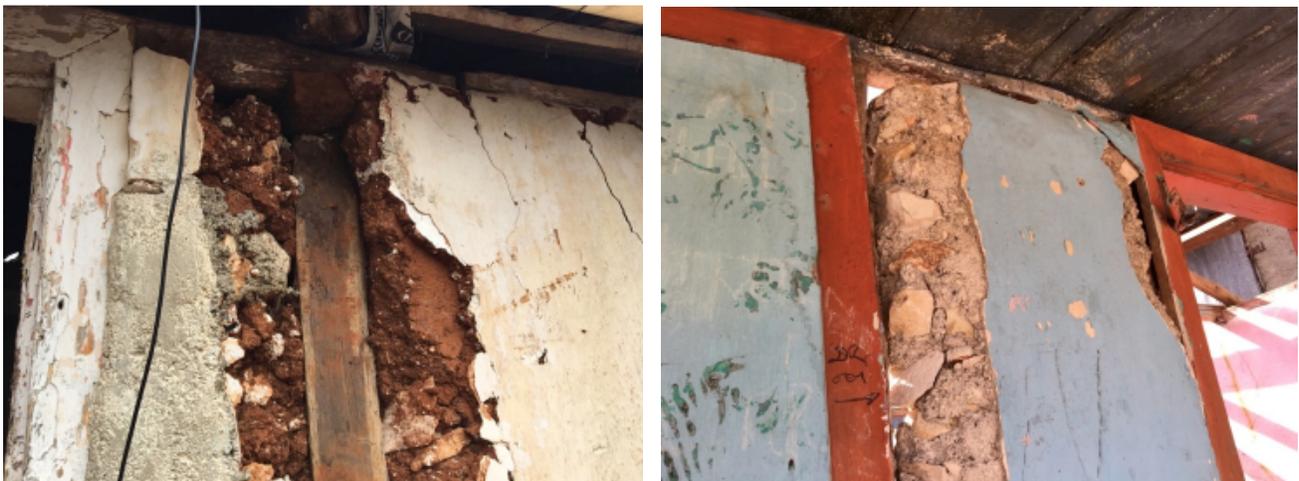
- Description:  
Cracks at the joint between the top of the wood pole and the masonry were observed. It is the top of the wall that generally suffered the most damage.

Figure 29 Visible cracks at corner of the masonry

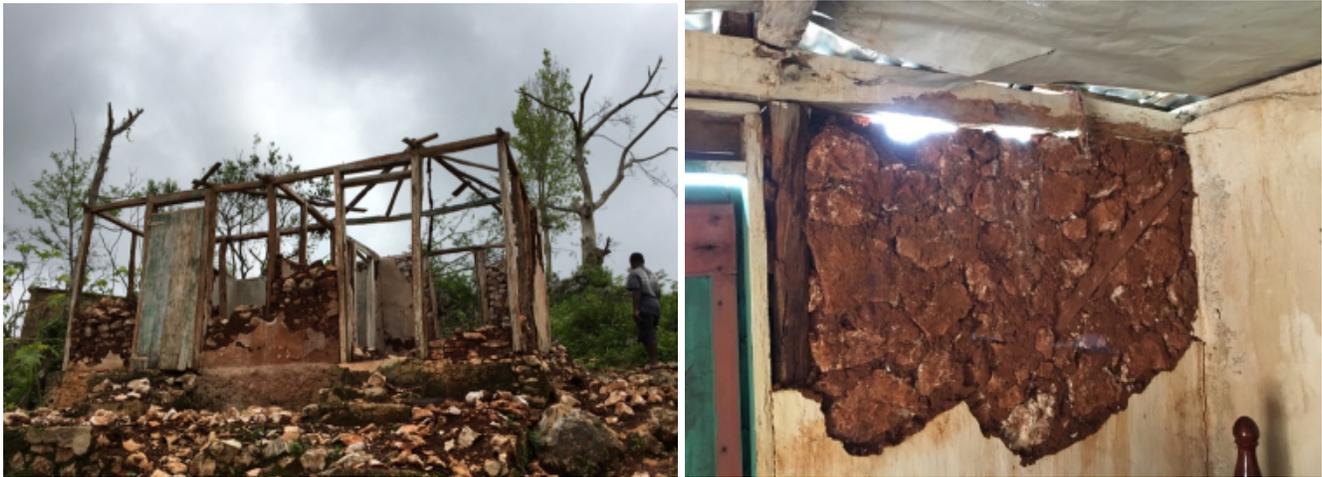
- Description:  
Diagonal cracking of the stone masonry infill due to in-plane shear loading was observed. Very occasionally we observed diagonal wood bracing in the infill and the wall panel withstand better the wind forces.

Figure 30 Left: Cracking of the infill  
Right: Partial wood diagonal bracing in masonry wall infill

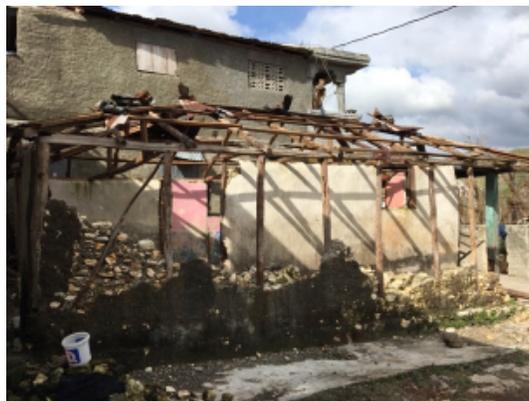
- Description:  
The stone masonry infill often collapsed during the hurricane, the damage varies from partial collapse of the top part to total collapse of the walls.

Figure 31 Out of plane failure of masonry infill

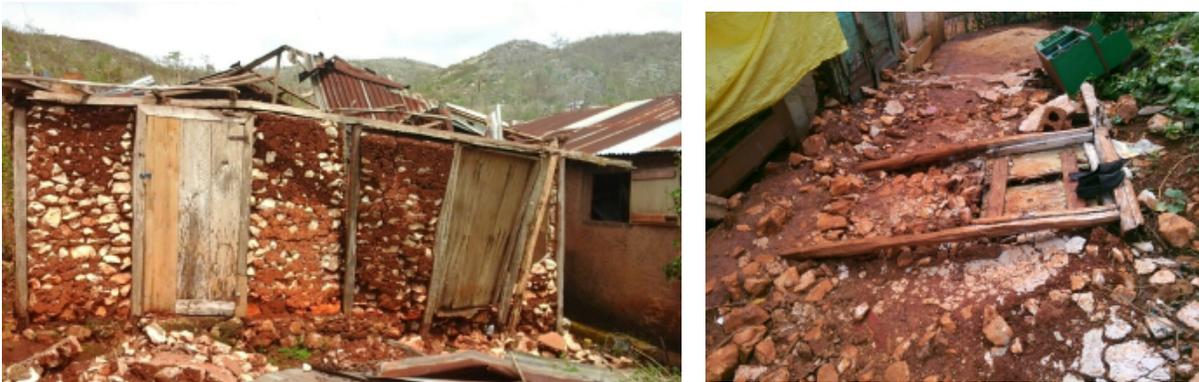
- Description:  
In some houses that collapsed completely the homeowner described an intense shaking of the structure, roof and wall, and the whole structure went down when the roof was blown away. In some sites, piles of stones and mud are visible as the only element remaining of the wall infill.

Figure 32 Out-of-plane failure of wall panels

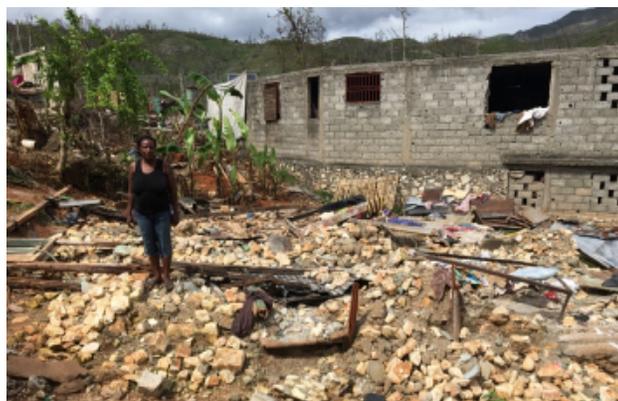
Figure 33 Total collapsed of a wood frame building

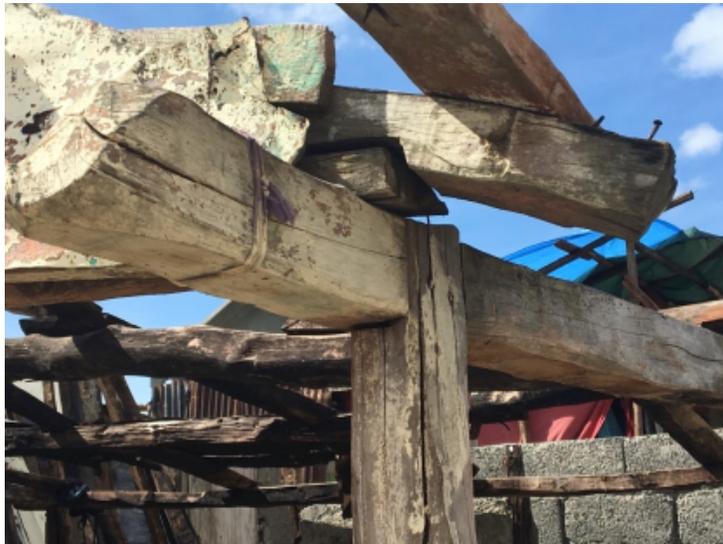
- Description:  
Failure of the connection between the wood pole and ring beam was observed in some houses. The connection quality varies between the structures; it can be the pole sticking into a notch in the ring beam (Figure 34) or just the ring beam nailed to the top of the wall. The connection failure was rarely directly observed as the infill is likely to collapse after the frame opened up.

Figure 34 Connection between the ring beam and the top of the wood pole

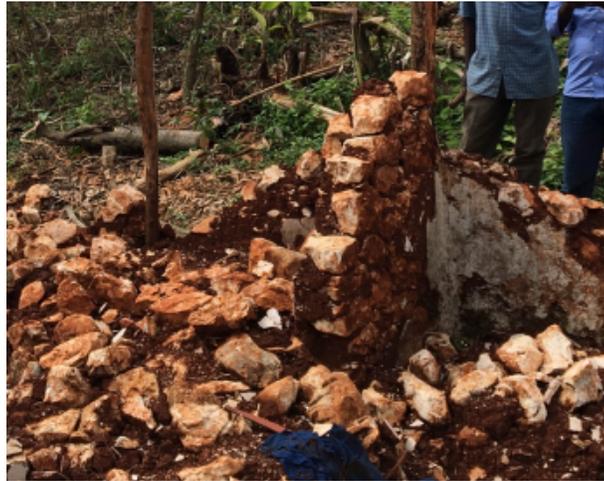
- Description:  
The infill, when cracked or not plastered, is directly exposed to the rain. The rain water soaked the mud mortar, which caused a loss of strength and led to the collapse of the infill walls.

Figure 35 Wall totally collapse due to water infiltration and saturation of mud mortar

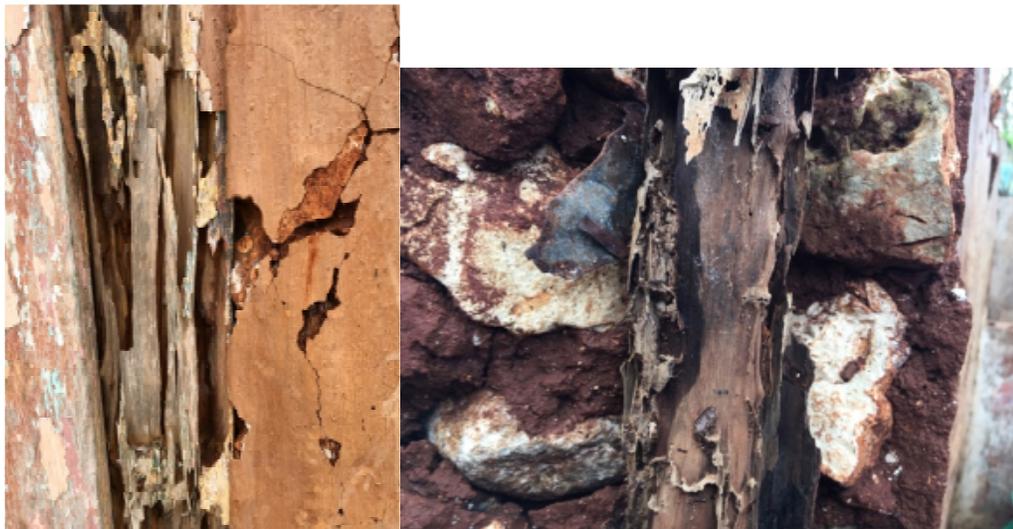
- Description:  
Insect infestation and the resulting deterioration of wood elements was often observed both in villages and in the cities. Rotten wood due to water was not observed often.

Figure 36 Infested wood poles

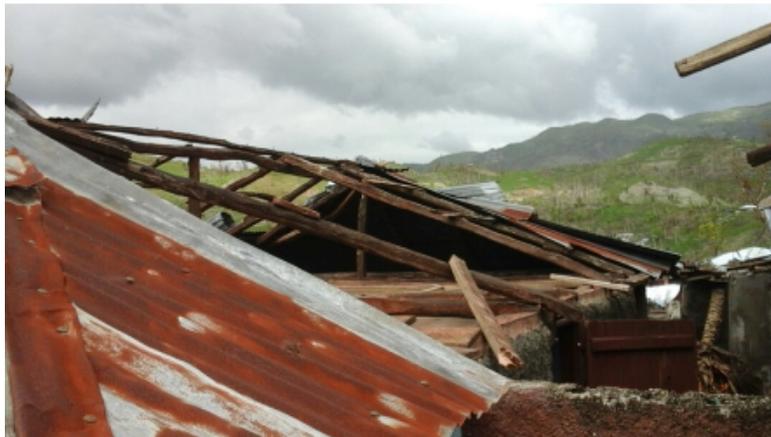
- Description:  
Failure of the roof metal sheets is probably the most typical damage we observed during the evaluation. Metal sheets were blown away by the high winds leaving the structure and its inhabitant unprotected from the hurricane. Metal sheets became high speed flying hazards when untied from the roofs. Roof nails are widely used but we also observed screw and washer connections that seems to be less resistant. The spacing of the nails is generally every 3 to 5 waves on the ondulated sheet and does not vary at edges or ridge.

Figure 37 Rusted metal sheet insufficiently nailed to the roof structure

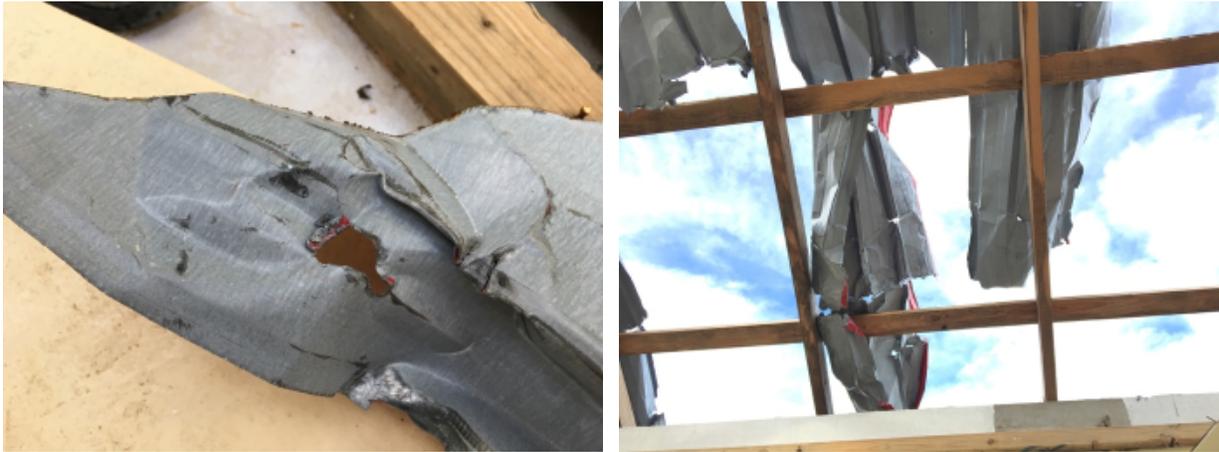
Figure 38 Left: Screw and washer hole on a metal sheet  
 Right: metal sheet torn apart due to insufficient thickness of the sheet

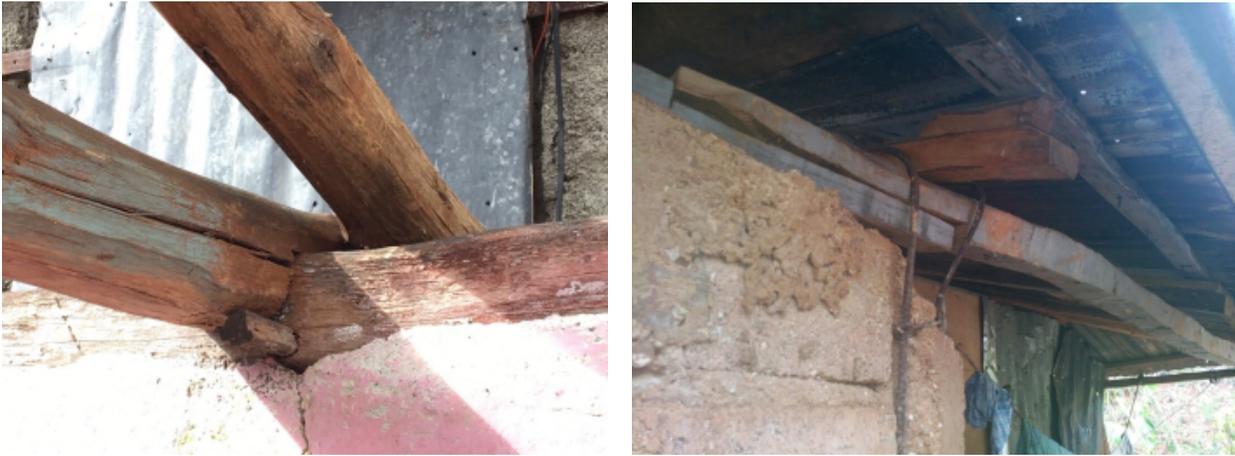
Failure of roof-to-wall connection was often observed. For wood frame structures, the connection type is typically the rafter nailed down to the top plate with a flat interface between the rafter and the top plate. For masonry structures, the roof-to-wall connection is typically a bent rebar wrapped around the rafter or top plate. As the block masonry structures rarely have a ring beam, the rebar is typically embedded in the last row of block at wall corners and wrapped around the wood structure.

Figure 39 Left: Roof system-to-top plate connection  
Right: Column-to-top plate connection

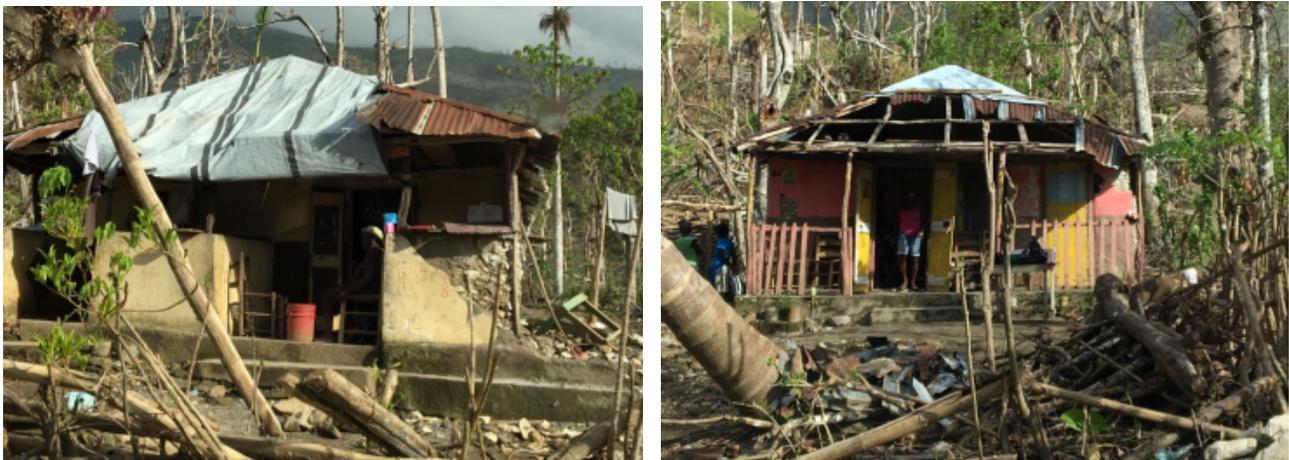
- Description:  
Even though the majority of lightweight roofs were completely gone, we observed failure of the cover was sometimes initiated at the gallery roof.

Figure 40 Gallery roof damaged

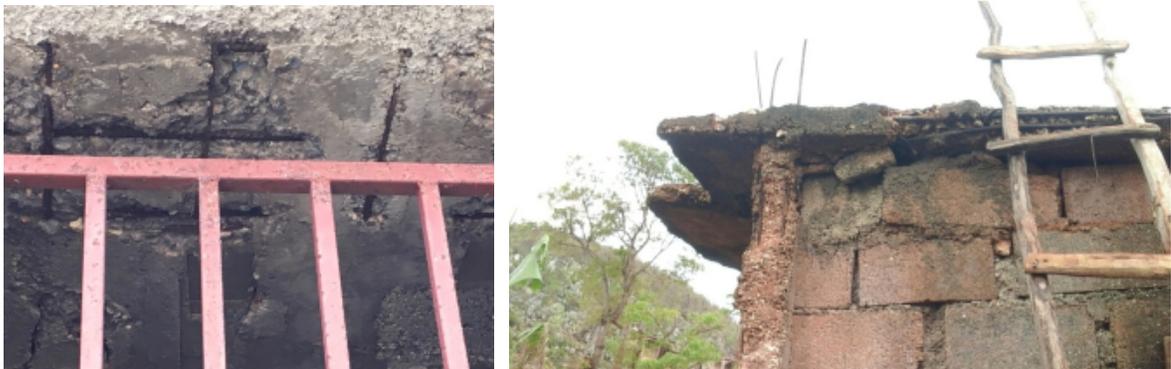
Figure 41 Exposed rebars and insufficient thickness of two slabs

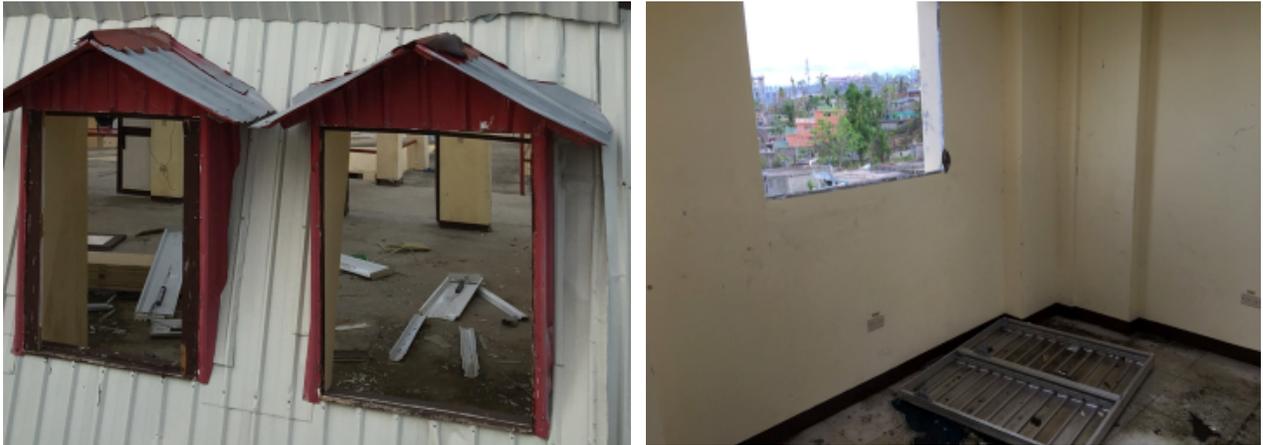
Figure 43 Left: Wood shutters failure  
Right: Metal louver failure

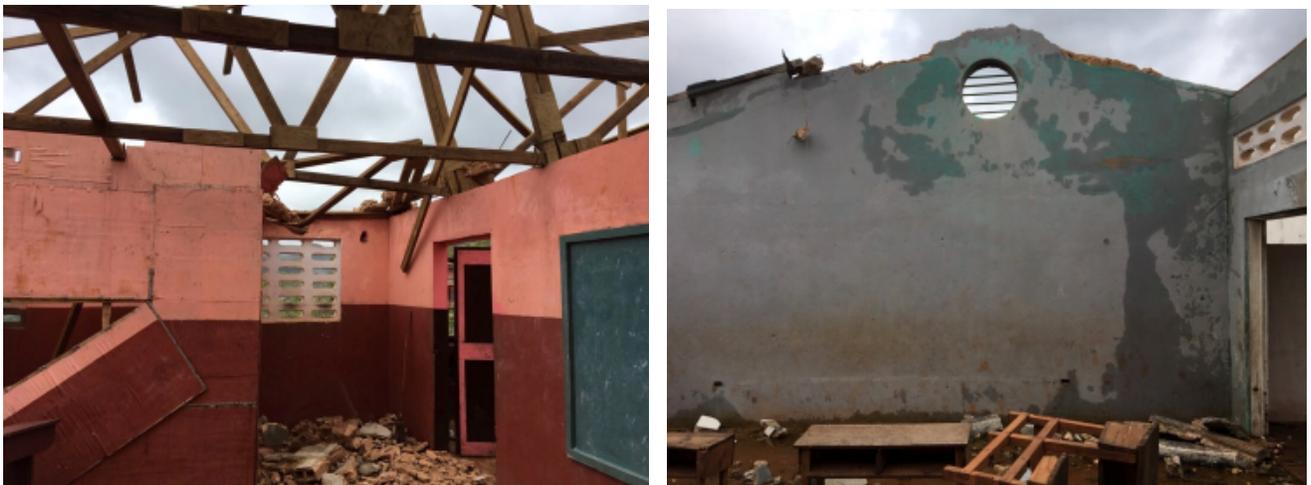
Figure 44 Left: Total collapse of masonry gable.  
Right: Partial collapse of masonry gable element due to the load from the roof structure.

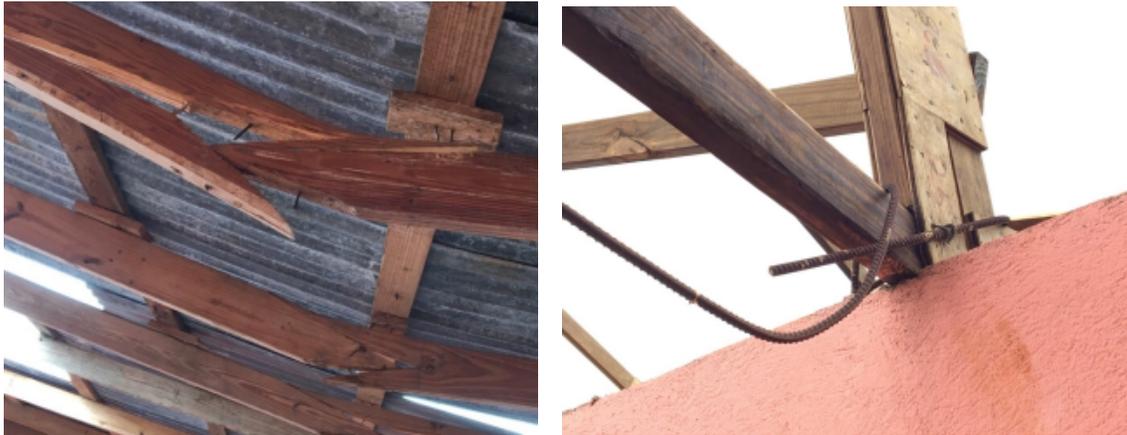
Figure 46 Left: Failure of rafter-to-rafter connection  
Right: Truss-to-top of the wall connection

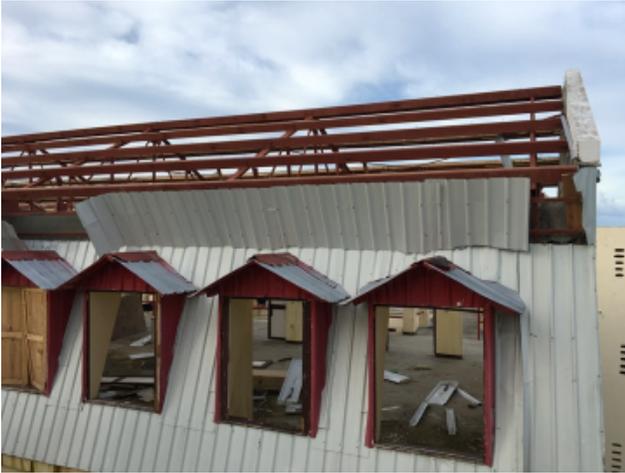
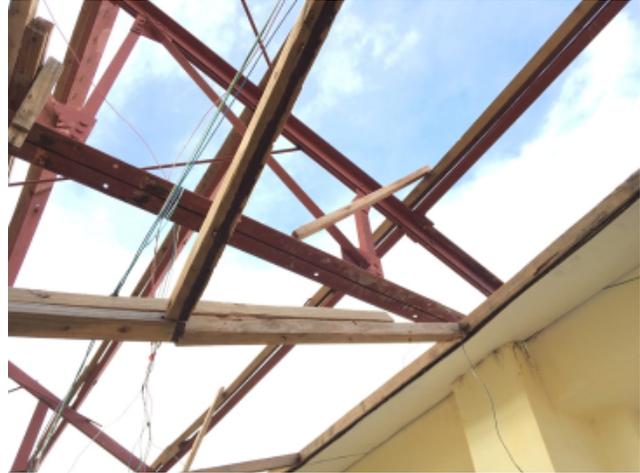
Figure 47 Left: metal sheets blown away  
right: Roof truss made of angles and metal gusset plates

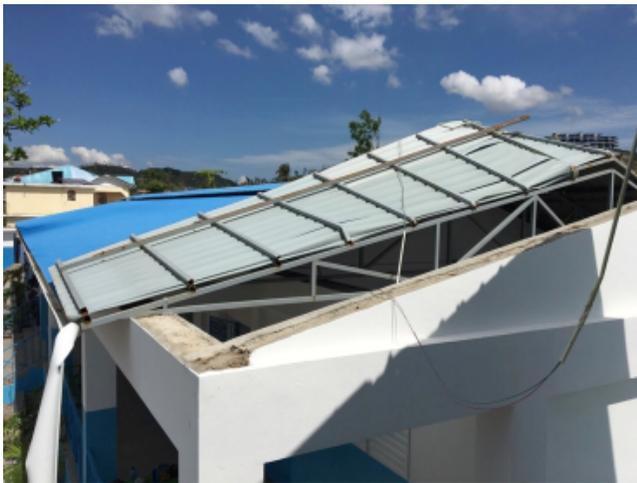
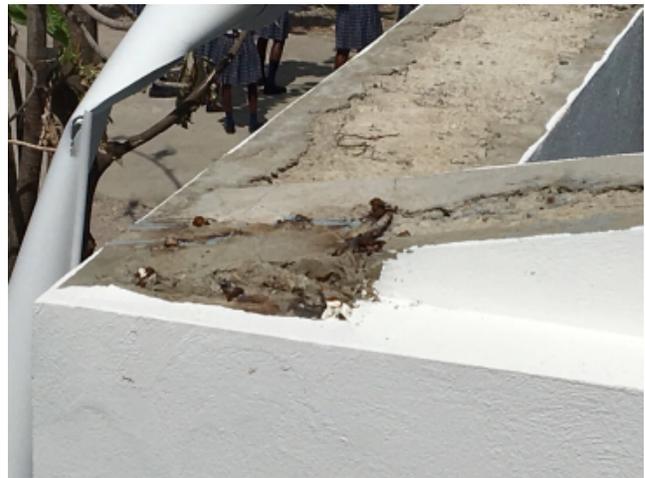
Figure 48 Failure of the welded connection of the masonry gable

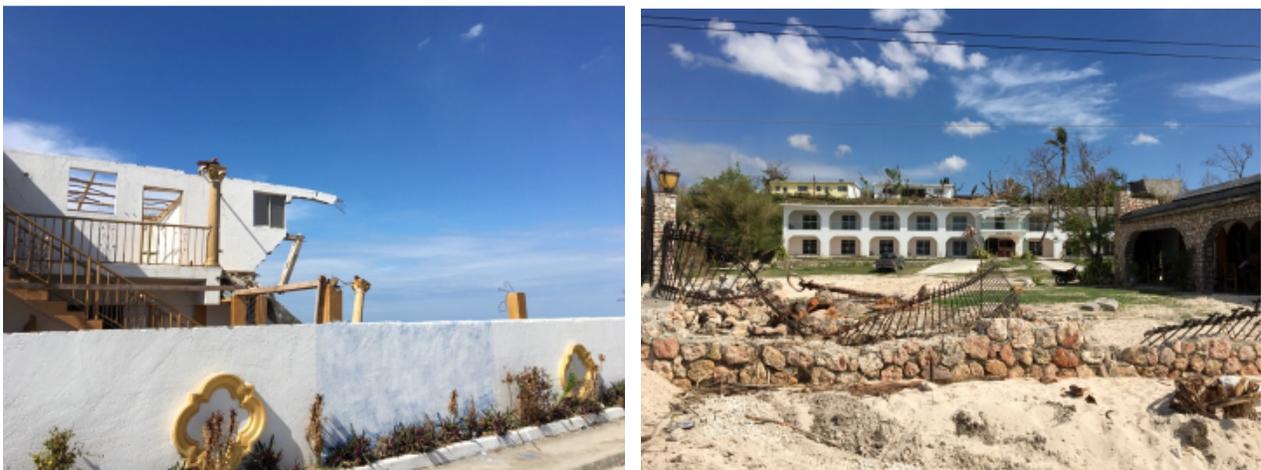
Figure 55 Left: Collapsed hotel in Port Salut due to the storm surge  
Right: Hotel not damaged but flooded up to the 1m above the first level

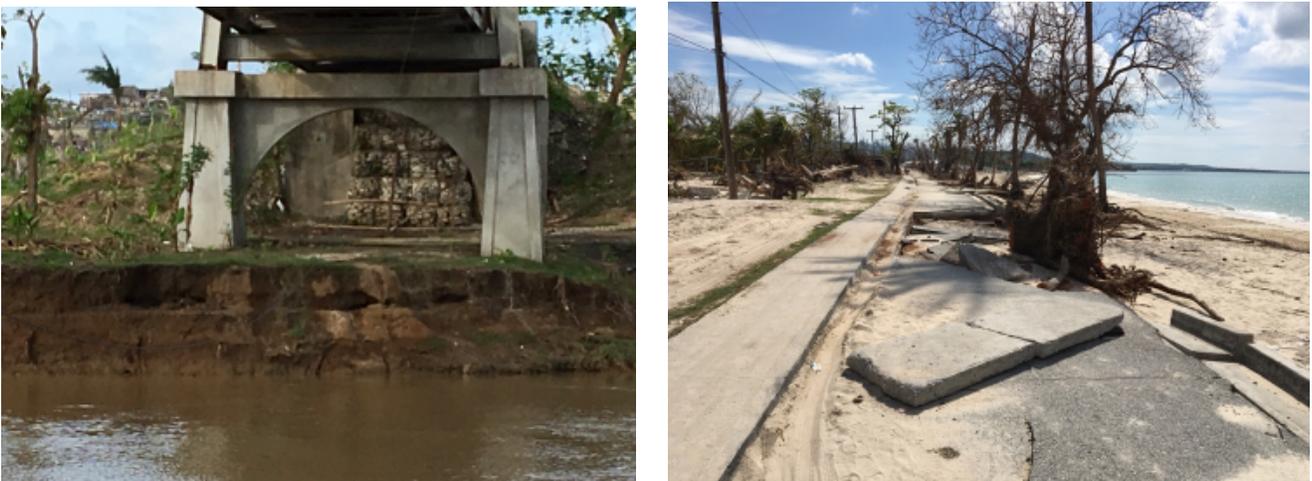
Figure 57 Left: Jérémie suspended bridge  
Right: Damaged Point Sable road in Port Salut
