**Overview**

**Housing Damage**

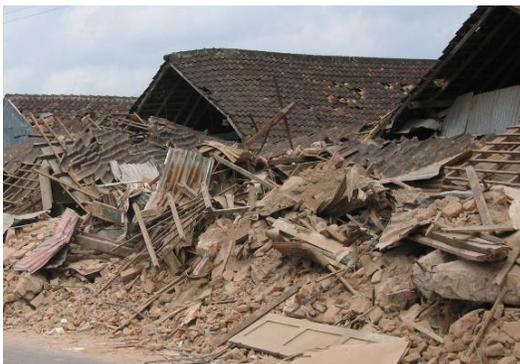
The most heavily affected areas are Bantul district in Yogyakarta Special Province (DIY), in which 47,000 houses were destroyed, and Klaten district in Central Java Province, in which 66,000 houses were destroyed. CGI, 2006 estimates 4.1 million cubic m of debris exist in the affected region (Figs 2 and 3).

*Figure 2.* Debris along main street through Imogiri, S7.92282°, E110.38374° IMG\_6551

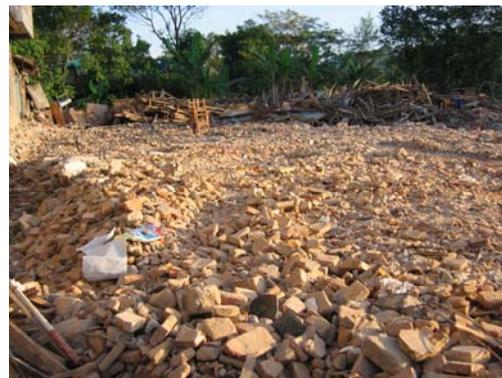
*Figure 3.* Debris in Gantiwarno (Klaten, Central Java). S7.76802 E110.54156 IMG\_6916

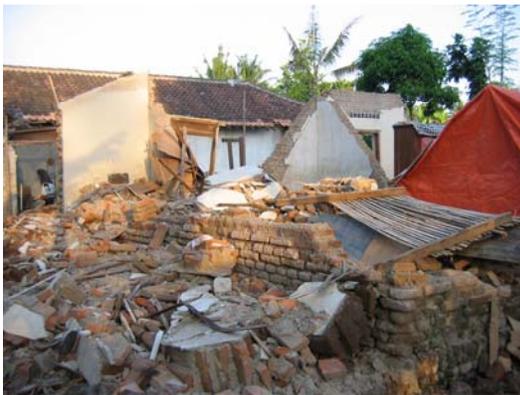
***Unreinforced Masonry.*** Unreinforced masonry houses were ubiquitous throughout the affected area and the most severely damaged (Fig. 4 and 5). No steel reinforced concrete foundation beams, columns, or ring beams were used in older houses.

*Figure 4.* Destroyed unreinforced masonry houses, Pleret (Bantul), S7.83686° E110.41552° IMG\_6633

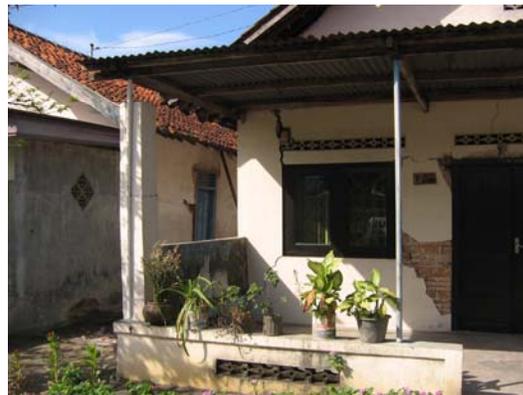
*Figure 5.* Unreinforced masonry house, damage category D3, Tlogo, Prambanan (Klaten), S7.75259° E110.49550° IMG\_6852

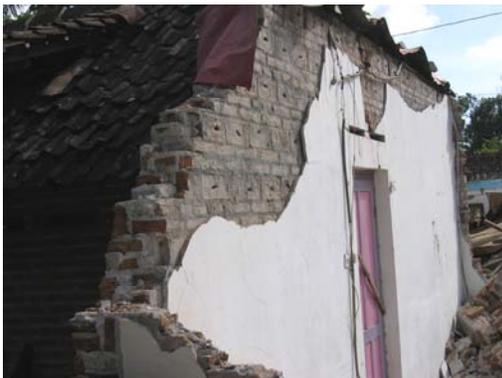
Wood-fired clay bricks were laid in sand-clay mortar or weak cement-sand-lime mortar. In many cases, the mortar would crumble under finger pressure. The walls of the oldest masonry houses were approximately 25 cm wide, built with full brick bonding (English bond). The bricks used in the oldest houses tended to be longer (25cm x 11cm x 4cm) than their modern counterparts (22 cm x 11cm x 4 cm). Full brick wide bonding is not possible with the shorter bricks, so common practice transitioned to a 17 cm wide bond in which two bricks were laid in the plane of the wall and one brick turned on its side (Fig. 6 and 7).

*Figure 6.* Unreinforced masonry. Sumbermilo (Bantul) IMG\_6771

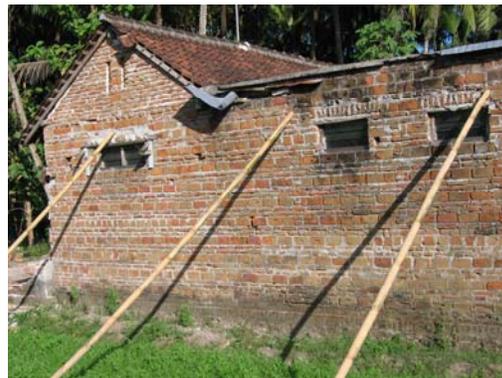
*Figure 7.* Unreinforced masonry, Bebekan Mulyodadi, Bambang Lipuro (Bantul). S7.94160°, E110.32297° IMG\_6806

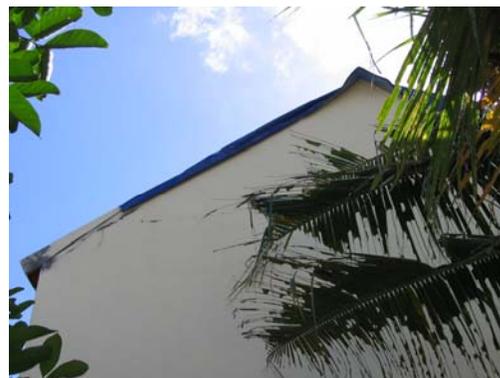
Prior to the earthquake, three houses were built in Wonokromo, Pleret (Bantul) under the supervision and direction of Prof. Sarwidi of the Center for Earthquake Engineering, Dynamic Effect, and Disaster Studies (CEEDEDS) at Universitas Islam Indonesia. These confined masonry houses used connection detailing shown in the posters distributed by CEEDEDS (Figure 11). The houses performed very well in the earthquake, with only hairline cracks, and in one case minor some damage to masonry gable wall (Figure 12).

*Figure 12.* Crack at masonry gable, CEEDEDS house, Jejeran-2, Wonokromo, Pleret (Bantul), S7.86676° E110.38764°, IMG\_6696

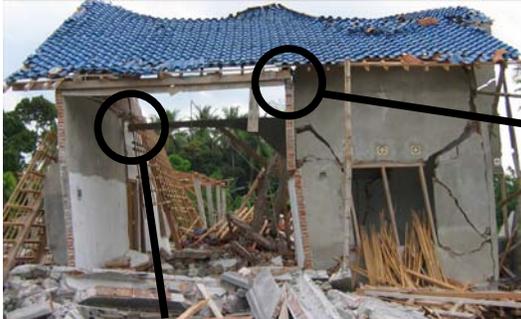
- (1) Insufficient connections between reinforced concrete tie columns and bond beams and between tie columns and masonry walls. This was the most dominant cause of failure for newly-built confined masonry houses in which tie columns and bond beams were present (Figs. 13 – 17).

*Figure 13.* Confined masonry house under construction, insufficient connections, Pleret (Bantul). S7.87574°, E110.40703°, IMG\_6575

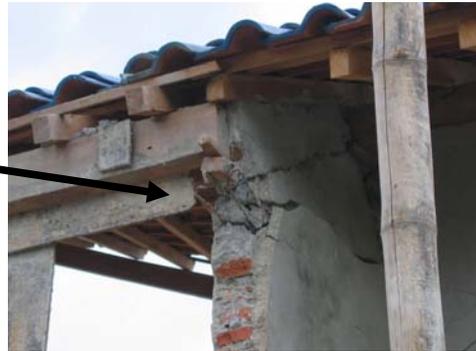
*Figure 14.* Zoom-in view of ring beam – column connection. IMG\_6577

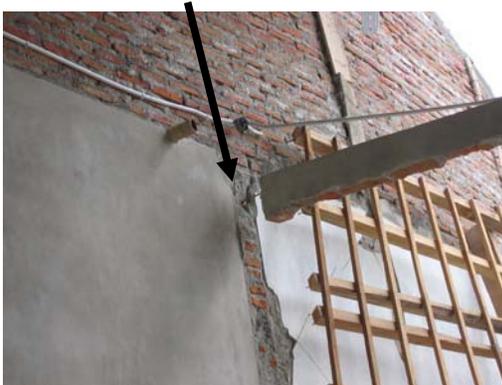
*Figure 15.* Zoom-in view of beam without connection, IMG\_6579

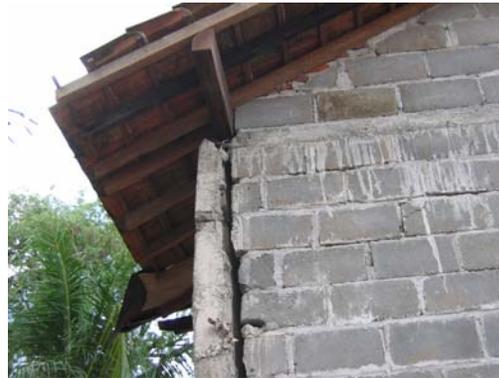
*Figure 16.* Insufficient connection between column and beam, Segoroyoso, Pleret (Bantul) S7.88174° E100.40869°, IMG\_6749

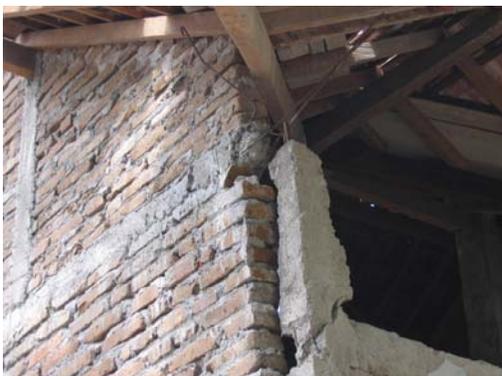
*Figure 17.* Insufficient connection between column and beam, Pleret (Bantul) S7.88174° E100.40869°, IMG\_6746

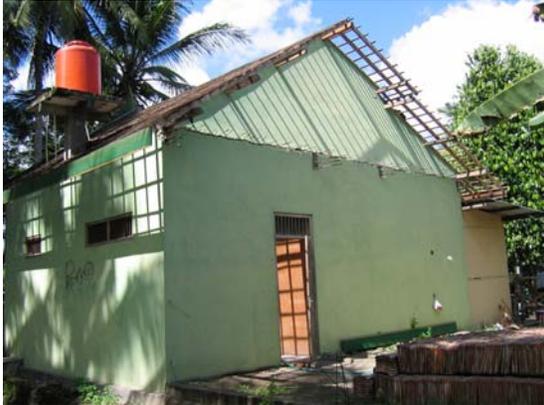
- (2) Tall, slender poorly confined masonry walls. Newer houses use running bond for the masonry wall, resulting in a half-brick wide wall (13 cm with plaster, 10-11 cm without) which is often over 3m tall. Gables add another 1 – 2m to the height. Damage and failure to masonry gable walls was widespread throughout the affected region and plagued both new and older houses with and without reinforced concrete ring beams (Fig. 18 and 19). In most cases, gable masonry was neither properly confined nor properly connected to the roof. Cross-bracing between gables was not common. Offset gables, a popular architectural style that accommodates a larger living room and terrace, were also damaged (Fig. 20 and 21).

*Figure 18.* Masonry gable wall overturning, Keputren, Pleret (Bantul) S7.86905° E110.40272°, IMG\_6721

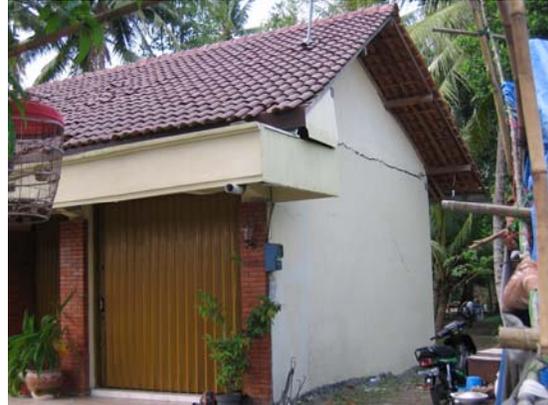
*Figure 19.* Masonry gable wall overturning (Bantul) S7.89468°, E110.37341°, IMG\_6542

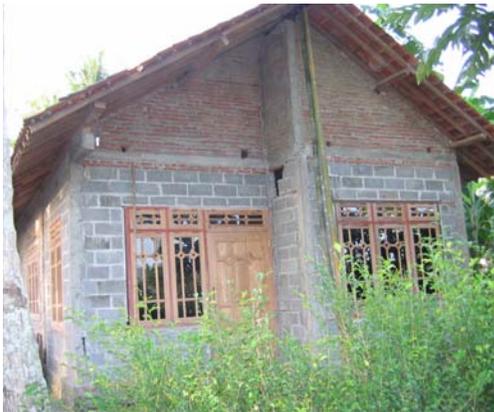
*Figure 20.* Minor damage to offset gable, Gantiwarno (Klaten), S7.75485° E110.53555°, IMG\_6905

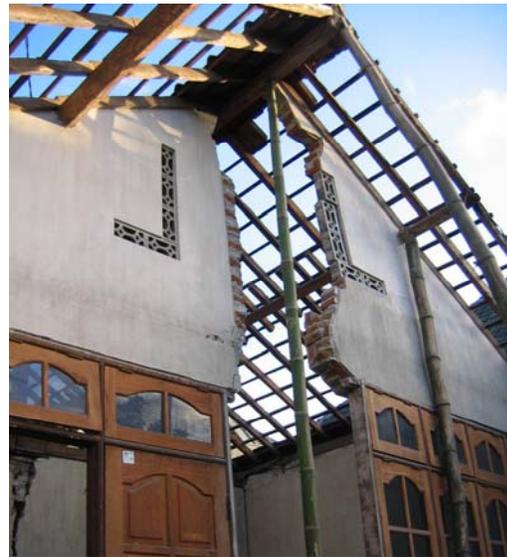
*Figure 21.* Collapse of offset gable, Kasongan, Kasihan (Bantul), S7.84512° E110.33534°, IMG\_6824

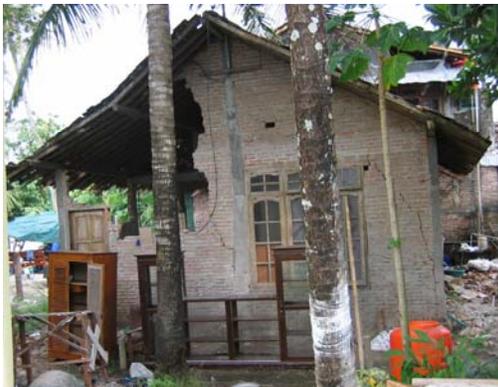
(3) Absence of plinth beams and ring beams. Many newer houses had reinforced concrete columns but no reinforced concrete ring beams (Fig. 22 and 23).

*Figure 22.* Collapse of masonry wall (note absence of ring beam), Pleret (Bantul) IMG\_6589

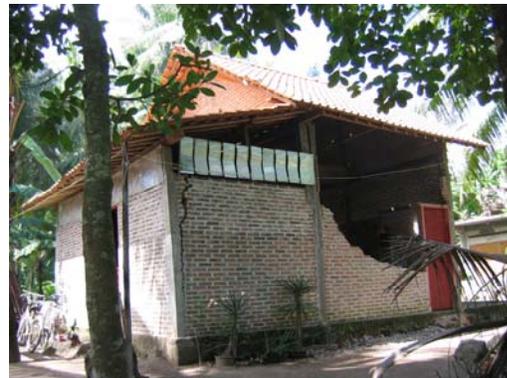
*Figure 23.* Collapse of masonry wall (note absence of ring beam), Kebutren, Pleret (Bantul) S7.86905° E110.40272°, IMG\_6725

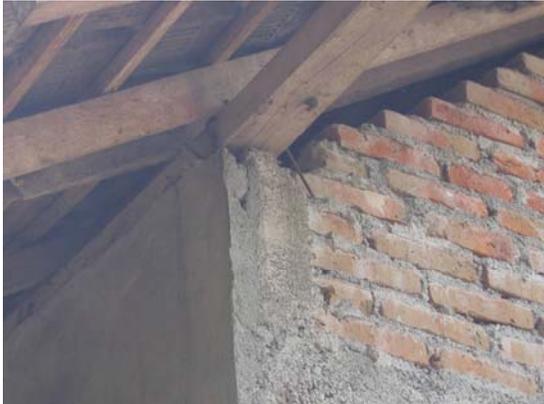
(4) Insufficient connections between walls or columns and roof. Column steel was often wrapped around a timber beam which functioned as a ring beam (Fig. 24). Timber beams were generally 8cm by 12cm and made from coconut trees or hardwood from Java and Kalimantan. Bamboo is also common for roof structures. Some older houses were a mix of structural system, in which part of the roof load was carried by timber posts infilled with masonry. A typical timber truss is shown in Fig. 25.

*Figure 24.* Common connection between column and beam – column steel wrapped around timber, Jejeran-1, Wonokromo, Pleret (Bantul), S7.86480° E110.38821° IMG\_6672.

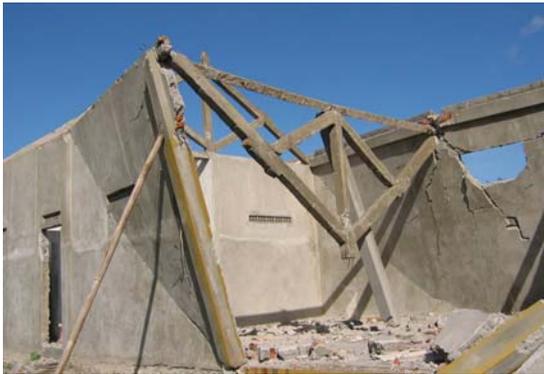
(5) Use of reinforced concrete trusses. Reinforced concrete trusses were seen in a few of the houses, all of which had non-ductile failures at the beam-column connections (Fig. 26 and 27). These buildings were mixed use; the rear part was used for storage or living area, and the front for a shop. As a result, the front was typically an open frame (no shear wall).

*Figure 26.* House/shop with reinforced concrete truss, Bebekan Mulyodadi, Bambang Lipuro (Bantul) S7.93460° E110.32194°, IMG\_6778

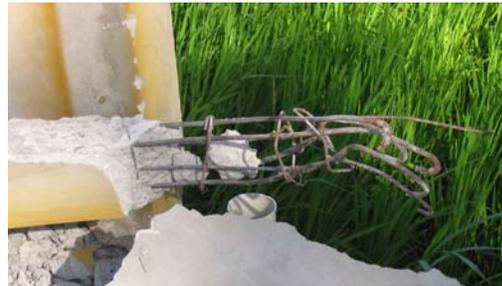
*Figure 27.* Reinforcement in beam for house/shop, Bebekan Mulyodadi, Bambang Lipuro (Bantul) S7.93460° E110.32194°, IMG\_6781

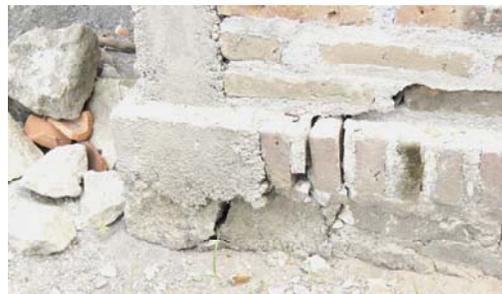
(6) Foundation Issues. Foundations for both older and newer houses consisted of shallow strip footings built of random, angular mountain stone or brick masonry in mud or cement mortar. Only one foundation-related failure was found; masonry walls of a single story house shifted horizontally at the interface between the wall and the stone masonry foundation (Fig. 28).

*Figure 28.* Sliding along wall/foundation interface, Tegal Kebong Agung, Imogiri (Bantul) S7.93434° E110.36667°, CIMG1769
