OVERVIEW

The M_w 7.9 earthquake in Wenchuan, China on 12 May 2008 was catastrophic in terms of lives lost and buildings destroyed or damaged: 69,185 people killed, 374,171 injured, 18,467 still listed as missing. More than 7.79 million houses were destroyed, and 24.5 million damaged.

This report provides more details on the five and seven-story buildings in Dujiangyan. Two structural systems were common: (1) load-bearing masonry (unreinforced or partially confined) and (2) reinforced concrete frame with masonry infill. See Table 1 for a listing of the types of residential structures surveyed during the reconnaissance.

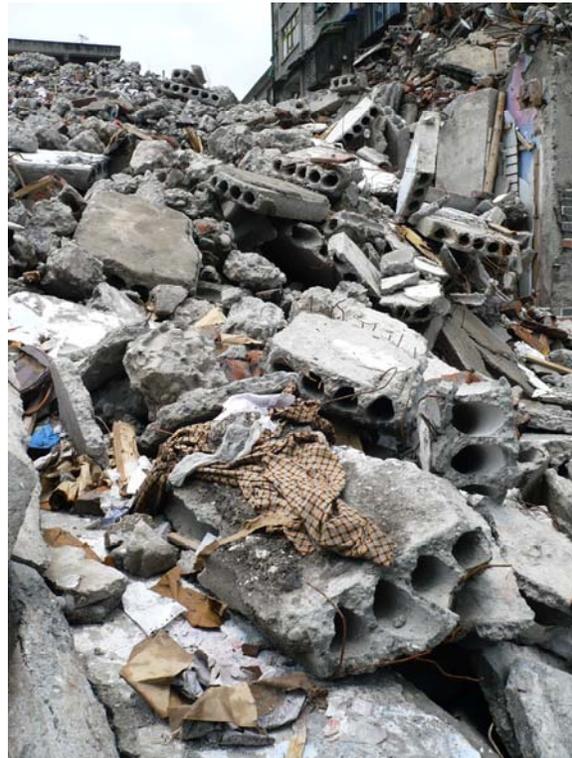
Fig 1. Precast concrete plank rubble, collapsed multi-story unreinforced masonry building, Dujiangyan.

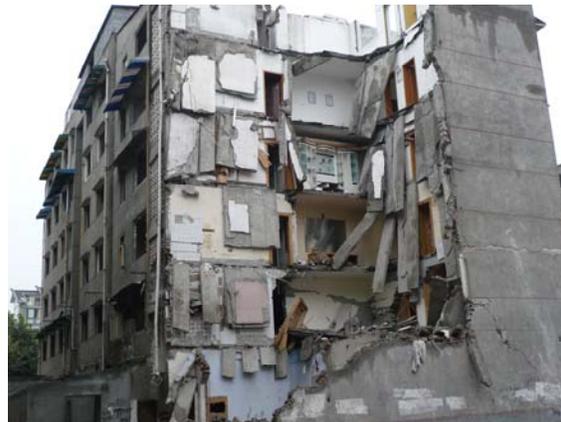
Fig. 2. Partially collapsed six-story unreinforced masonry apartment building with precast concrete plank floors, Dujiangyan.

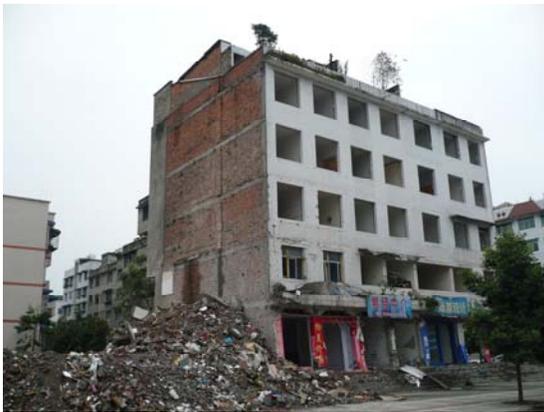
Fig 3. Five story unreinforced masonry building, damage to open frame ground floor, Dujiangyan. IMG0166

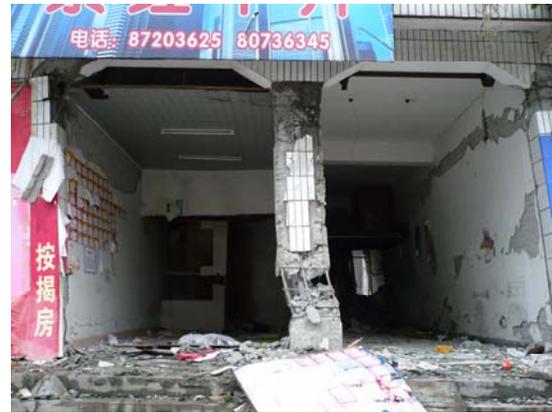
Fig 4. Five story unreinforced masonry building (4th column from left in Fig. 3), shear failures in first story columns, Dujiangyan. IMG0168

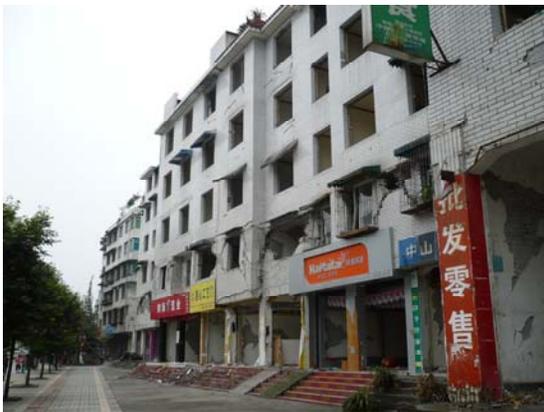
Fig 5. Five story partially confined masonry buildings, damage to open frame ground floor and second floor, Dujiangyan. IMG0183

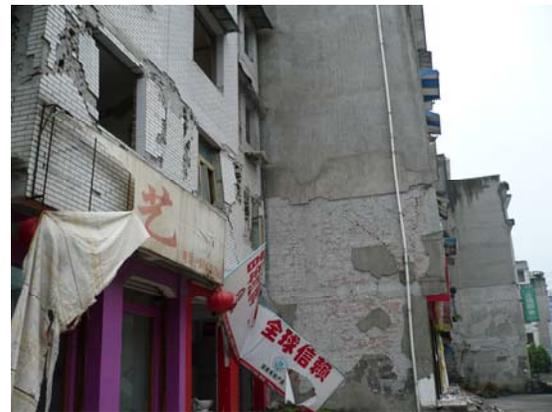
Fig 6. Five story partially confined masonry buildings (Fig. 5), damage to open frame ground floor and second floor, Dujiangyan. IMG0189

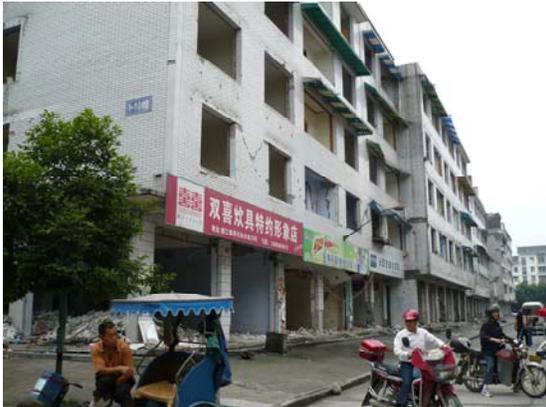
Fig 7. Five story masonry buildings, damage to open frame ground floor and second floor, Dujiangyan. IMG0216

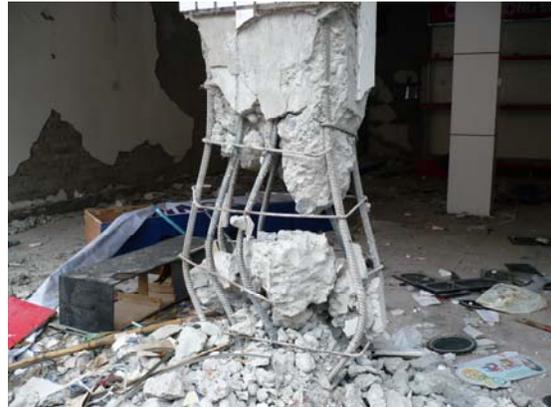
Fig 8. Five story masonry building (6th column from left in Fig. 7), shear failures in first story columns, note large spacing between ties, lack of hook, and use of large, rounded aggregate, Dujiangyan. IMG0219

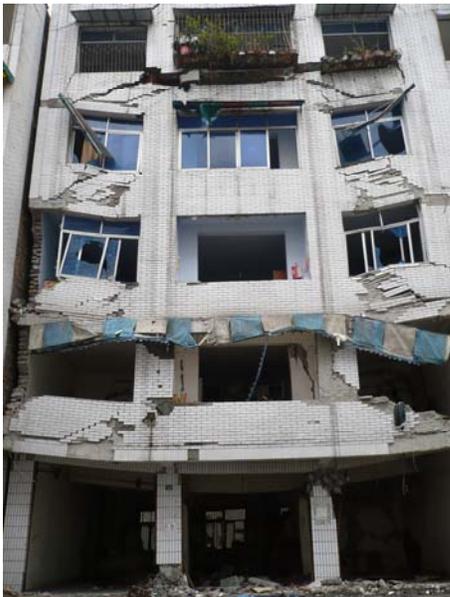
Fig 9. Five story masonry building, collapse probably prevented by adjacent buildings, Dujiangyan. IMG0243

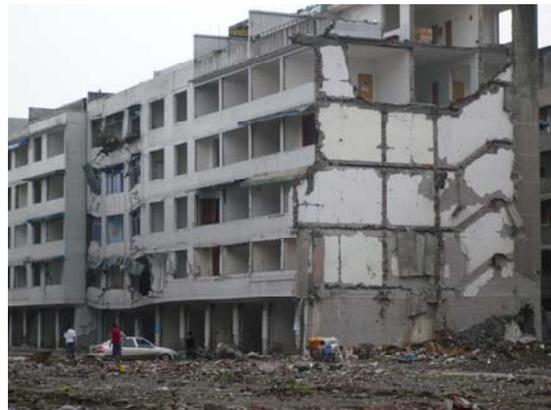
Fig 10. Five story building (Fig 9), debris from adjacent building collapse already removed, Dujiangyan. IMG0287

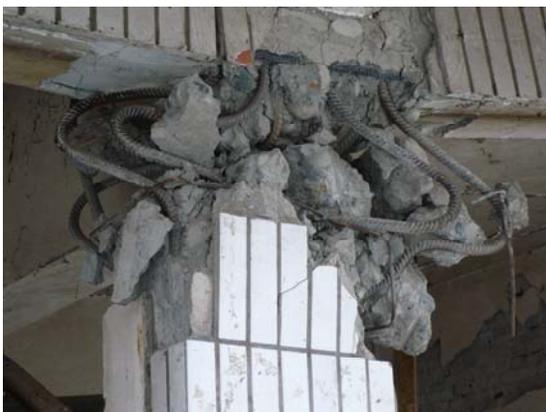
Fig 11. Ground floor column failure (rightmost column in Fig. 9), Dujiangyan. IMG0240

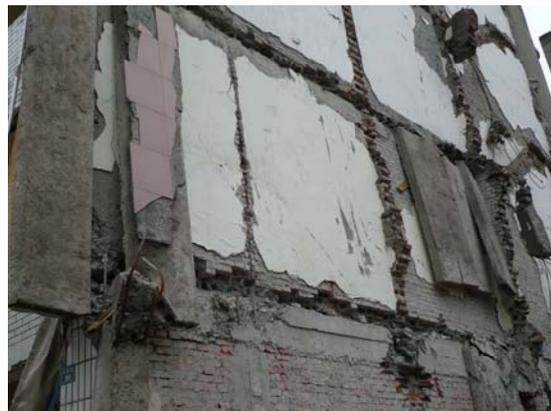
Fig 12. Side view of five story building (Fig. 10), note lack of connection between ground story column and upper floor columns and beam. IMG0254

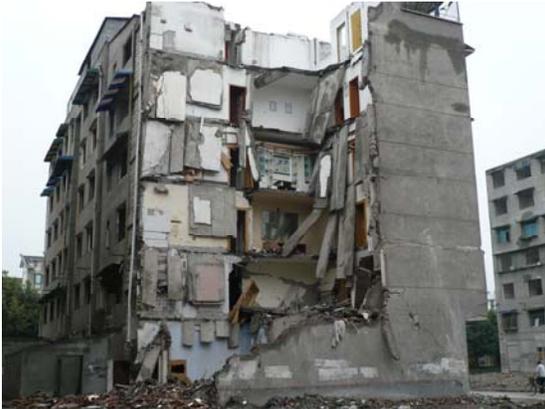
Fig 13. Partial collapse of six story masonry with precast plank floor, Dujiangyan. IMG0267

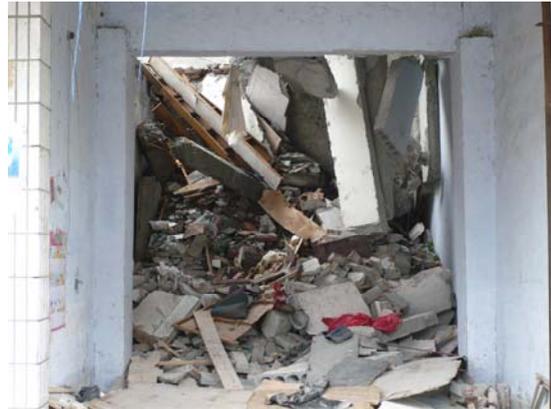
Fig 14. View from streetside of six-story building in Fig. 13, Dujiangyan. IMG0282

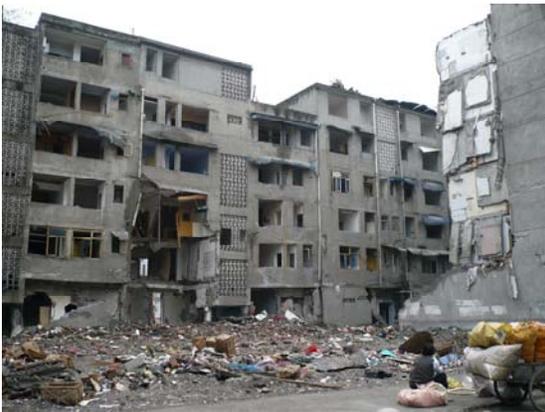
Fig 15. Partially collapsed buildings (Fig. 13 on right), debris already removed from collapsed building in foreground. IMG0252

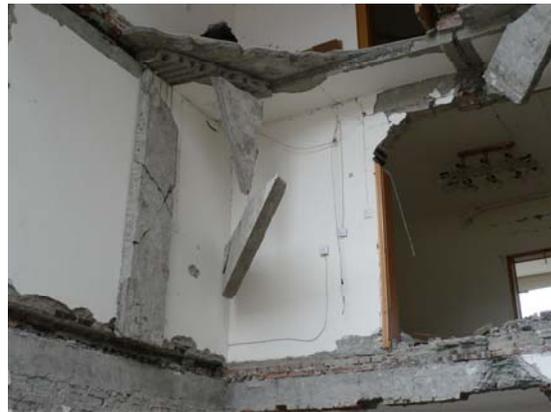
The collapsed and heavily damaged buildings employed precast concrete planks for the floor, and like low-rise residential, rural counterparts, the precast concrete planks were not well connected to the walls. Instead of being confined by the ring beam, if present, they rest on it. Some planks have small diameter (4mm-6mm) steel bars plastered to the bottoms which held them in place at the wall.

Fig 16. Close-up view of partial collapse of building in back of Fig. 15, note precast planks resting on top of, rather than connected to, ring beam, Dujiangyan. IMG0280

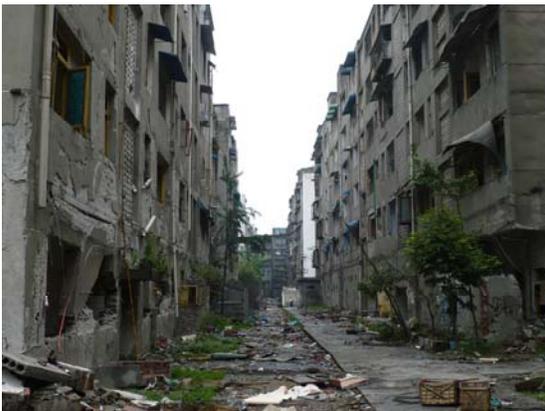
Fig 17. Backside of buildings shown in Fig. 10. IMG0263

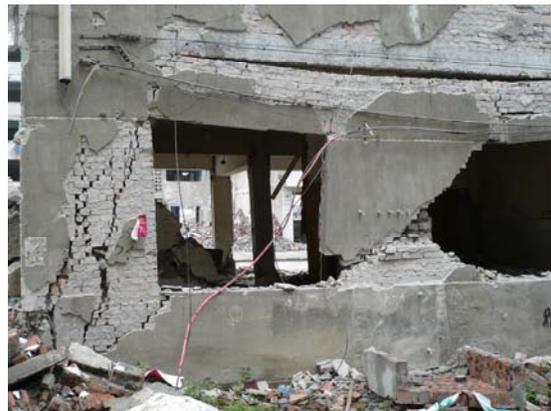
Fig 18. Shear failure in ground floor masonry, building shown in Fig. 17 (left) and Fig. 10. IMG0266

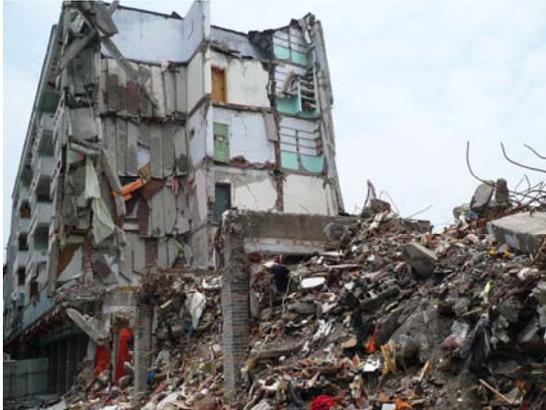
Fig 19. Partially collapsed URM with precast concrete plank, Dujiangyan. IMG0324

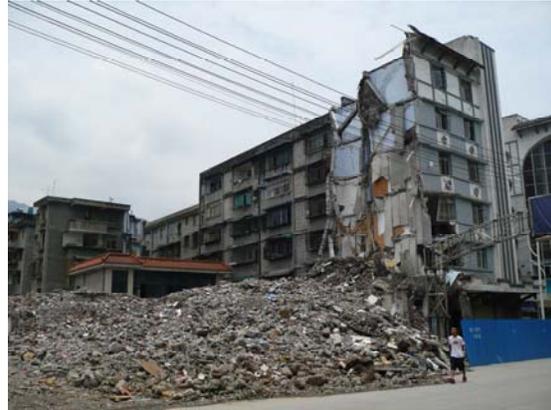
Fig 20. Partially collapsed URM with precast concrete plank, Dujiangyan. IMG0335

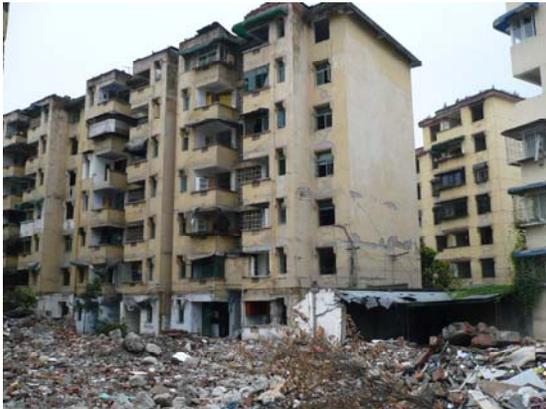
Fig 21. Seven story masonry building with shear cracks, Dujiangyan. IMG0300

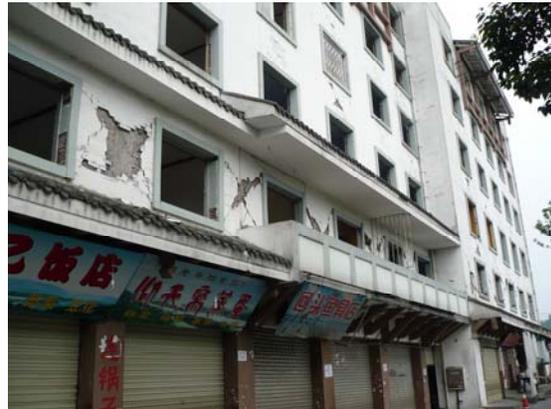
Fig 22. Shear cracks through columns in six-story confined masonry building, Dujiangyan. IMG0307

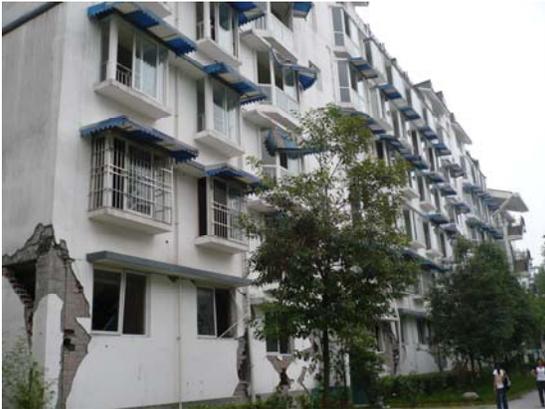
Fig 23. Damaged six-story reinforced concrete frame with masonry infill, Dujiangyan. IMG0714

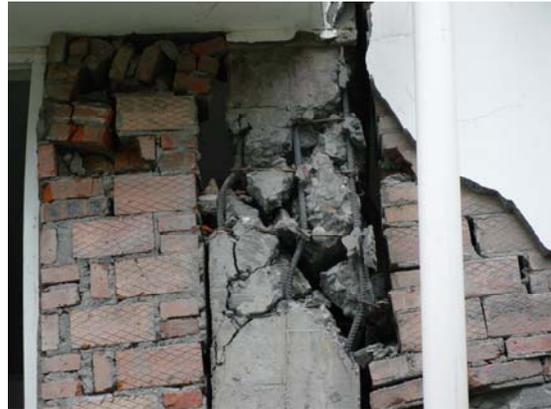
Fig 24. Shear failure at top of ground floor column, six story building from Fig. 23. IMG0705

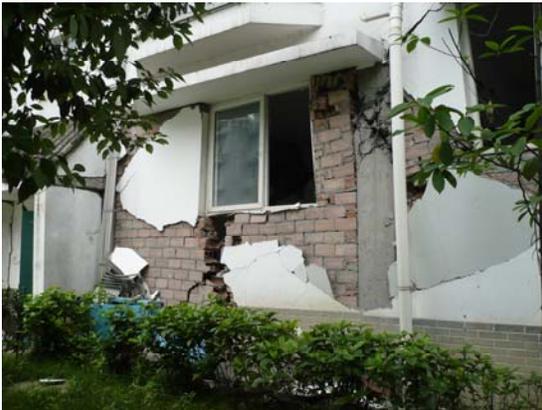
Fig 25. Adjacent masonry infill panel (see Fig. 24). IMG0702

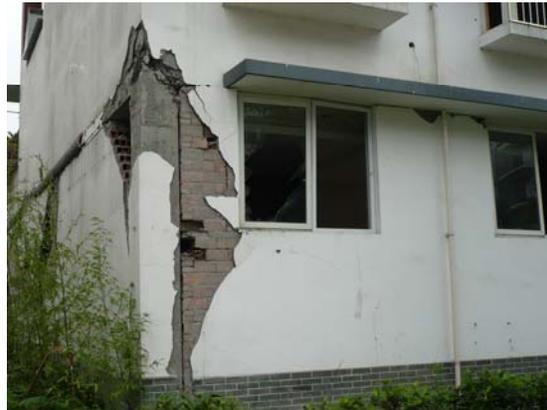
Fig 26. Shear failure in corner column. IMG0712

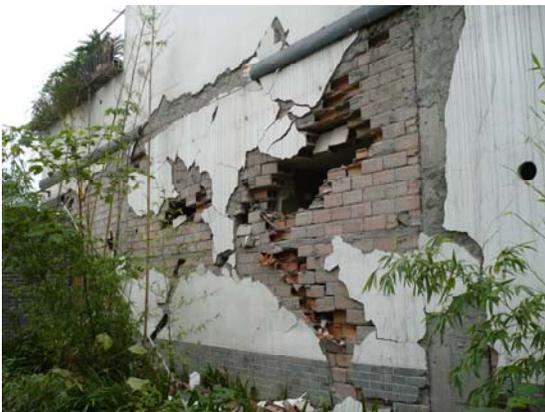
Fig 27. In-plane shear failure of masonry infill wall, note that thin horizontal band at mid-height was not sufficient to prevent crack propagation. IMG0715

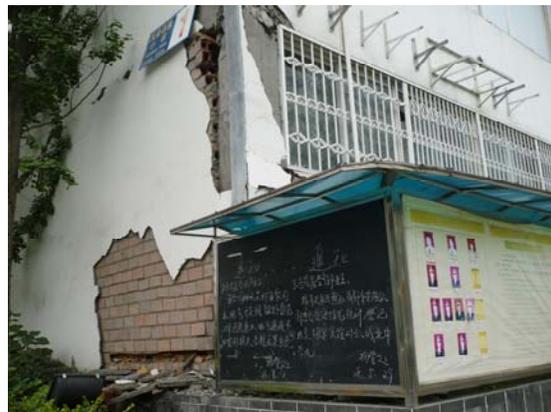
Fig 28. Overturning failure of masonry infill wall. Shear failure in corner column. IMG0717

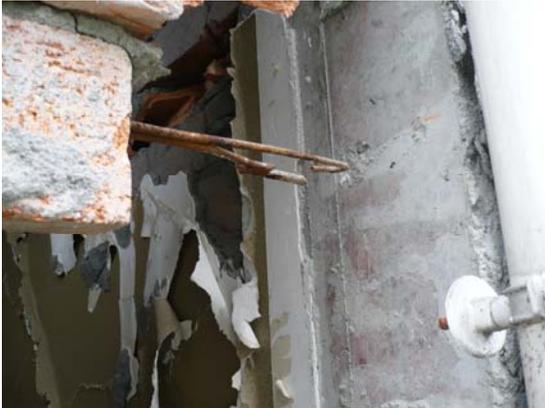
Fig 29. Steel for connection between infill wall and column, note that bolt holes in column have been plastered over. IMG0711

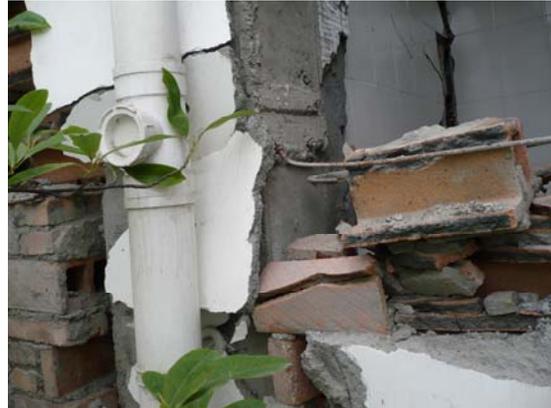
Fig 30. Steel connection between infill wall and column. IMG0668

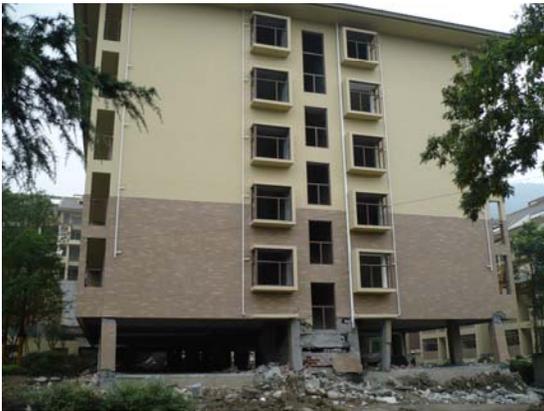
Damage to ground floor/soft story columns in new, six-story apartment buildings is shown in Figs. 31 and 32.

Fig 31. Damage to ground floor columns, new six-story apartment building, Dujiangyan. IMG0718

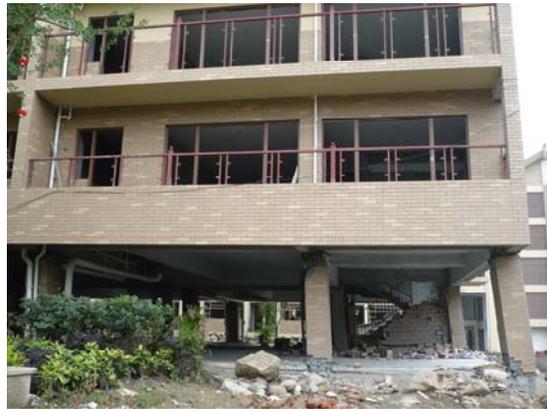
Fig 32. Soft ground story failure of new apartment building IMG0721
