**MARCH 10, 2015 - LOS SANTOS, SANTANDER EARTHQUAKE,
COLOMBIA**

**Surveyed March 24-25, 2015
Report Released June 16, 2015**

Build Change Post-Disaster Reconnaissance Report

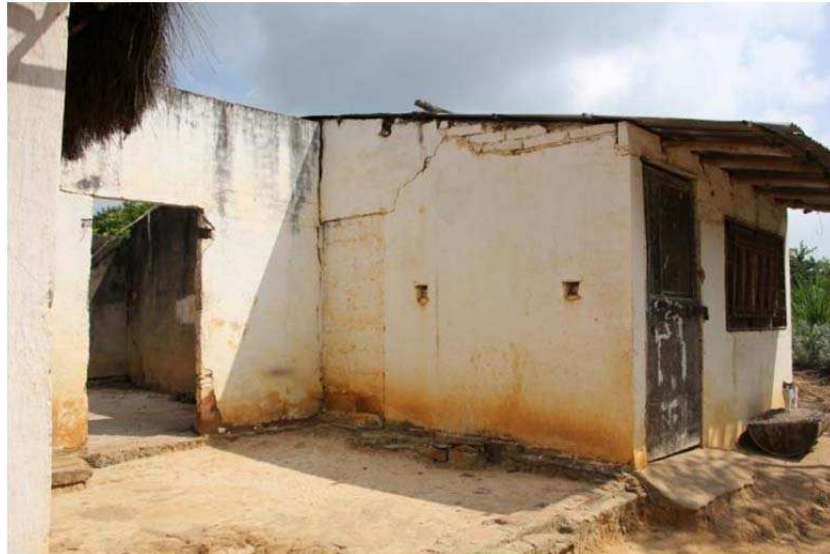
Rammed earth or adobe masonry walls are relatively rigid and typically have a lower load resistance than modern wall systems common in newer house construction, such as clay masonry block walls. The occurrence of damage in buildings in the region was mainly found in earth-based wall systems; the general damage observed was the separation between walls because of the lack of competent connections between them (Picture 1).

Picture 1. House in the rural area of Betulia, Combination between Brick and Adobe Unreinforced Masonry.

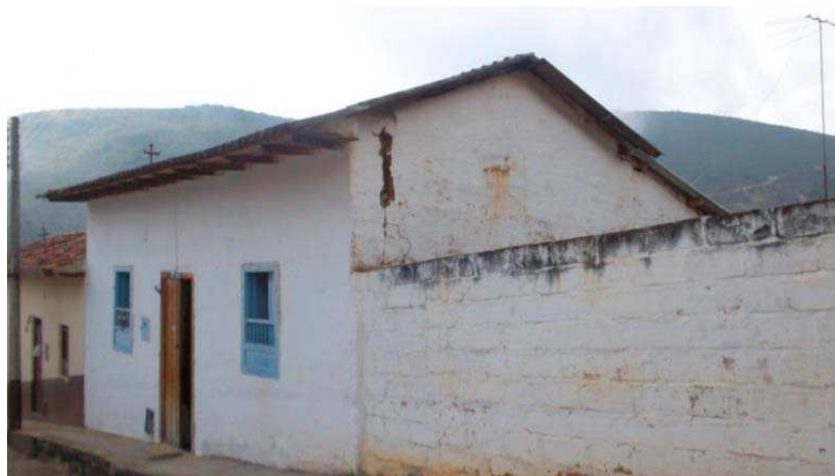
Damage was also observed, although in lesser quantities, on isolated unreinforced hollow clay tile wall systems (HCT), especially on longer walls, such as in public buildings (schools and health care facilities), and residential lot enclosures with little or no transversal walls (Picture 2).

Picture 2. House in the urban area of Betulia, lot enclosure perimeter wall next to a house (undamaged).

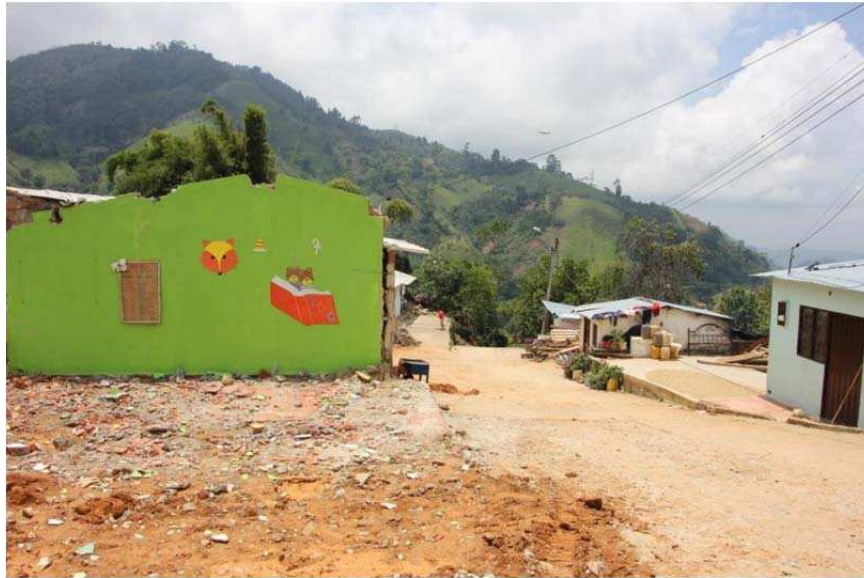
The team visited Matanza, including the villages of La Capilla and Santa Cruz de la Colina. In Matanza and La Colina, extensive damage was not observed. However, in the small village of La Capilla, roughly two-thirds of the structures were significantly damaged, including a school and daycare center of adobe construction. By the time the team arrived in La Capilla, the community center and school had already been demolished (Pictures 3 and 4).

Picture 3. Plot where the school previously sat, image of the demolition.

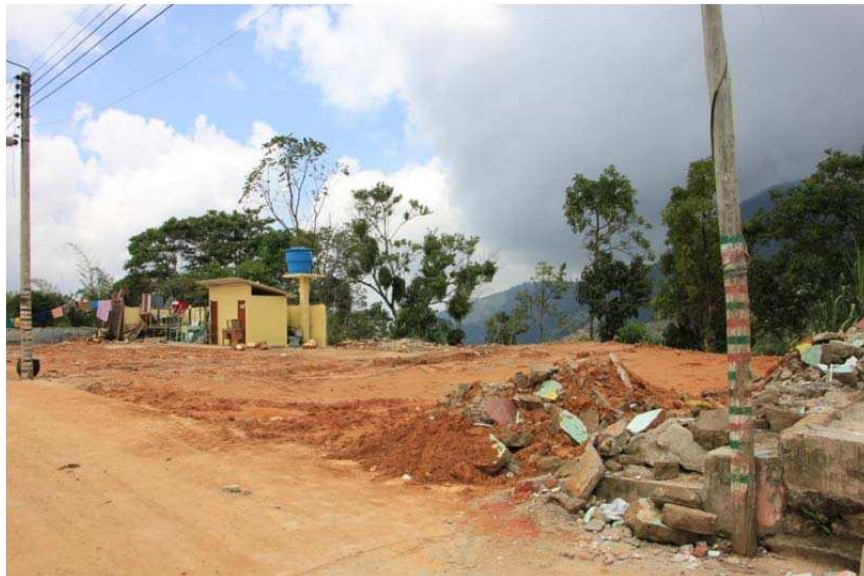
Picture 4. Lot where the school previously sat, image of the demolition.

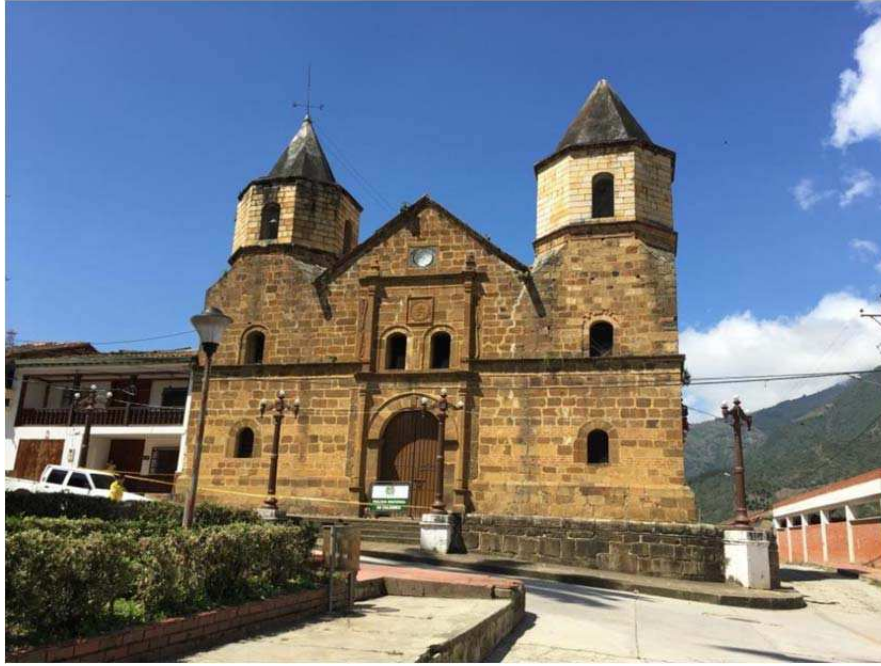
In the town of Matanza, residential damage was not very significant, except for isolated cracking of walls. The largest building, the church, did suffer more damage and has been closed off. The

building shows many older and previously repaired cracks on the walls, probably from other seismic events (Pictures 5, 6, 7, and 8).

Picture 5. Matanza village church.

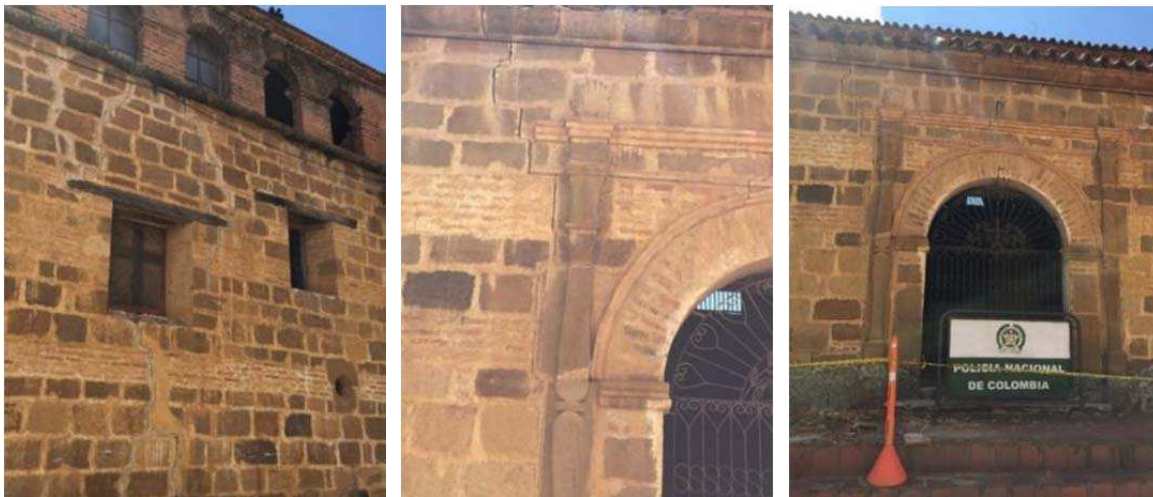
Pictures 6, 7, and 8. Previously repaired and reopened cracks on the church façade.

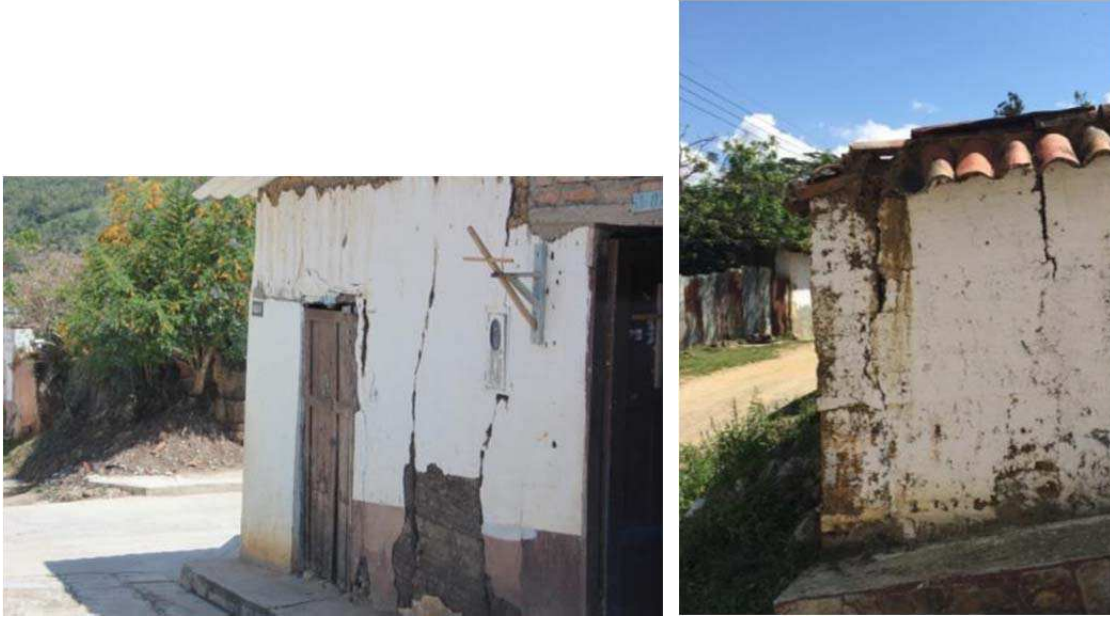
Where partial or total collapse of buildings was found (mainly in rural areas), the buildings were constructed of unreinforced masonry with no confining elements, such as reinforced concrete beams and columns. Additionally, these more damaged buildings typically were composed of a combination of masonry types, further increasing their vulnerability. This mix of masonry is likely due to the progressive construction process of lower-income homes. In these cases, the

homeowners build their houses as funds become available, and purchase the most affordable construction materials available at that time (Pictures 9 and 10).

Pictures 9 and 10. Examples of residential damage observed in Matanza.

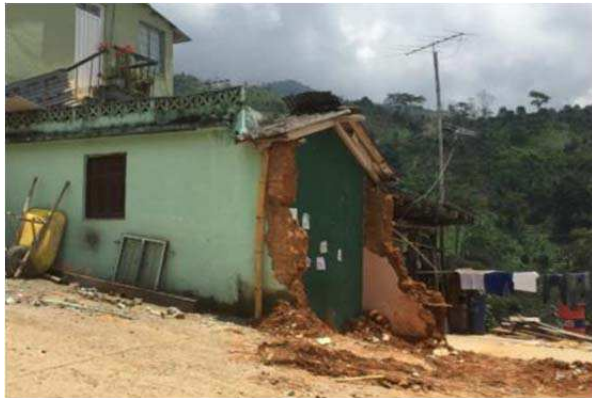
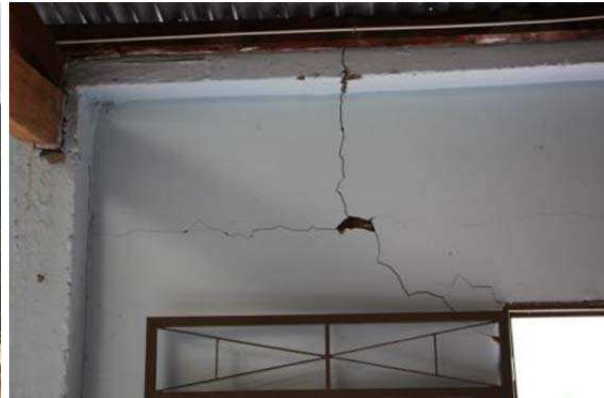
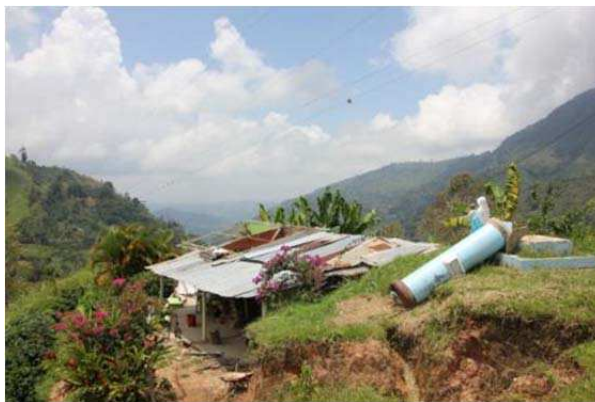
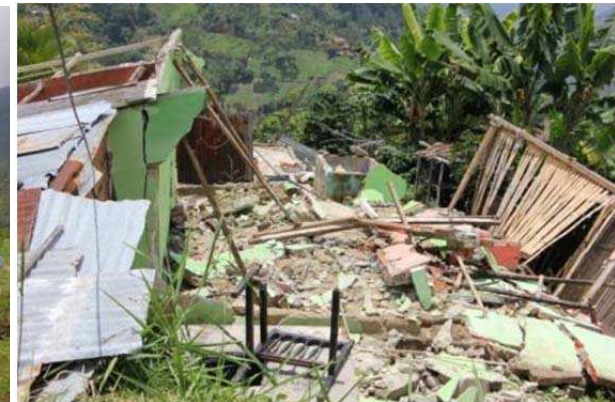
The village of La Capilla in the municipality of Matanza presents widespread damage, mainly in earth construction and in unreinforced or not fully confined masonry wall types. It was common to find cracks with a stepwise trend, in two directions in unreinforced masonry houses. The school and day care center that have a simple adobe masonry wall structure were completely demolished, as were many homes (Pictures 11, 12, 13, and 14).

Pictures 11, 12, 13, and 14. Damages in houses of the rural and urban area of La Capilla; Diagonal cracks on the bearing walls and partial collapse of a house built in unreinforced masonry.

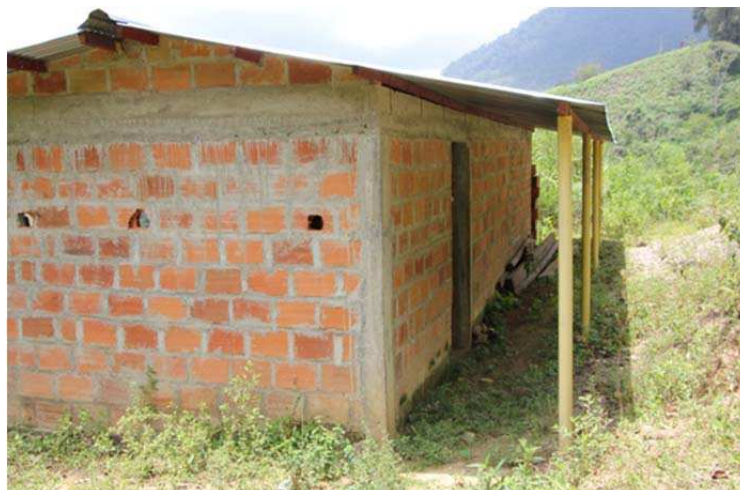
Picture 15. House in rural area of La Capilla, construction in confined masonry with no damage.

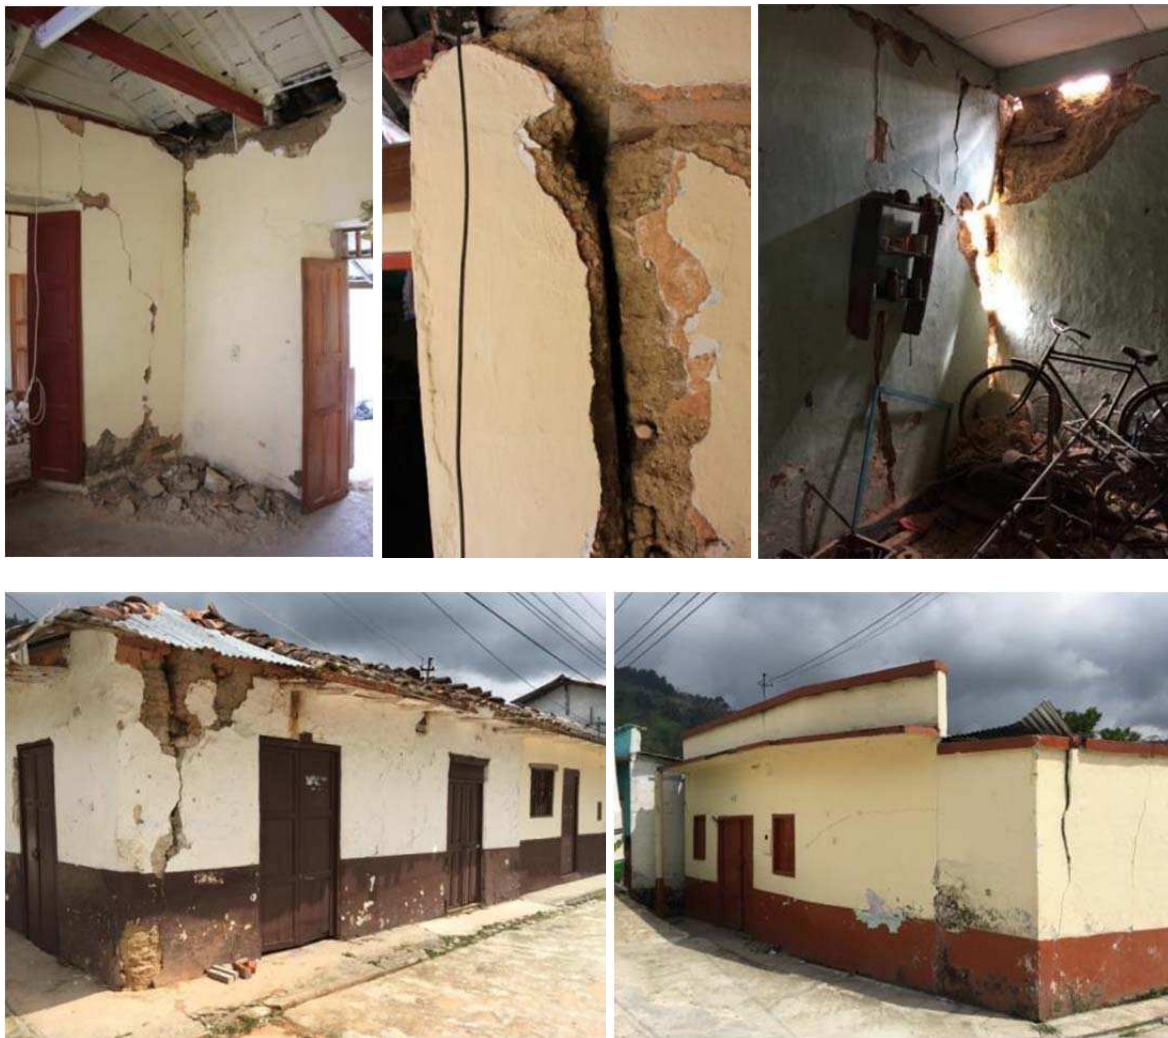
In homes built of adobe and masonry walls of rammed earth, it is common to see separation in the corners where walls meet, a result related to a lack of competent connections between walls and the heavy weight of the walls generating out-of-plane movement. This was the most frequently observed failure caused by the earthquake (Pictures 16, 17, 18, 19, and 20).

Pictures 16, 17, 18, 19, and 20. Houses damaged in Santa Cruz de la Colina

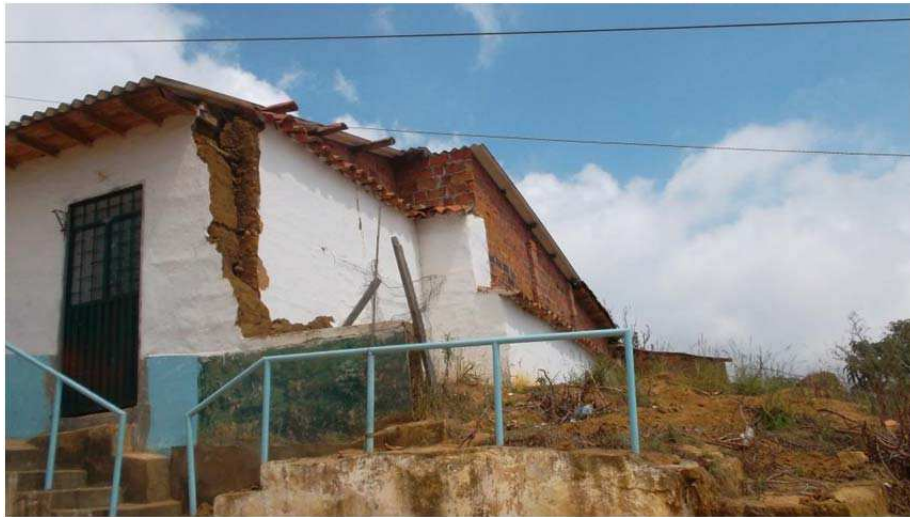
Picture 21. House partially collapsed in Betulia, cracking in areas of wall corner intersection, with combination of masonry types.

As noted in Matanza, most failures were found in the more traditionally-built homes of earth construction, and characterized by separation and significant cracking in wall corners; this separation is between the exterior walls at the corners due to the lack interconnection between walls and heavy walls generating higher out-of-plane loads. Build Change also observed frequent partial collapse of unbraced unreinforced masonry elements and partial collapses of roofs (Pictures 21 and 23).

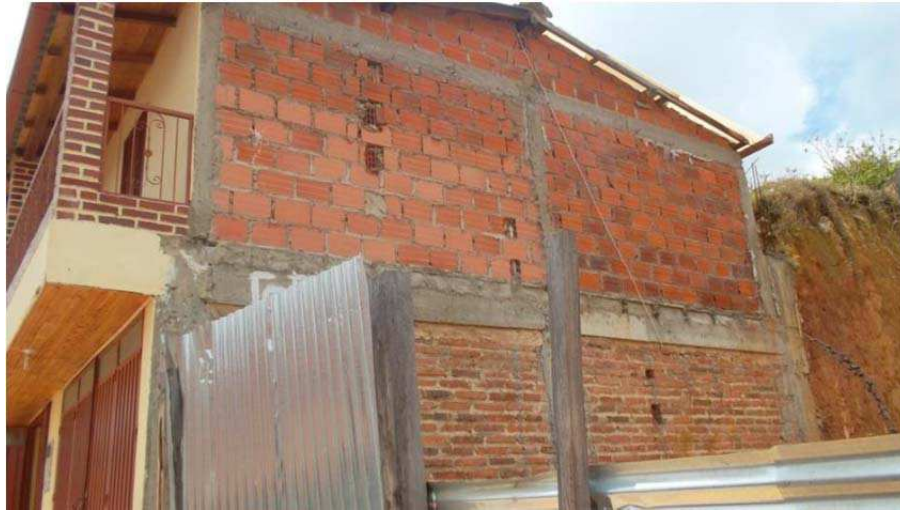
Due to the relatively low ground accelerations experienced, even confined masonry homes with relatively open fronts, which would be considered vulnerable to earthquake damage, seemed to be relatively undamaged in Betulia (Picture 22). The majority of damage observed was in the more traditional construction types of adobe and rammed earth.

Picture 22. House that did not suffer damage in rural area of Betulia, construction in confined masonry with combination of types of masonry.

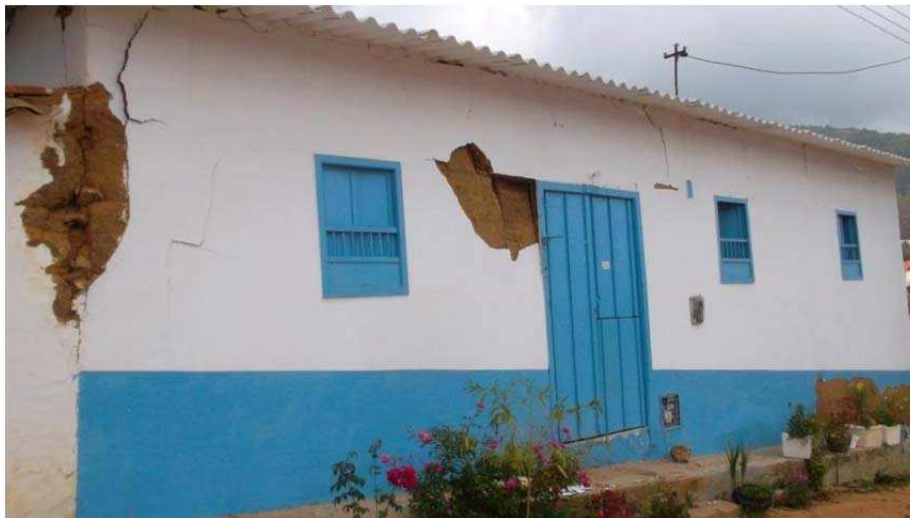
Picture 23. House partially damaged in urban area of Betulia, construction in adobe and rammed earth.

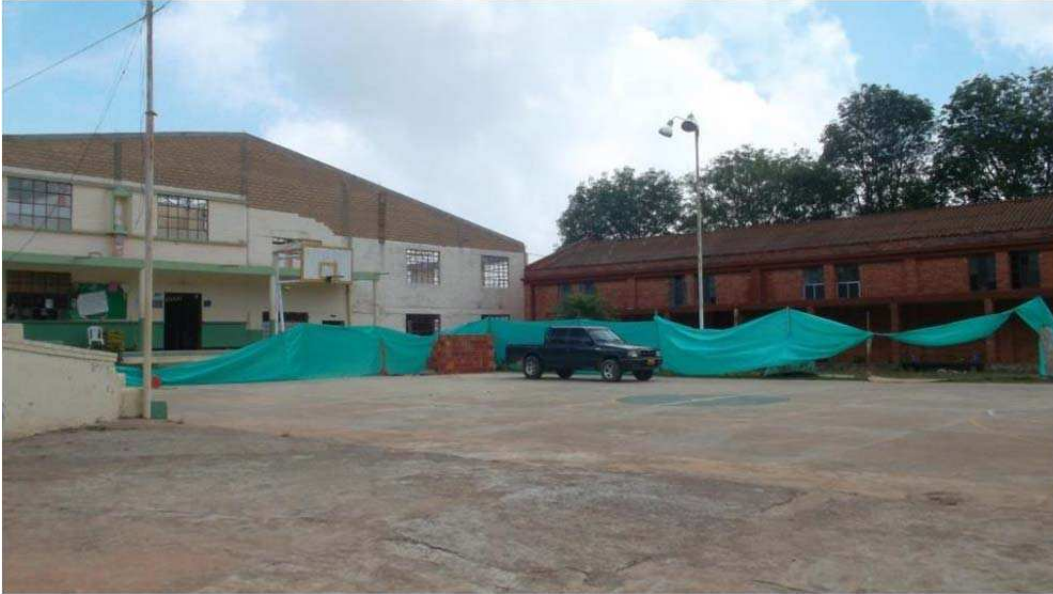
Nuestra Señora de Lourdes is a secondary school for approximately 200 students. Damage was observed in two of the school buildings: a split level three-story classroom building with a moment frame structure, with some frame infills with unreinforced masonry, and others without infill. In this building there was partial damage in non-structural elements, like collapse of the masonry infill of the frames and collapse of the gable wall. The theater building, in simple brick masonry, also suffered damage (Picture 24).

Picture 24. Nuestra Señora de Lourdes School (classroom building on left, theater building on right).

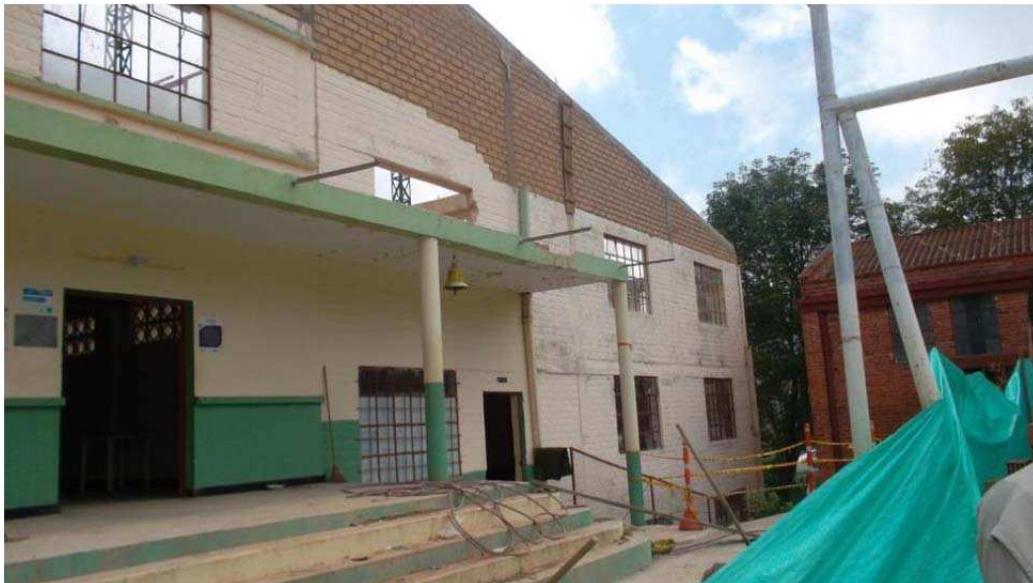
The earthquake occurred while the roof of three-story classroom building was being replaced. This left the masonry walls unbraced at the top, leading to toppling of portions of the upper

masonry in some areas. Many portions of the gable wall which had collapsed were already rebuilt (Pictures 24 and 25) and visible as unpainted brick at the time of the team's visit. Other walls were cracked and damaged due to out-of-plane movements of the unbraced walls (Pictures 25, 26, and 27).

Picture 25. Façade walls previously partially collapsed, view of the reconstructed new wall (red brick).

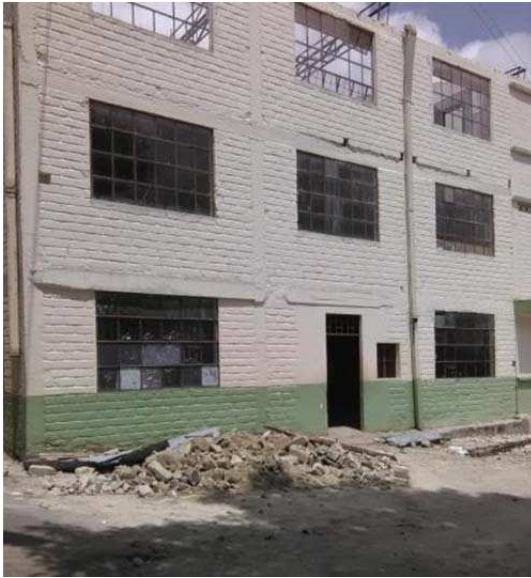
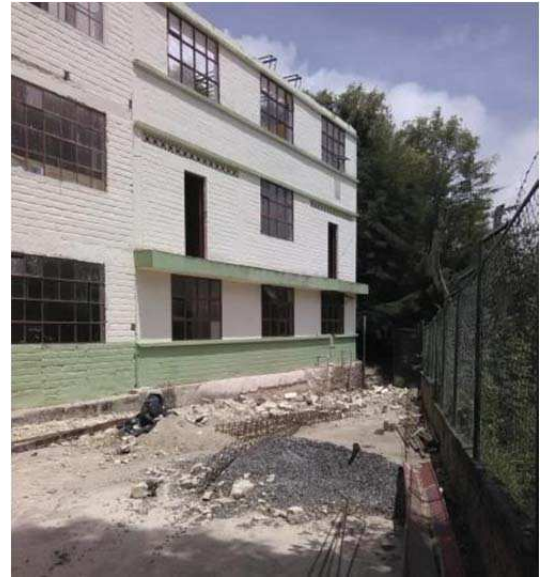
Pictures 26 and 27. Lateral façade with pieces of masonry on the ground and locations from which they fell at the top.

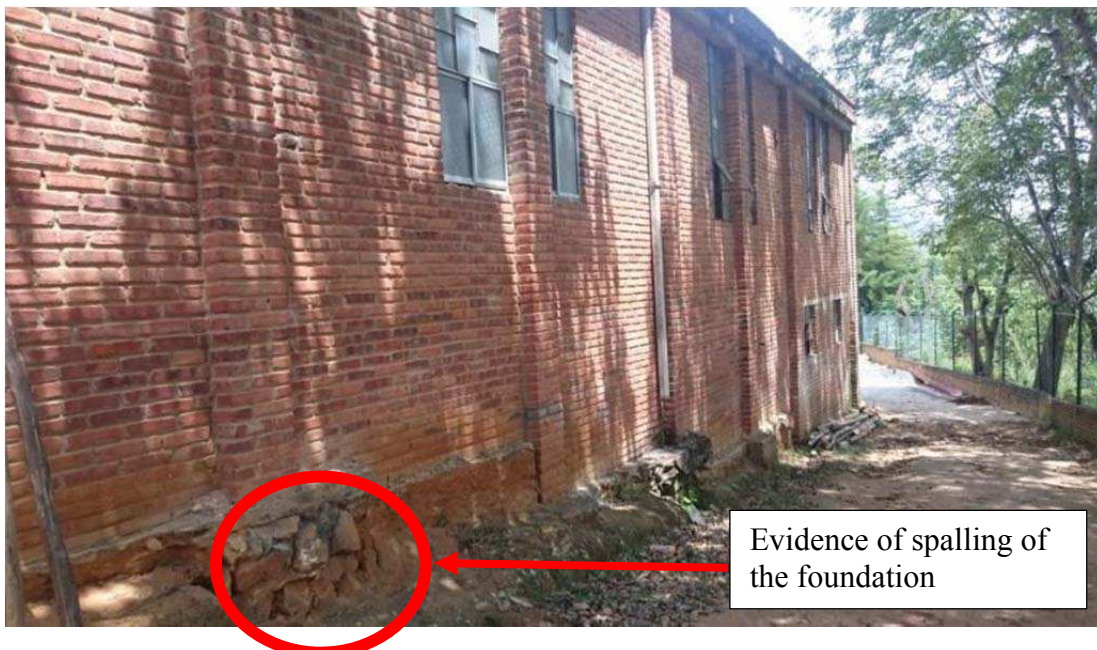
The theater building is an unreinforced brick masonry structure. It is one-story with a walk-out basement at one end of the building where the exterior grade slopes down. Localized damage was observed at the ground level near some of the column/pillar locations. This was observed as settlement and cracking at interior floor around the columns and spalling of the foundation wall around the columns at the exterior. Minimal cracking of the masonry walls was observed (Pictures 28 and 29).

Picture 28. View of the back side of the theatre building of the school.

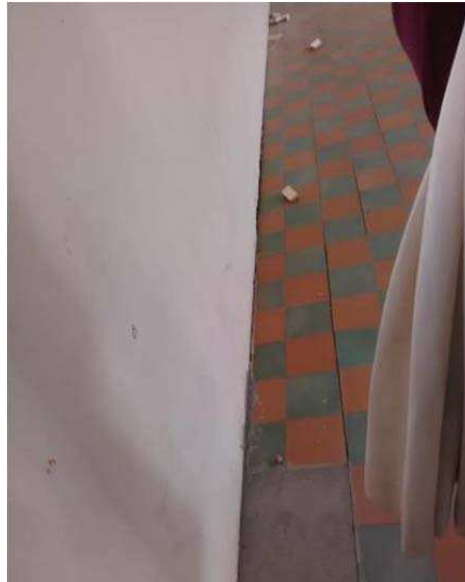
Picture 29. View from the interior of the theatre, the floor sinks at the wall intersection, possible evidence of a failure of the foundation.
