**April 25, 2015 – GORKHA EARTHQUAKE, NEPAL**

**Surveyed May 5-19, 2015  
May 31, 2015**

## Build Change Post-Disaster Reconnaissance Report

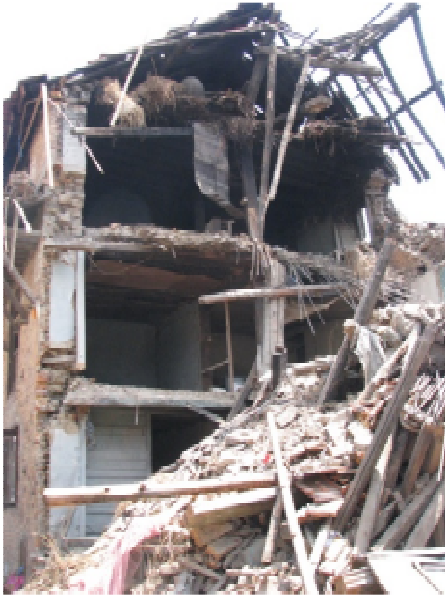
*Figure 2. Housing damage in Bungamati.*

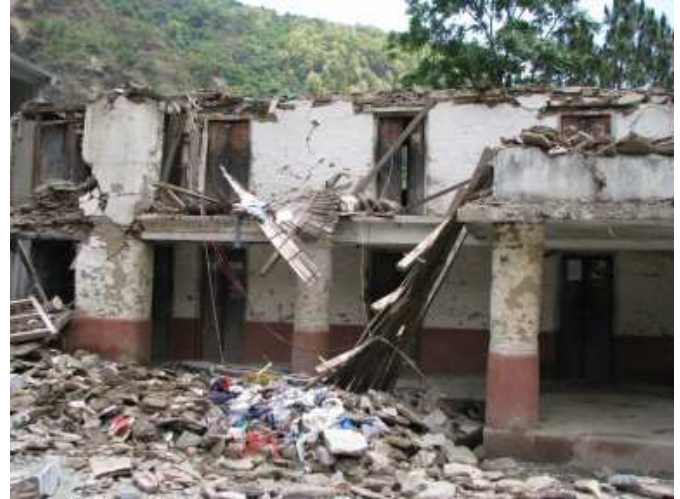
*Figure 3. Damaged school in Mahakal, Sindhupalchok.*

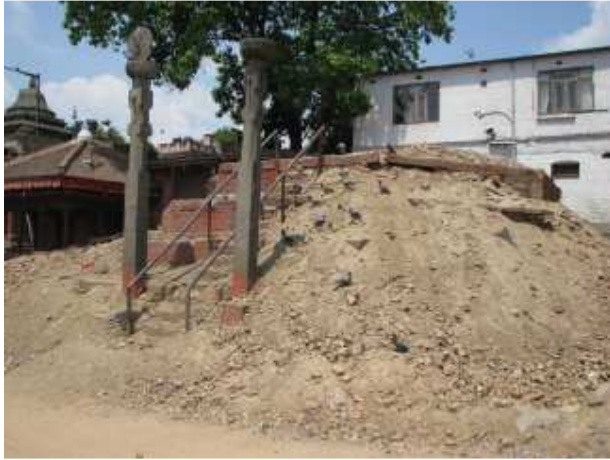
*Figure 4. Destruction at UNESCO site in Kathmandu Durbar Square.*

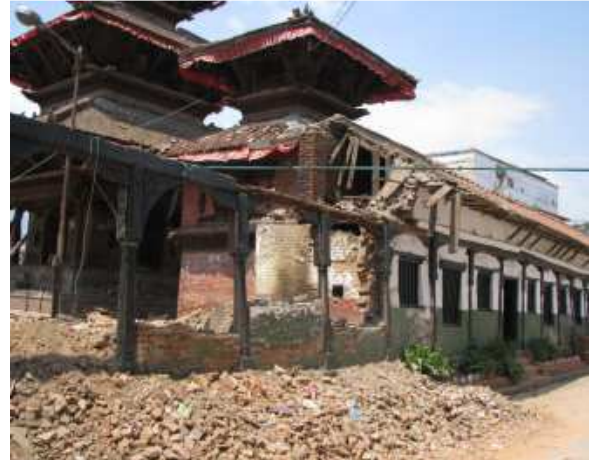
*Figure 5. Destruction at UNESCO site in Kathmandu Durbar Square.*

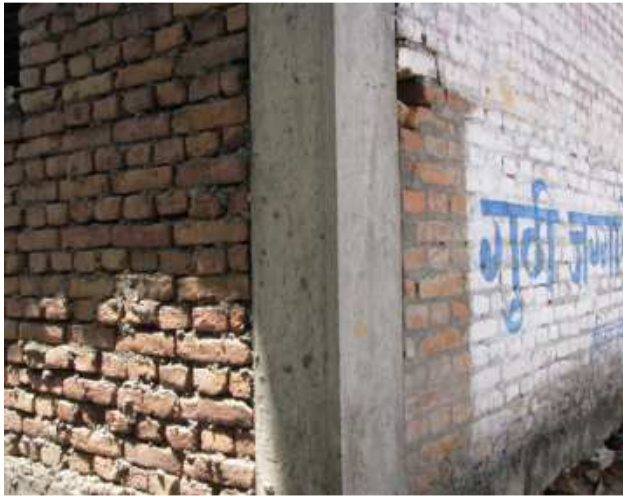
*Figure 13. Note mortar finishing on exposed side wall versus mortar finish on “out of sight” back wall, Chautara.*

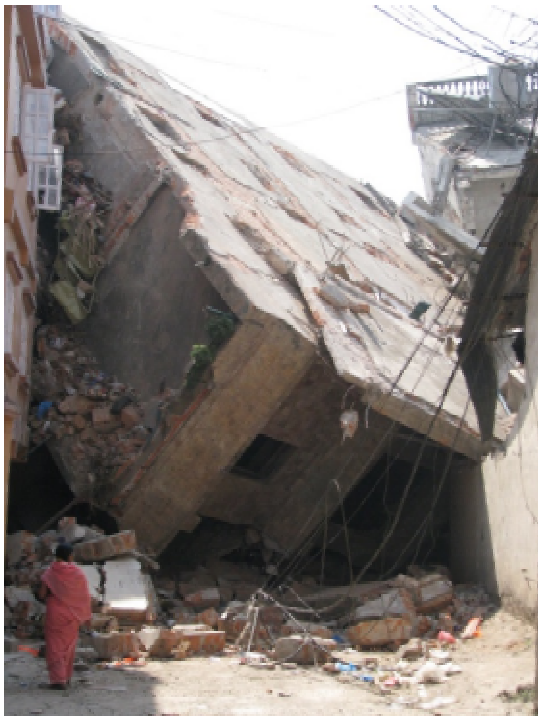
Store front/soft story failures were more common at recent construction where the concrete columns at the ground level would fail at the column top or bottom joints. Often, after a failure of one or more ground story concrete columns, the upper portion of the structure would remain intact as the building fell over to one side (See Figures 34 – 36 for examples of this failure).

*Figure 34. Soft story failure, Kuleswor.*

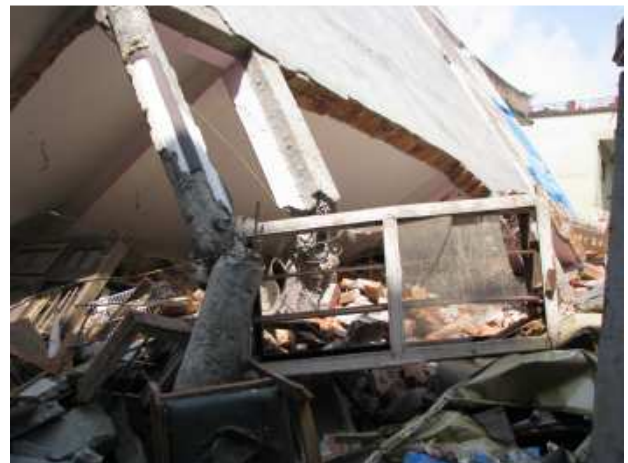
*Figure 35. First story column failure, Balkhu.*

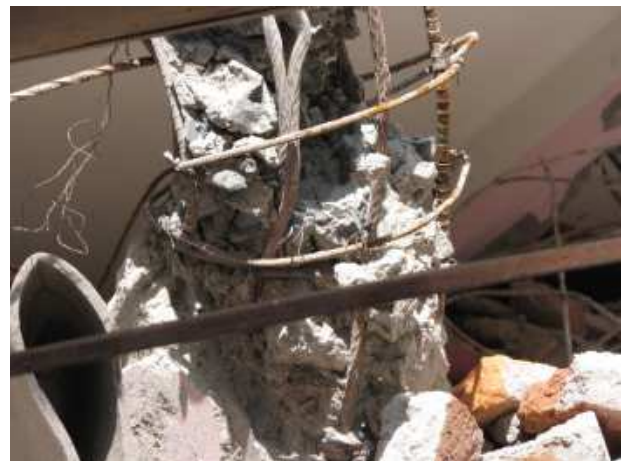
*Figure 36. Close up of Figure 35 column failure, Balkhu.*

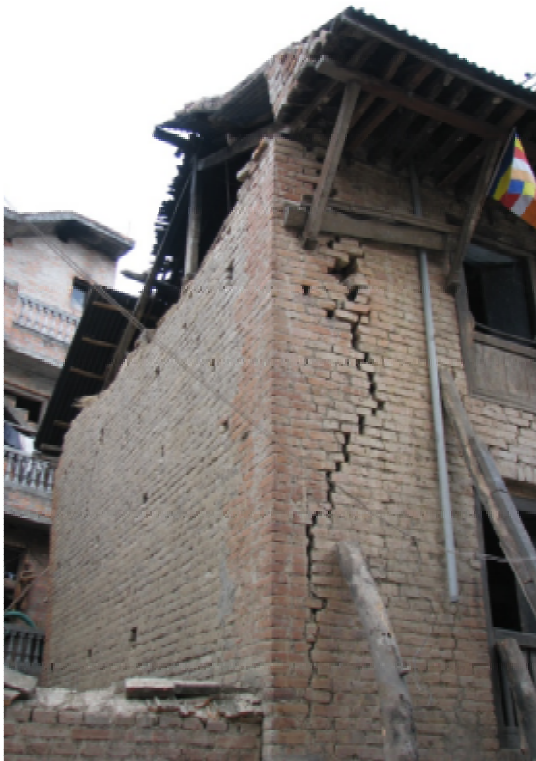
At older construction that did not utilize concrete frames, there was a substantially higher rate of failure and collapse, particularly at the wall corners and gable roof ends. There is no reinforcement tying perpendicular walls together at the corners. While the low ends of the roofs are supported by masonry walls, and the timber roof framing often runs into the wall, the gable wall ends had no ties or bracing back to the roof framing, and were frequently a source of initial collapse.

*Figure 37. Gable wall failure & corner separation, Khokana.*

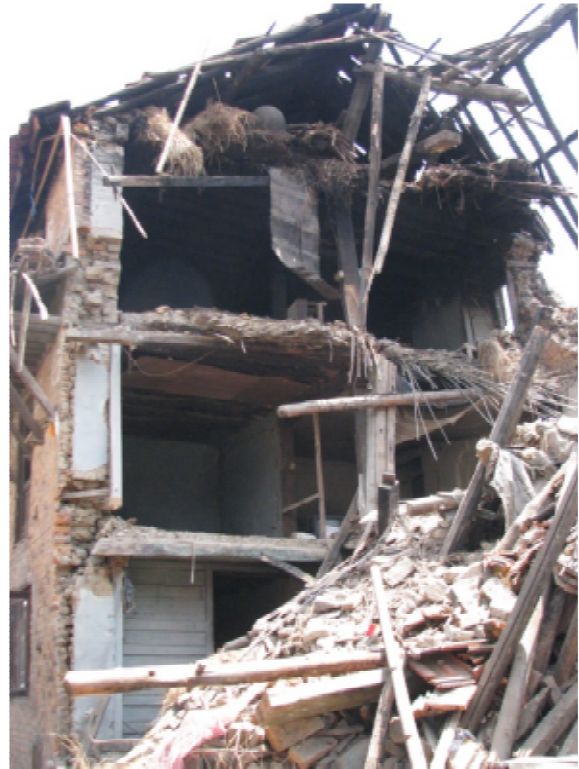
*Figure 38. End wall collapse, Bungamati.*

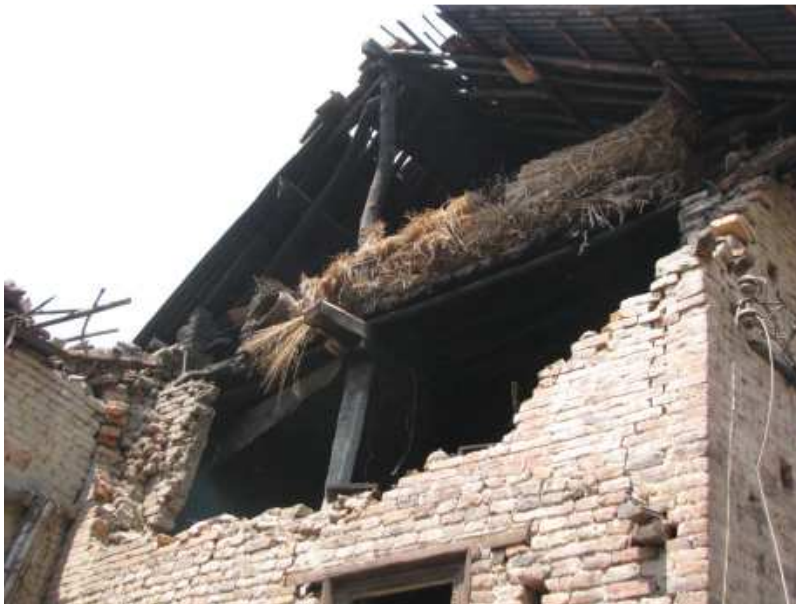
*Figure 39. Collapsed end wall at gable, Bungamati.*

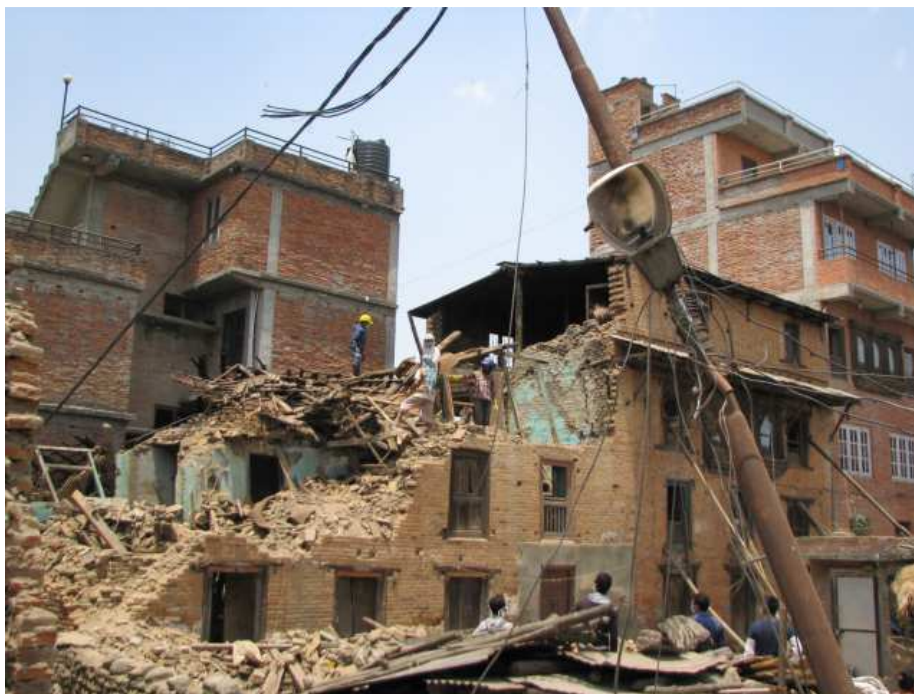
*Figure 40. Unconfined masonry collapse. Note undamaged infilled frame in background, Khokana.*

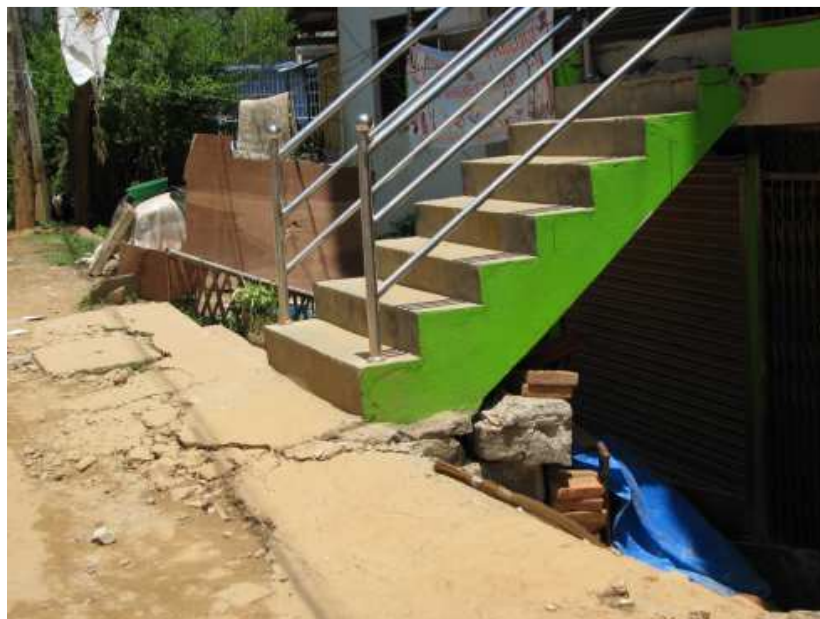
Cracking along entire front side at the base of buildings located above the steep hillsides was often clearly evident even where no other building damage was noted. Where hillside building failures did occur, it often appeared to be due to inadequate ties to a foundation or partial lower level, or a lack of a solid foundation – such as the use of stone rubble for foundations. The presence of buildings lower on the hillside, below the upper buildings, prevented closer observation to try to determine whether the damage observed was actually due to foundation slippage or failure, or damage to lower hillside columns or walls.

*Figure 41. Evidence of foundation shifting at front of building (bottom of stair), Chautara.*

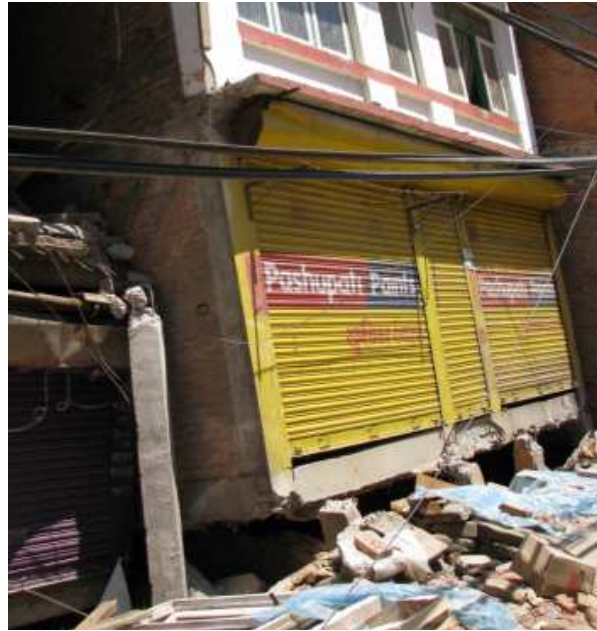
*Figure 42. Foundation/lower level failure on hillside, Chautara (See Figures 43 & 44 for column failure details).*

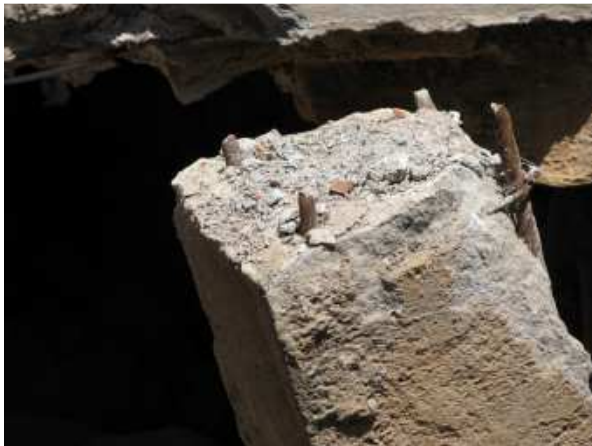
*Figure 43. Foundation column failure, Chautara.*

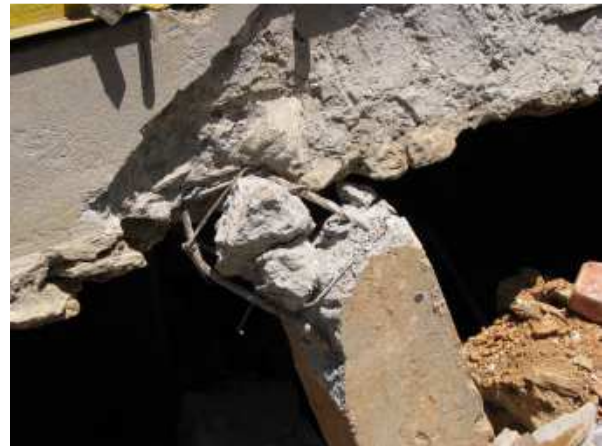
*Figure 44. Foundation column failure, Chautara.*

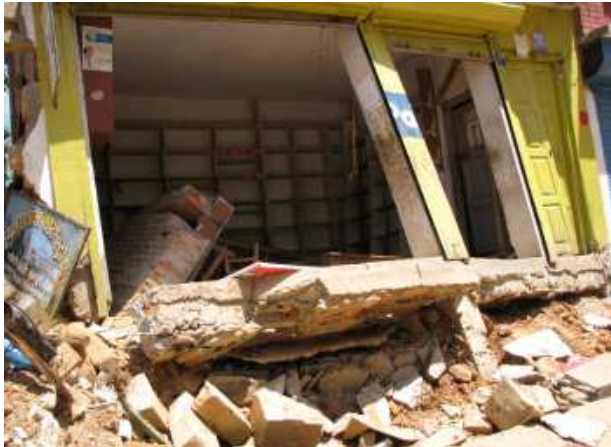
*Figure 45. Foundation failure, Chautara.*

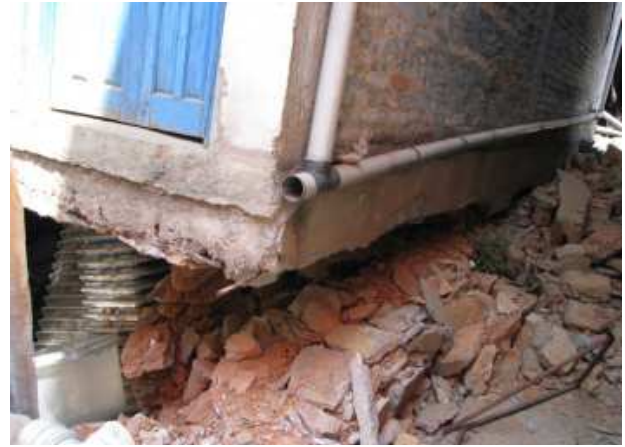
*Figure 46. Foundation failure, Chautara.*

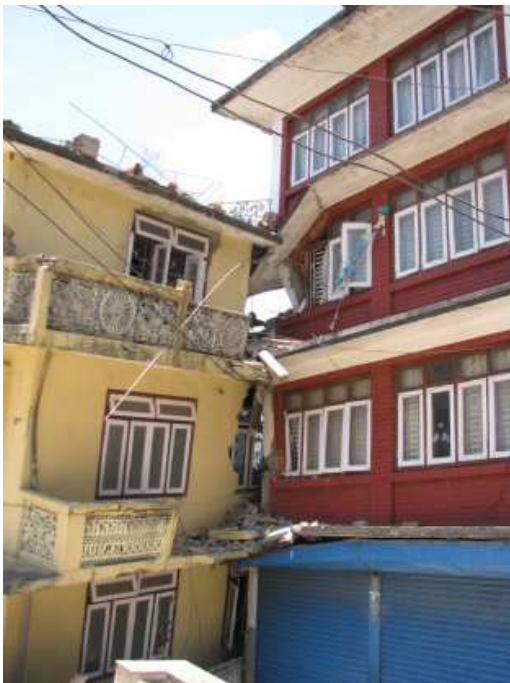
Other causes of damage and/or collapse were related to masonry wall failure, pounding by adjacent buildings, and collapse of adjacent structures onto a building (See Figures 47 – 49 below).

*Figure 47. Damage due to adjacent building collapse, Chautara.*

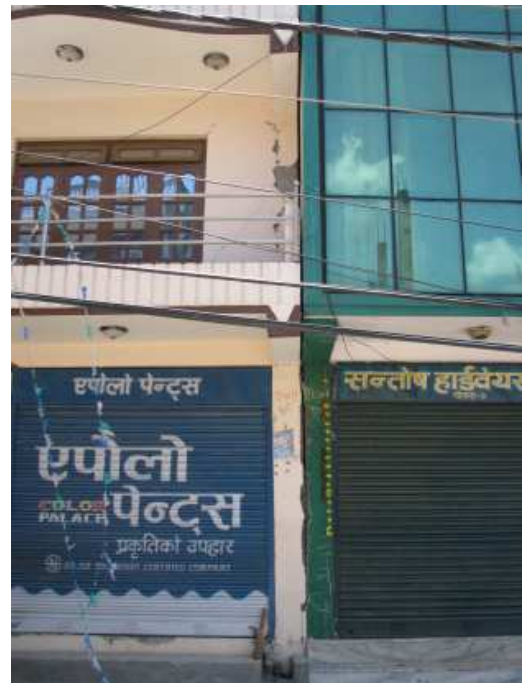
*Figure 48. Pounding damage, Chautara.*

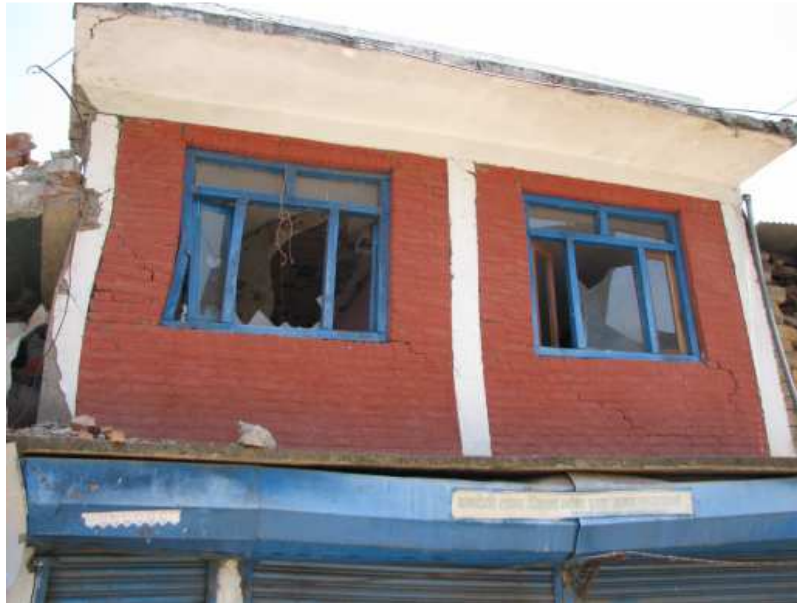
*Figure 49. Damage due to pounding and collapse of adjacent building, Chautara.*

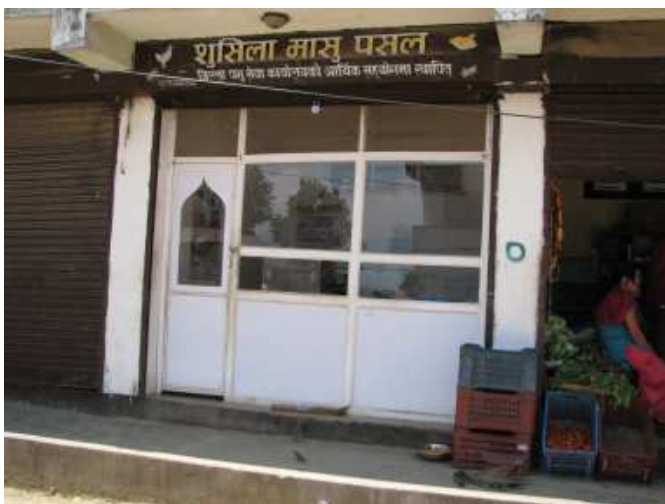
*Figure 50. Green tagged structure, Chautara.*

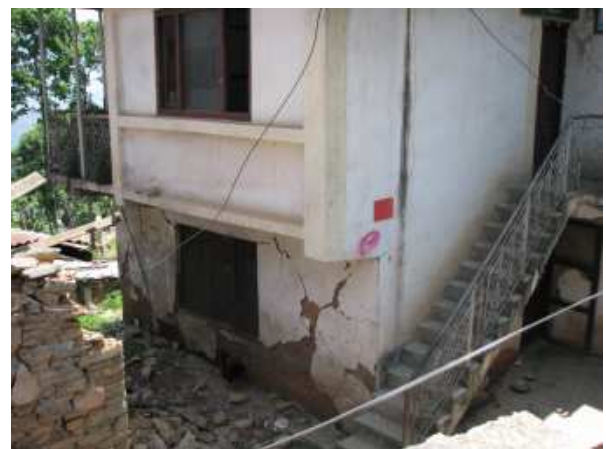
*Figure 51. Red tagged structure with placard, Chautara.*

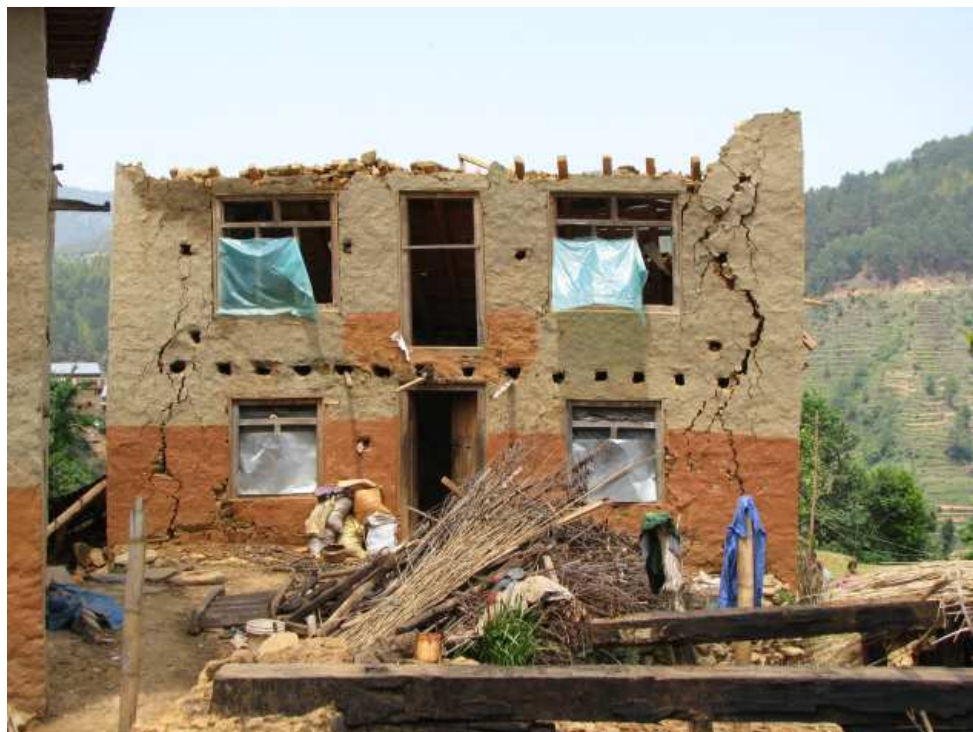
*Figure 53. Severely damaged stone masonry home with randomly shaped rocks, Thula Gaun.*

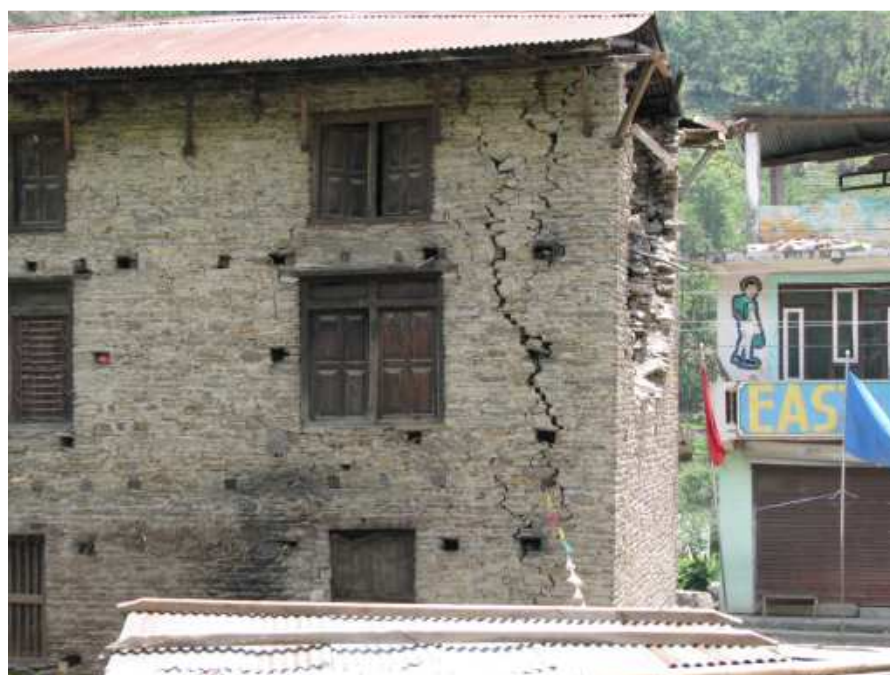
*Figure 54. Damaged stone masonry with small cut stones, Mahankal.*

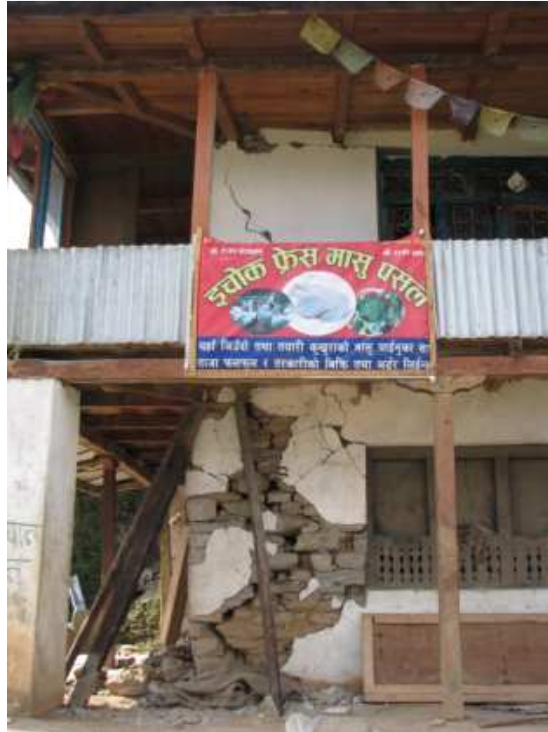
*Figure 55. Large cut stones in damaged stone masonry, with plaster over stonework, Ichok.*

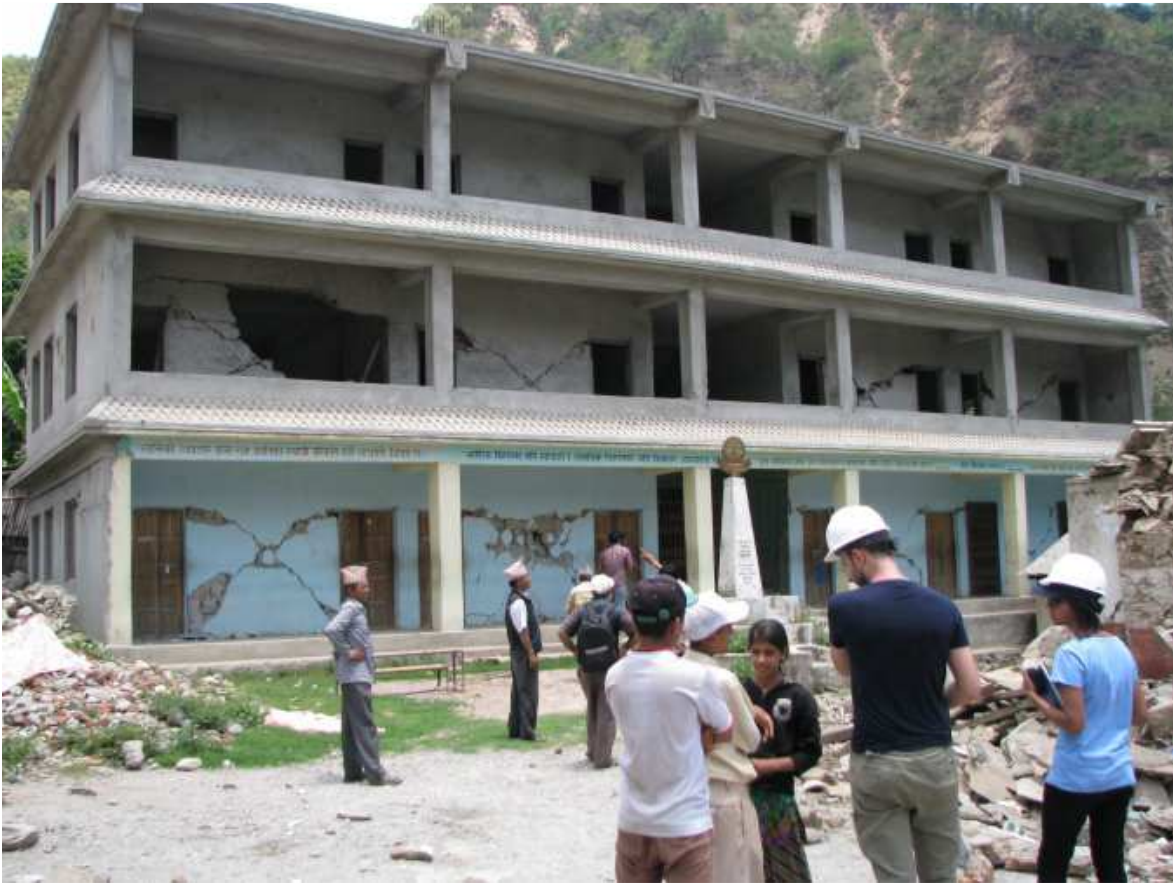
The Shree Saraswati Higher Secondary School in Mahankal has only one structure that may be able to be retrofit and repaired for use again. This was a 3-story concrete frame structure, consistent with the type of building being constructed in recent years at most other school sites. The structure is about 3 years old and took about 3-4 years to build, being built one story at a time as funding was available. The infill at the first, ground level story is a combination of stone and brick. The upper 2 stories both have brick infill. There is evidence of significant lateral movement – shear cracking of the infill and wracking of doorframes (See Figure 57). There was severe concrete spalling at the interior stairs, with cracking at the stair to floor landing joints that left exposed, making the stairs to the upper levels unsafe (See Figures 58 and 59).

*Figure 57. 3-story concrete frame Shree Saraswati School structure with shear cracking at infill walls, Mahankal.*

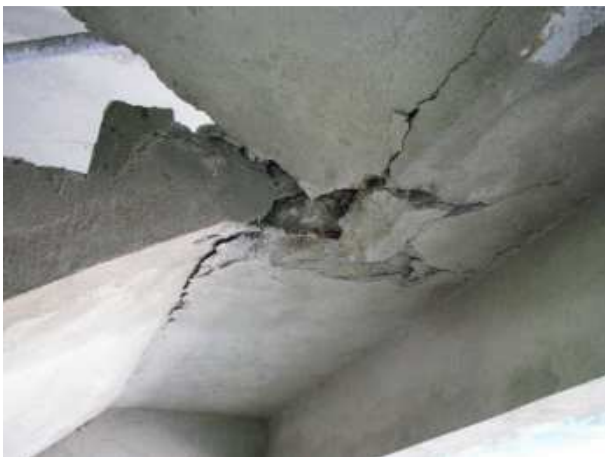
*Figure 58. Concrete cracking at stair floor landing.*

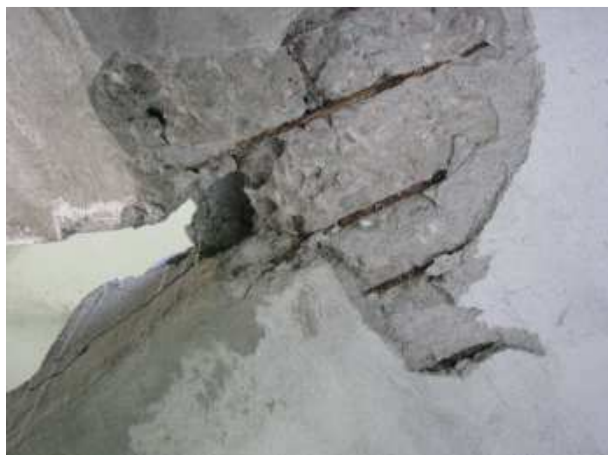
*Figure 59. Close-up of stair landing spalling, Mahankal.*

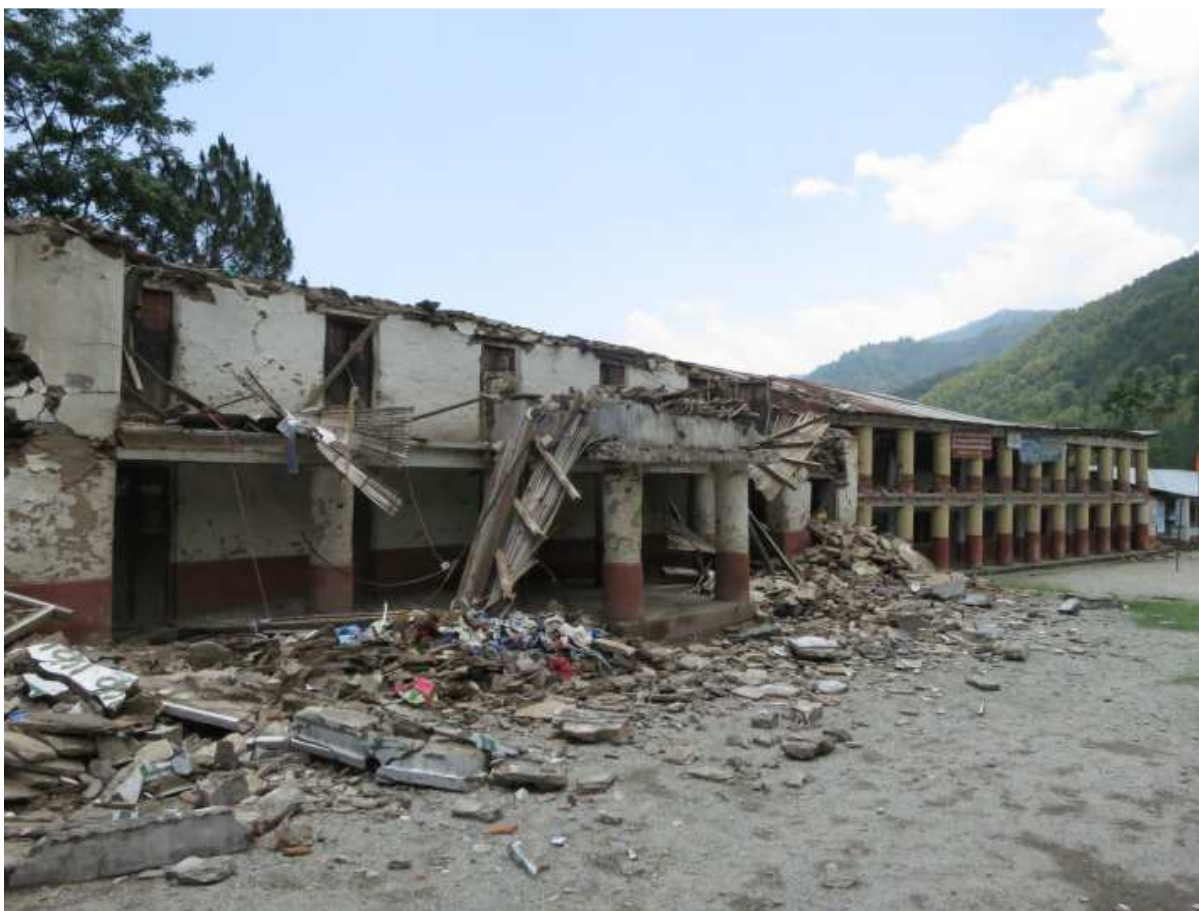
*Figure 60. Heavily damaged structures, 50 and 35 years old (left to right), at Shree Saraswati School, Mahankal.*

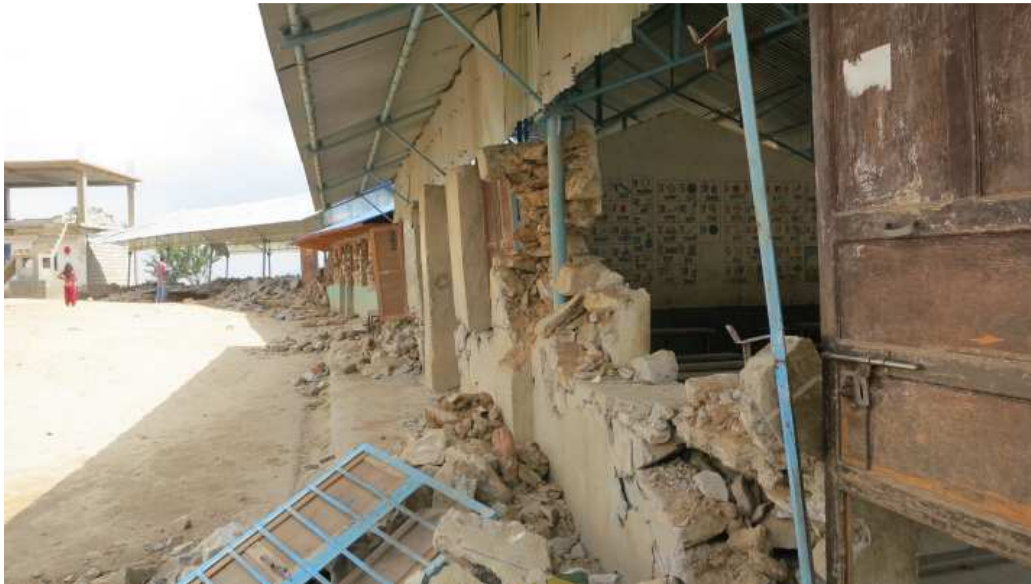
A multi-structure school in the remote village of Ichok also suffered similar damage as the Mahankal school. The older stone masonry structures had severe damage with most walls partially collapsed in the single story structures, although the steel supported and framed roof structures were still standing. Collapse of the walls appeared to be primarily due to out-of-plane failure of the unreinforced stone masonry. A newer two-story concrete frame structure was damaged primarily at the unfinished upper story. If the upper story were removed, the two lower story classrooms could be used again (See Figures 62 and 63).

*Figure 61. Damaged single-story structures at school, Ichok.*

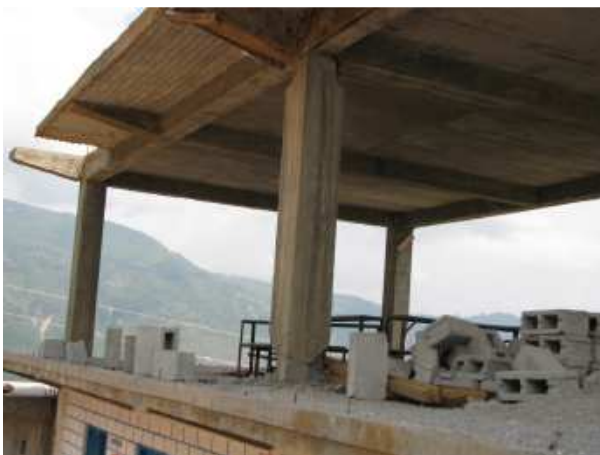
*Figure 62. Unfinished second story of school, Ichok.*

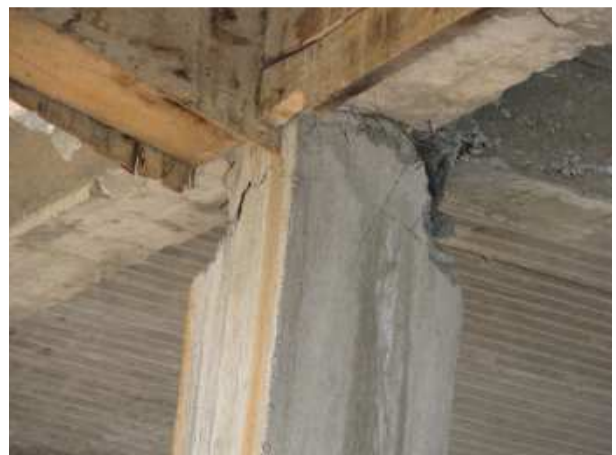
*Figure 63. Beam-column connection damage, Ichok.*

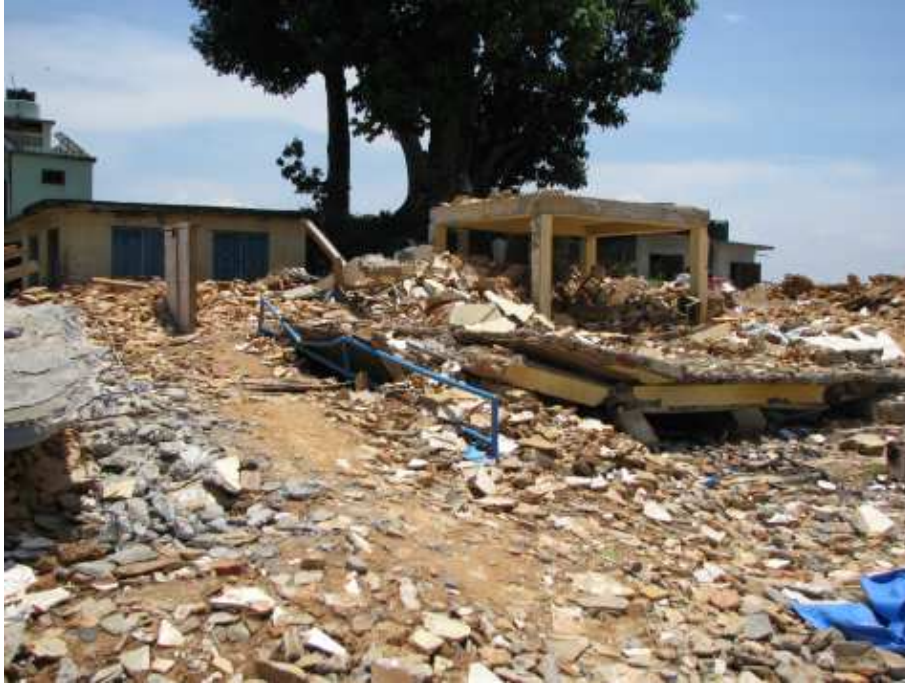
Most schools observed had similar damage types. Typically, the more recent concrete frame buildings showed evidence of shear cracking in the infill and damage at beam-column joints, while older stone masonry structures typically had wall failure and collapse, for the same reasons as previously discussed for other buildings. A school observed in Chautara had been entirely reduced to piles of rubble. The only discernable sign of a building was a door still standing in the middle of a rubble pile, as seen in figure 64.

*Figure 64. Collapsed school buildings, Chautara.*

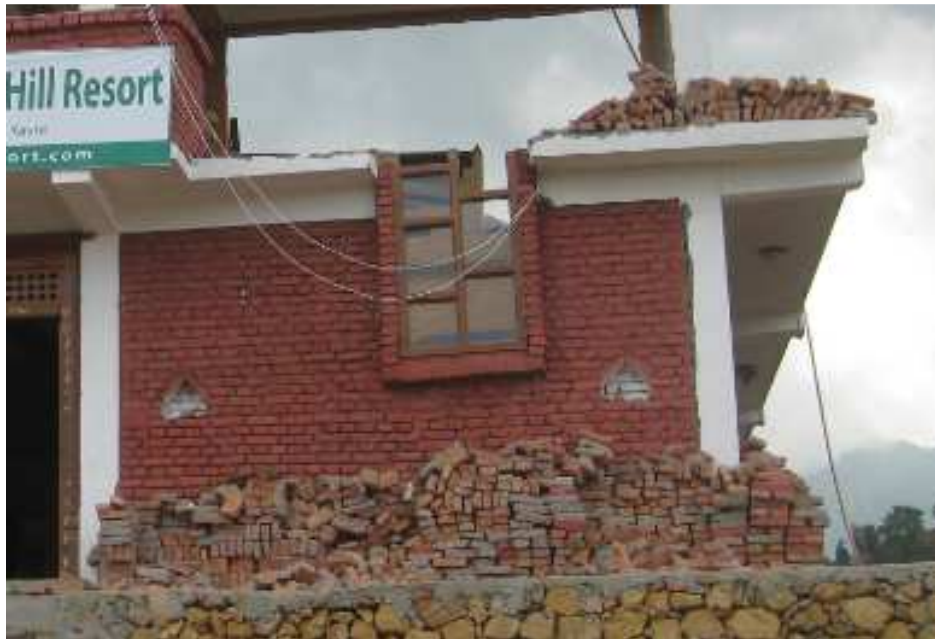
*Figure 65. Construction of non-continuous, non-code complying beam at stairway of hotel structure in rural area, Thula Gaun.*
