Build Change Post-Earthquake Reconnaissance Report

Surigao Del Norte, Mindanao, Philippines

10 February 2017

Survey Date: 23-25 February 2017

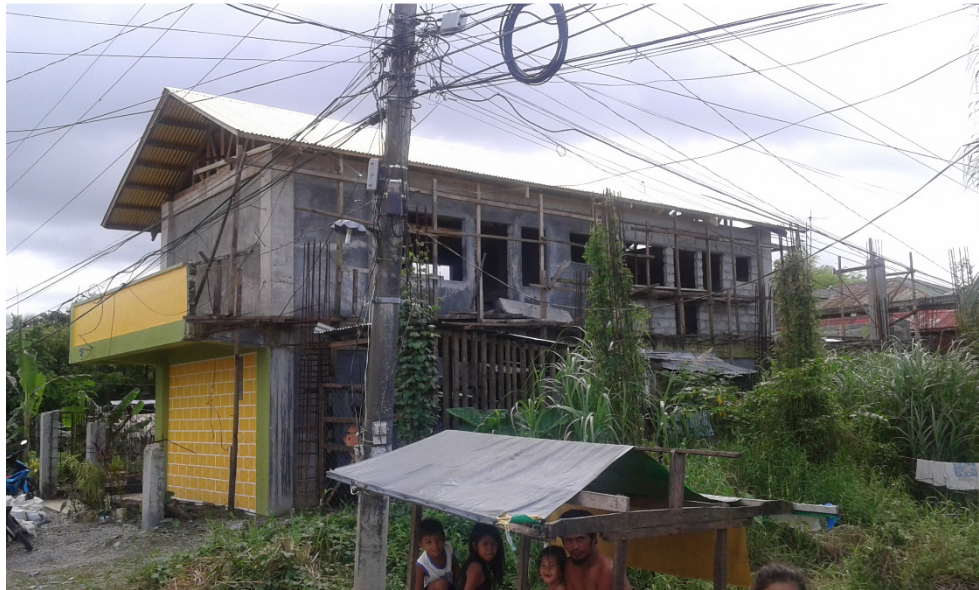
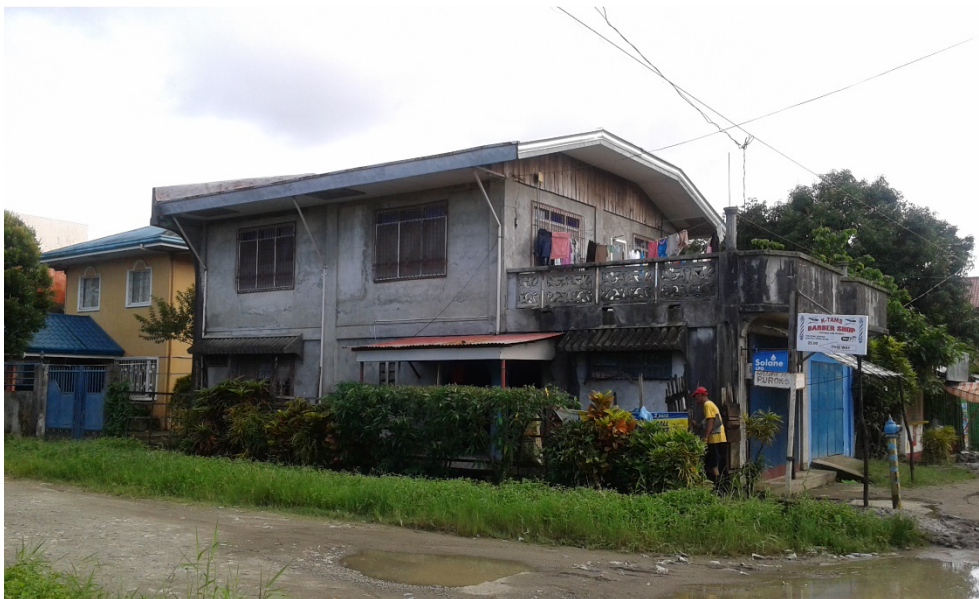
Figure 2.3 – Typical concrete frame with masonry infill construction: two story homes with lightweight roofs

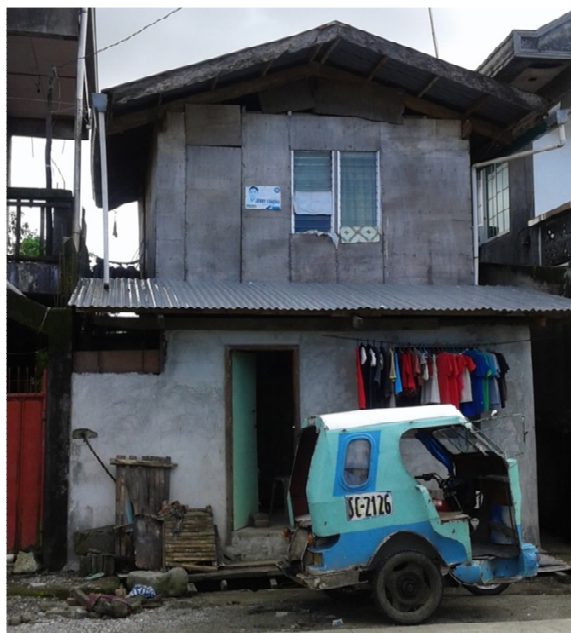
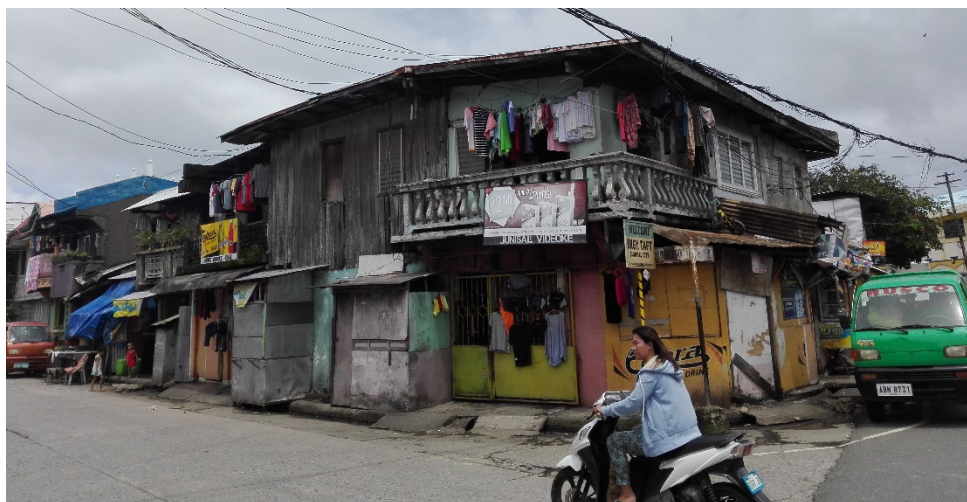
Figure 2.4 – Masonry/timber combination house: timber upper story above masonry ground story (top) and timber/masonry upper story above masonry ground story (bottom)

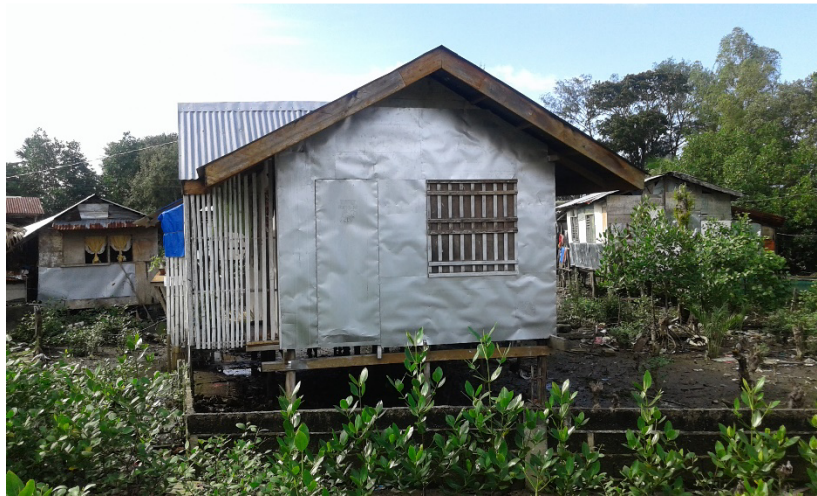
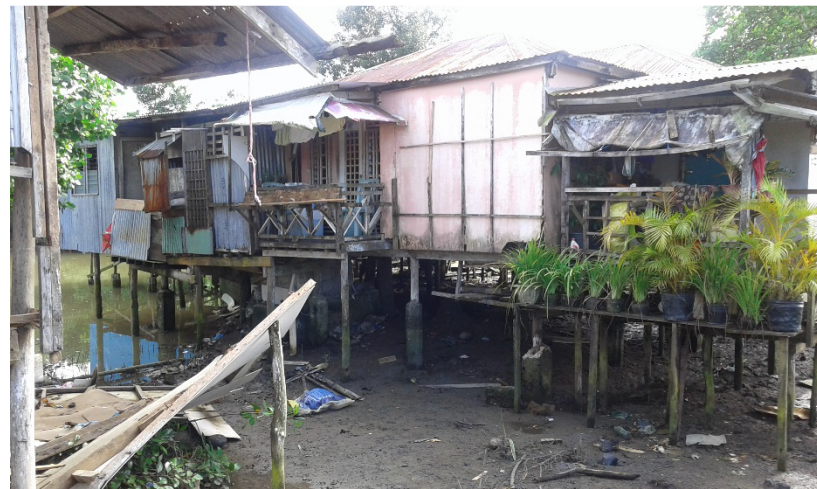
Figure 2.5 – Timber framed houses. Note the lack of cripple walls or braces below floor level.

2. Stilted timber homes should be retrofitted with lateral bracing below the floor level to prevent soft/weak story collapse.
3. All buildings, including lightweight timber construction, require adequately sized reinforced concrete foundations. Soil investigations should be performed if practical, and conservative bearing design values should be employed if an investigation is not possible. Liquefaction zones and surface fault rupture zones should be avoided.
4. Large openings on the ground floor should be avoided to prevent soft/weak story failures.

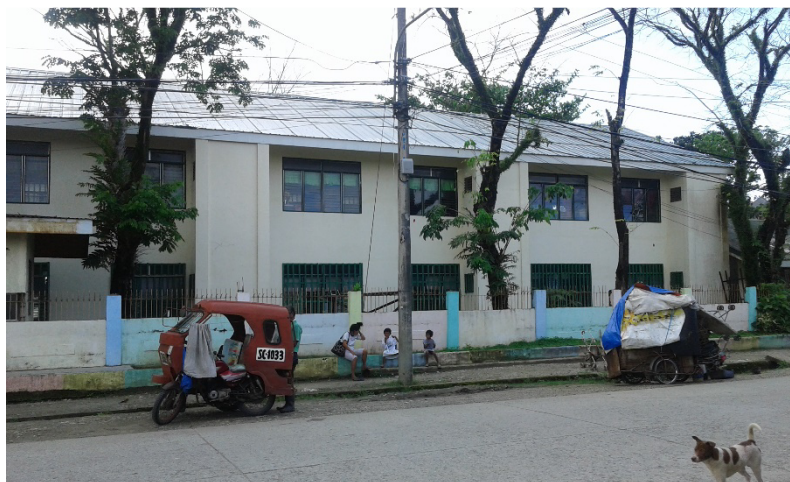
Figure 2.6 – Typical school building in Brgy San Juan. No damage to classroom buildings occurred at this site.

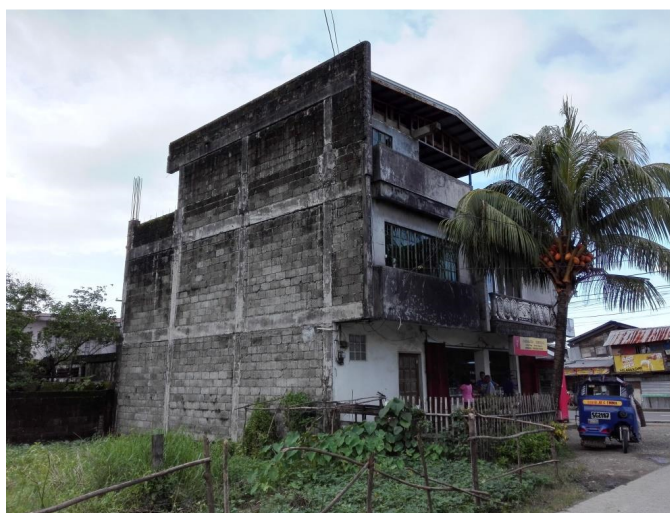
Figure 2.7 – 3 story concrete frame with masonry infill and cantilever walls showing no sign of damage

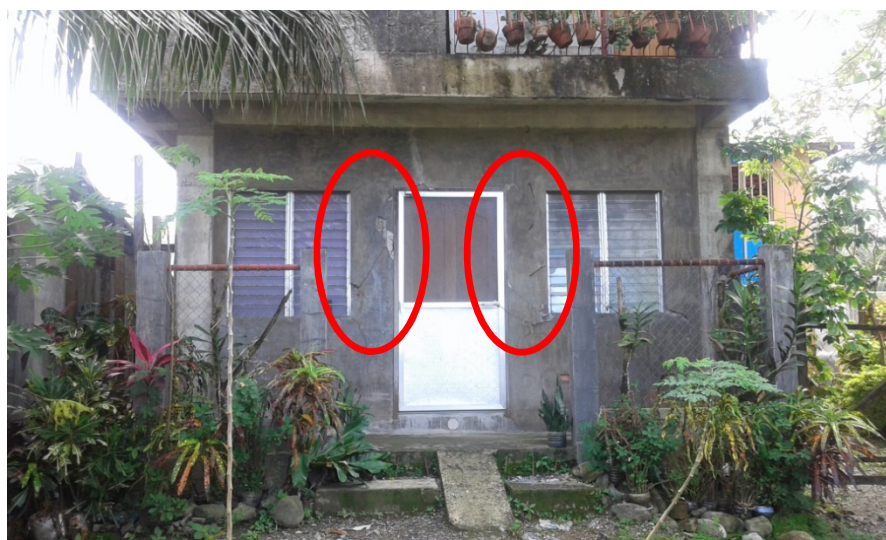
Minor damage of masonry construction houses observed included minor wall cracking and cracking of masonry gable walls where no ring beam or concrete diaphragm was present to brace the gable wall out-of-plane. Although these damages appear superficial, they can weaken the structure, lead to dangerous collapse in future events, and should be addressed and repaired/replaced.

Figure 2.8 – 3 story concrete frame with masonry infill wall with minor in-plane cracking on front wall

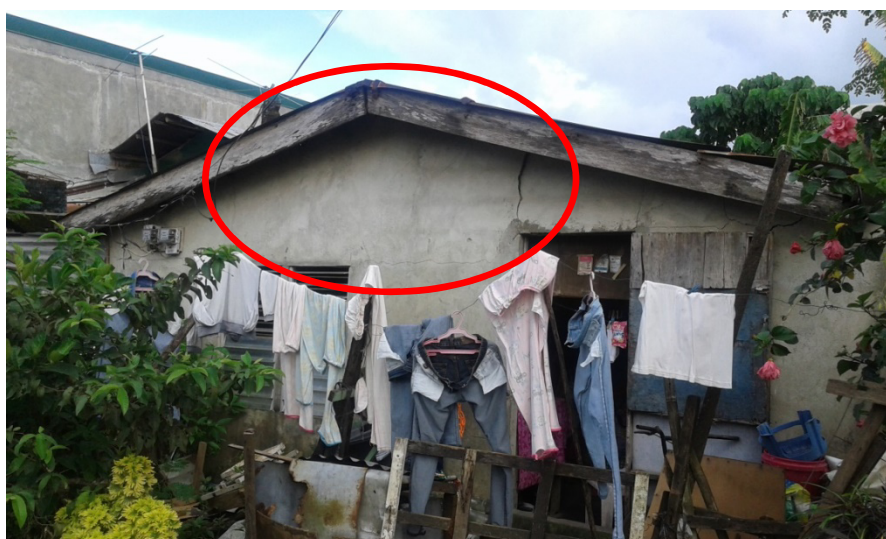
Figure 2.9 – Out-of-plane wall failure; masonry gable wall cracking.

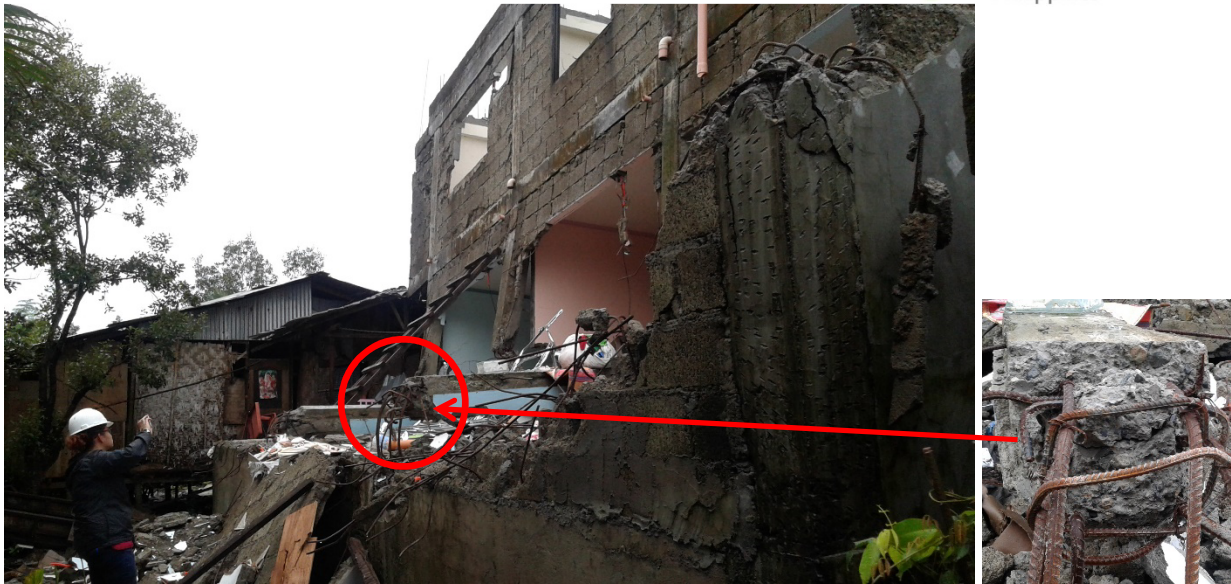
Total damage or building collapse appears to be caused by poor design and poor construction (typical of non-engineered, informal housing) insufficient to meet the NSCP requirements. Buildings that collapsed due the shaking are closest to the river where the soil conditions are the softest and where the highest concentration of low-income housing are located.

Figure 2.10 – Soft/weak story collapse of 3 story concrete frame with masonry infill. The coarse aggregate was found to be intact at concrete column failures indicating a potentially low-strength concrete mix with insufficient cement or too much water.

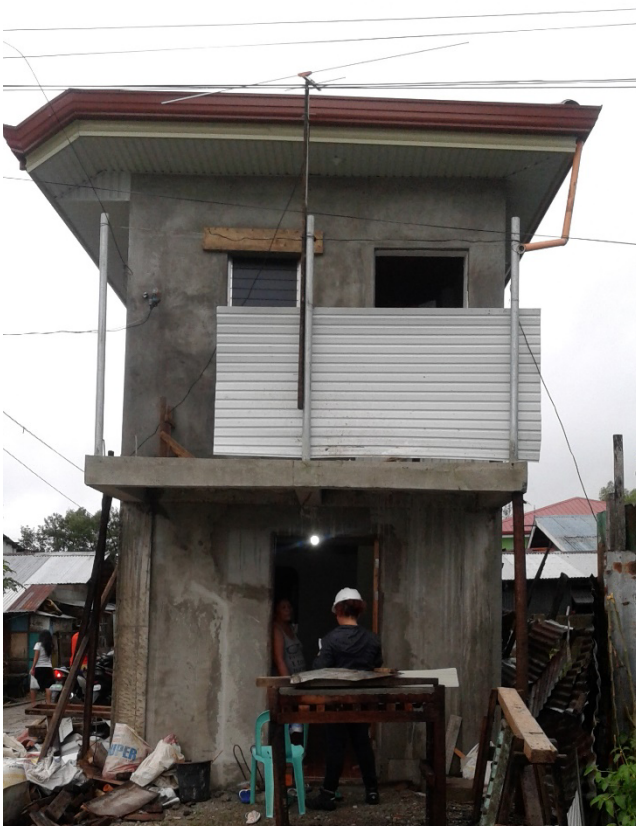
Figure 2.11 – 2 story masonry home with permanent tilt. Soft soil adjacent to river appears to have settled during the earthquake, resulting on one half of the building permanently sinking such that building is out of plumb. Lack of sufficient foundation expected.

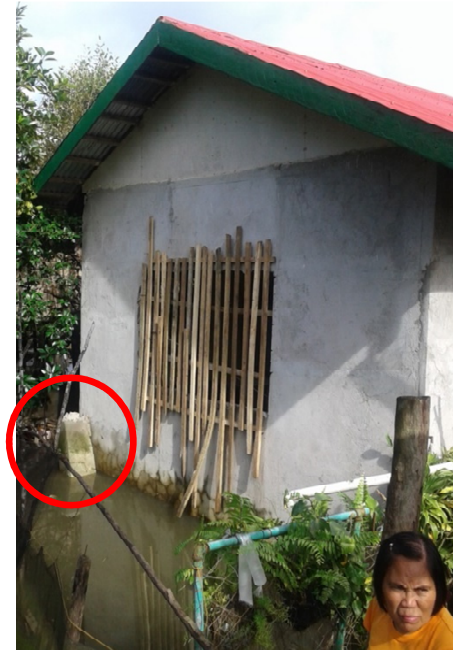
Figure 2.12 – Soft/weak story failure of stilted masonry home on river plain. Note the lack of reinforcing on the supporting concrete posts (red circle). No positive connection existed between the concrete post and the floor.

Lightweight stilted houses in the river plain performed poorly due to the lack of cripple walls or diagonal bracing below the floor level (no direct load path to the ground) and the lack of adequate foundations.

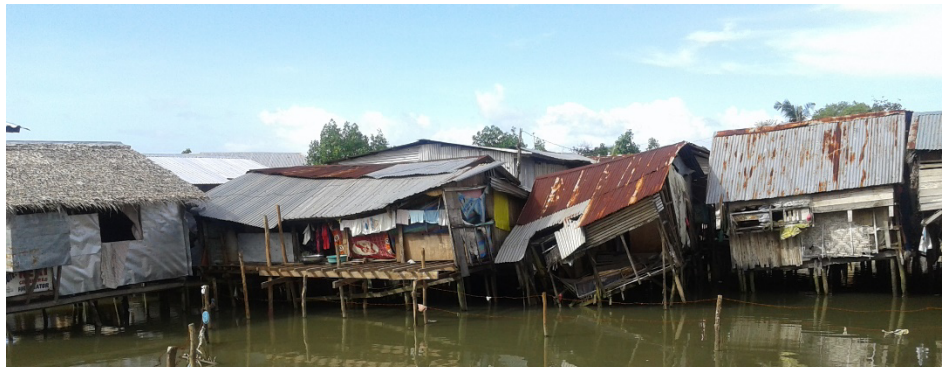
Figure 2.13 – Soft/weak story collapse of stilted timber homes in the flood plain. No cripple wall or bracing present below floors and foundations were likely not present.

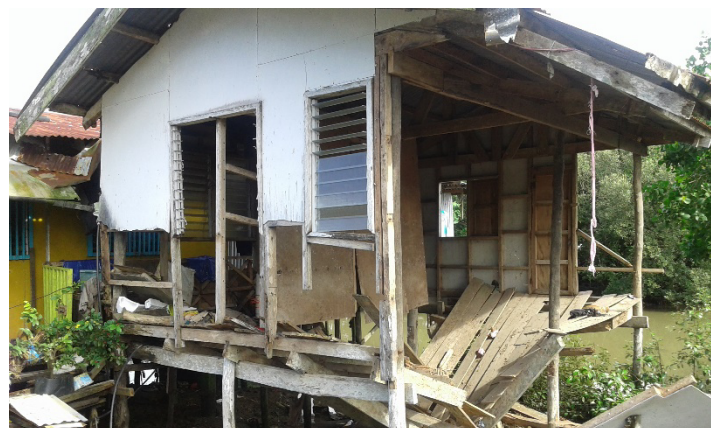
Figure 2.14 – Floor collapse of stilted home in river plain caused by collapsed posts supporting floors and walls. The posts were not supported by foundations.

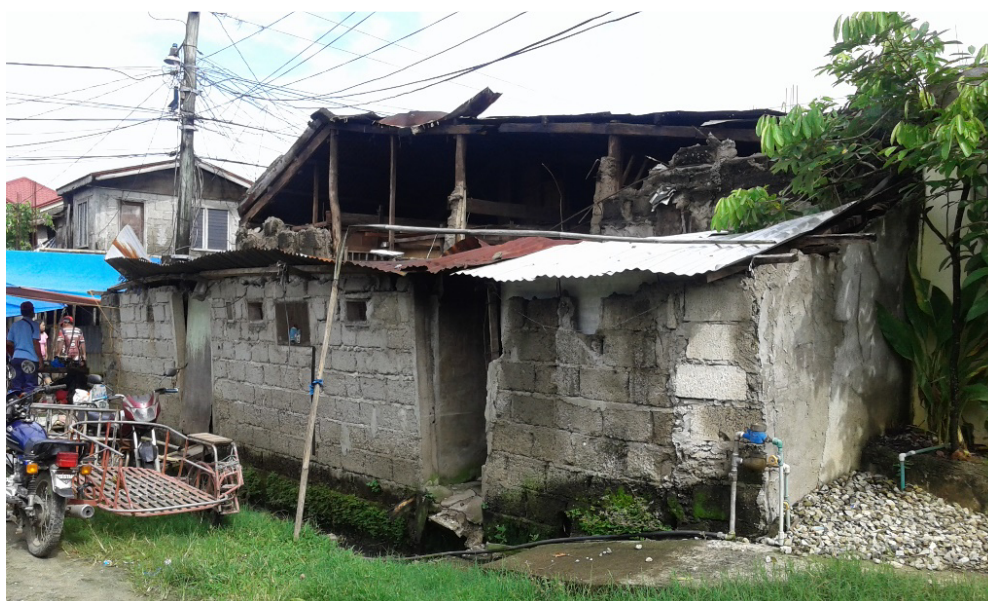
The most common failure mechanism observed in Washington was out-of-plane collapse of masonry infill walls and masonry gable walls. Collapsed walls were lacking ring beams, connections to supporting diaphragms and/or adequate connections to columns on either end of the wall. Few unreinforced masonry walls were observed. Failed masonry walls contained some amount of reinforcement, although development of the reinforcement as well as size and spacing were inadequate.

Figure 2.15 – Out-of-plane gable wall collapse and out-of-plane wall collapse in masonry wall with timber post construction. No ring beams or diaphragm support present at top of walls.

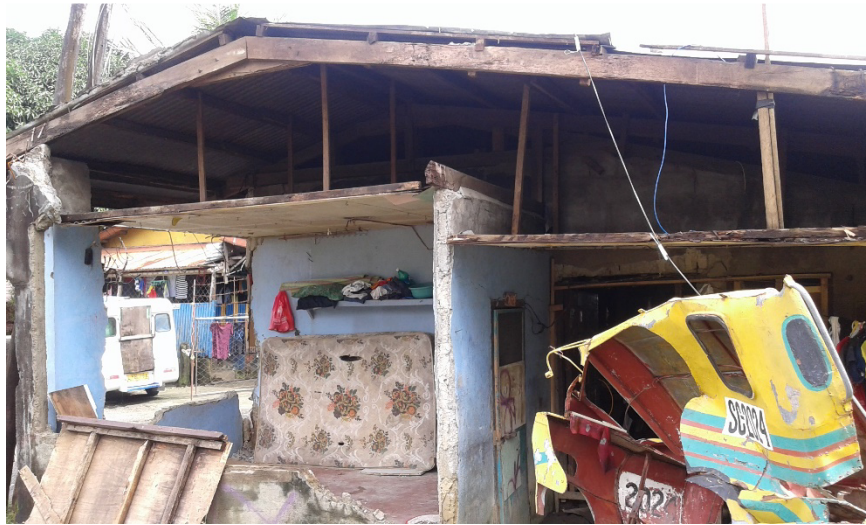
Figure 2.16 – Out-of-plane wall collapse. No columns or ring beams present. House exhibited extensive in plane and out-of-plane damage to 4" CHB walls with insufficient reinforcement.

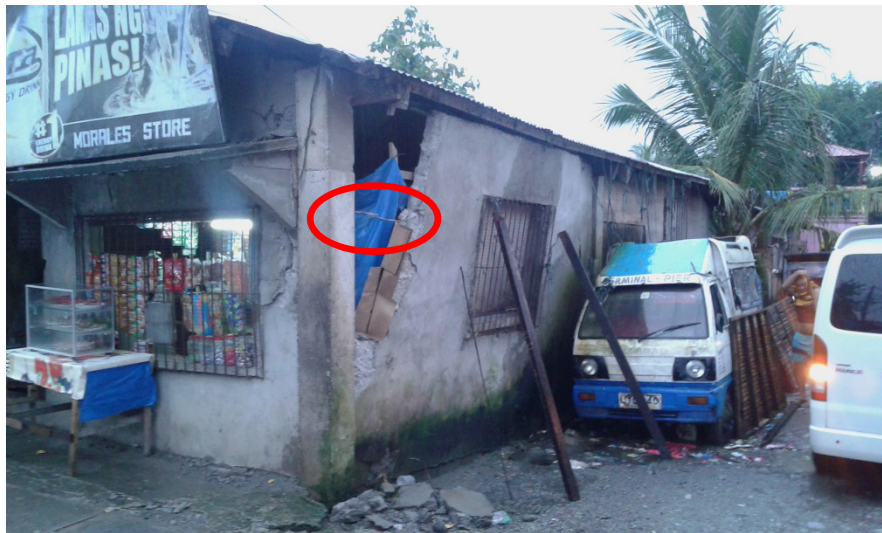
Figure 2.17 – Out-of-plane wall collapse. No ring beams present and only 2 bars with insufficient lap splices were used to connect wall to column. In plane diagonal cracking can also be seen on perpendicular wall.

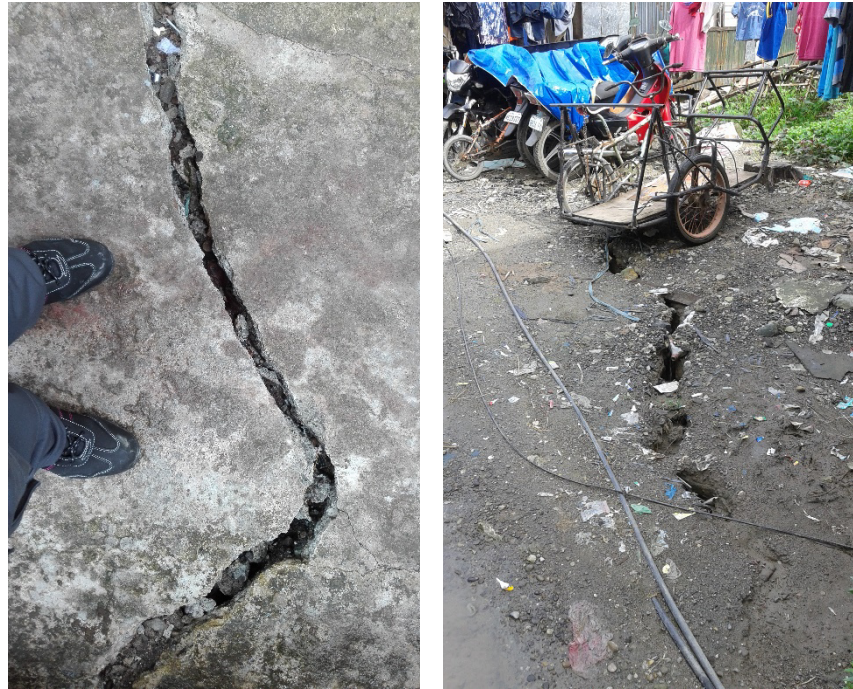
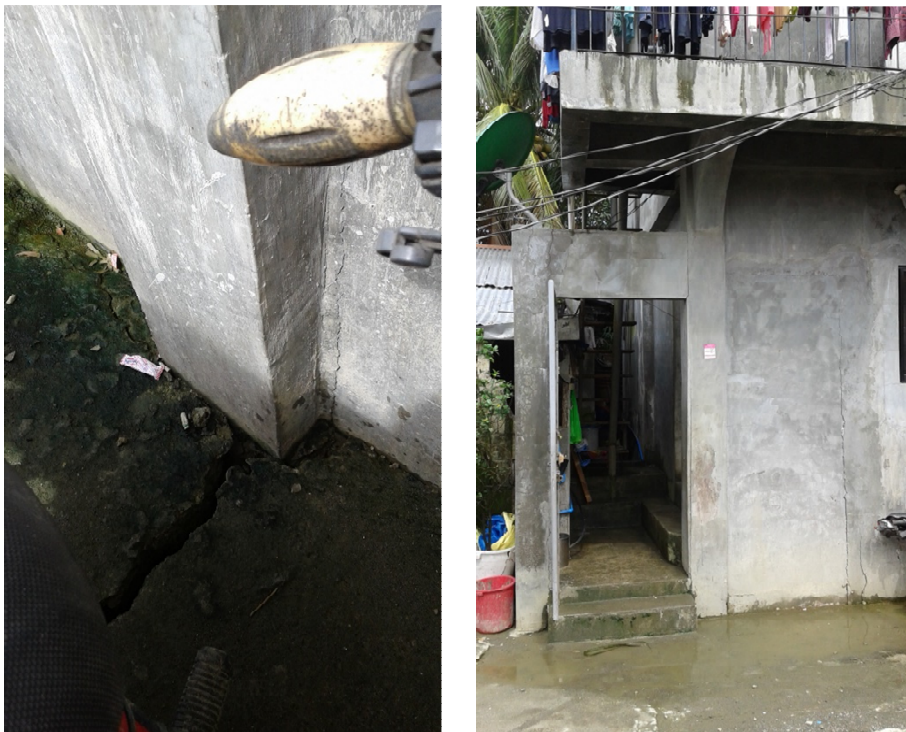
Figure 2.19 – Well constructed concrete frame with masonry infill home, minor cracking on shear walls and no damage to foundations observable, despite evidence of ground rupture immediately adjacent to building on exterior sidewalk concrete and heavily damaged neighbor house next door.

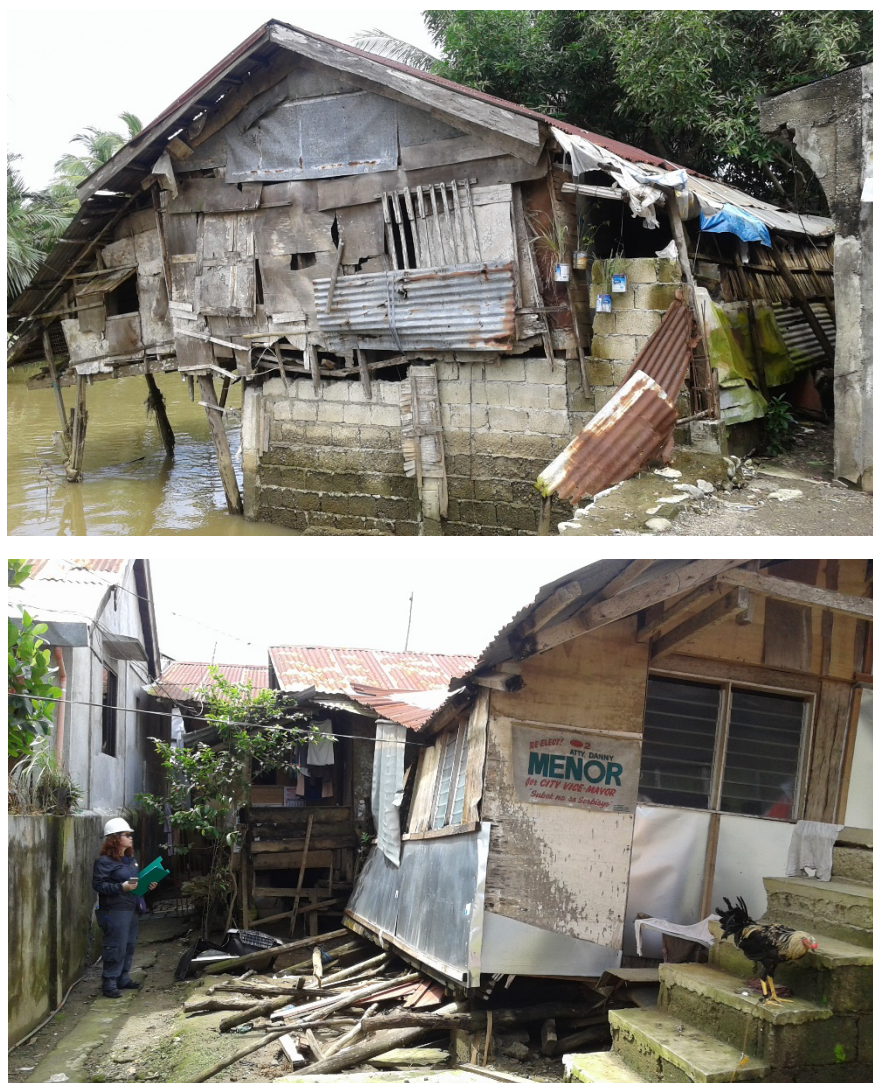
Similar to Barangay San Juan, non-engineered informal housing adjacent to the river exhibited the lowest family income and the lowest construction quality. Lightweight timber structures without cripple walls or bracing below the floor level collapsed completely due to the lack of a complete lateral load path and due to a suspected lack of foundation.

Figure 2.20 – Soft/weak story collapse of lightweight timber structures adjacent to the river.

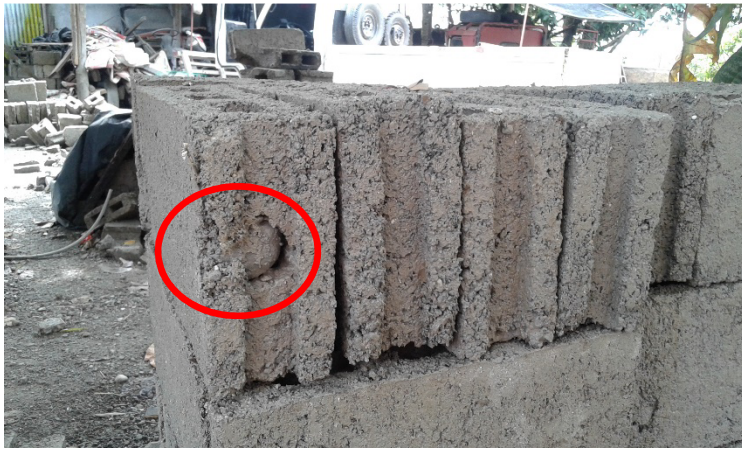
Several concrete hollow block manufacturers were encountered in Washington. Manufacturers appeared to use insufficient cement ratios, rounded and large river stones for coarse aggregate, and water sequestered from the nearby river in production. The manufacturing process appears to be unsatisfactory as evidenced by the piles of broken blocks in the production yard.

Figure 2.21 – Production of poor quality concrete hollow blocks encountered in Barangay Washington

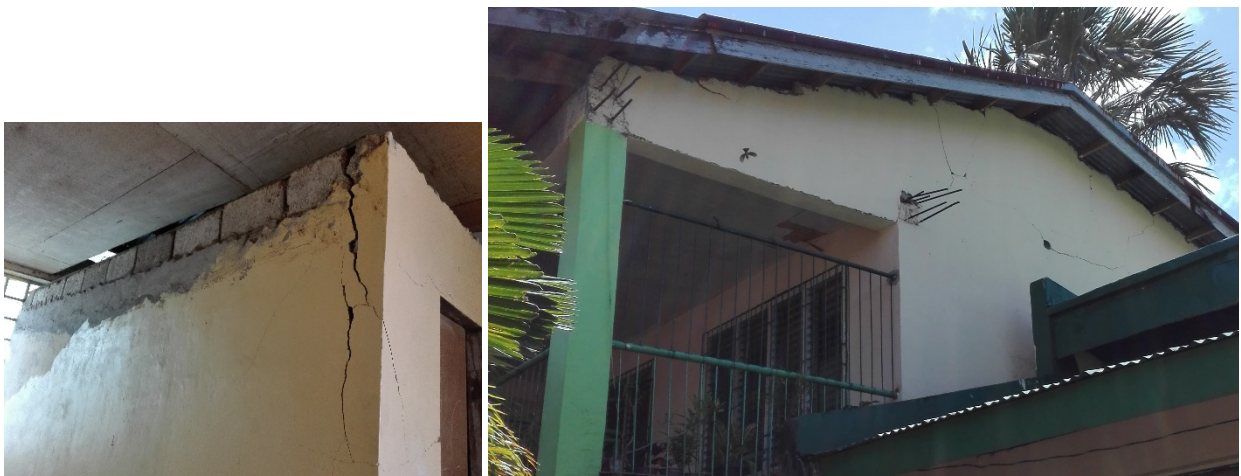
Figure 2.21 – Minor cracks due to insufficient out-of-plane support on gable wall and nonstructural masonry wall. In a more severe earthquake, walls would likely collapse and become a safety hazard.

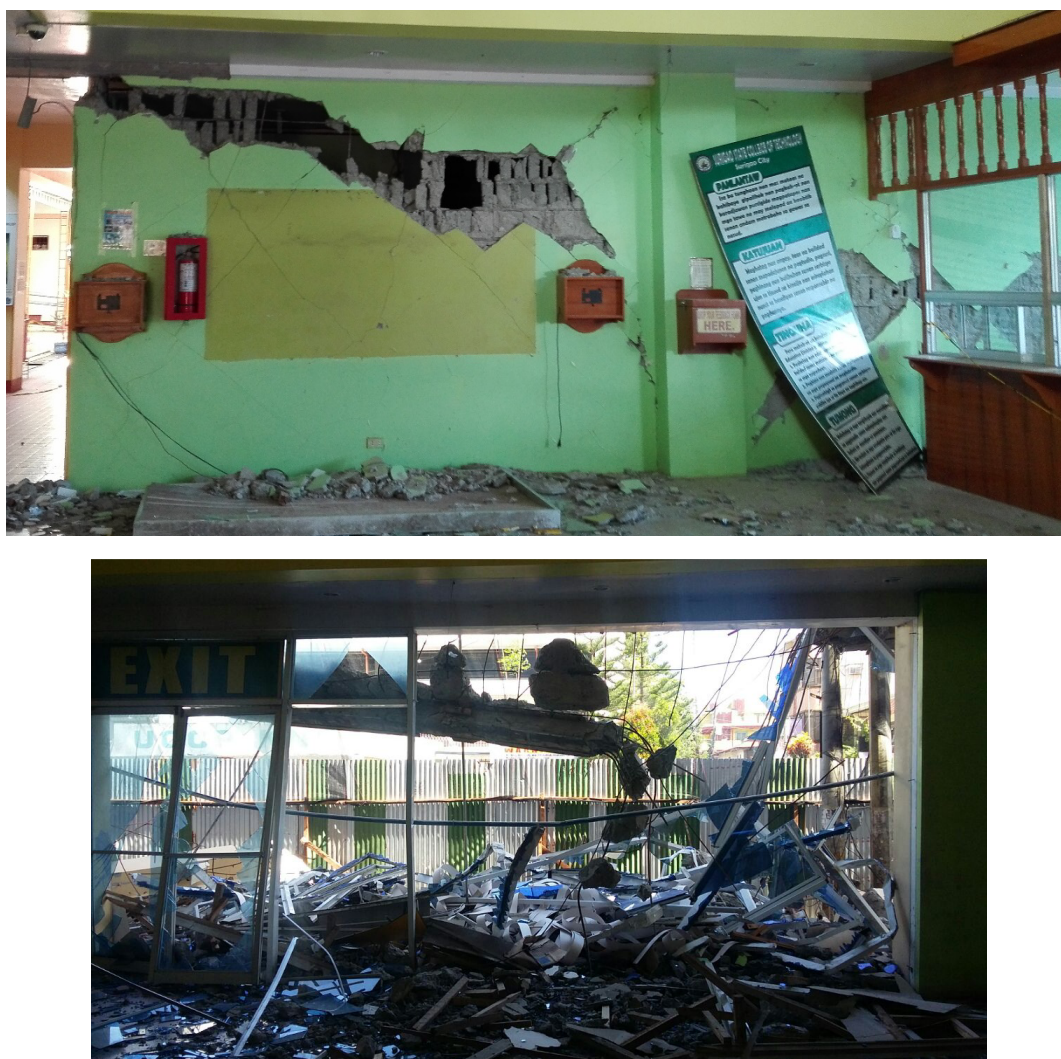
One building on the Surigao State College of Technology campus experienced severe damage to nonstructural components. The structural system was a reinforced concrete moment frame; the

concrete masonry infill walls were not detailed to accommodate the large deflections experienced by the moment frame building. A masonry roof parapet with insufficient reinforcement and connection to the main structure collapsed and destroyed the glass entry structure at the front of the building. Although the damage was to nonstructural components, both pose a significant threat to life safety and emphasize the necessity of properly detailing all building components to resist earthquake shaking.

Figure 2.22 – Masonry infill wall cracking (above) and entry structure destroyed by collapsed parapet wall (below). Main structure remained undamaged, but nonstructural components could be life threatening.

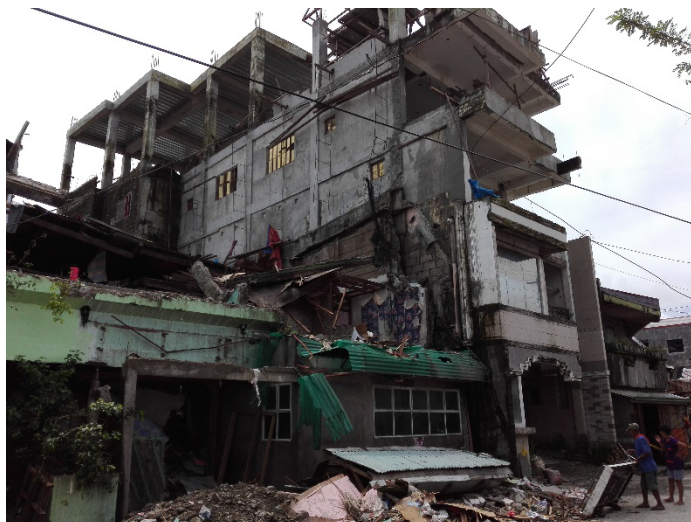
Figure 2.23 – Complete collapse of timber structure above concrete lower story. Cause of collapse unknown. This was the only complete collapse observed in Barangay Taft.

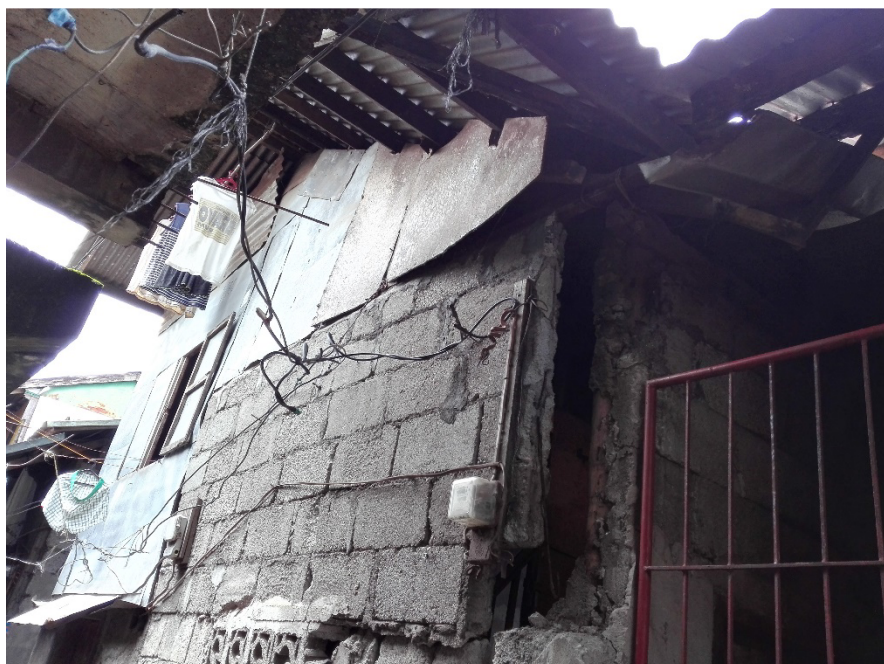
Similar to other barangays, out-of-plane wall failure was the most common failure mechanism observed. Masonry infill walls without ring beams and with timber posts are minimally restrained, causing collapse. In most cases the buildings are small enough such that the entire building did not collapse, but the future risk of progressive failure is high. Commercial buildings, hotels, and higher budget residential buildings exhibited favorable performance. Cracking was evident on ground floor shear walls on the largest structures and at wall openings where proper detailing was not present but the primary structural systems performed well.

Figure 2.24 – Out-of-plane wall failure. Masonry wall cannot accommodate deflection of the more flexible timber post. No tension connection between timber post and masonry wall.

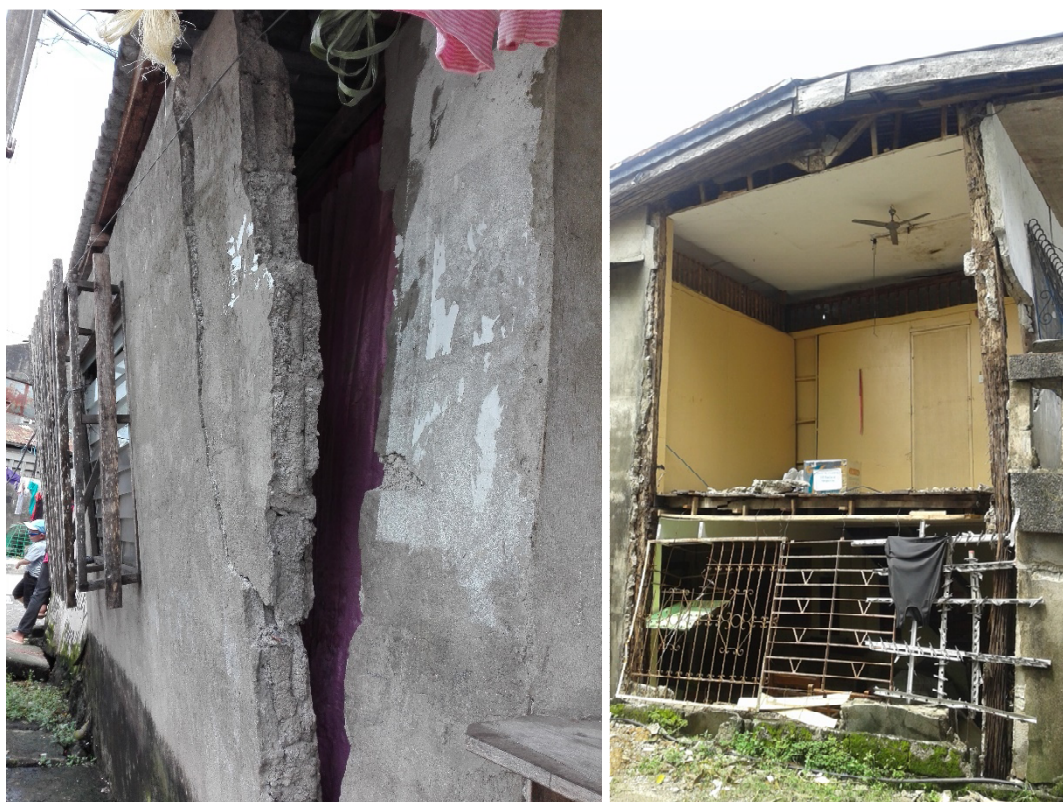
Figure 2.25 – Out-of-plane wall failure. Masonry wall with no columns and no ring beam (left). Masonry wall with timber posts and no floor diaphragm connection (right). The wall on the right was unbraced for 2 full stories, thus the total destruction of the wall.

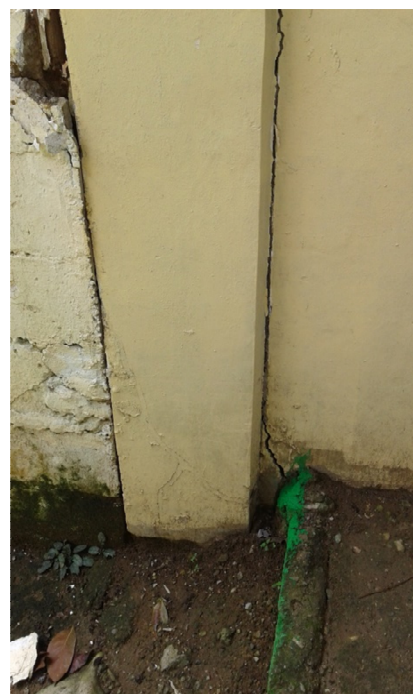
The Mariano Espina Memorial Central Elementary School in Barangay Taft experienced severe damage to the floor slabs of classroom buildings due to ground rupture, some walls experienced minor in plane cracking, one wall failed out-of-plane, and the perimeter fence experienced widespread collapse. Given the severity of the ground rupture however, the building systems performed rather well. No major structural or nonstructural elements collapsed that could become a life safety hazard. Some repair is necessary to return affected classrooms to functionality.

Figure 2.26 – Minor cracking between reinforced concrete column and masonry infill wall.

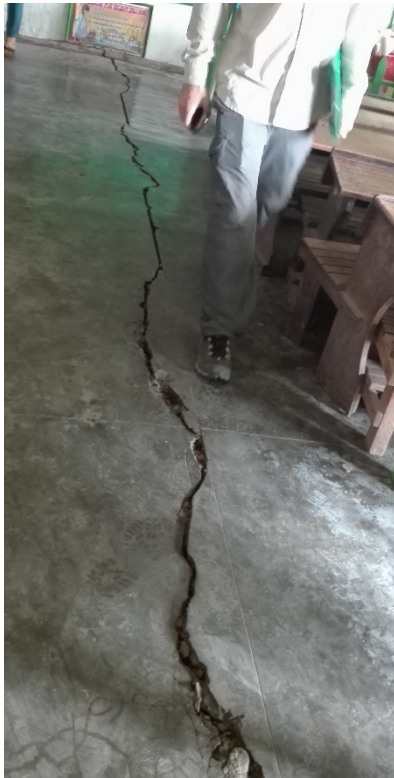
Figure 2.27 – Ground rupture in classroom building. Slab on grade does not contain reinforcement.

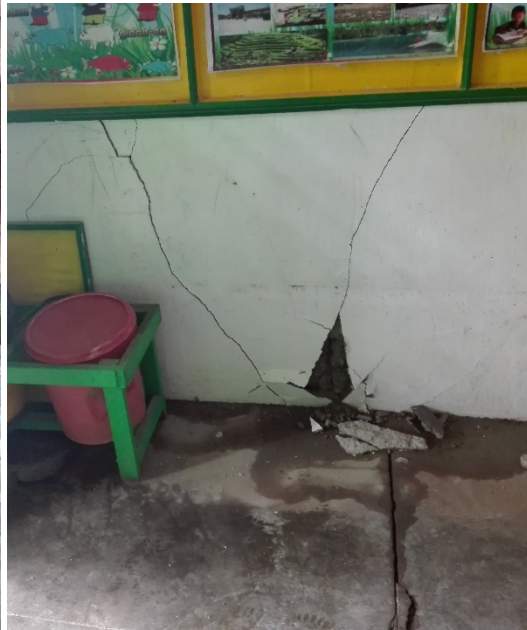
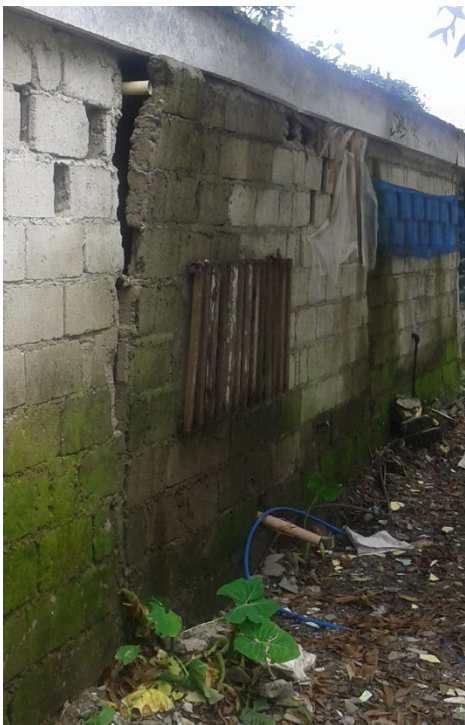
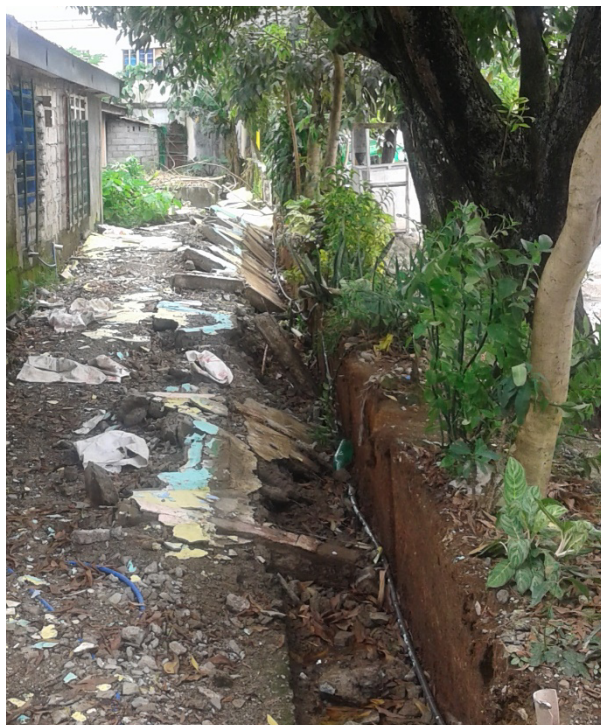
Figure 2.28 – Out-of-plane wall failure. No confining columns or beams present in wall (bottom left). Collapsed perimeter fence wall (bottom right). Perimeter wall constructed in masonry without sufficient reinforcement or confining elements

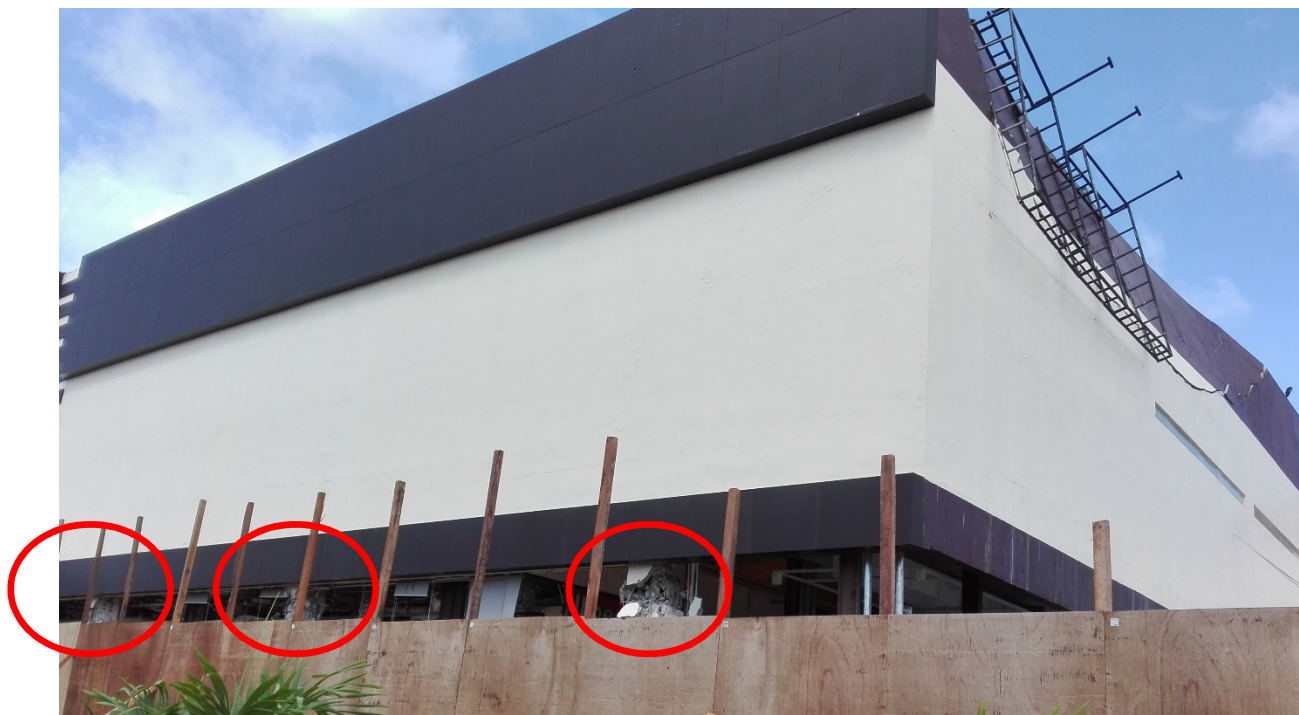
Figure 2.29 – Shear failure of reinforced concrete columns and parapet failure – mall complex/shopping center.

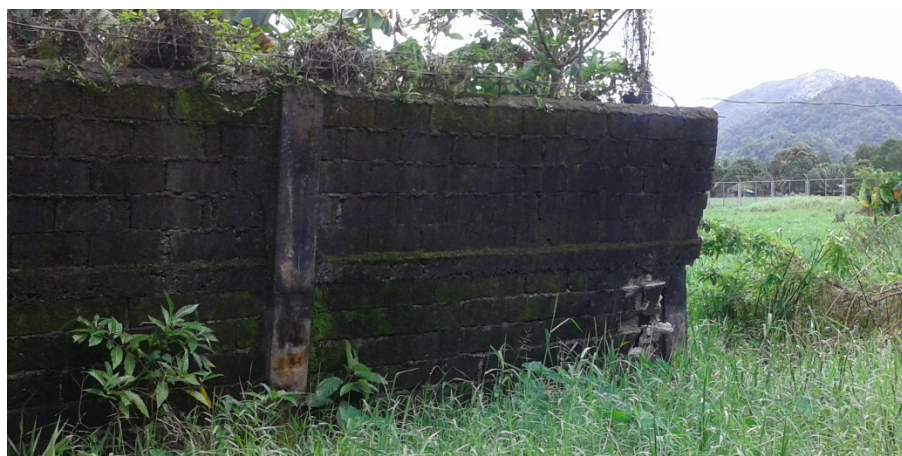
The Margarita Memorial Central Elementary School in Barangay Luna experienced spalling damage to concrete columns and collapse of a perimeter fence wall.

Figure 2.30 – Out-of-plane failure at perimeter fence wall.

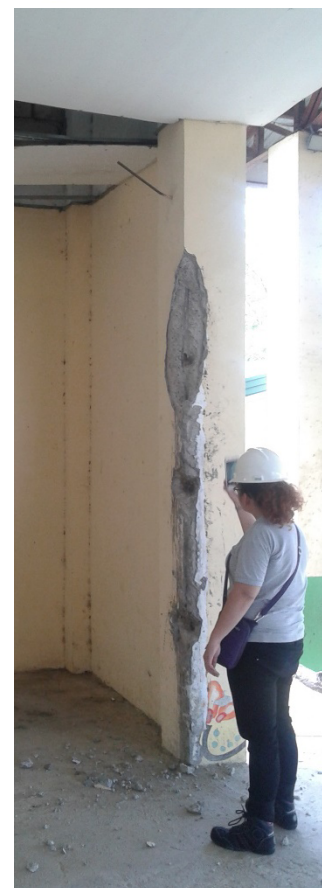
Figure 2.31 – Spalling of concrete column at auditorium stage. Longitudinal rebar exposed and in danger of future buckling if not
