## **EARTHQUAKE RECONNAISSANCE REPORT 4 – 7 September 2018, LOMBOK - INDONESIA**

**Submitted: 12 October 2018**

This report was prepared by Build Change Design Engineer Laura Masmia Putri and Indonesia Program Manager Mediatrich Triani N. with support from the other reconnaissance team member, Elwahyudi, Technical Supervisor.

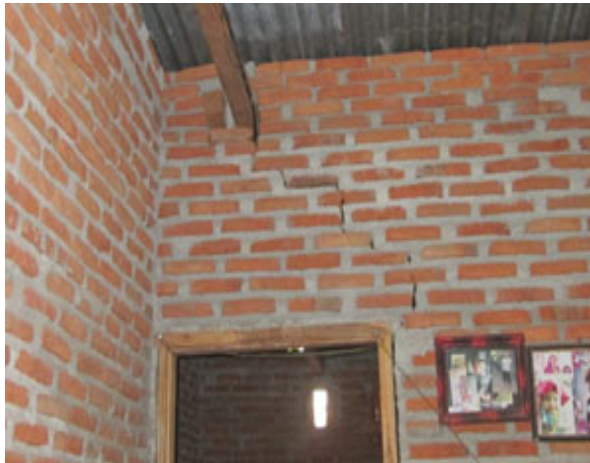
The most common types of damage encountered for URM buildings were diagonal cracks around openings (see **Figure 11**), cracking due to out-of-plane movement at free corners of walls (see **Figure 12**) and vertical cracks/separation of wall panels at intersections (see **Figure 13**). In some villages, long wall spans were preferable, causing flexural cracks, partial or total out-of-plane (OOP) collapse of walls to be prevalent (see **Figure 14** and **Figure 15**). Some houses with plastered walls were evident to perform better than those without plaster. Since the roof truss structure was mostly made of good quality wood and light-weight, the damage to roof structure was minimum, aside from instances where damage was caused by collapsing wall. Buildings that completely collapsed usually had been demolished prior to survey, so the damage of the roof was not observable. An unusual but common practice of adding smooth rebar at the top corner of unreinforced masonry was encountered (see **Figure 16**). Since gables were mostly of clay bricks or concrete block without confinement, partial or total OOP gable collapse (see **Figure 17**) was also prevalent.

**Figure 11.** Diagonal cracks around openings

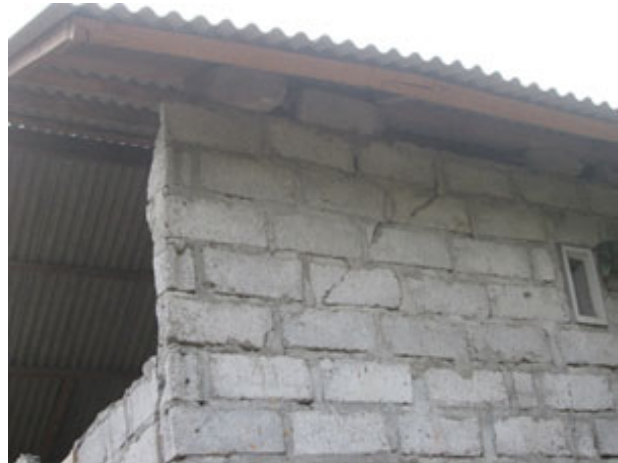
**Figure 12.** Cracking of top corners walls

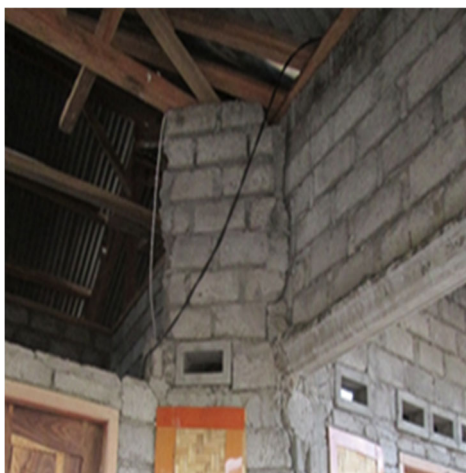
**Figure 13.** Vertical cracks/separation of wall panels at intersections

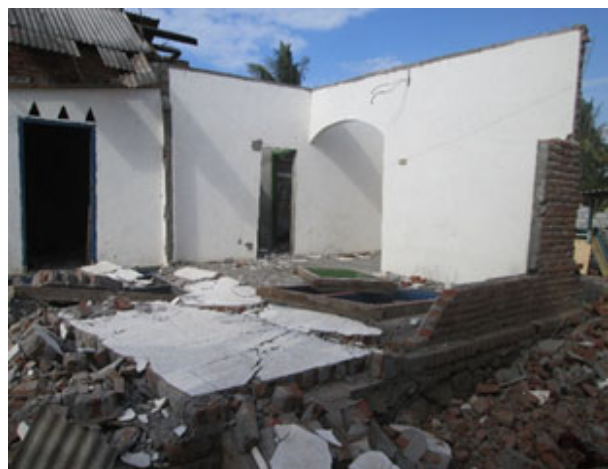
**Figure 14.** Total wall panel OOP collapse

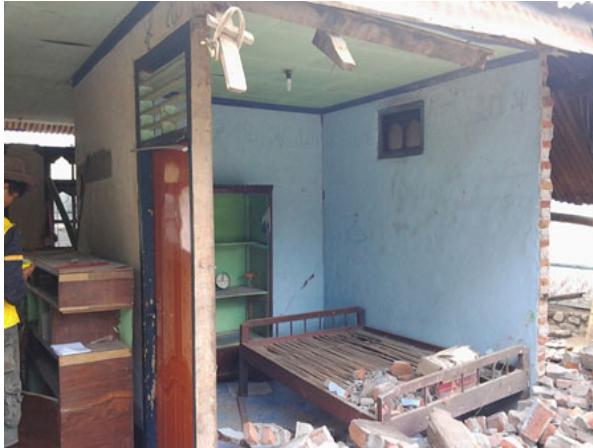
**Figure 15.** Heavy damage on walls

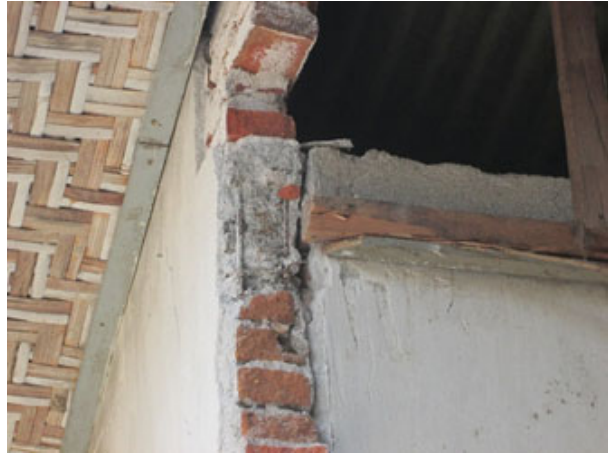
**Figure 16.** Adding smooth rebar at the top of URM as an anchorage from URM walls to roof truss was a common practice

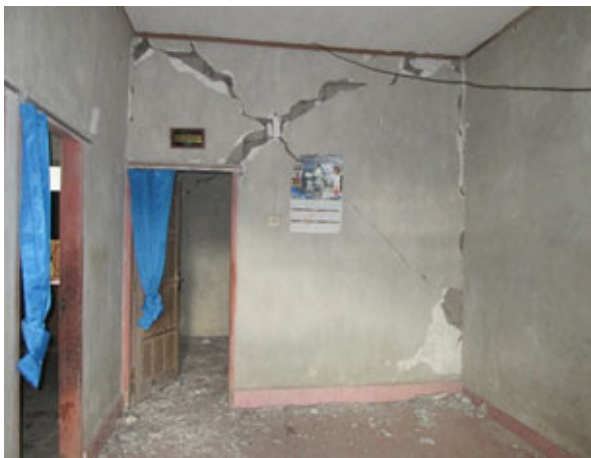
Most of the confined masonry houses experienced light damage. The most common damages of this type of building were the diagonal cracks of masonry around openings (see **Figure 28**) and cracks at the boundaries of wall panels and reinforced concrete elements. Vertical cracks along the connection between walls and reinforced concrete elements caused the separation between concrete columns and walls (see **Figure 29**). Some walls also experienced OOP collapse (See **Figure 30**). Horizontal cracks on some wall panels were encountered (see **Figure 31**), however it was not prevalent. Even though severe damage to the concrete elements was not encountered and therefore reinforcement details were not visible, it was estimated that the reinforcement did not meet the minimum earthquake resistant standards (consistent with typical practice). The concrete observed was mostly of poor quality. In contrast to the heavy damage in the walls, the roof truss usually remained undamaged or only minor damage was observed.

**Figure 28.** Diagonal wall cracking

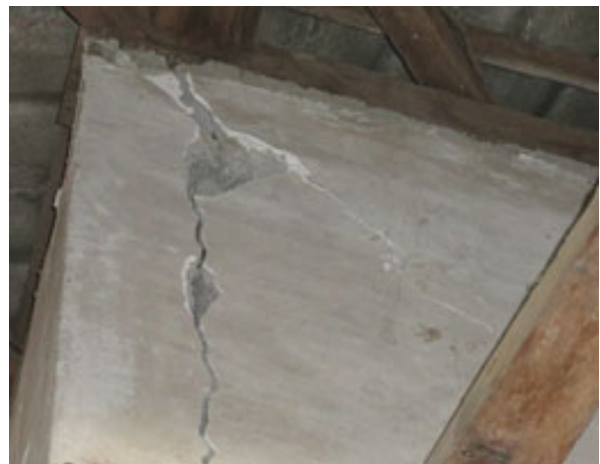
**Figure 29.** Vertical cracks in masonry walls and reinforced concrete beam

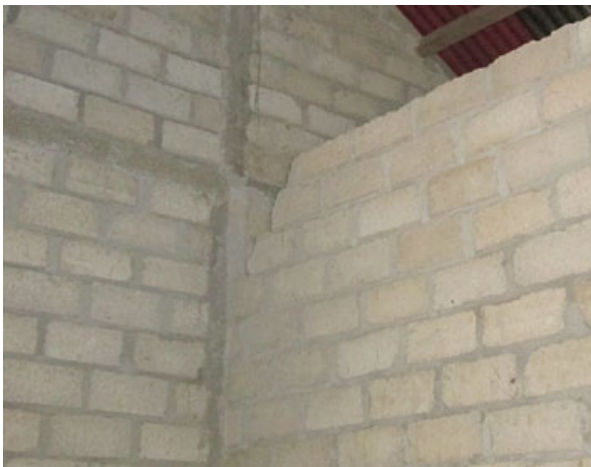
**Figure 30.** OOP wall collapse

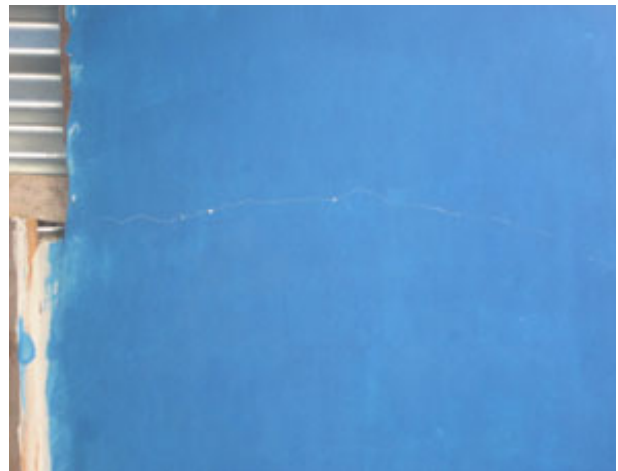
**Figure 31.** Horizontal cracks at walls

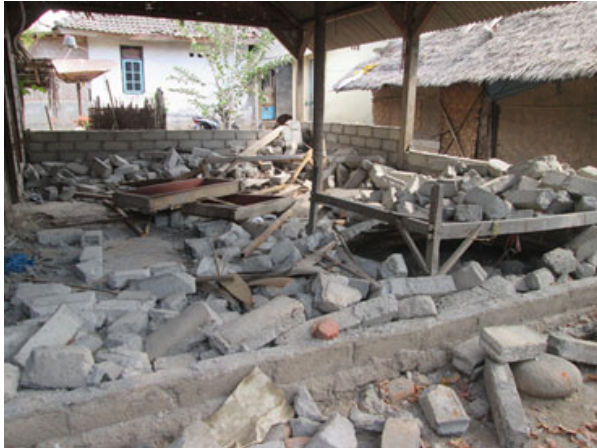
Many houses of this building type did not fully collapse in the earthquake - despite the collapse of the wall infill/skirts, the timber frame was merely damaged (see **Figure 34**). The walls that were supported by knee bracing performed better compared to other timber frame houses in the same area. The damage observed for this type of building usually happened on the masonry infill/skirts, instead of the timber frames. The damage to these structures consisted of shifting of timber posts from the footing (see **Figure 35**) and cracking of the masonry panel as shown in **Figure 36**. Poor connection between the timber frames and the heavy infill (see **Figure 37**) caused the OOP collapse of infill panels/skirts (see **Figure 34** and **Figure 38**) to almost all buildings observed. Despite the poor inter-connection between timber elements, the damage to timber frames was at a minimum. Cracks on foundation (see **Figure 39**) of few houses were also encountered, especially for those that were positioned above ground level. The poor quality of foundation's mortar, that seemed to lack cement, was considered as the main cause of the foundation cracks/damage/collapse.

**Figure 34.** OOP collapse of masonry infill panels

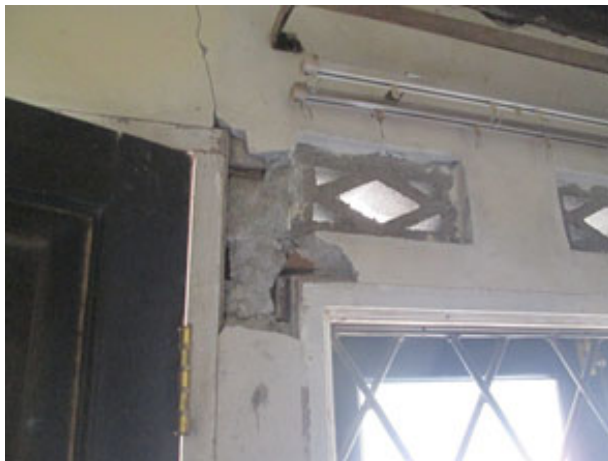
**Figure 36.** Cracks on masonry infill

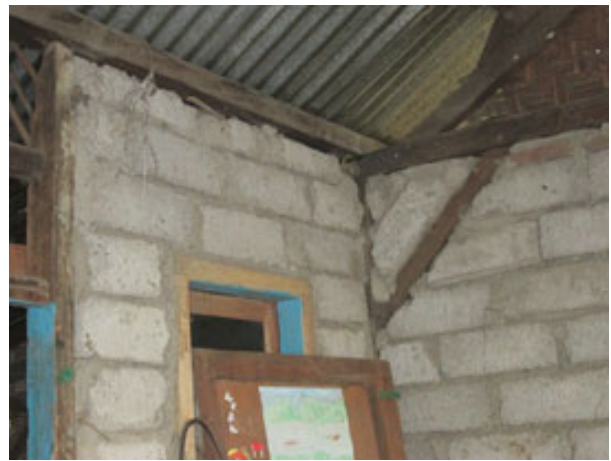
**Figure 37.** Poor connection between timber frames and masonry infill

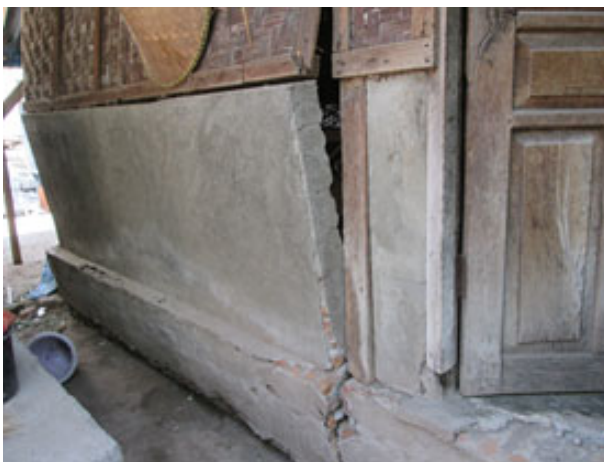
**Figure 38.** OOP collapse of masonry infill, leading to damage to the bamboo panel above

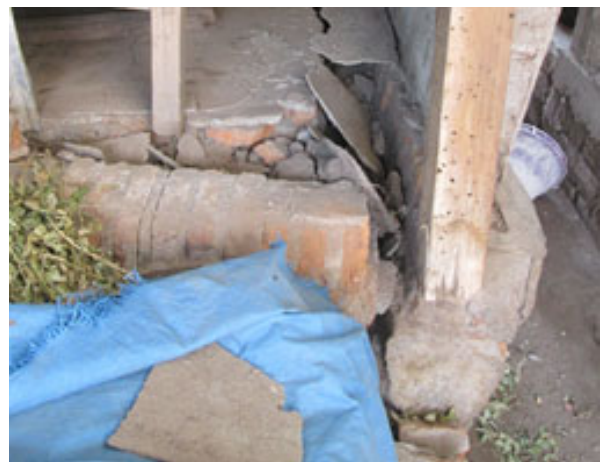
**Figure 39.** Cracks of foundation

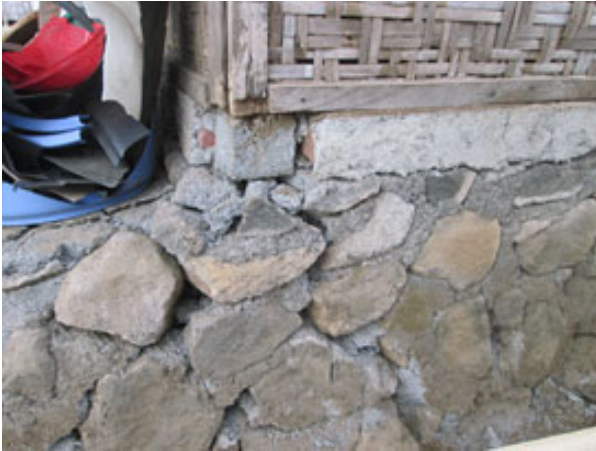
There was no significant damage observed in timber frames due to the earthquake for this type of building. However, cracks in the foundation (see **Figure 42**) was encountered along with cracks in the concrete floor (see **Figure 43**). Foundation damage was evident due to the poor quality of mortar. Some damage observed in the roof of one house was mainly due to timber deterioration. Foundation collapse that led to the damage of the lower part of the wall as was encountered (see **Figure 44** and **Figure 45**). Some posts were not embedded into the foundation, causing the posts to shift and building to tilt. However, because homeowners had already done some emergency actions to their houses, only minor wall displacement was encountered during the survey.

**Figure 42.** Cracks on foundation

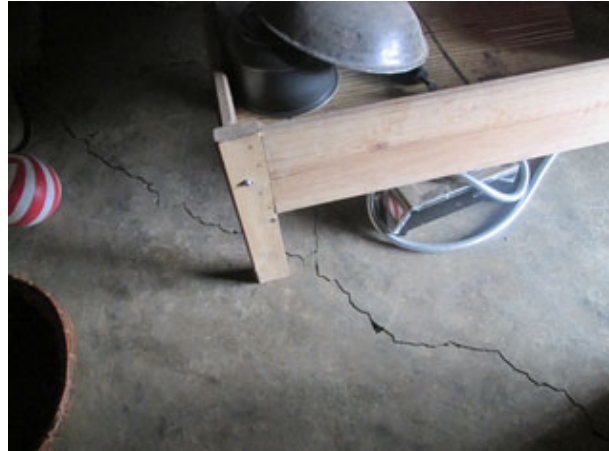
**Figure 43.** Cracks on concrete floor

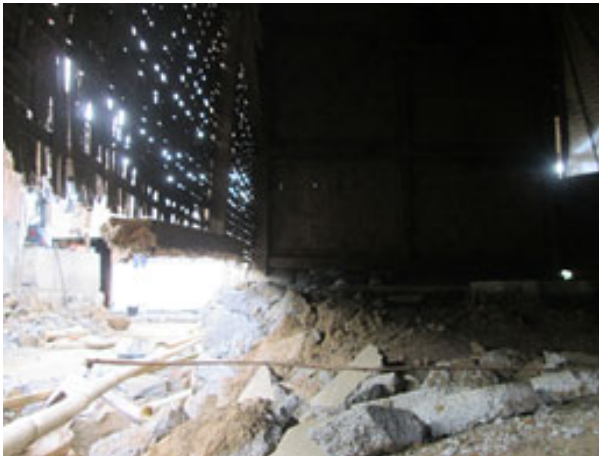
**Figure 44.** Damages on lower parts of wall due to foundation collapse and the absence of sill plate

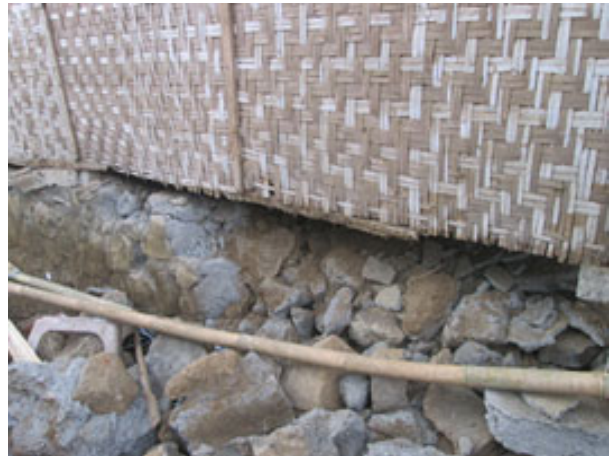
**Figure 45.** Foundation collapse (lacking cement mortar)

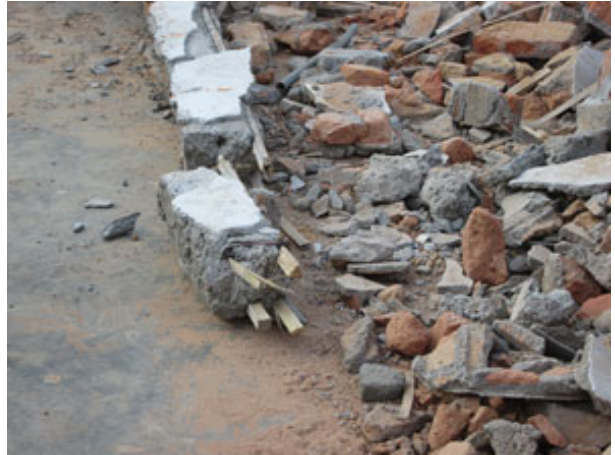
A few unusual construction practices were encountered in Akar-akar Village, Bayan Sub-district. In one case, lightweight steel was used for the main frame of the house (see **Figure 46**). Even though the house was already demolished by homeowner, the lightweight steel seemed to not be able to resist either the gravity loads or the lateral loads due to the earthquakes. In another case, bamboo was used as concrete reinforcement for a house that was estimated to be reinforced concrete frame with masonry infill or confined masonry (see **Figure 47**). The bamboo was also proven to be too weak and crushed due to the earthquake.

**Figure 47.** Bamboo reinforced concrete

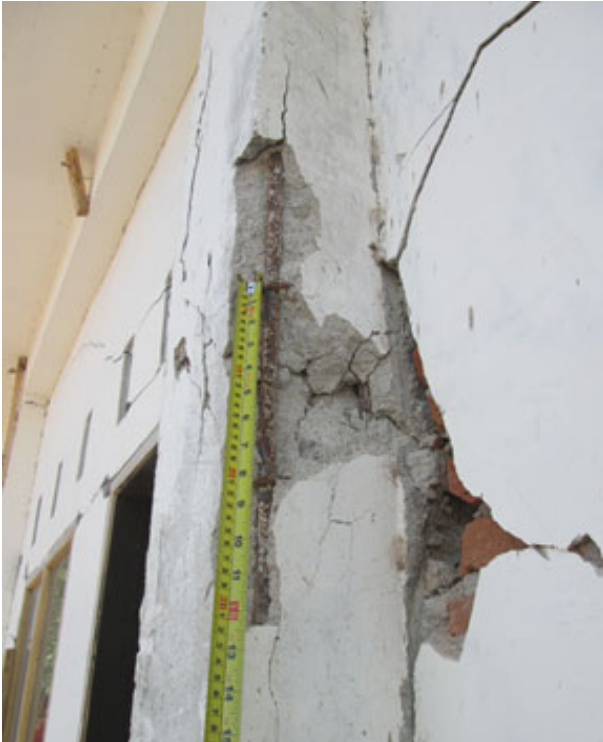
**Figure 54.** 6mm stirrup was provided every 20cm or more

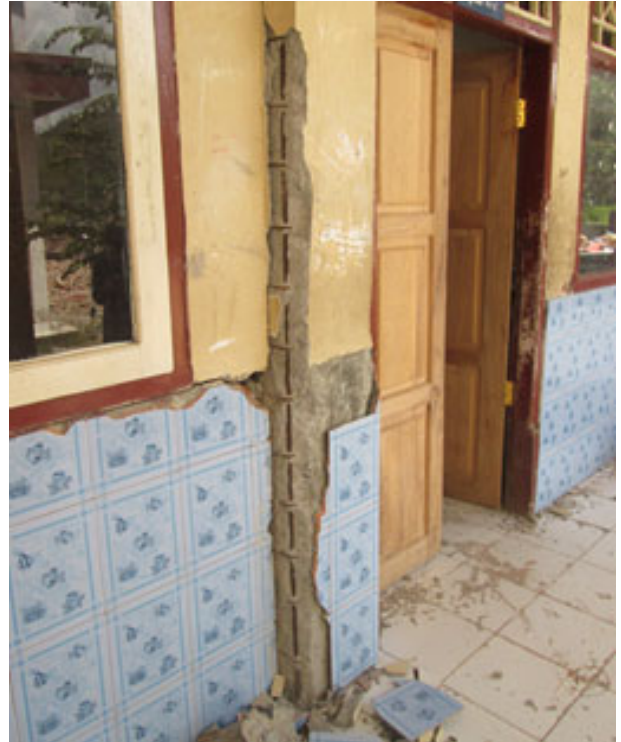
**Figure 55.** 6mm stirrup was provided every 20cm or more

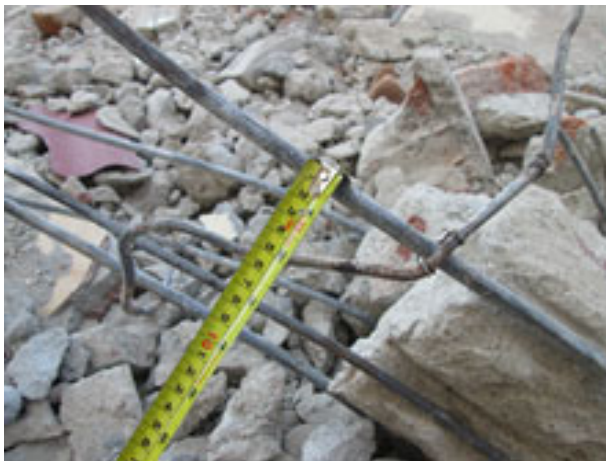
**Figure 56.** Smooth 10mm longitudinal rebar

In SNI 2847:2013, article 3.5.1, it is mentioned that the longitudinal rebar of reinforced concrete must be deformed, while from all building observed, it was found that all of the longitudinal rebars were smooth. Due to the smaller surface area of smooth bars, around 40% more are required to achieve the same strength as deformed bars and the development and splicing of the bars is affected. The concrete cover of structural concrete is also limited in SNI 2847:2013 to be no less than 4cm. However, from the observation, exposed rebar due to thin concrete cover was prevalent.

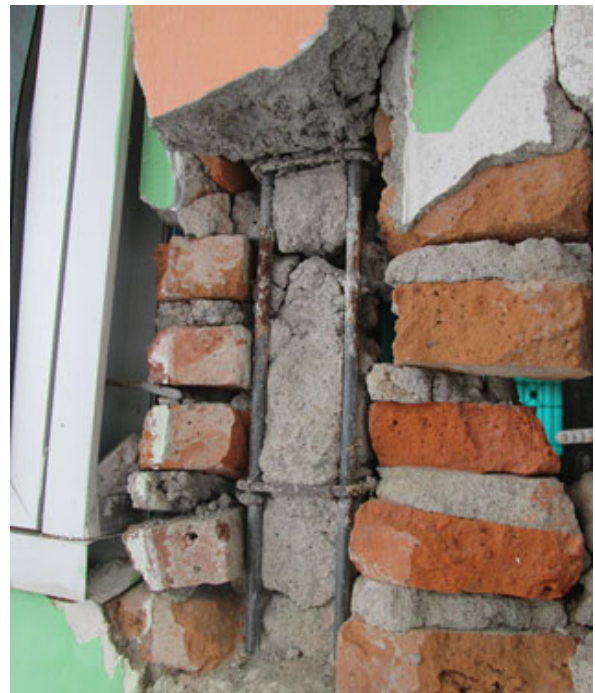
The connection between frame elements (e.g columns-beams, column-plinth beams) were poor with insufficient ductility detailing. Inadequate or excessive concrete cover of columns (see **Figure 57**) and slabs (see **Figure 58**) were common, while for beams, the concrete cover and reinforcement were not observable.

**Figure 57.** Column with both inadequate and excessive (10cm) concrete cover with poor quality of concrete

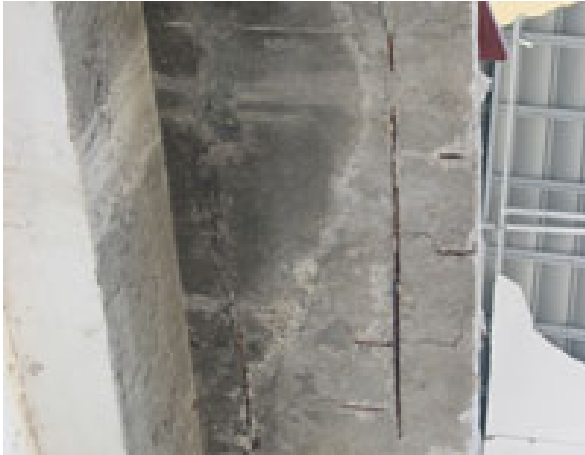
**Figure 58.** Slab with thin concrete cover and exposed rebars

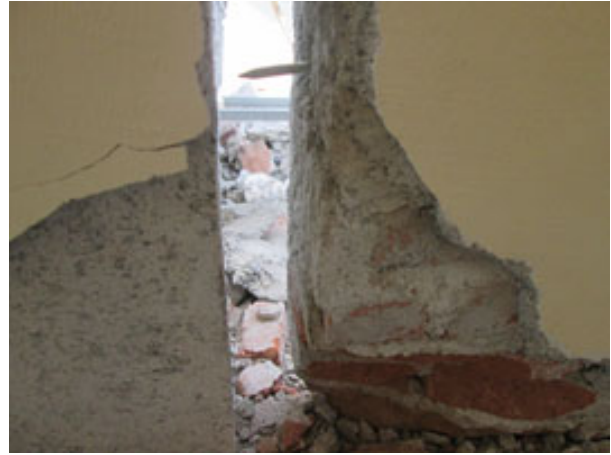
The dimension of bricks was approximately 4cmx9cmx22cm and of fair quality. The masonry walls had minimal connection to the reinforced concrete frames. At one school, a minimum effort to connect the masonry wall to columns using nails was found (see **Figure 59**).

**Figure 59.** Minimum connection between masonry infill and the reinforced concrete frames

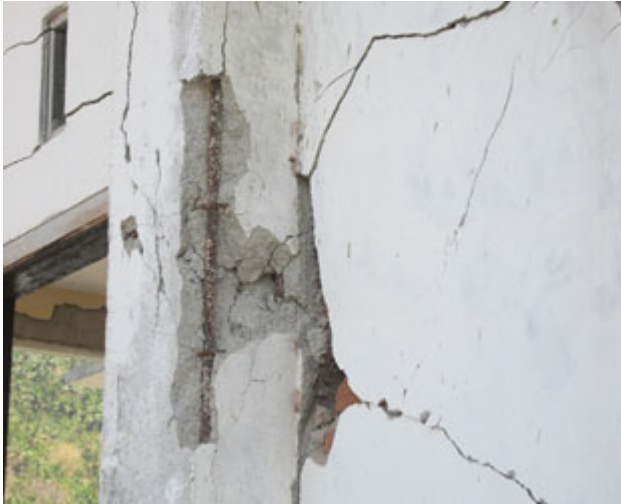
Cracks on columns and beams, especially near the joints were common. Diagonal cracks on columns (**Figure 60**), beam sliding cracks (**Figure 61**), cracks on columns due to corrosion of reinforcing rebar (**Figure 62**), and splitting cracks of columns (**Figure 63**) were also encountered. Especially at RCF joints, columns and beams were cracked or crushed. Where ductility or seismic detailing was not sufficient and the cracks were severe, the separation between frames (i.e column-beam, column-plinth beam) were encountered (**Figure 64**). Captive column damage near door/windows openings was also common (**Figure 65**). At one school building, it was evident that the buildings were renovated and the height of the building was increased. This was done by adding new columns and masonry walls to the top of old ones without providing a good connection between the new and old structures. The significant difference of quality between the old and new structures caused severe damage at the adjoining areas **Figure 66**).

**Figure 60.** Diagonal cracks on reinforced concrete columns

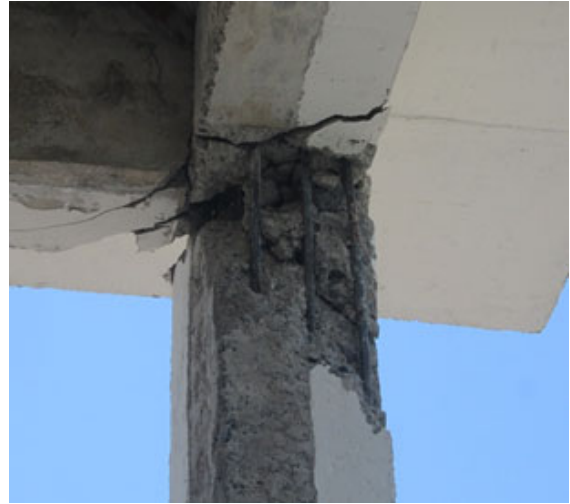
**Figure 61.** Beam sliding cracks

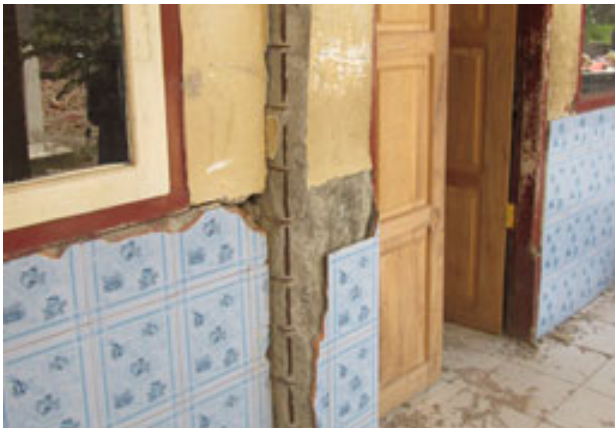
**Figure 62.** Cracks on columns due to rebar corrosion

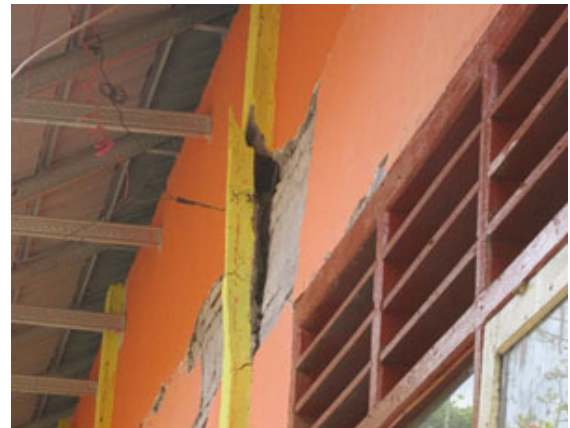
**Figure 63.** Splitting crack on columns

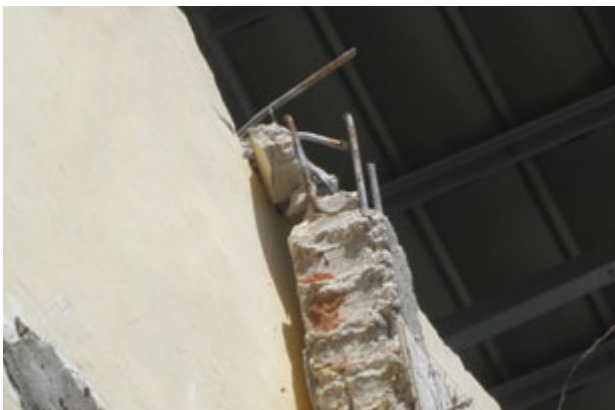
**Figure 64.** Separation of reinforced concrete frames (columns from gable frames)

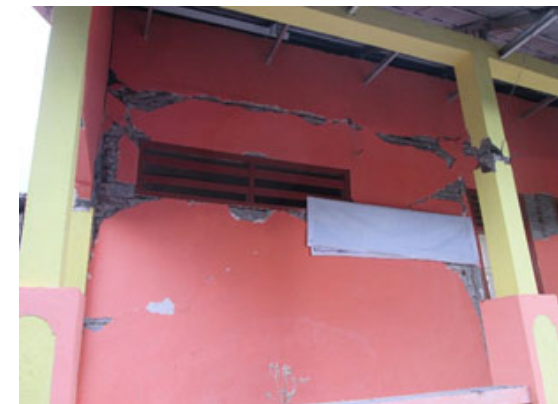
**Figure 65.** Captive columns damage

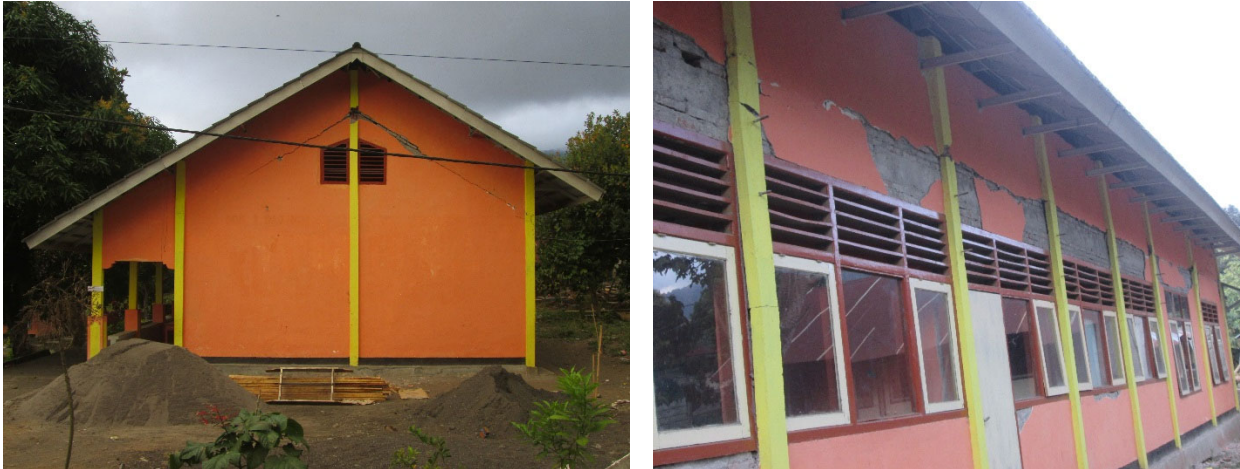
**Figure 66.** Damage due to significant quality difference between old and new structure

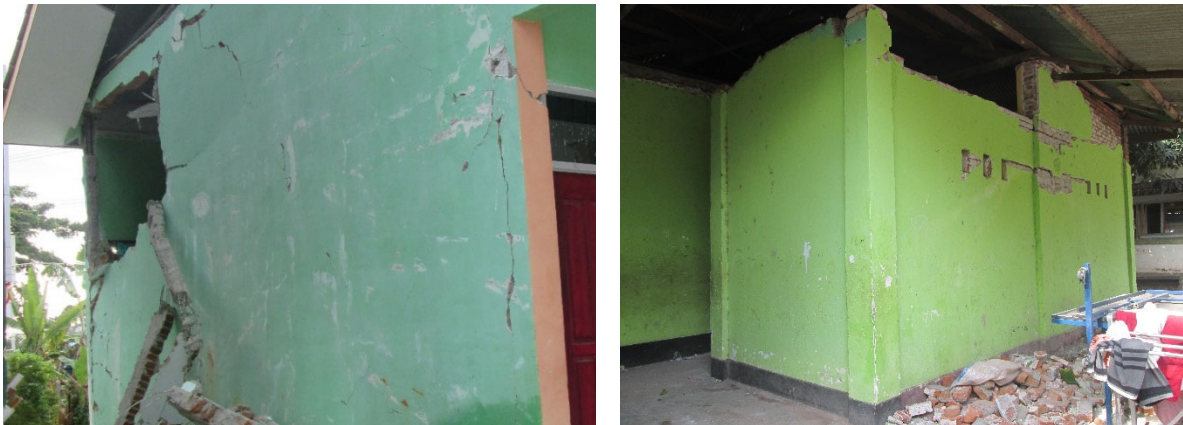
For school buildings that were severely damaged, out-of-plane collapse of masonry walls and gables were prevalent (**Figure 67**, **Figure 68** and **Figure 69**). Partial or total OOP collapse was encountered due to the long (3m-4m), tall (usually 3.7m to 4m), slender (around 13cm) wall panels, large distances between cross walls, poor quality of material and workmanship, and the poor connection provided between masonry and frames/ties. Despite being confined, it was observed that heavy masonry gables experienced heavy damage. At one school, the falling masonry gable and/or masonry wall of a two-story building crushed another one-story building nearby (see **Figure 70**). At another school, similar case also showed how an OOP collapse of wall and gable inward the building causing the damage to roof truss and ceilings (see **Figure 71**). The last two cases showed how disastrous OOP wall/gable collapse was.

**Figure 67.** Partial OOP collapse of wall panel

- replacing masonry gable walls with lightweight materials,
- replacing clay tiles for roofing with CGI sheeting, or strengthening the connection of clay tiles to the framing and truss members and providing additional bracing,
- ensuring long spans between cross walls are braced by an adequate ring beam or horizontal bracing system to connect the top of walls to perpendicular cross walls,
- providing confined masonry shear wall panels along the open longitudinal sides of the classroom buildings and/or at open/missing transverse walls,
- replacing masonry panels above windows and doors with lightweight materials or louvers for ventilation, or otherwise support with adequate reinforced concrete lintel beams,
- upgrading roof truss framing and connections to strengthen,
- strengthening the support and connection of ceilings to the building structure.

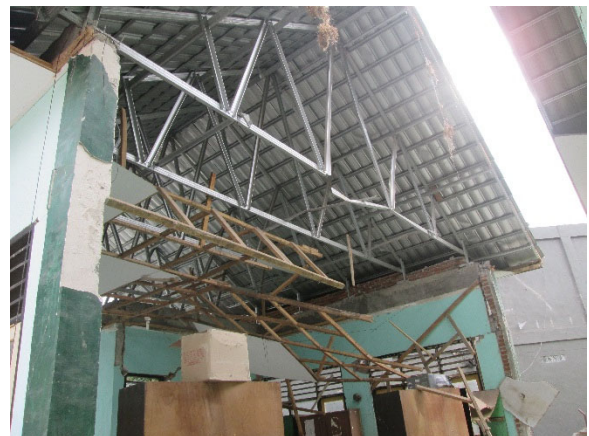
**Figure 71.** OOP walls and gable collapse caused roof truss and ceiling damages

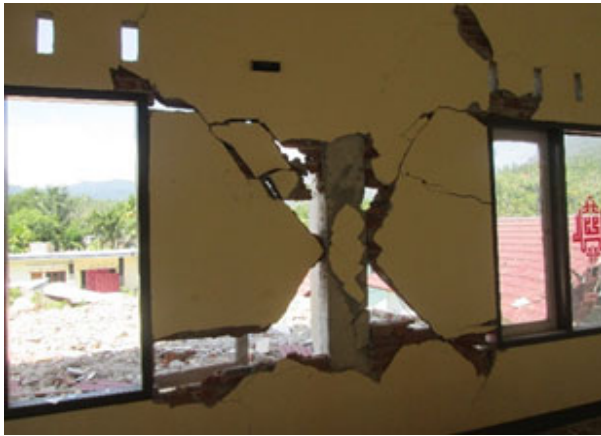
Aside from OOP collapse, other common damage to walls encountered were: diagonal cracks around openings (**Figure 72**), flexure/vertical cracks (**Figure 73**), separation of walls from beams and columns (**Figure 74**) and crushing at wall toes (**Figure 75**).

**Figure 72.** Diagonal cracks around openings

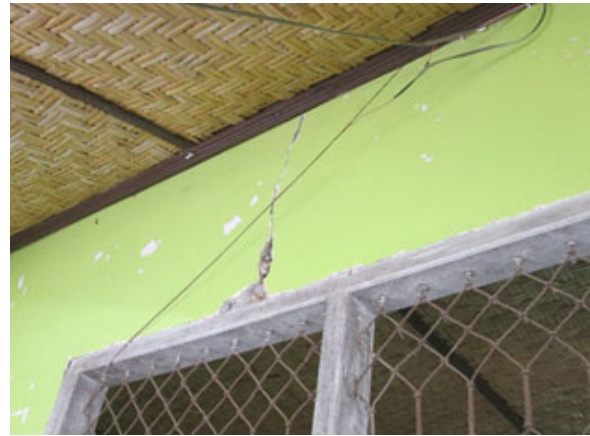
**Figure 73.** Vertical flexural cracks at mid-span of wall

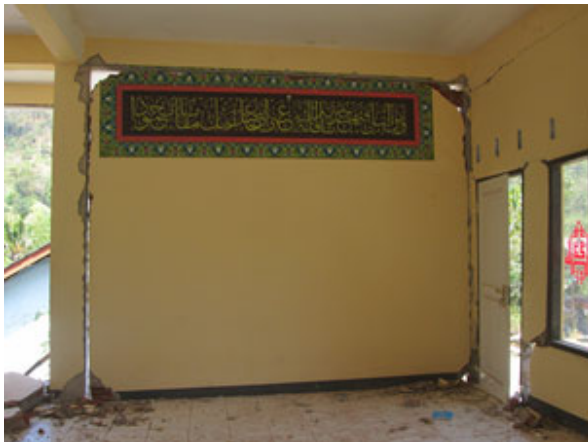
**Figure 74.** Separation of walls from beams and columns

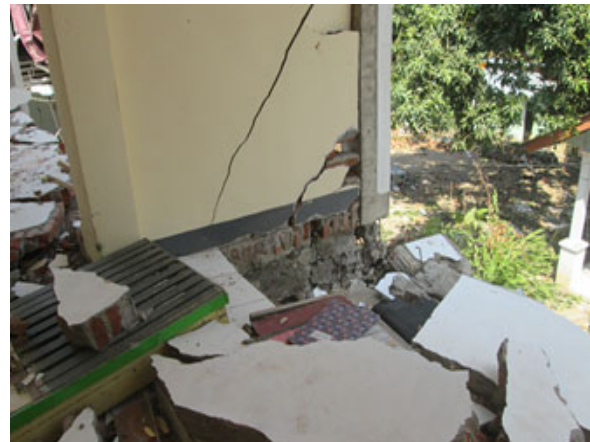
**Figure 75.** Crushing at wall-toe

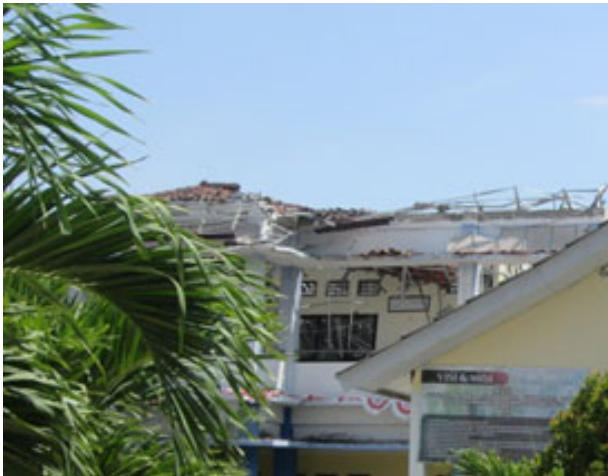
The damage to roof trusses was mainly caused by movement of a heavy gable, causing the damage mainly to occur at the end of the roof near gables (see **Figure 68** and **Figure 69**). The damaged ceiling was also found near falling gables or collapsed walls (see **Figure 71**). For schools with clay tile coverings, falling clay tiles was also encountered, causing the damage on roof trusses that were made of lightweight steel (see **Figure 76**).

**Figure 76.** Falling clay tiles, causing damage to lightweight steel roof truss

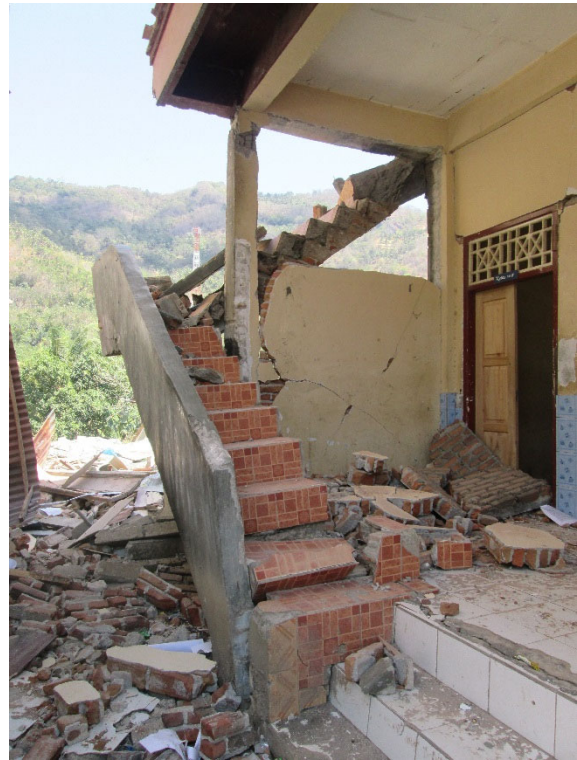
**Figure 77.** Partial collapse of only egress stair to upper classrooms that accommodate hundreds of students

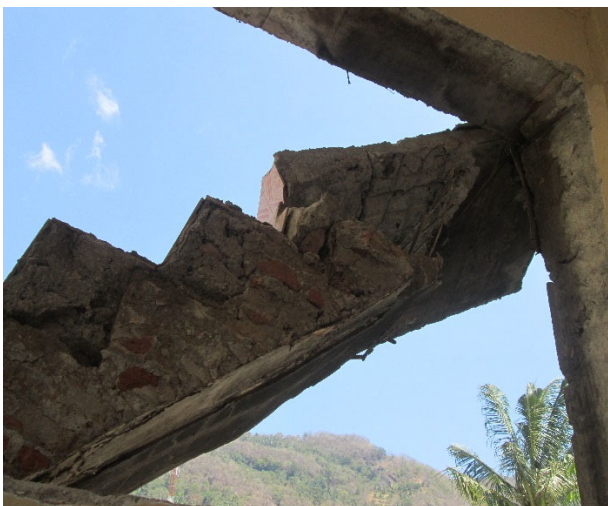
the second floor classrooms. This stair was fractured (see **Figure 78**), showing the insufficient reinforcement provided (see **Figure 79**).

**Figure 78.** Fracture of reinforced concrete stairs.

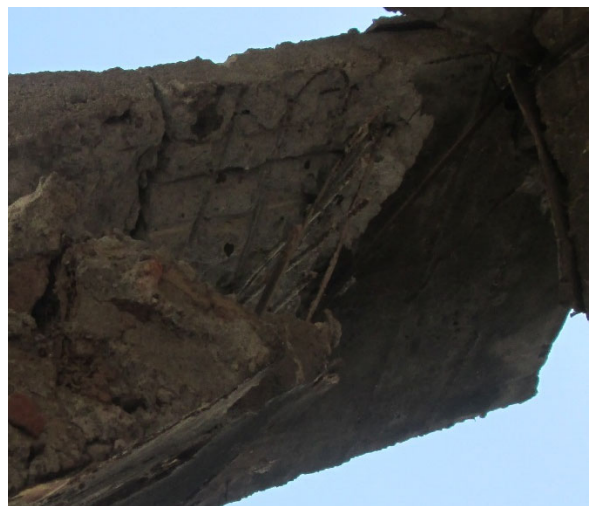
**Figure 79.** Insufficient stair reinforcement
