EARTHQUAKE AND TSUNAMI RECONNAISSANCE REPORT
31 October 2018 - 8 November 2018, PALU - INDONESIA

Submitted: December 2018

This report was prepared by Build Change Design Engineer Laura Masmia Putri and Volunteer Sam Adiputra, with support from Technical Supervisor Elwahyudi and IMR Officer Ridzki Rachman M.S.

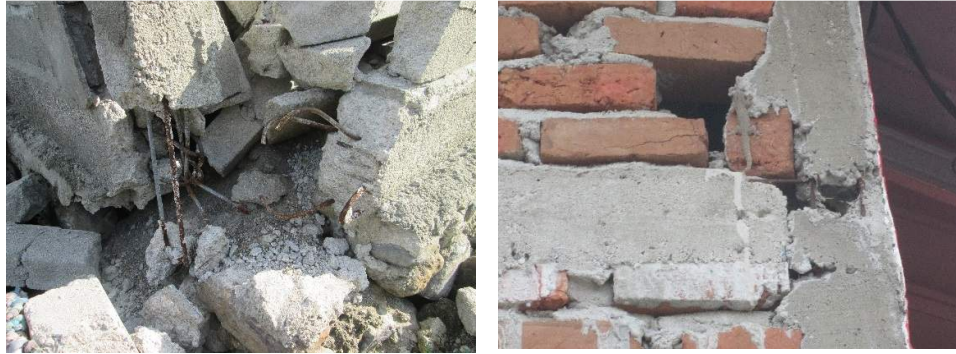
concrete cover and exposed rebar was common to encounter (see Figure 45), causing the rebar to be rusted and fragile (Figure 46). Typically stirrups were only provided every 20cm – 40cm (Figure 45). The connection between each confining element was usually insufficient (see Figure 47). Minimum or no overlapping was provided between confining elements.

Figure 47. Insufficient seismic detailing between confining elements

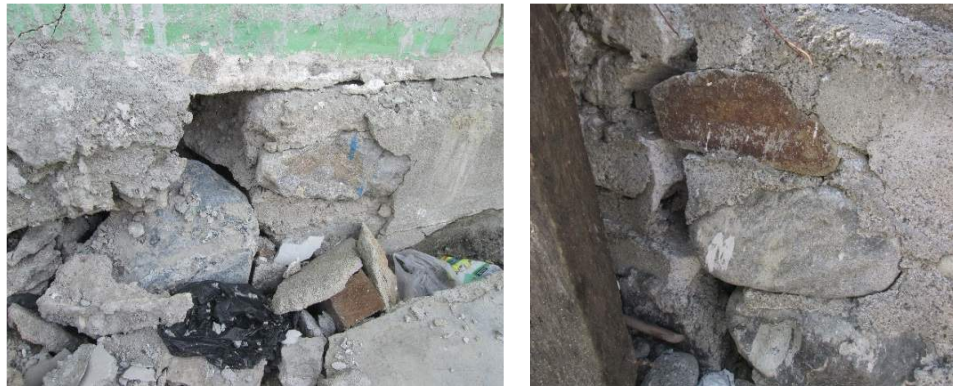
Cracks in the foundation was very common to encounter due to ground settlement at these sites and poor mortar quality, which lacked cement (see Figure 54). The cracks that were caused by partial settlement also led to damage to other structural elements such as columns, plinth beams and walls. Separation between the plinth beam and foundation was encountered, showing the absence of a connection between the plinth beam and stone foundation (see Figure 55).

Figure 54. Cracks on stone foundation

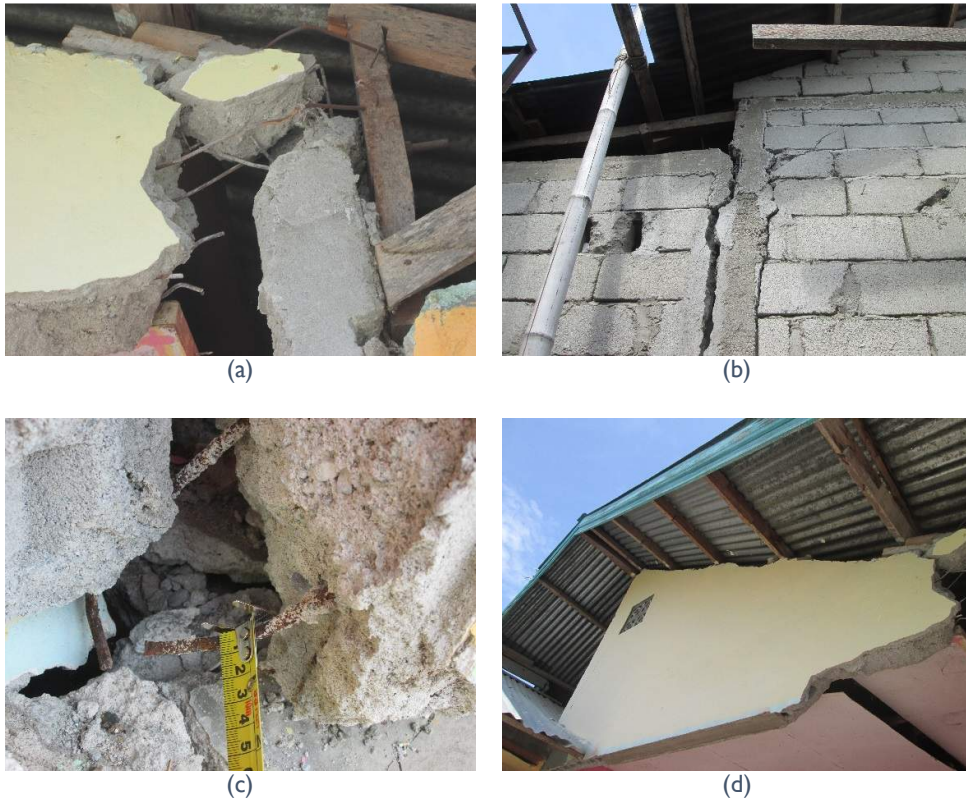
The separation of confining elements (i.e. column – beam, foundation – columns, column – plinth beam) was common (see Figure 56) due to poor seismic detailing, poor concrete strength and insufficient concrete capacity. Cracks on columns due to captive column mechanism were also prevalent (see Figure 57). A case was found where a wall panel without a top confining element led to splitting the adjoining column that had to support all the lateral load at the adjoining wall (see Figure 58). Separation between confining elements and masonry was also common to encounter (see Figure 59).

Figure 56. Separation of confining elements

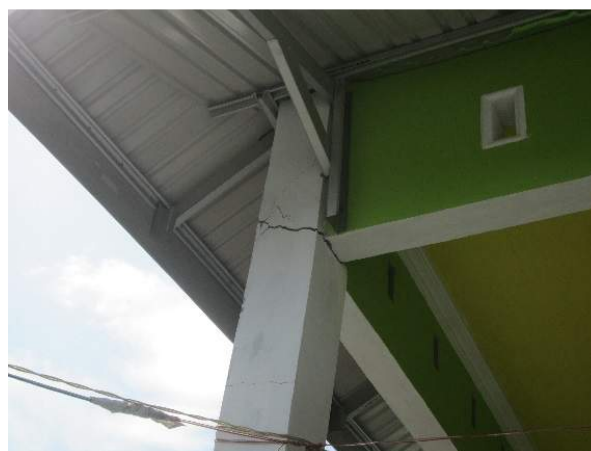
Figure 57. Captive column crack

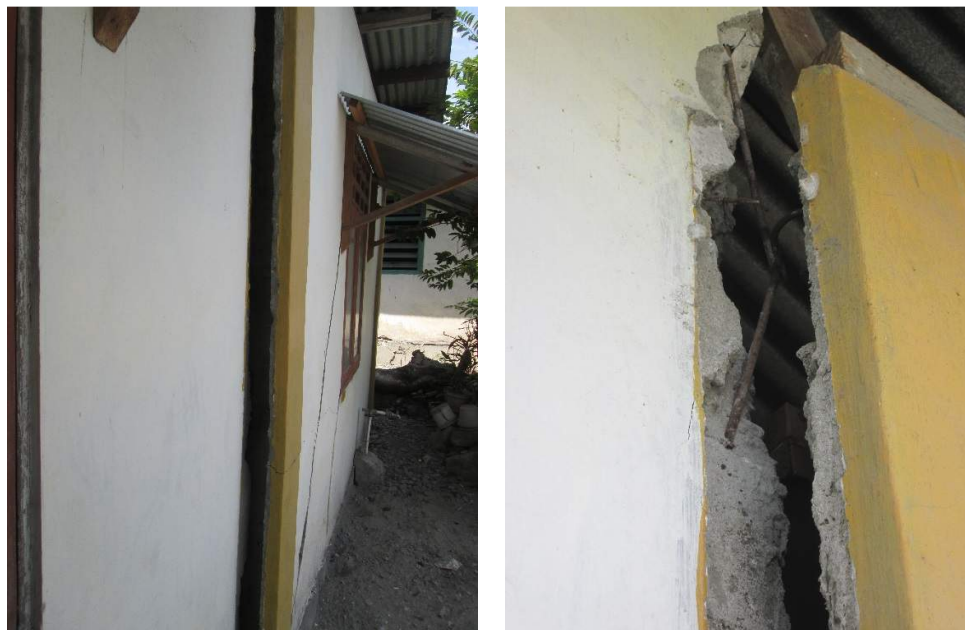
Figure 58. Splitting column due to poor concrete quality

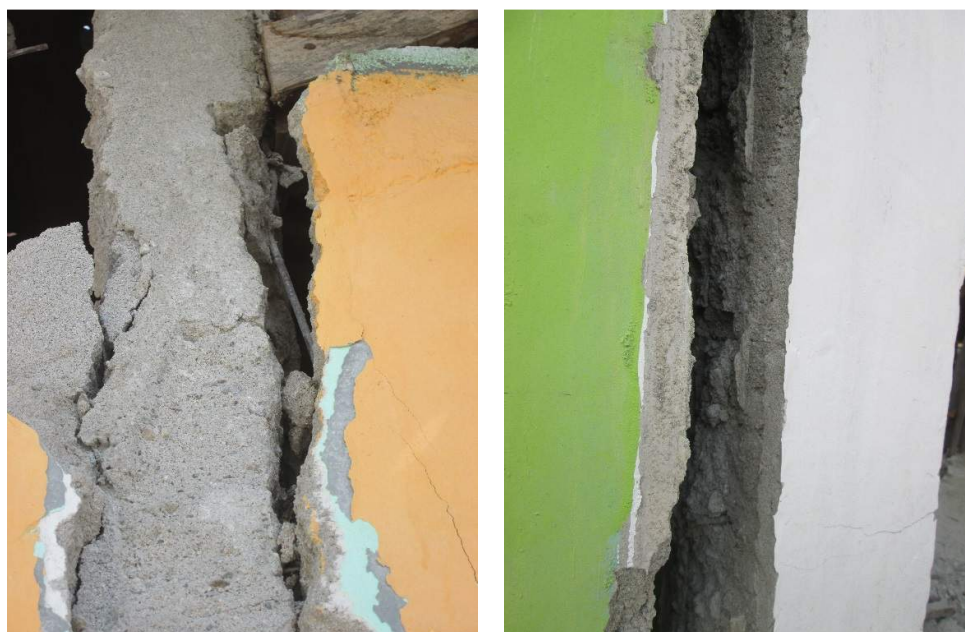
Figure 59. Separation between confining elements and masonry

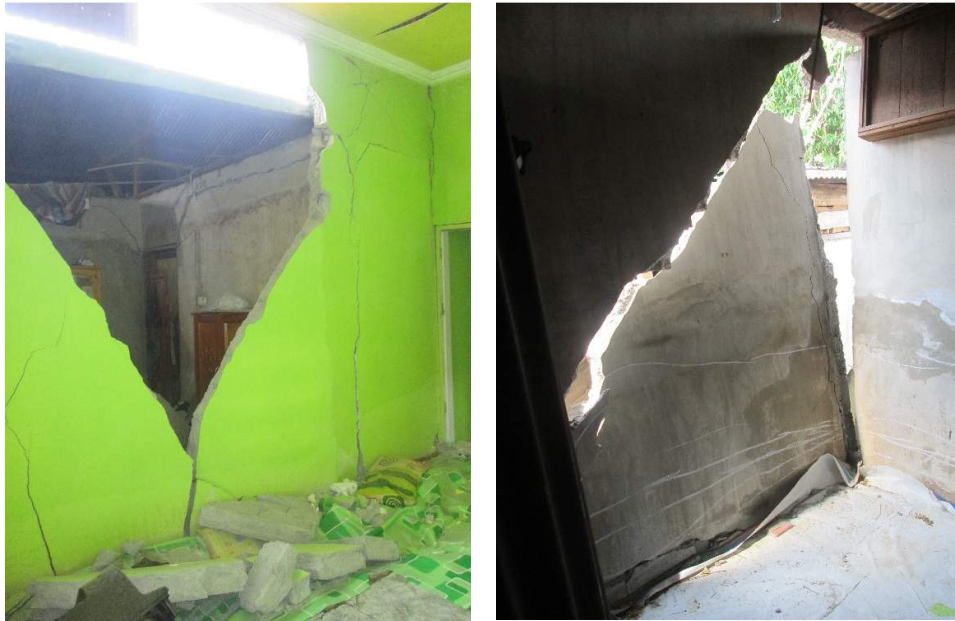
Partial or complete out-of-plane collapse (see Figure 60) of slim-slender walls, diagonal cracks around openings (see Figure 61) caused mainly due to the absence of confining elements, and flexural vertical cracks at mid-length of walls (see Figure 62) were common. Stair-step diagonal cracks that showed the poor quality of mortar were also prevalent (see Figure 63). Damage to non-structural components such as floors were found in most houses (see Figure 64), while damage to ceiling (Figure 65) only happened to heavily damaged or collapsed buildings (Figure 66).

Figure 60. OOP collapse of wall

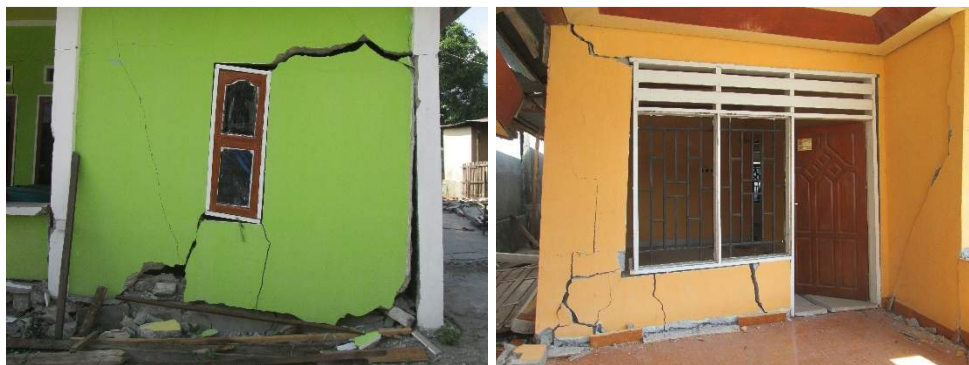
Figure 61. Diagonal cracks on wall around openings

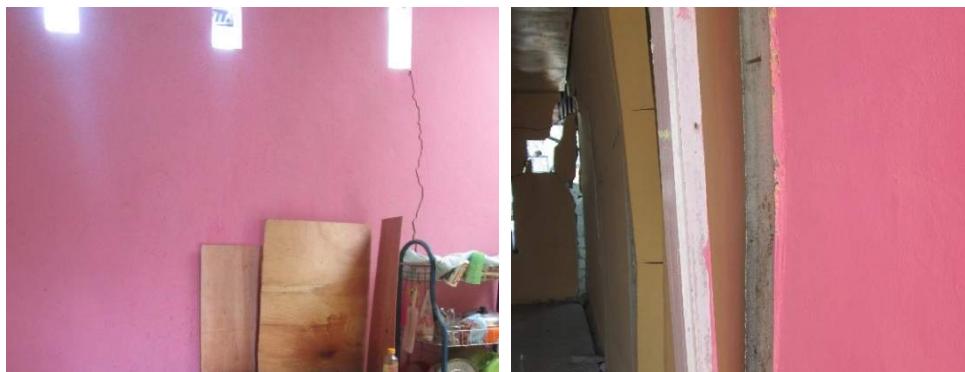
Figure 62. Vertical flexural cracks of walls

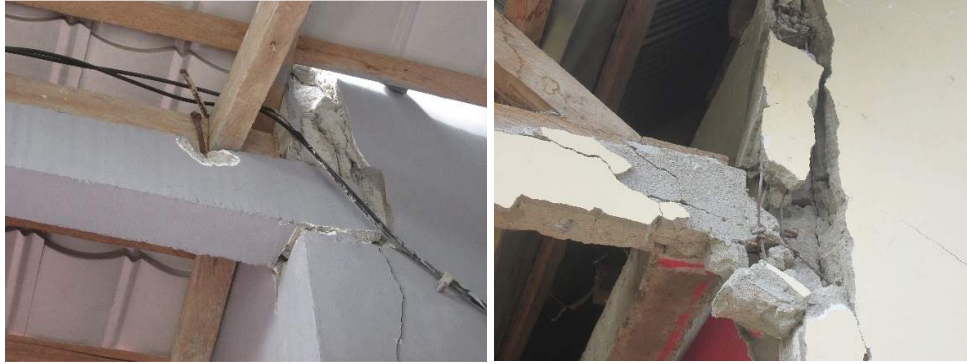
The most common damages are separation between RCF elements (see Figure 78), separation between RCF and masonry infill (see Figure 79), splitting columns (see Figure 80), diagonal cracks around openings (see Figure 81), out-of-plane (OOP) collapse of masonry infill (see Figure 82), leaned walls (see Figure 83), cracks on floor (see Figure 84) and damage and fall of ceilings (see Figure 85).

Figure 78. Separation between column and ring beam

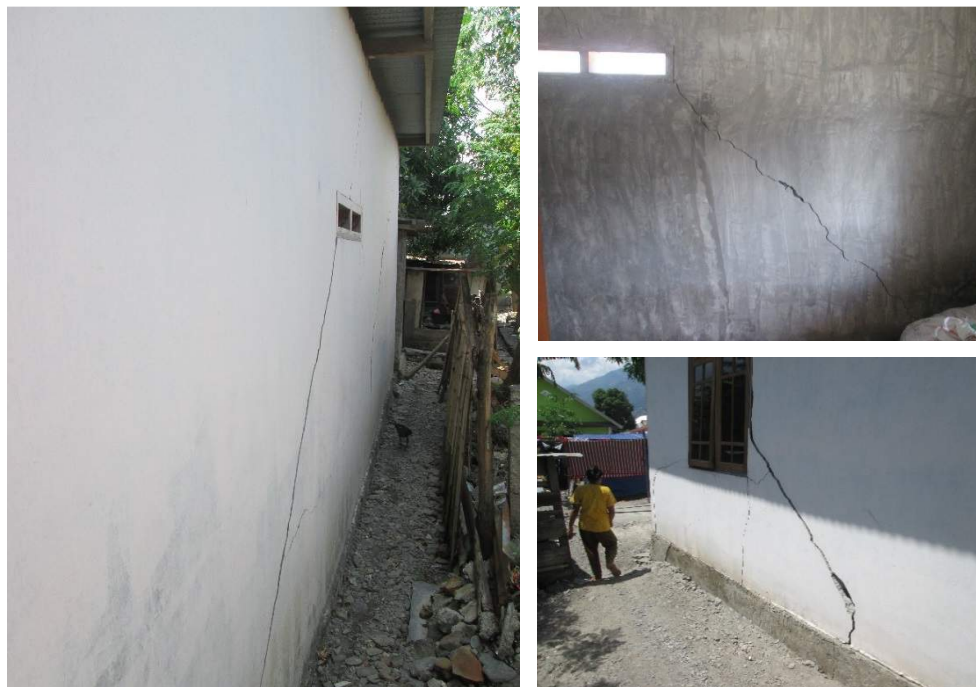
Figure 81. Diagonal cracks around openings

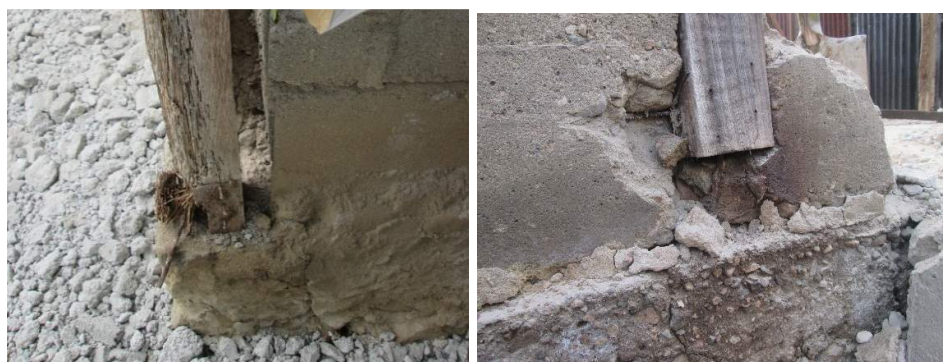
Figure 111. Post was not embedded into foundations

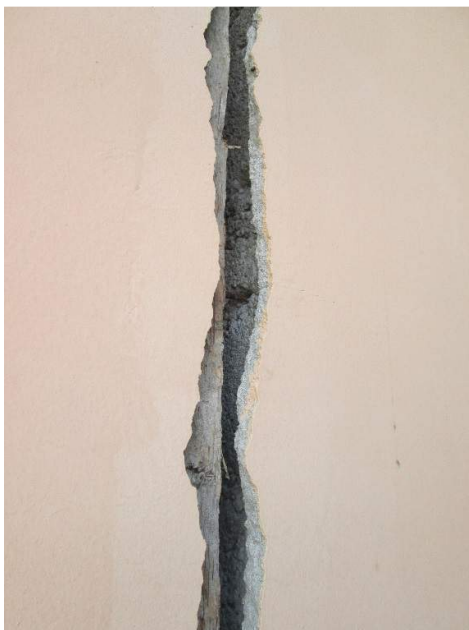
Figure 118. Separation between timber frame and concrete block infill

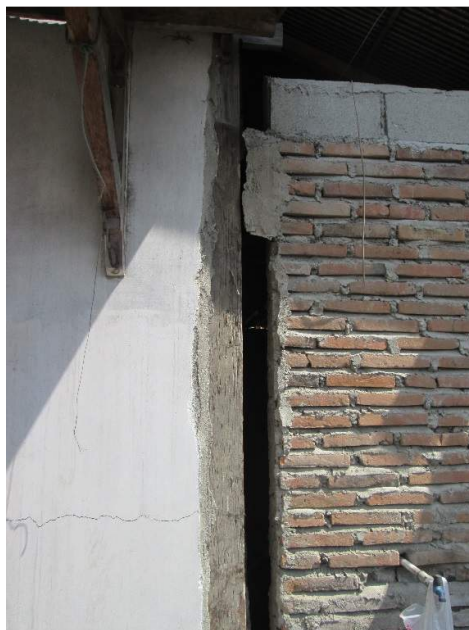
Figure 119. Cracks of heavy infill at wall corner

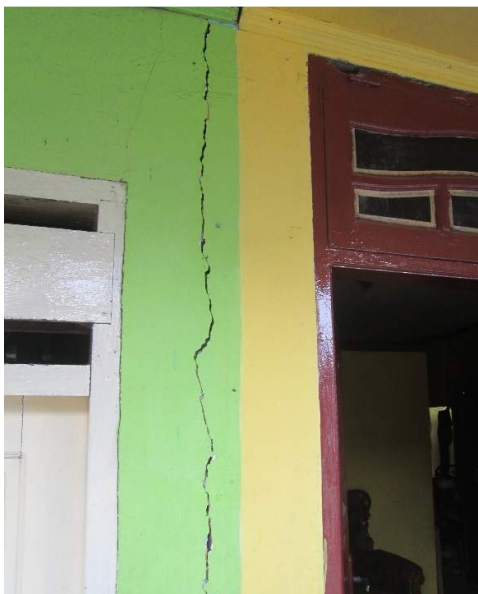
Figure 123. Flexural vertical cracks on masonry infill walls at the mid span of wall

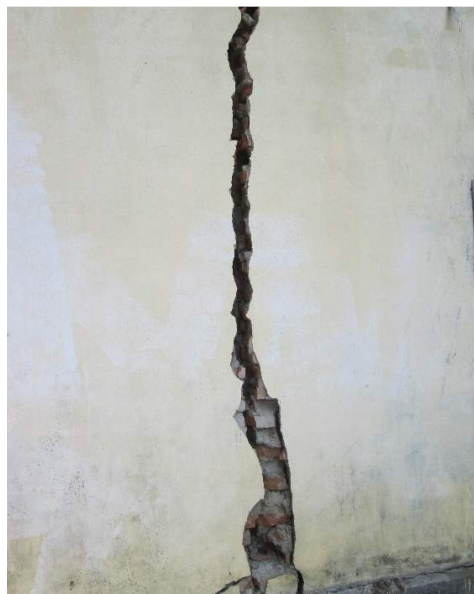
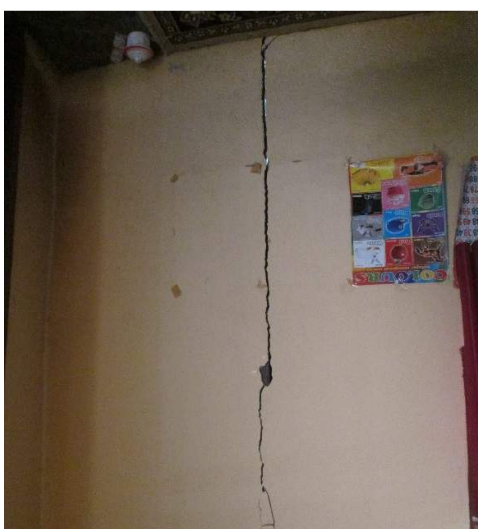
Figure 124. Vertical splitting of heavy infill

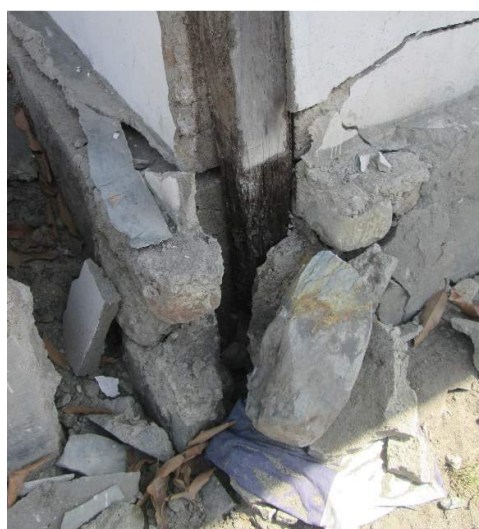
Figure 125. Foundation crushed due to poor mortar quality

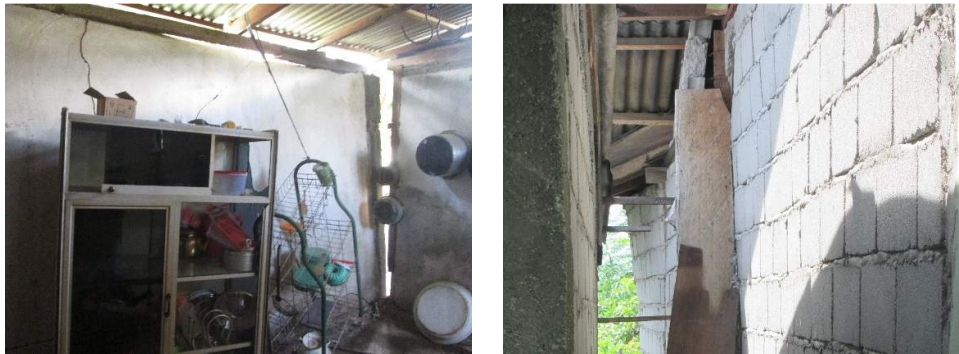
Figure 127. Leaned infill walls

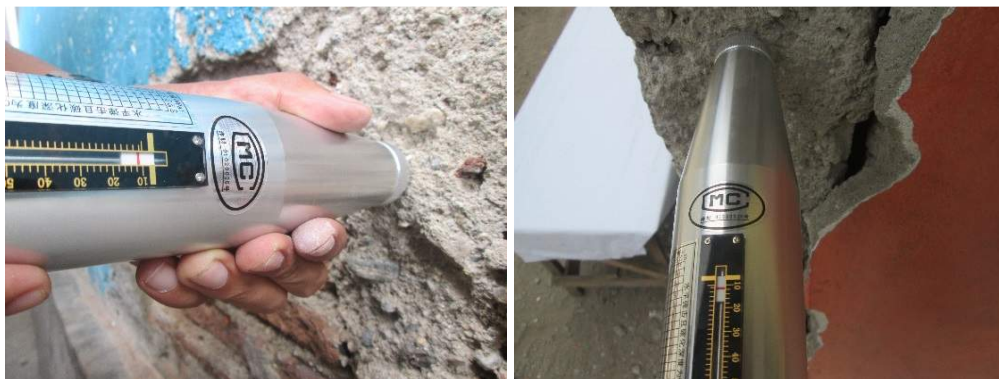
Figure 174. Old building had a very low compressive strength (less than 10 MPa)

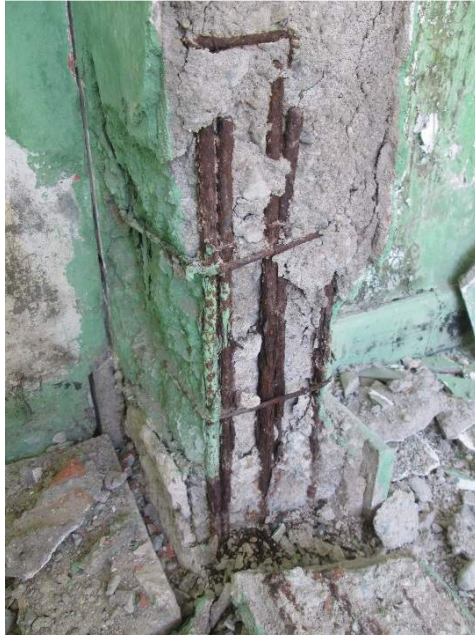
Figure 178. Rusty reinforcing rebar

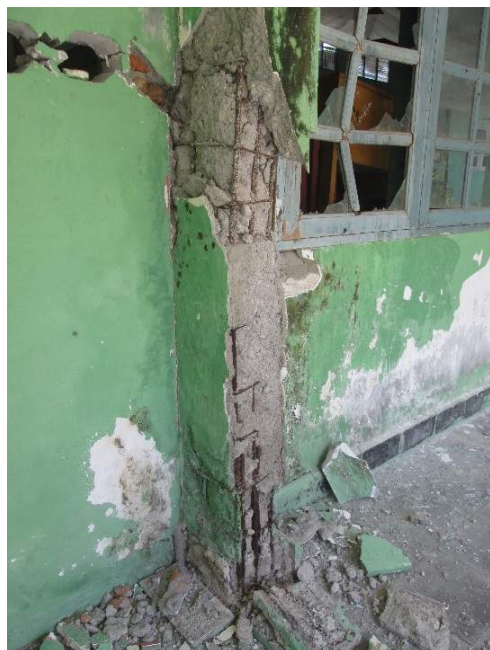
Figure 189. Cracks on columns due to rebar corrosion and poor concrete quality

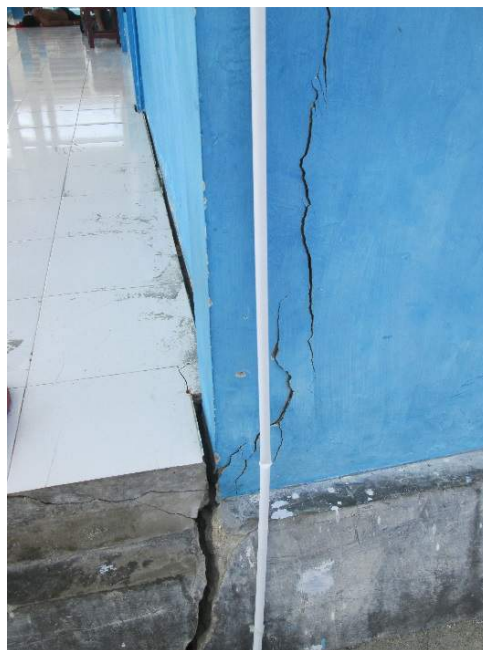
Figure 190. Diagonal cracks on columns

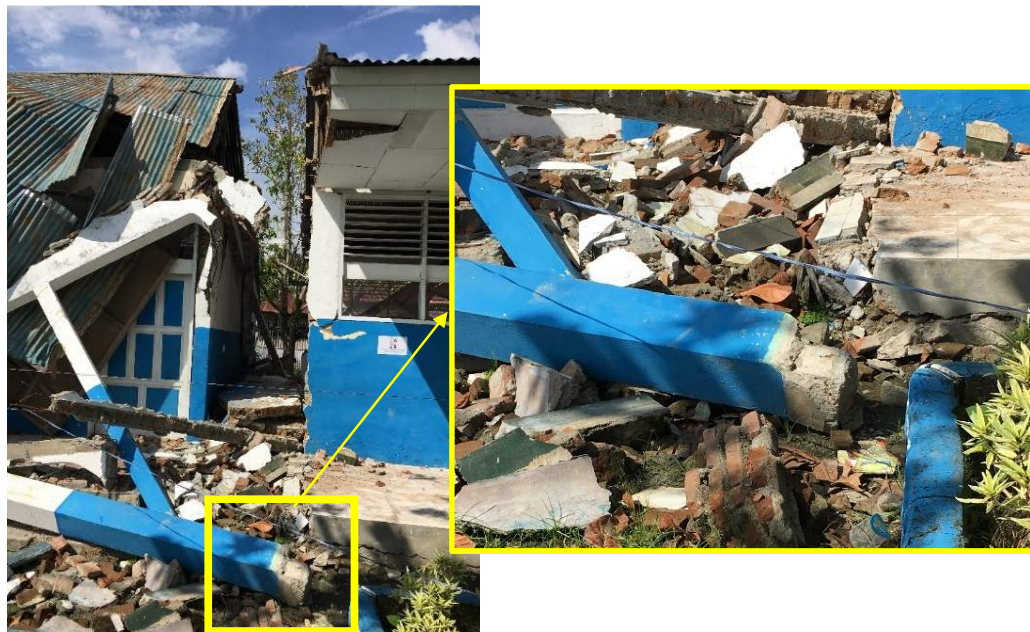
In one case, verandah columns were not embedded into the foundation and simply sat on the foundation without additional connection to plinth beams, causing the structure to overturn and causing damage to the adjoining columns, roof truss, ceiling and roof covering (see Figure 196). In another case, one school building was damaged by the nearby collapsed building (see Figure 197).

Figure 196. Unembedded columns caused structure overturning and collapse

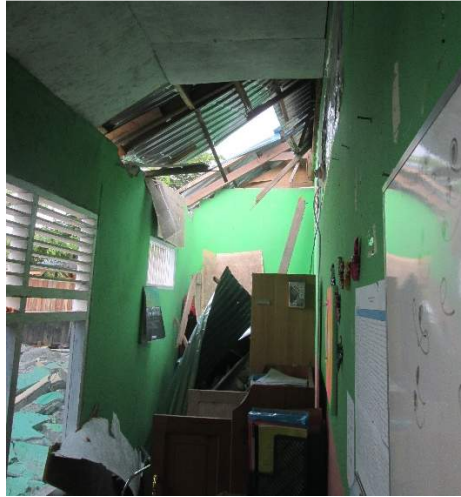
Figure 197. One school building that was damaged due to the collapsed building nearby

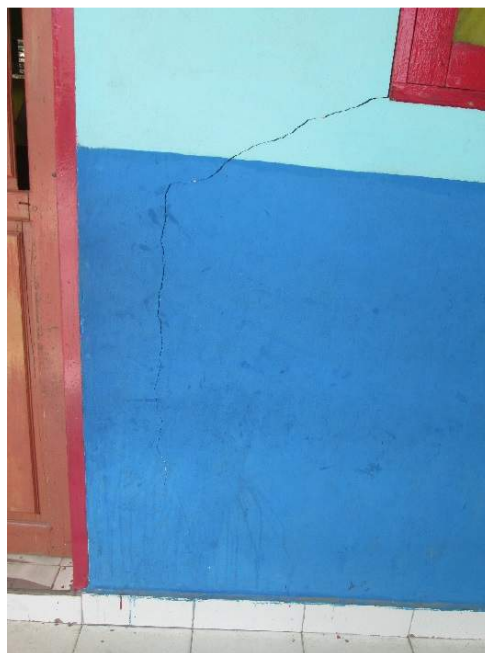
Figure 202. Diagonal cracks on walls around opening

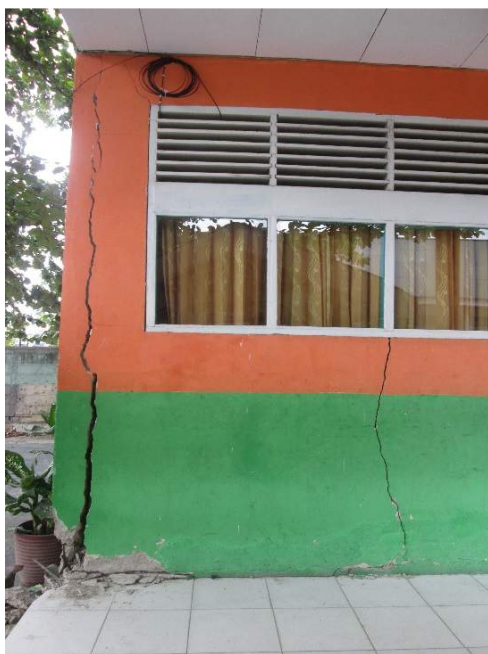
Figure 203. Separation between RCF or confining elements and wall

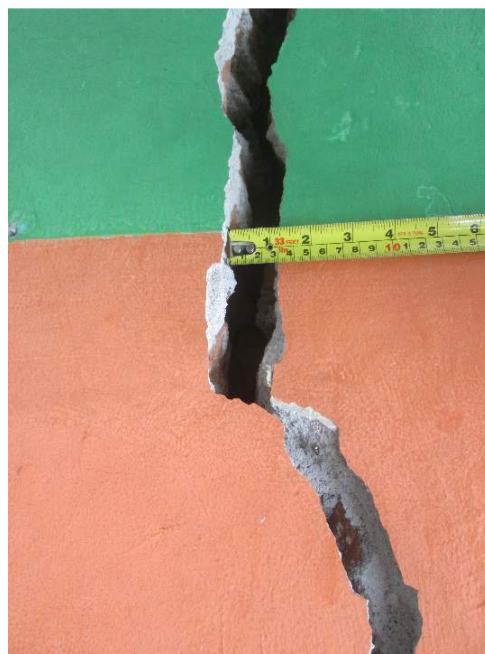
Figure 204. Vertical cracks on wall

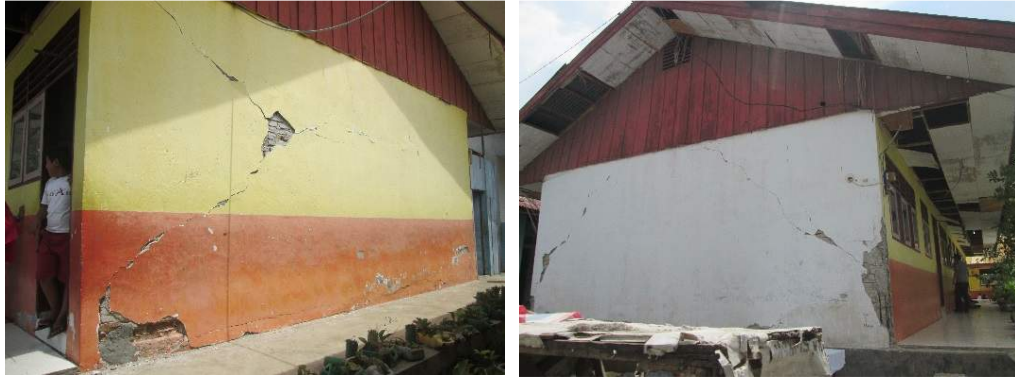
Figure 205. Diagonal cracks on long and slender wall

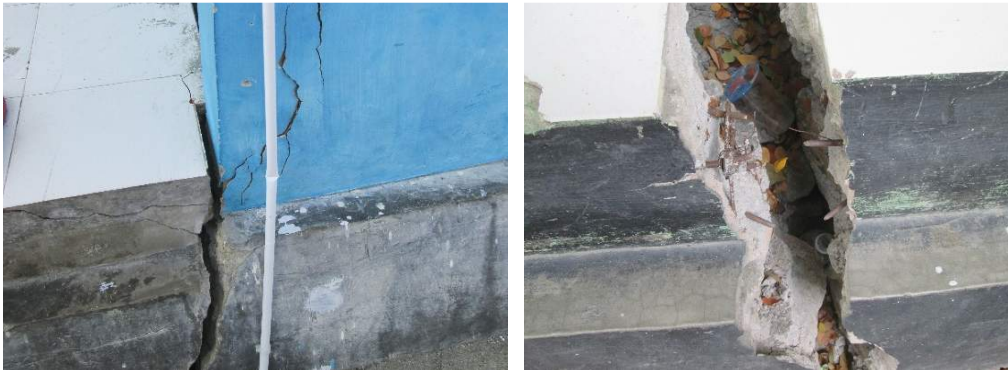
Cracks on foundation either due to poor mortar quality, ground settlement or ground cracking were also common (see Figure 206). Damage to concrete floors (see Figure 207), falling ceilings and damage to roof covering (see Figure 208), and damage doors and windows (see Figure 209) were also prevalent. Significant ground settlements that caused the floor to be uneven were also observed (see Figure 210). Some school's fences were collapsed (see Figure 212).

Figure 206. Cracks on foundation and plinth beam

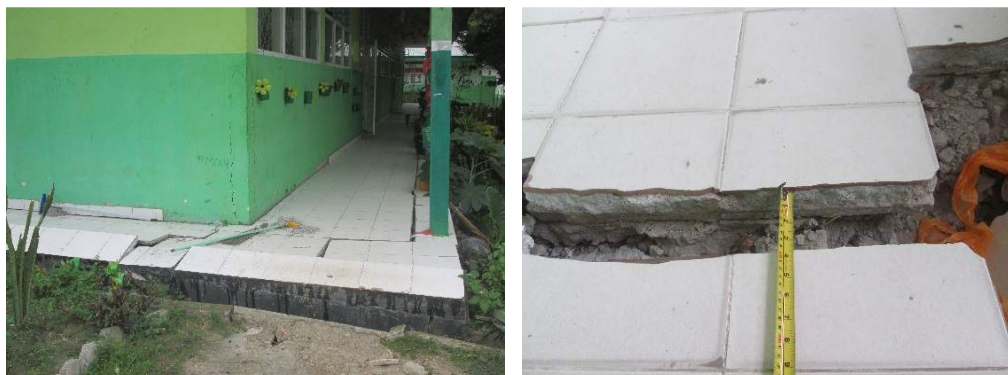
Figure 207. Cracks on floor

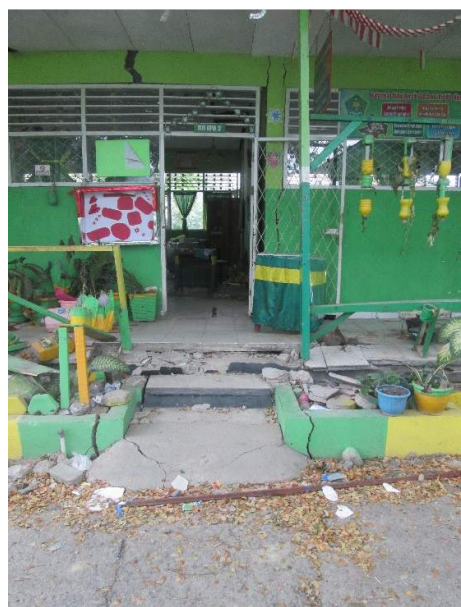
Figure 209. Damage to doors and windows

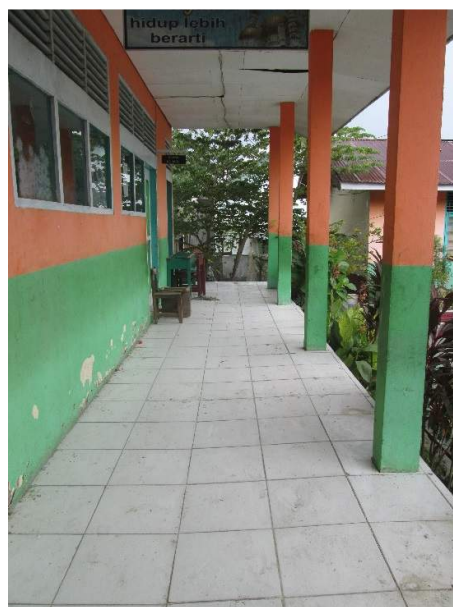
Figure 210. Ground settlement

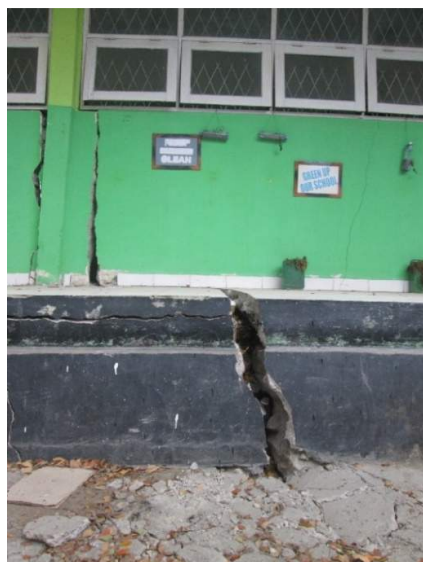
Figure 211. Damage to foundation and plinth beam

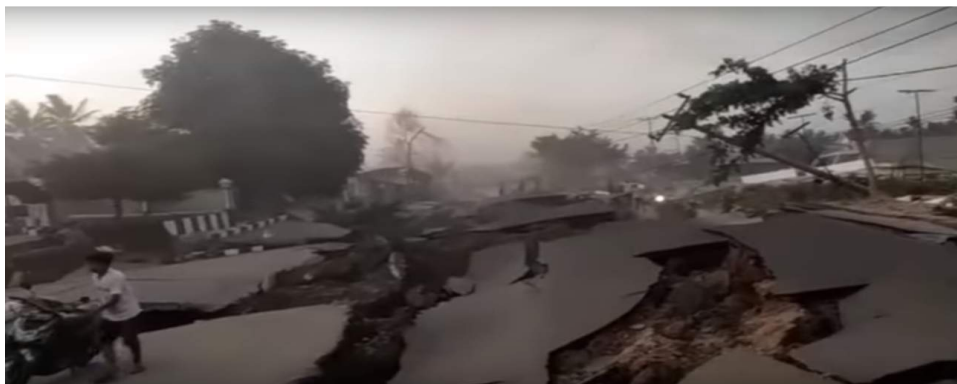
Figure 213. Destroyed road near Jono Oge immediately after the earthquake (*Lotus Sunda Art, 2018*)

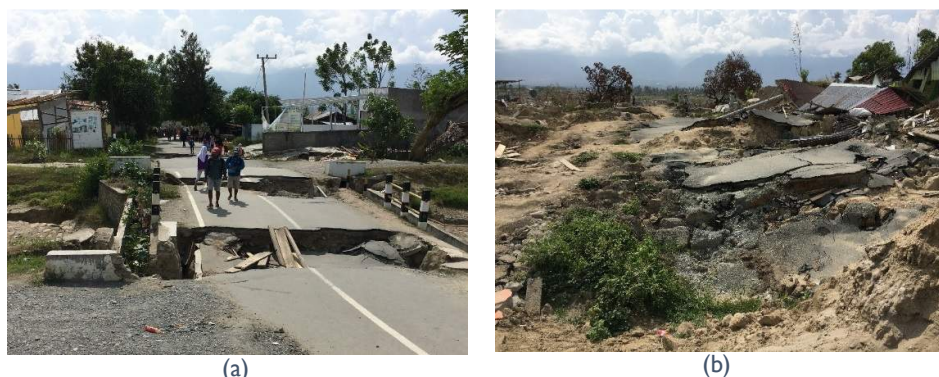
In the four villages where severe liquefaction occurred (Balaroa, Petobo, Jono Oge, and Sibalaya), roadways were destroyed long with the villages by the mudflow. Figure 216 shows the aftermath of the liquefaction in the village of Petobo, with damage to the main road that runs through it. Figure 217 shows the before and after of the view from the bridge, at one end of the liquefaction zone in Jono Oge. The before view was taken from Google Maps street view, while the after view was taken during the visit. The roadway that connects the two-end point has been taken by the flow a few kilometers downstream.

Figure 216. (a) Bridge overpass leading towards Petobo village. (b) Remains of the main road that runs through Petobo village

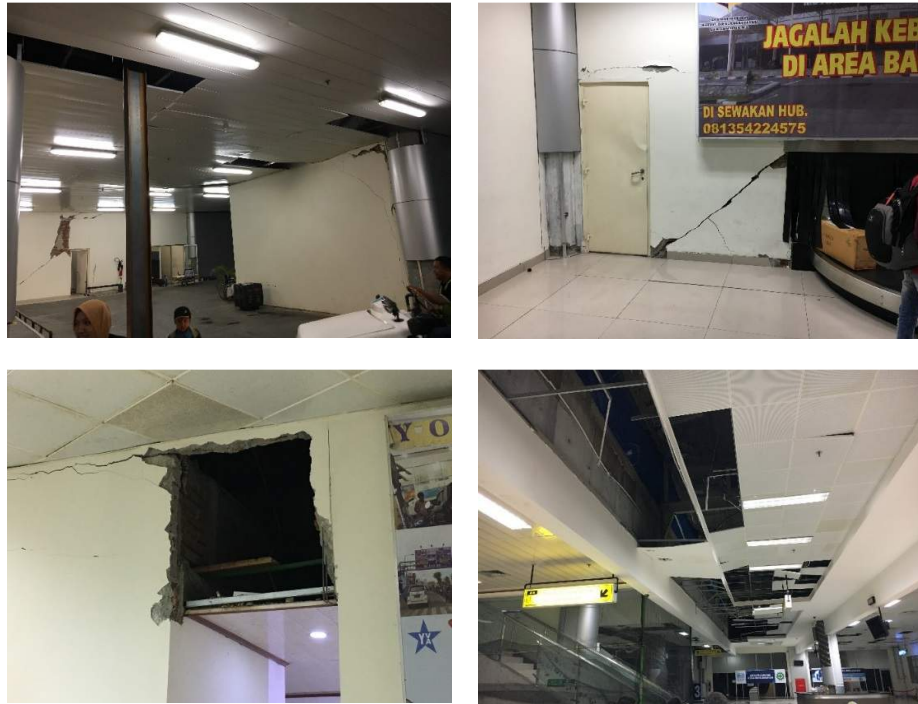
Parts of the airport were damaged due to the earthquake. Some significant cracking was observed in the brick masonry wall. Partial collapse of the brick wall was observed near the restroom. Evidence of broken glass in the airbridge was observed (see Figure 226). The entire second floor of the airport was closed to the public during the visit. Some cracking was observed on the stairs. These damages did not significantly impact the operation of the airport, and repair efforts had begun at the time of the visit

Figure 226. Damaged of Mutiara SIS Al-Jufrie airport

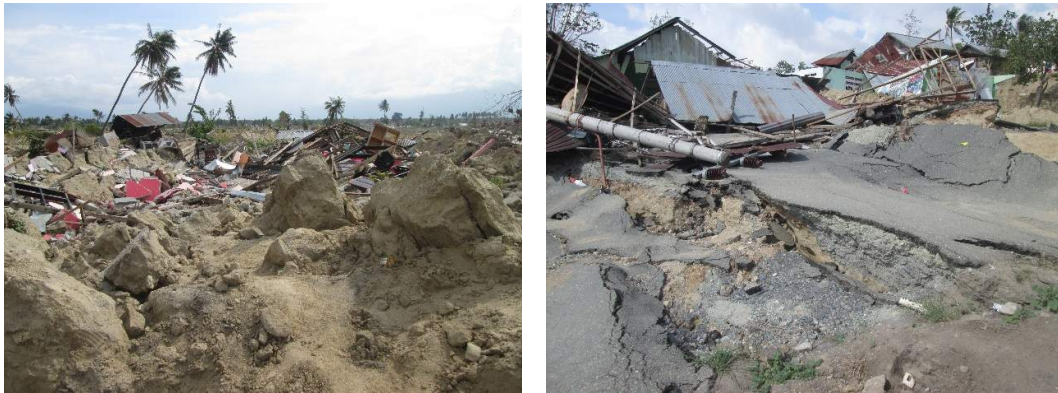
(c) Remaining damaged buildings in Petobo

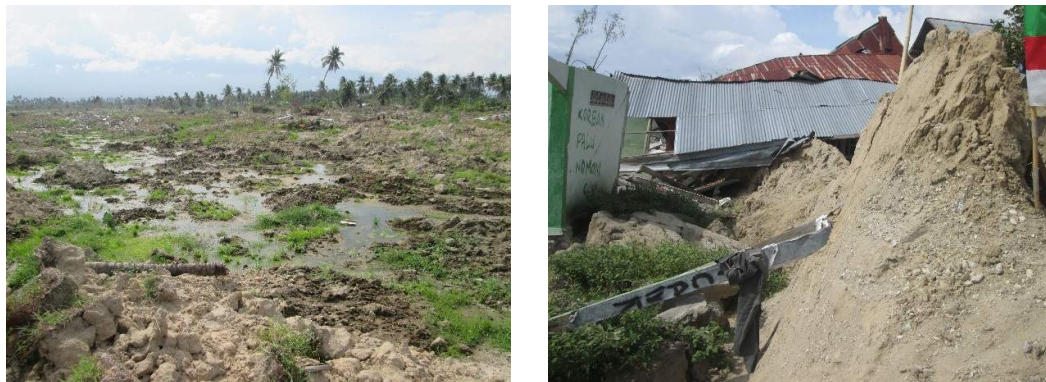
(d) Water emerged in Petobo, showing shallow ground water level

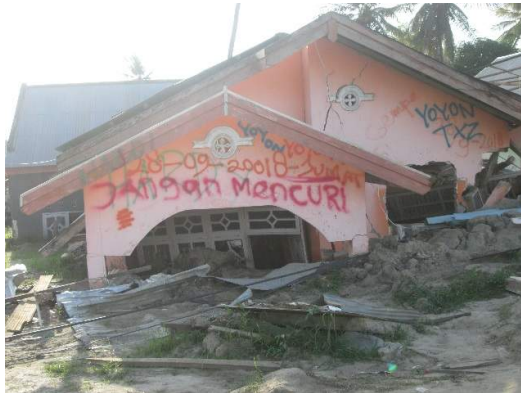
(b) Remaining damaged buildings in Biromaru after liquefaction

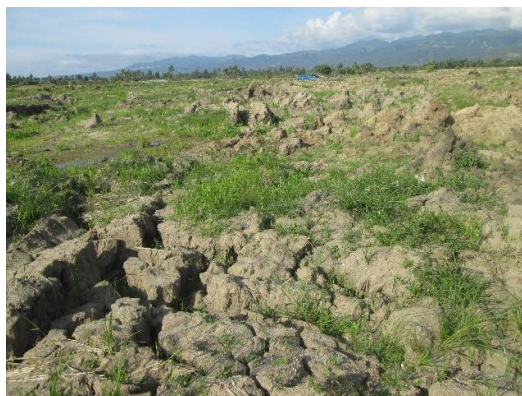
(c) Water emerged in Biromaru, showing shallow ground water level
