# July 27, 2019 Batanes Post-Earthquake Reconnaissance Report

## Itbayat, Batanes

Survey Date: October 1-11, 2019

Report Date: October 31, 2019

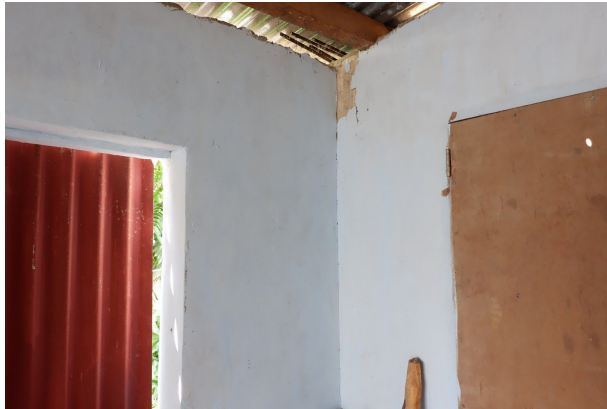
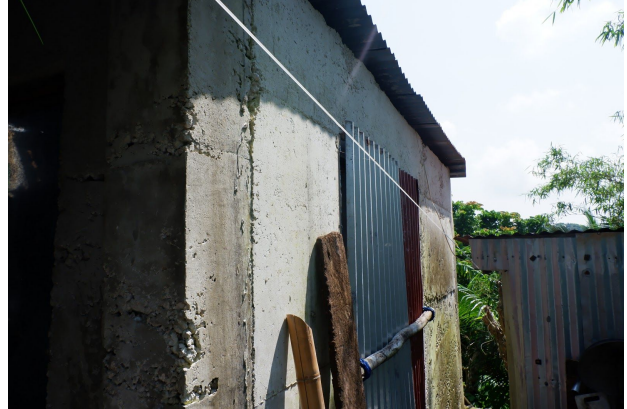
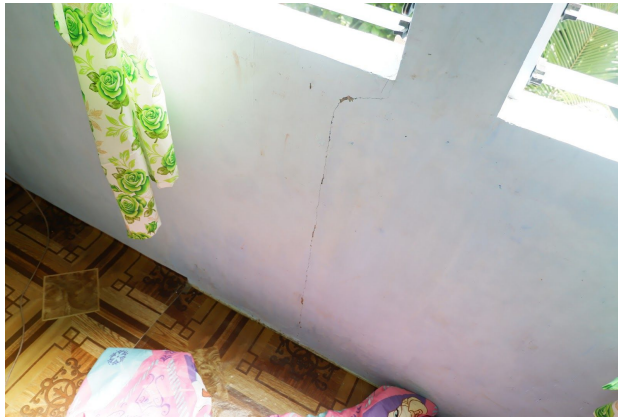
**Figure 3.6**

*One Story house with concrete columns and concrete walls. Minor cracks developed in the walls and in the connection between the walls and columns. Concrete mix used is made up of cement and crushed limestone with an 1:7 ratio.*

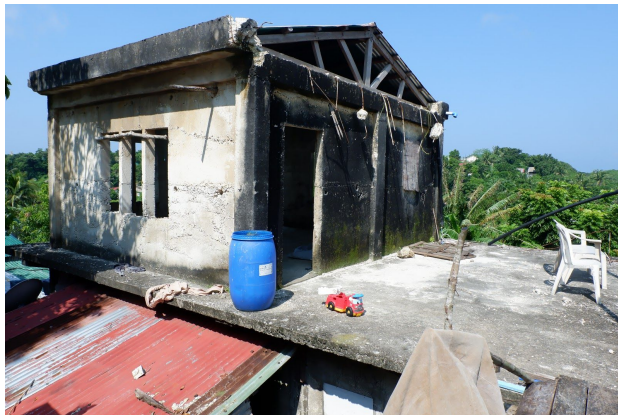
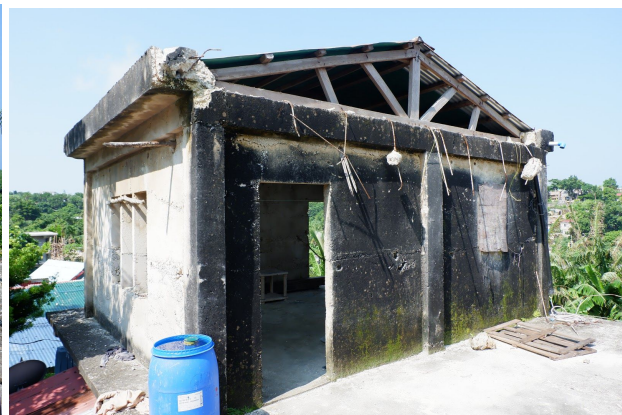
**Figure 3.7** Two story concrete house with walls made up of concrete (not CHB). Gable wall and concrete gutters collapsed on both sides during the earthquake and cracks developed in the walls and columns.

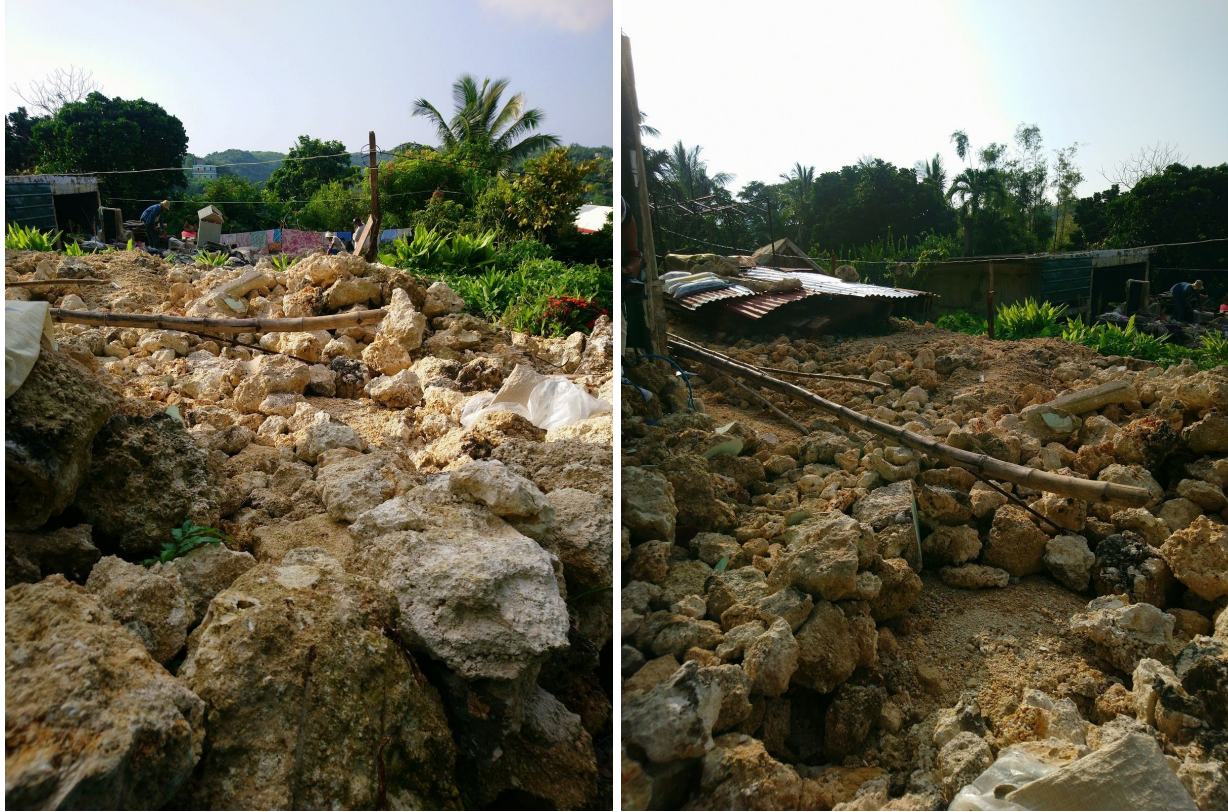
*Figure 3.8 One story traditional unreinforced limestone masonry house. Already demolished, according to homeowner the house totally collapsed during the earthquake.*

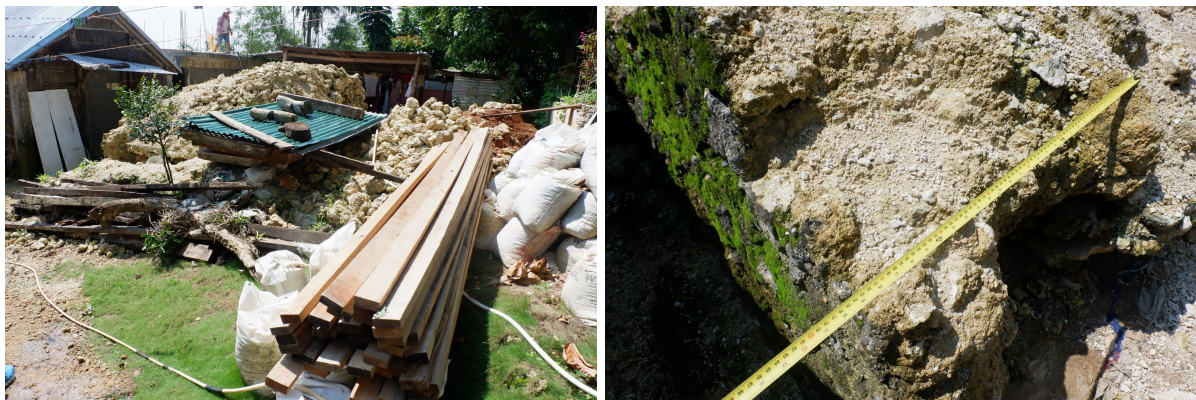
*Figure 3.10 One story traditional unreinforced limestone masonry house. Already demolished, according to homeowner the house totally collapsed during the earthquake. The wall was approximately around 700mm thick. The homeowner has already received materials for their temporary shelter and is preparing to start with construction. Materials include CGI sheets, lumber and 100mm diameter GI Pipe for the columns.*

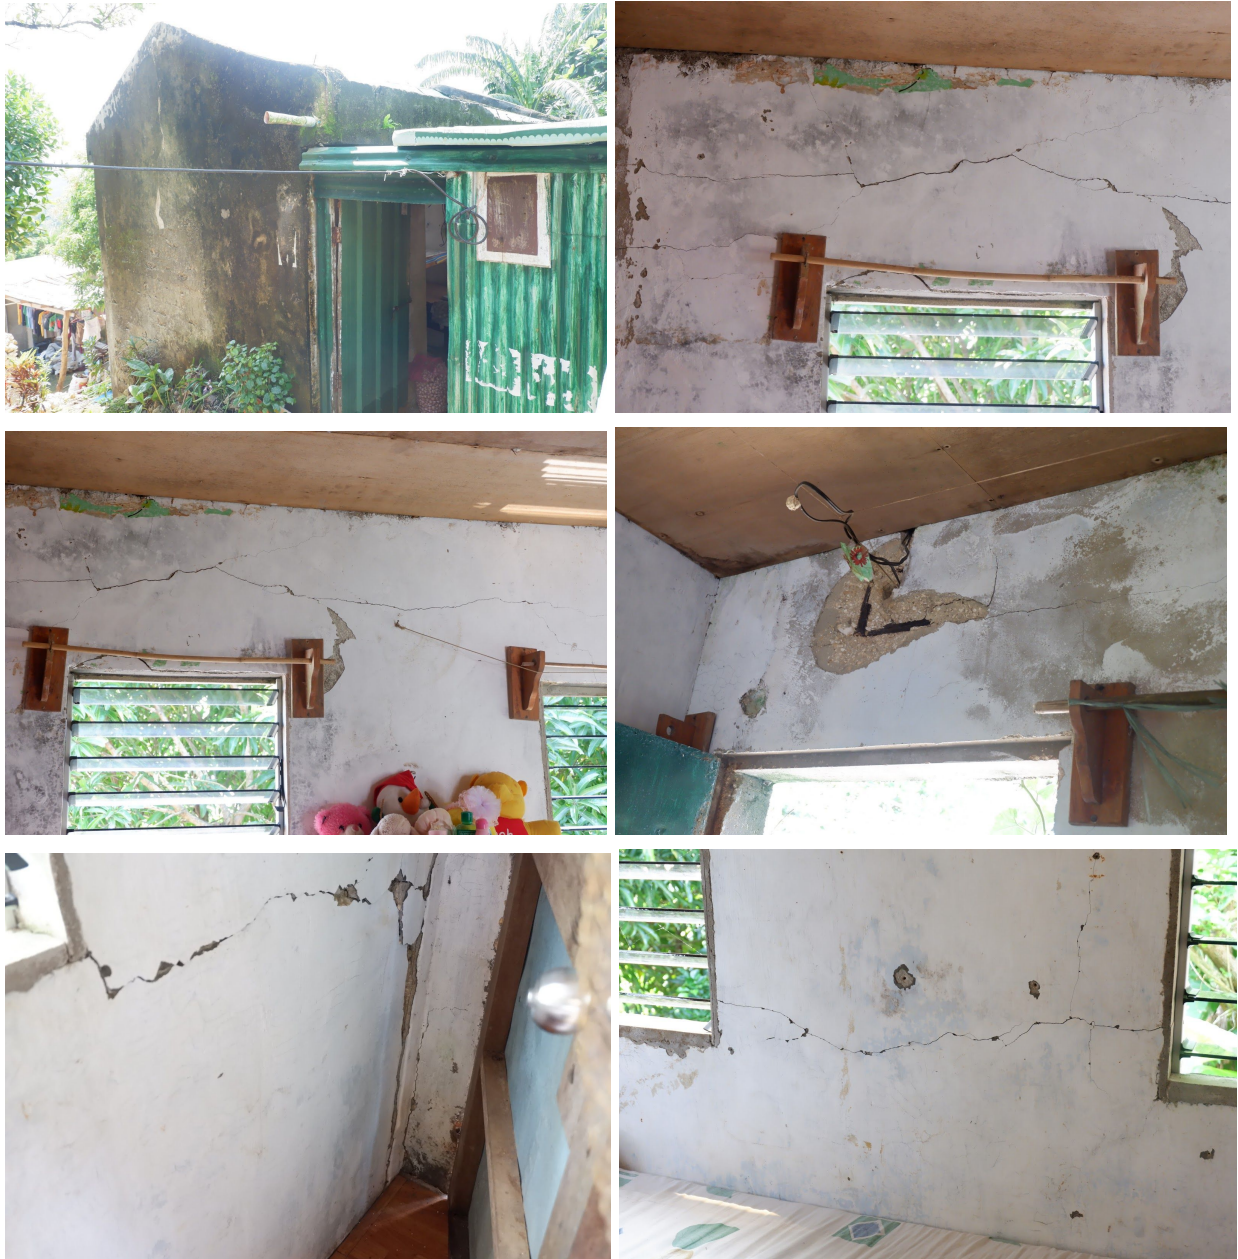
*Figure 3.9 One story concrete house with walls made up of concrete (not CHB). Concrete mix used was made up of cement and crushed limestone with an 1:7 ratio. Cracks developed in all the walls, especially near openings. The house is visibly out of plumb.*

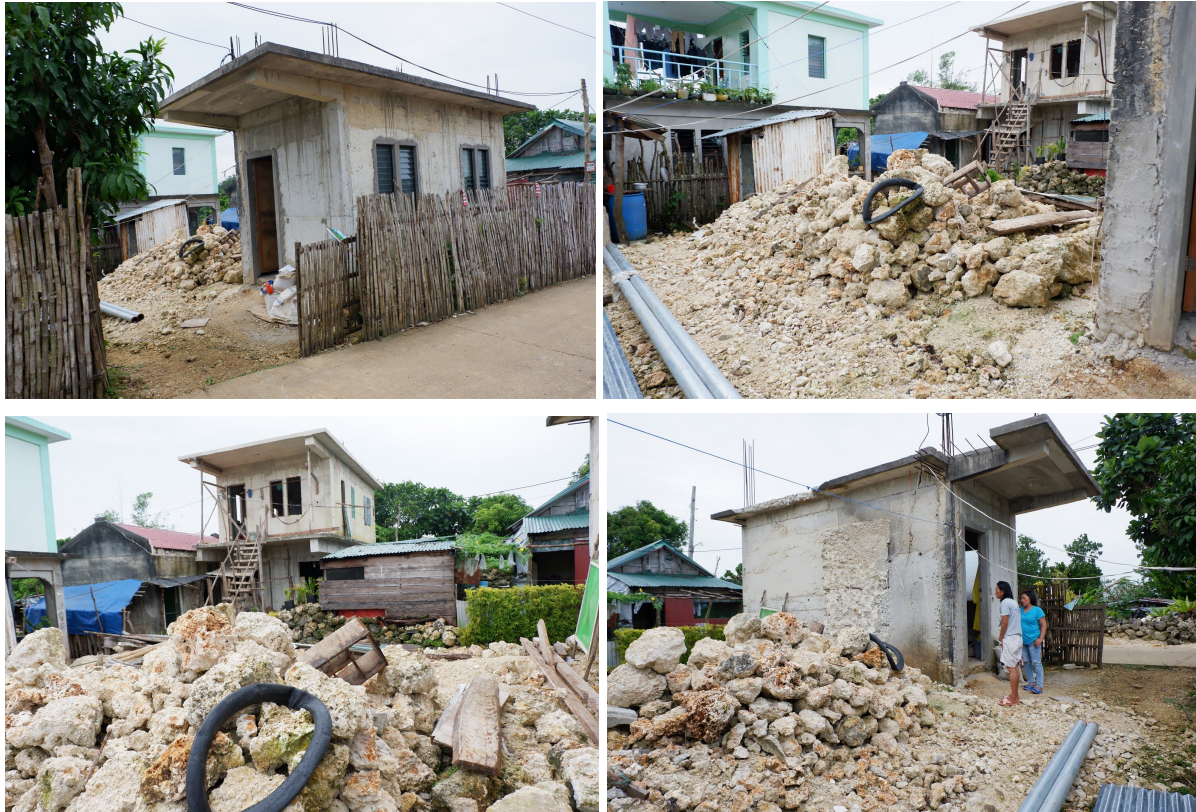
*Figure 3.11 One story traditional unreinforced limestone masonry house. Already demolished, according to homeowner the house totally collapsed during the earthquake. The wall was approximately around 700mm thick. The homeowner has already received materials for their temporary shelter and is preparing to start with construction. Materials include CGI sheets, lumber and 100mm diameter GI Pipe for the columns.*

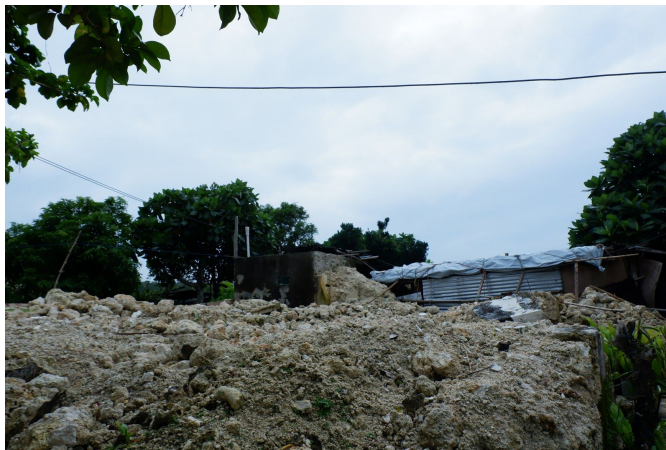
*Figure 3.12 One story traditional unreinforced limestone masonry house. Already demolished, according to homeowner the house totally collapsed during the earthquake. The wall was approximately around 700mm thick. The homeowner has already received materials for their temporary shelter and is preparing to start with construction. Materials include CGI sheets, lumber and 100mm diameter GI Pipe for the columns.*

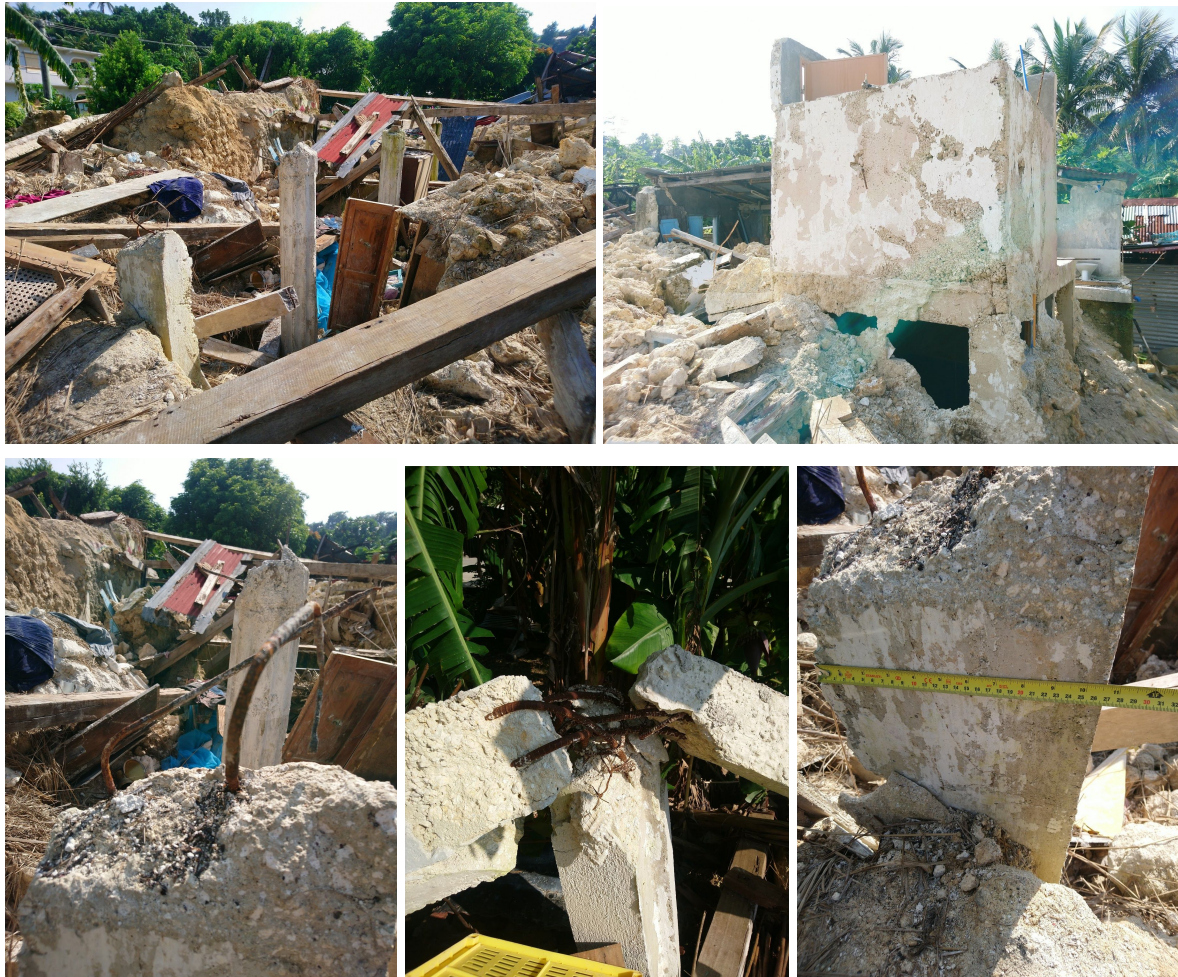
*Figure 3.13 One story traditional unreinforced limestone masonry house. Already demolished, according to homeowner the house totally collapsed during the earthquake. The wall was approximately around 700mm thick. The homeowner has already received materials for their temporary shelter and is preparing to start with construction. Materials include CGI sheets, lumber and 100mm diameter GI Pipe for the columns.*

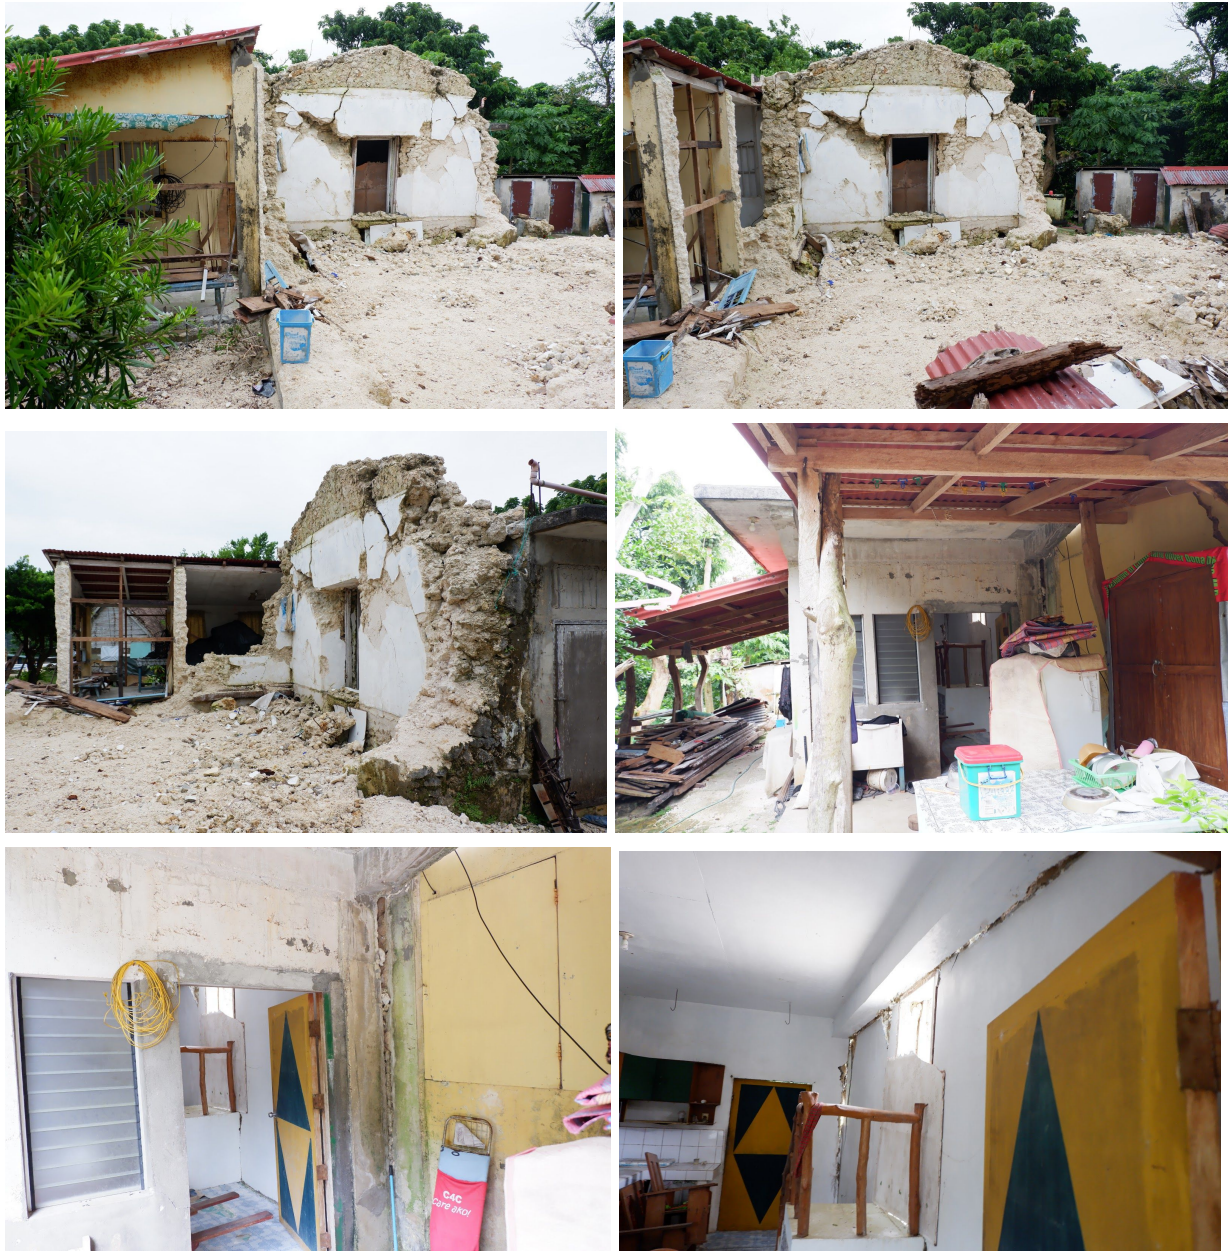
*Figure 3.14 One story traditional unreinforced limestone masonry house with concrete house extension. The traditional stone house collapsed and the concrete house extension was severely damaged due to the force induced by the stone house. The RC house extension is out of plumb with major cracks and separations of the wall-columns and wall-beams. The homeowner has already received materials for their temporary shelter and is preparing to start with construction. Materials include CGI sheets, lumber and 100mm diameter GI Pipe for the columns.*

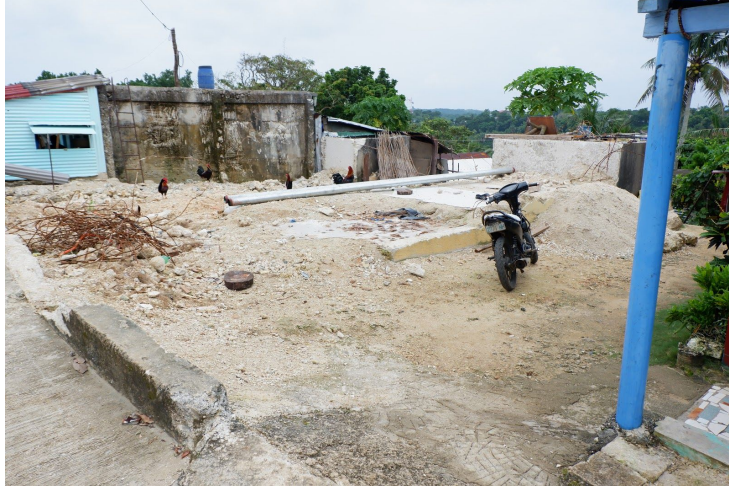
*Figure 3.15 One story traditional unreinforced limestone masonry house. Already demolished, according to homeowner the house totally collapsed during the earthquake. The wall was approximately around 700mm thick. The homeowner has already received materials for their temporary shelter and is preparing to start with construction. Materials include CGI sheets, lumber and 100mm diameter GI Pipe for the columns.*

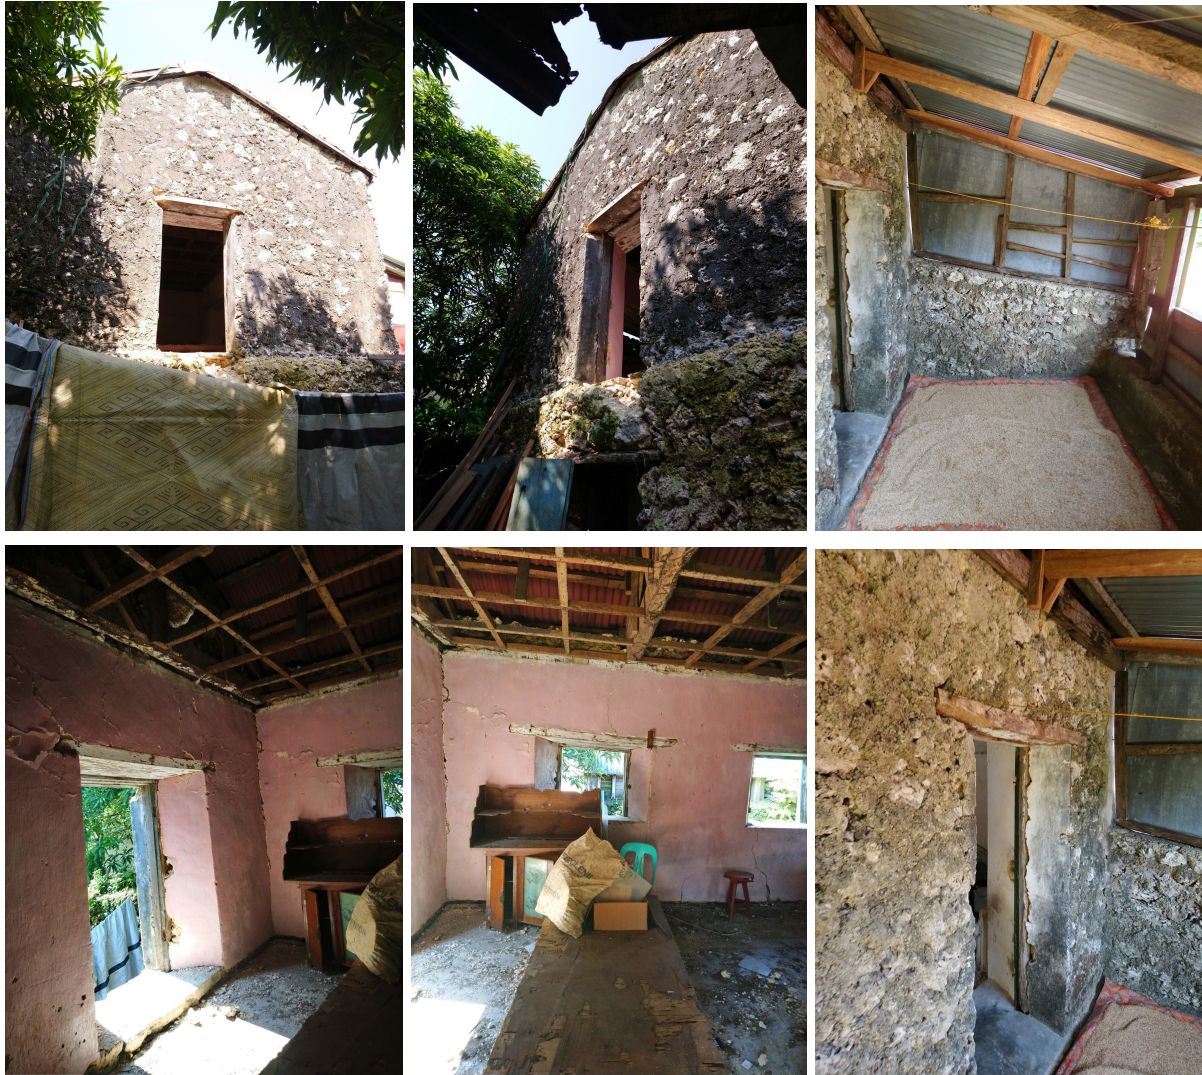
*Figure 3.16 One-story unreinforced limestone masonry house. The stone wall suffered major cracks especially near wall openings and on wall corners. Most of the stone houses did not totally collapse in Raele as residents said they experienced less earthquake intensity compared to other barangays. Raele is 9km away from the town center. This house is tagged as Unsafe by the government engineers and awaiting either retrofit or demolition.*

1. The unreinforced limestone masonry houses that are still standing but with cracks should be further evaluated by a qualified Structural Engineer in order to determine if it is still possible to repair and strengthen for the next earthquake. The houses where this is not possible should be demolished and cleared as they pose a hazard to people living adjacent to those houses.
2. Reinforced concrete houses visited show cracks near wall openings and column-wall connections. We are recommending that reinforced concrete houses that are partially damaged undergo further evaluation of a qualified Structural Engineer.
3. Walls are normally made up of concrete with cement and crushed limestone with 1:6-7 ratio as gathered during the interview with builders in the community. It is recommended

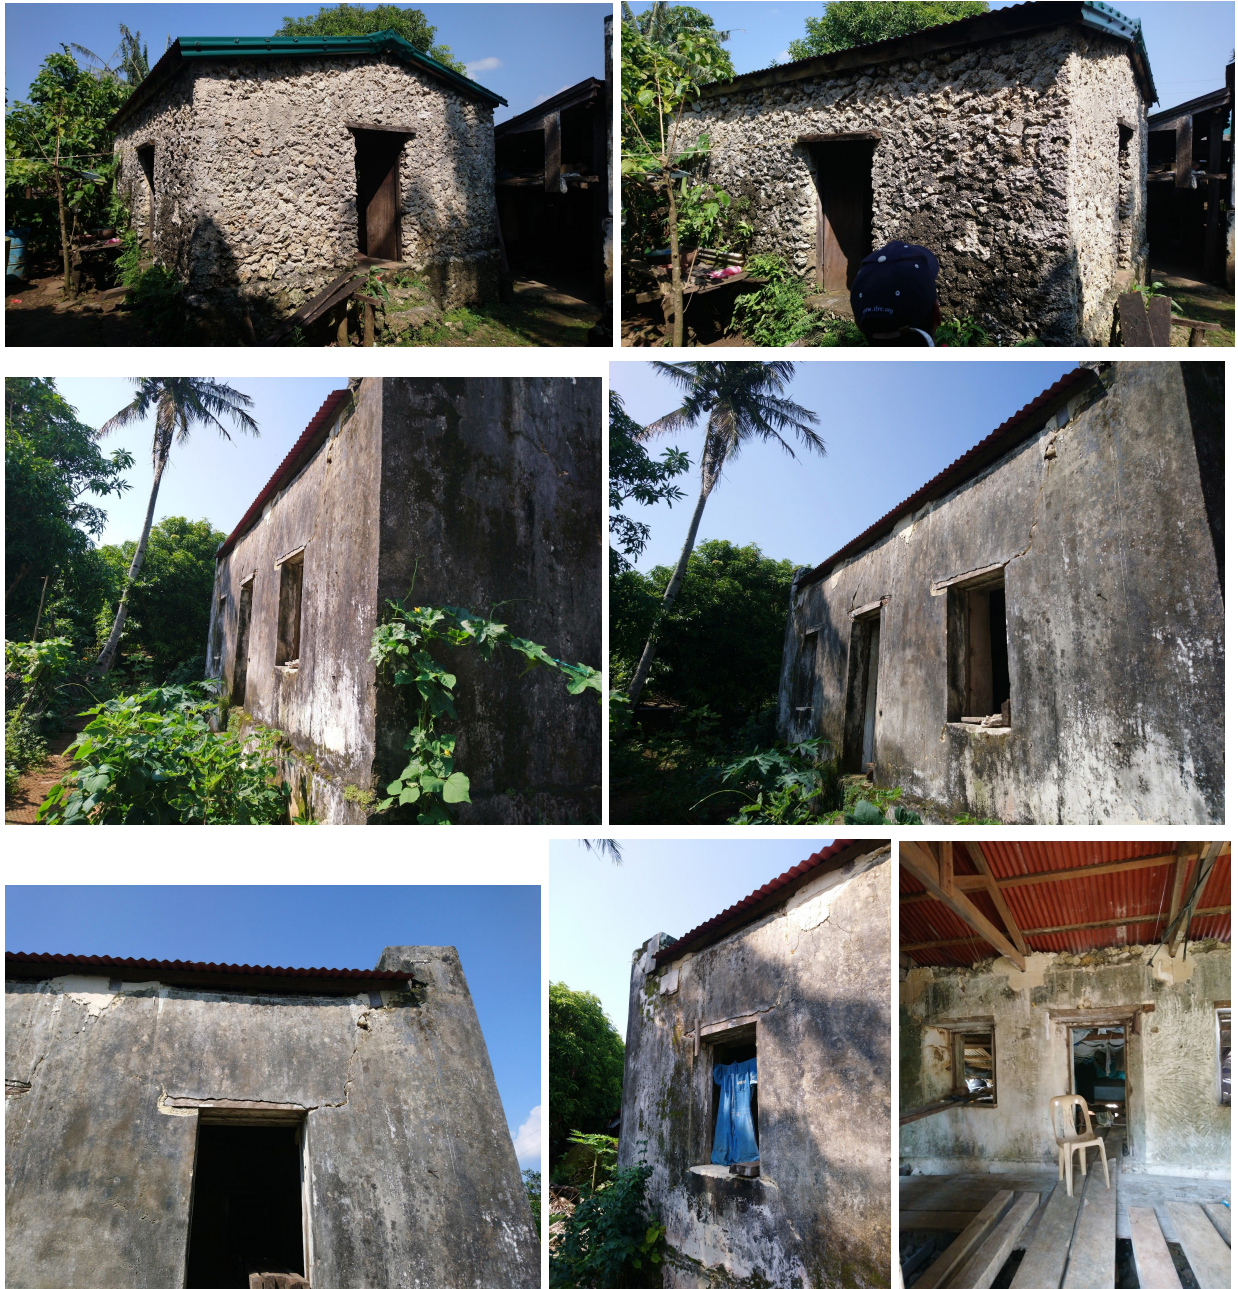
*Figure 3.17 One-story unreinforced limestone masonry house (Kitchen - photos 1&2, Main House - photos 3-7). The stone wall suffered major cracks especially near wall openings and on wall corners. Most of the stone houses did not totally collapse in Raele as residents said they experienced less earthquake intensity compared to other barangays. Raele is 9km away from the town center. This house is tagged as Unsafe by the government engineers and awaiting either retrofit or demolition.*

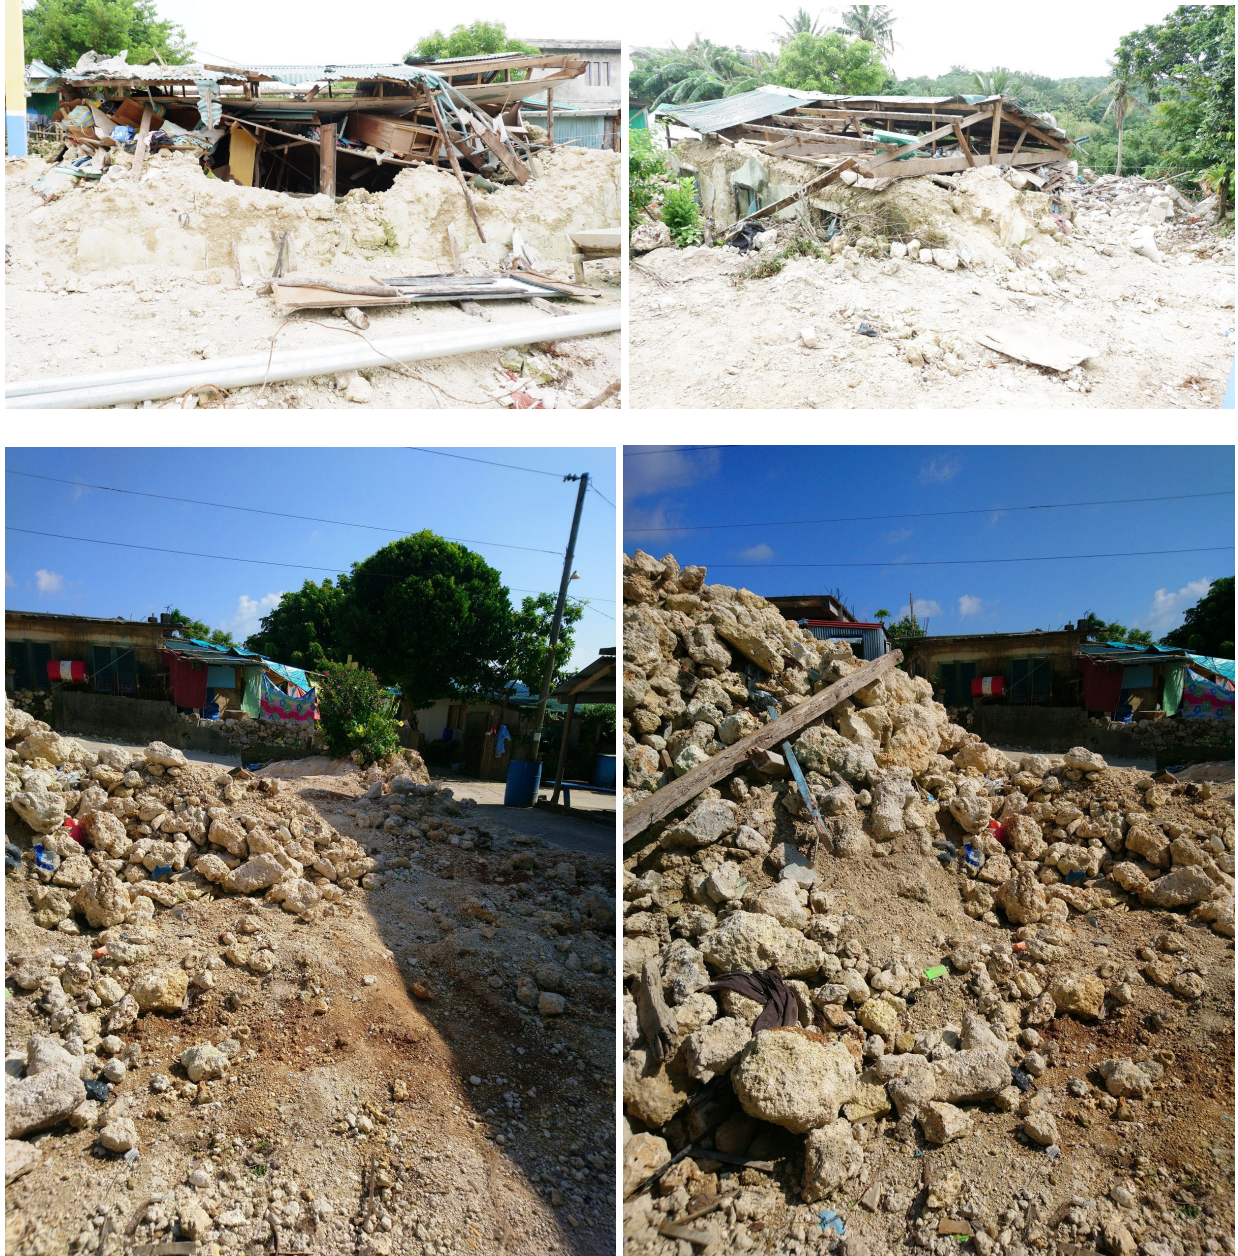
*Figure 3.18 One story traditional unreinforced limestone masonry house. Already demolished, according to homeowner the house totally collapsed during the earthquake. The wall was approximately around 700mm thick. The homeowners have already received materials for their temporary shelter and is preparing to start with construction. Materials include CGI sheets, lumber and 100mm diameter GI Pipe for the columns.*

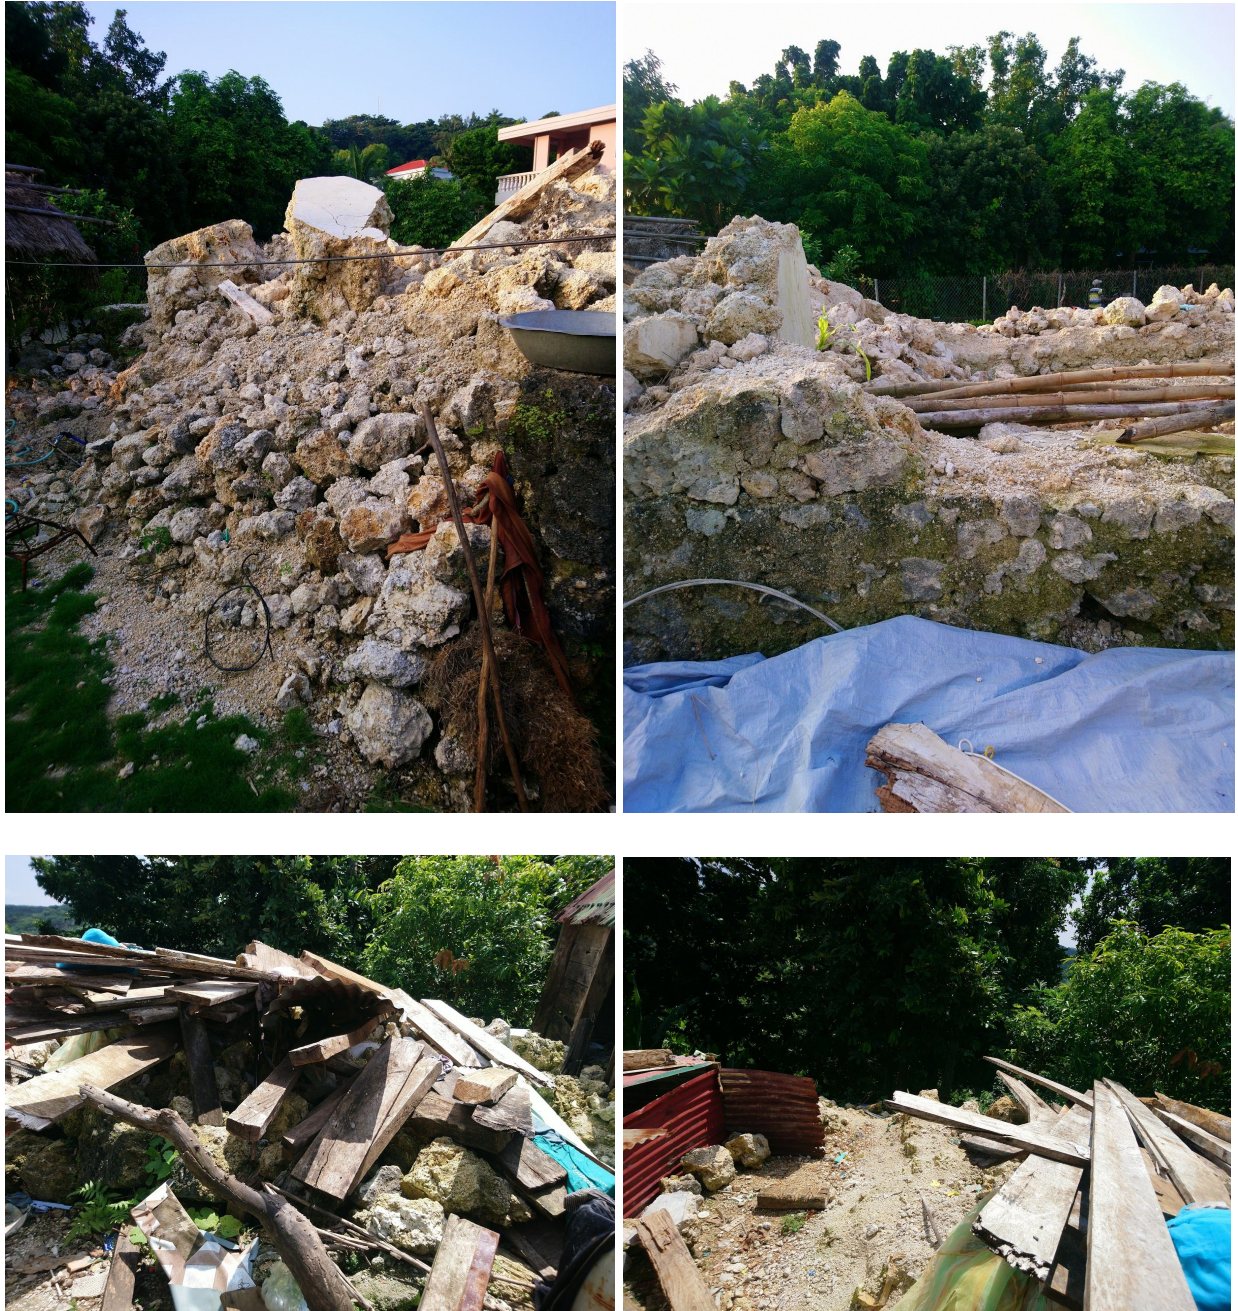
*Figure 3.19 One story traditional unreinforced limestone masonry house. Already demolished, according to homeowner the house totally collapsed during the earthquake. The wall was approximately around 700mm thick. The homeowners have already received materials for their temporary shelter and is preparing to start with construction. Materials include CGI sheets, lumber and 100mm diameter GI Pipe for the columns.*

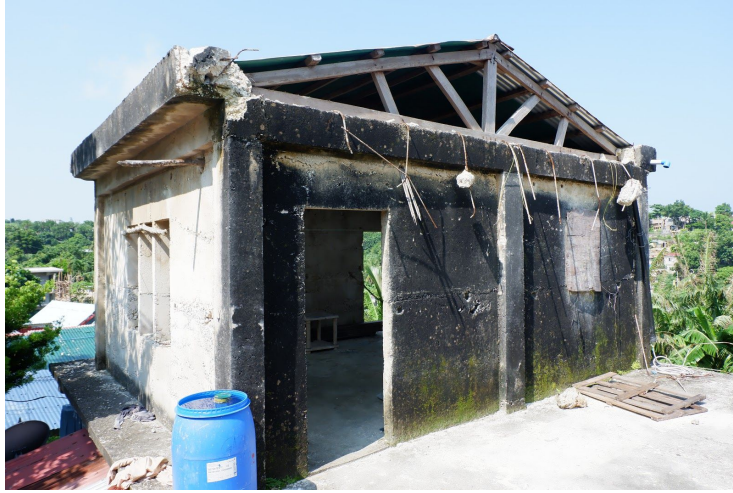
At some of the reinforced concrete houses, there were gable walls that collapsed out-of-plane. This is a common failure seen whenever heavy gable walls are not braced to the roof or the walls below.

*Figure 4.1 Two story house with out of plane failure of gable wall.*
