# Typhoon Odette: Needs Assessment in Bohol

# Initial Needs Assessment: Loboc, Bohol

# Initial Needs Assessment: Inabanga, Bohol

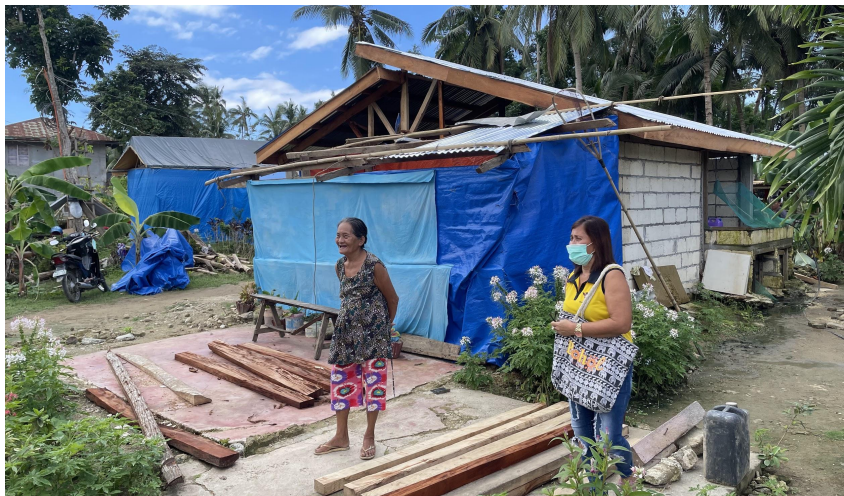
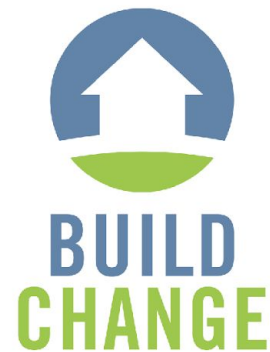
## Partially Damaged Houses:

**Brgy. Ugpong:** 33 Houses

(Estimated Cost: PhP 2.64 Million)

**Brgy. Valladolid:** 82 Houses

(Estimated Cost: PhP 6.56 Million)

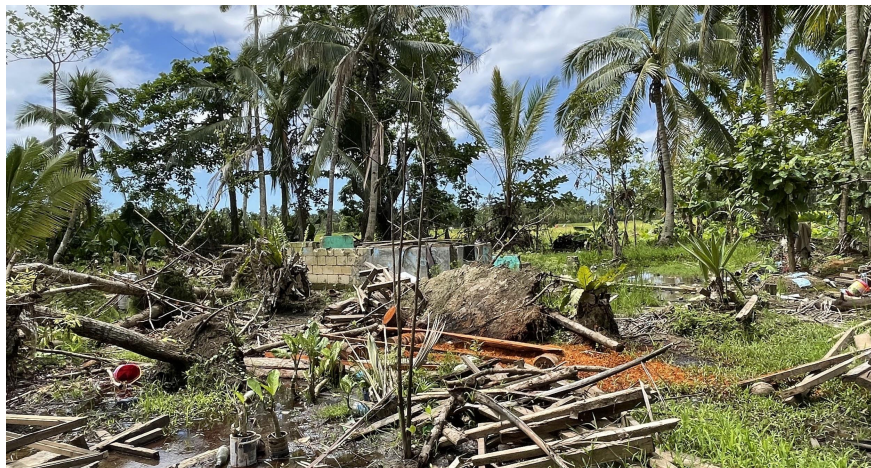
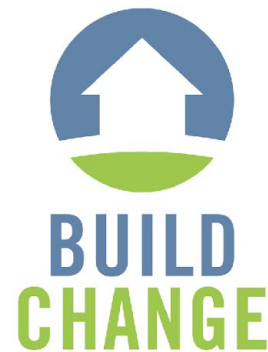
## Fully Damaged Houses:

**Brgy. Ugpong:** 19 Houses

(Estimated Cost: PhP 3.8 Million)

**Brgy. Valladolid:** 25 Houses

(Estimated Cost: PhP 5 Million)

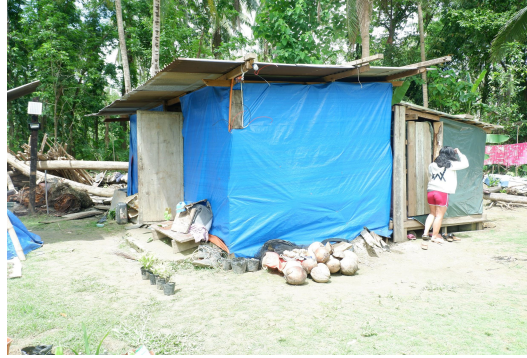
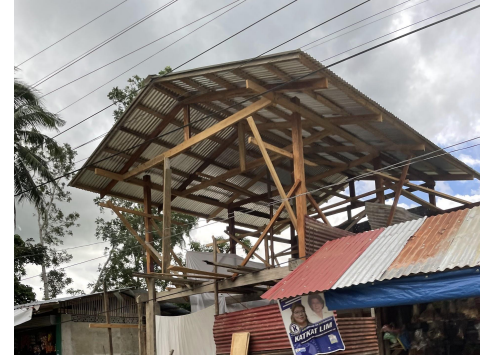
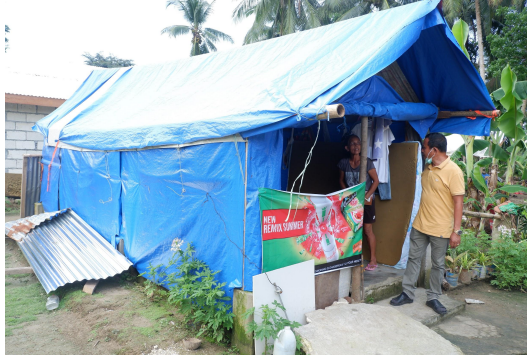
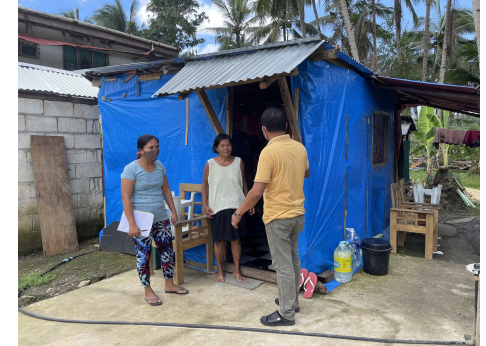
- Both communities, Ugpong and Valladolid, had already started rebuilding through assistance from LGUs and private sector.
- Totally damaged households are still residing at temporary shelters.
- Assistance provided were for transitional shelter such as:
  - CGI Sheets
  - Coco Lumbers
  - Tarpaulins

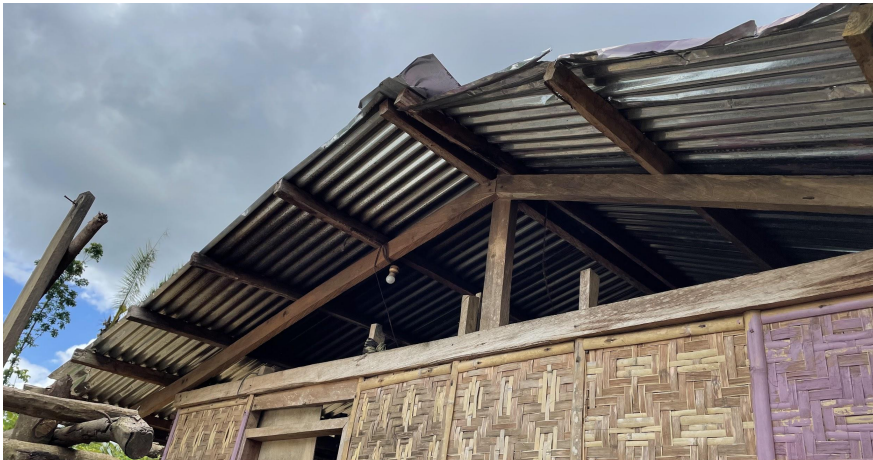
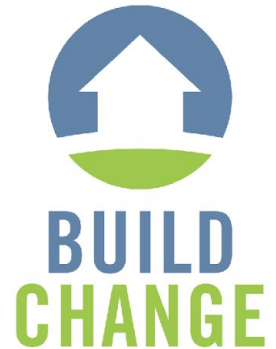
## Partially Damaged Houses:

**Sitio Bacayan, Barangay Badiang:**

3 Houses

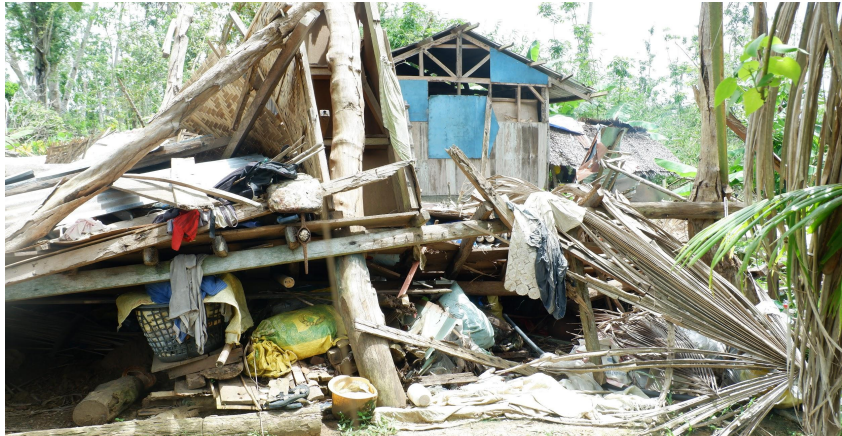
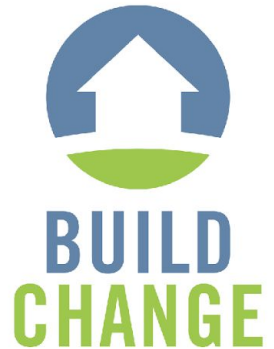
## Fully Damaged Houses:

**Sitio Bacayan, Barangay Badiang :**

49 Houses

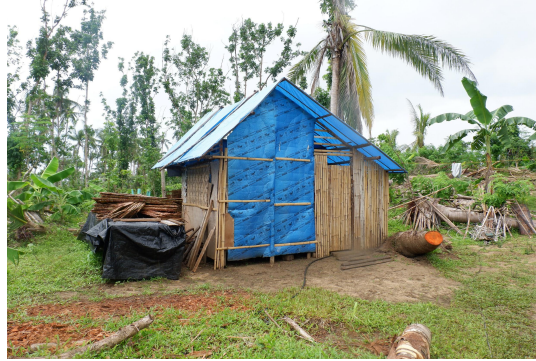
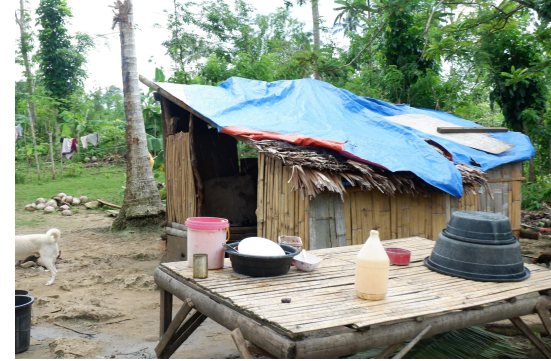
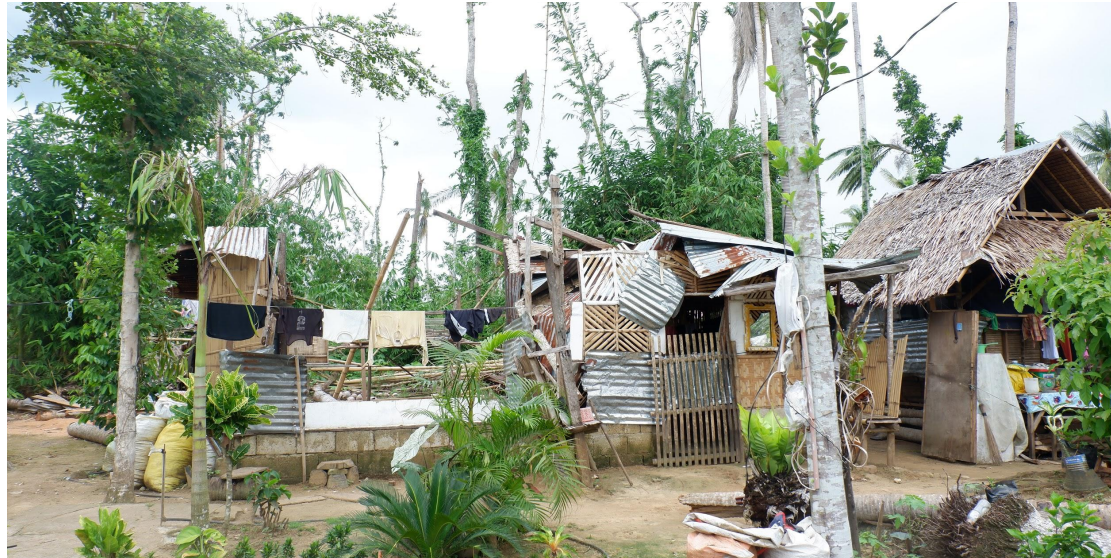
- Majority of the affected households are still living with relatives.
- Some households built makeshift houses using salvaged materials for their temporary shelter because no shelter assistance has been provided yet.

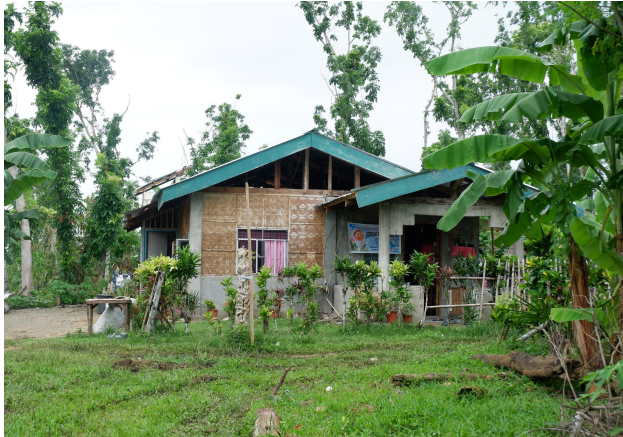
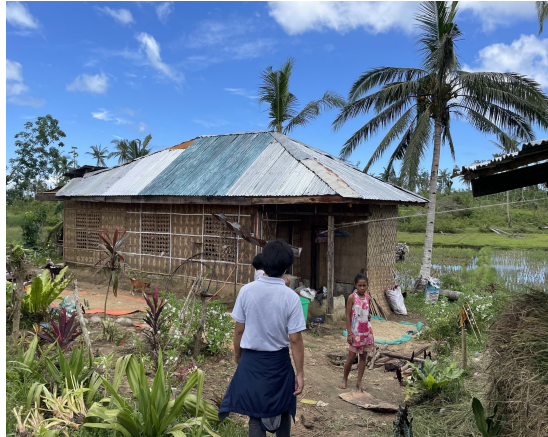
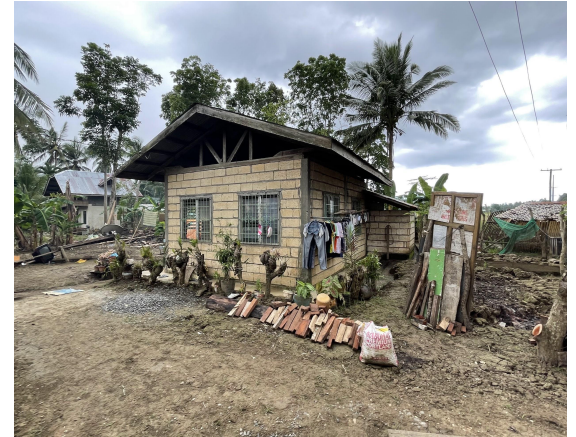
- > 95% of Totally damaged houses are Timber and Light materials
- Majority of the homeowners prefers to rebuild their houses using concrete/masonry if funding is available

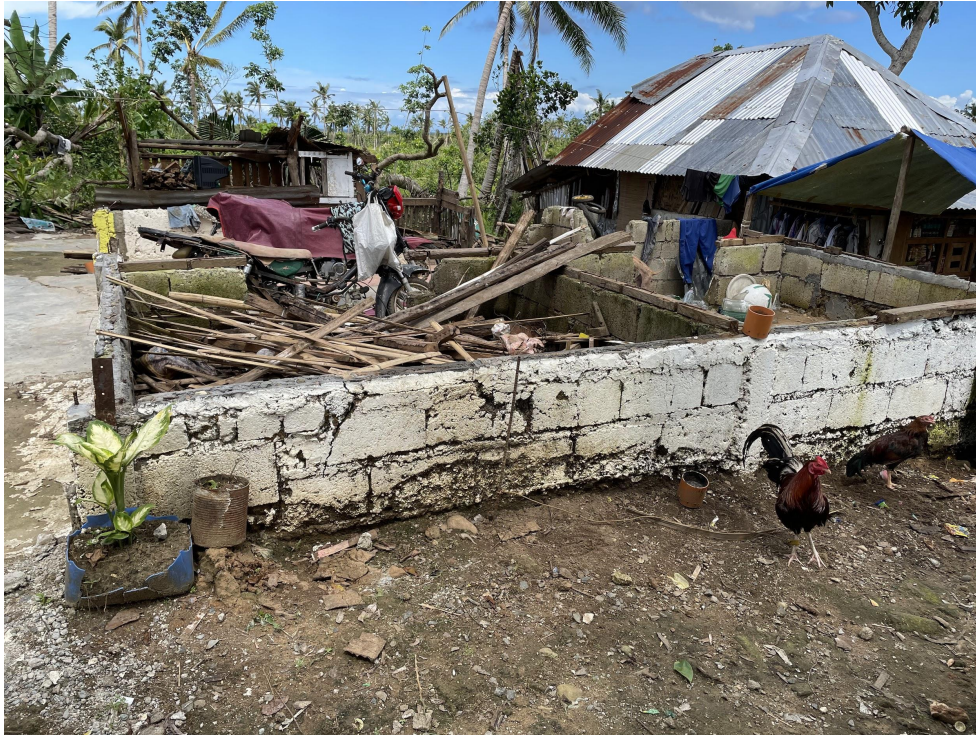
# House built after 2013 Bohol Earthquake

**Houses built after the 2013 Bohol earthquake made out of Mixed Masonry and Timber wall were fully damaged by Typhoon Odette**
