## SEISMIC RETROFIT OF CONFINED MASONRY HOUSES IN HAITI: LESSONS FROM IMPLEMENTATION

C. Davy<sup>(1)</sup>, M. L. Blaisdell<sup>(2)</sup>, K. M. Sinclair<sup>(3)</sup>, E. Hausler Strand<sup>(4)</sup>

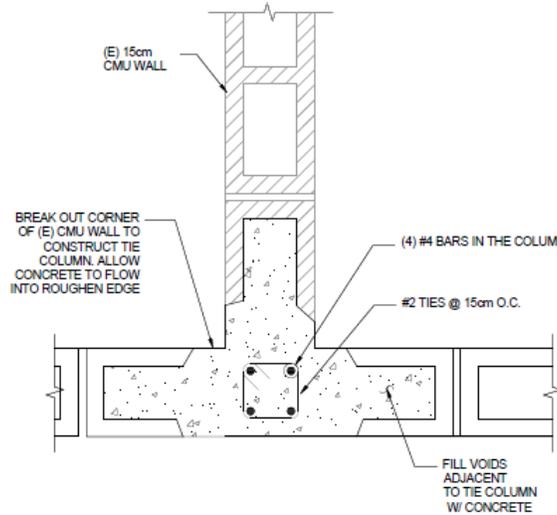
Fig. 2 - Retrofit detail to install a new vertical confining tie at the intersection of two existing walls

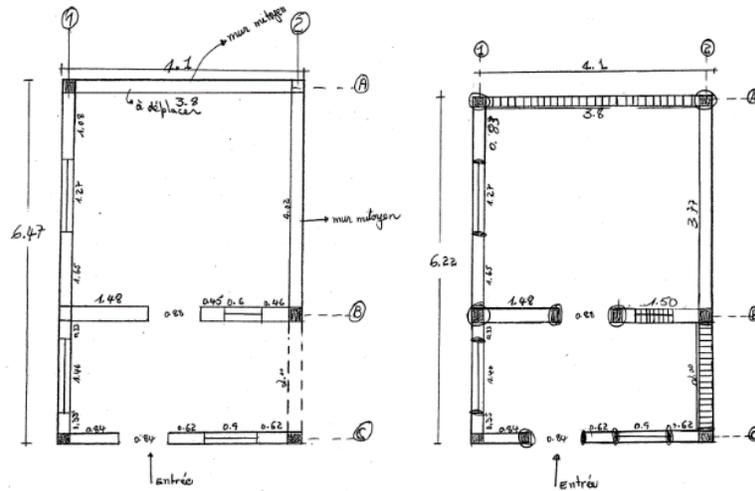
Fig. 3 - Existing (left) and retrofit (right) plans of an unreinforced masonry house retrofit to a confined masonry house (circled columns indicate new vertical ties and hatched walls indicate new walls)

performing the wall area percentage check, the engineer evaluates the building and then designs directly a retrofit solution as needed. The engineer then develops the retrofit plans for each level and a roof plan, as needed, to indicate the required interventions. See an example existing and retrofit design plans in Fig. 3.

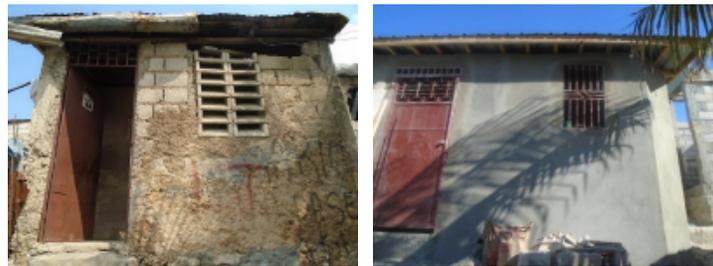
Fig. 4: A home in Port-au-Prince before (left) and after (right) a seismic retrofit

Retrofitting is particularly suited to the homeowner driven approach because the technical solutions for the retrofit can be varied to suit the needs of the homeowner. For example, in cases where a homeowner would like to add a new story to the house in the future, the retrofit can be designed so that the existing home can safely resist the additional earthquake demands from the future level when it is constructed. Homeowner satisfaction is further increased because often retrofitted houses are improved, safer versions of the houses that the same families lived in before the earthquake [8]. See Fig. 4 for an example of a retrofitted house.

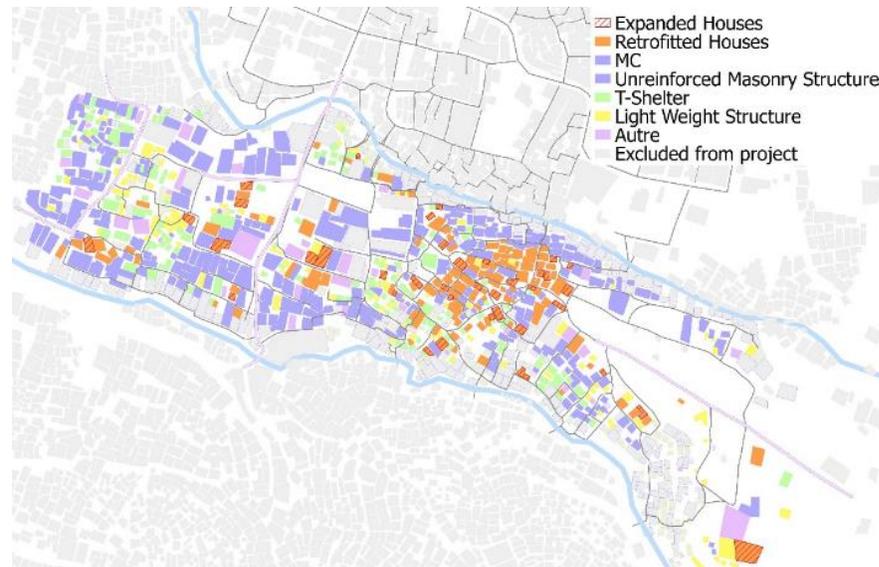
Fig. 5: Map of house structure typology and intervention in Carrefour Feuilles, Port-au-Prince

One example retrofit program used the Manual to improve houses in Carrefour Feuilles, an area with a large density of informal housing construction in Port-au-Prince. Following a rapid assessment of approximately 1,100 houses and a geotechnical investigation in the area, technical criteria for eligibility of homeowners to participate in the program was established. The resulting intervention of the project is illustrated in Fig. 5, where 224 houses for 508 families were retrofitted and in some cases expanded vertically or horizontally. Orange and red hatched buildings were retrofit, while the purple buildings indicate those that were confined masonry (CM) or unreinforced masonry, but did not participate in the program.

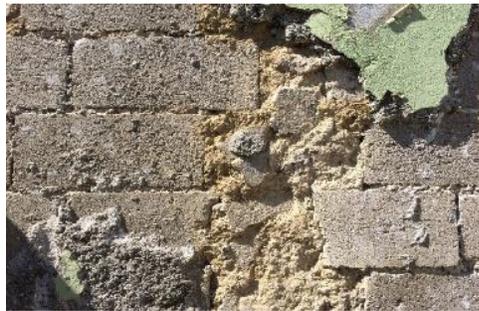
Fig. 6 – Poorly repaired wall crack

Cracks in existing walls can be superficial and concern only the cement plaster covering; in that case the plaster can be removed around the crack and repaired. If the masonry is cracked on only one side of the wall, repair during the retrofit should be made. In the cases where the crack is visible on both sides of the masonry, it is recommend to replace the damaged portion of wall. In Fig. 6, the crack in the wall was previously repaired: first filled with unwashed sand mortar and pieces of rubble, and then plastered over. This condition would require a larger, more significant repair with adequate construction materials, and potentially replacement of the wall.

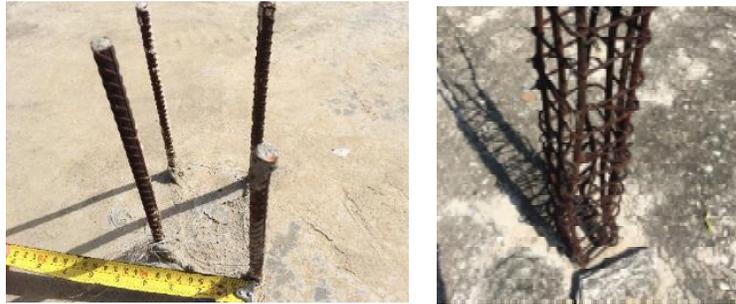
Fig. 7 – Left – Existing column extension with (3) #4 and (1) #3 bars  
Right – Existing column extension with smooth rebar and stirrups already placed

Very few existing confining columns are built to standards for new construction, see Fig. 7; nevertheless the Manual procedures do not aim to replace all the columns of a house. Engineering judgement is needed to evaluate the adequacy of an existing column depending on the role of the column in the structure. For example, a confining column in a deteriorated state, particularly with corroded reinforcing, or very poorly built should be replaced. A confining column that does not meet all of the new construction standards, but is in decent state may be kept and still serve to adequately confine an existing wall.

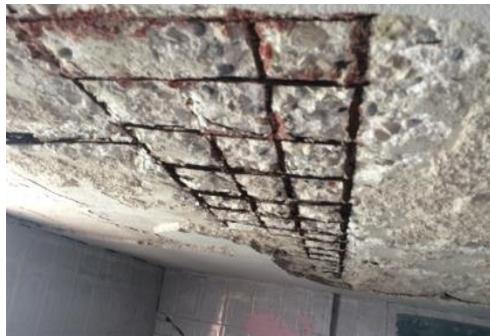
Fig. 8 - Existing slab in poor condition

It is common for the ceiling plaster below the slab to appear to be in good condition, but when construction starts and the slab vibrates more than usual, the plaster can collapse and expose corroded reinforcing (Fig. 8). The high rate of slab replacement required (40%) can be attributed to the poor construction techniques used during the original slab pour – primarily lack of adequate concrete cover below the reinforcing.
