Seismic Retrofitting of Traditional Stone Masonry Houses in Rural Nepal

Abstract— The Gorkha earthquake affected 1,048,574 homes across Nepal; of these, an estimated 500,000 damaged houses can be retrofitted. To cater to this large need for retrofitting, an intervention in which a pre-engineered retrofit design is developed for a certain building type and applied to multiple buildings that meet a narrow applicability criteria, was found to be most effective in addressing these houses, taking into account the constraints in cost and availability of experienced structural engineers. Stone masonry in mud mortar buildings are the most prevalent construction typology for housing in rural Nepal. A large portion of these traditional houses are very similar in overall size, configuration, connections and member sizes. Built with low-strength, random rubble load bearing masonry walls and timber diaphragms, these buildings are highly vulnerable in earthquakes. The resulting retrofit scheme was designed based on the typical damages and failure sequences observed in this building type in the 2015 Gorkha earthquake and based on relevant building codes. Most of the common failures were due to o

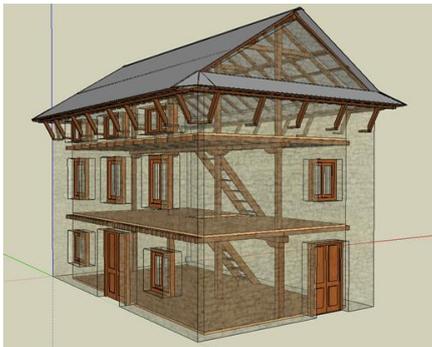
A typical Stone Masonry in Mud mortar (SMM) house in rural Nepal is 2 stories with an attic as shown in Fig. 2 and Fig. 3. The bottom floor is used as a barn, the first floor is used for sleeping and the attic floor is used as the kitchen and for grain and produce storage. Two stories and attic space is essential for the homeowner’s agrarian lifestyle. The structure typically consists of 450mm thick SMM load bearing walls composed of two faces of placed stone with a rubble filling in the center of the wall cavity. The floor, usually mud, is supported by a timber framing diaphragm.

Fig. 2. Typical SMM building in Nepal

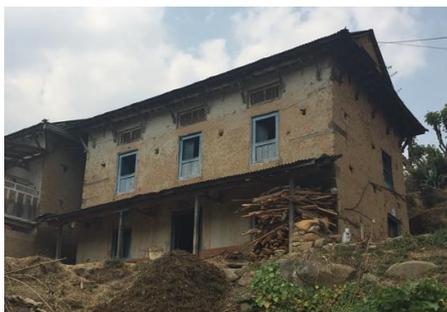
Fig. 3. An SMM building in Kavrepalanchowk district

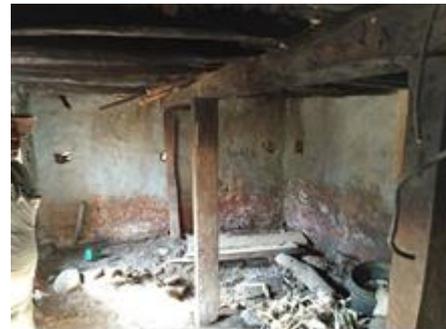
Fig. 5. Wooden posts, Girder beam and joists in a typical SMM house in Kavrepalanchowk

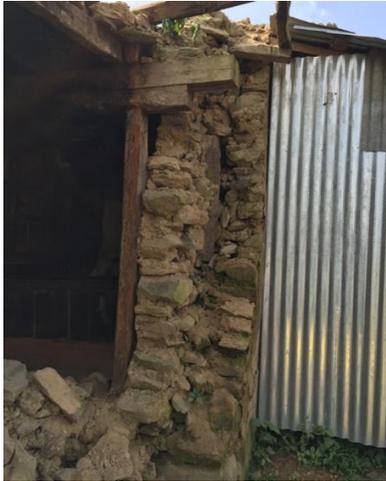
a) Delamination of walls: The width of these walls on average is 450mm. As described above, the walls are built with two faces and lack the connections between the inner and outer wythes, this causes the wythes to behave as two separate slender walls under out-of-plane shaking. This resulted in frequently observed delamination and led to subsequent damage or even out-of-plane collapse in some houses. This could be clearly observed in damaged buildings as shown in Fig. 7.

Fig. 7. Cross section of a SMM House showing the dual layer of stones

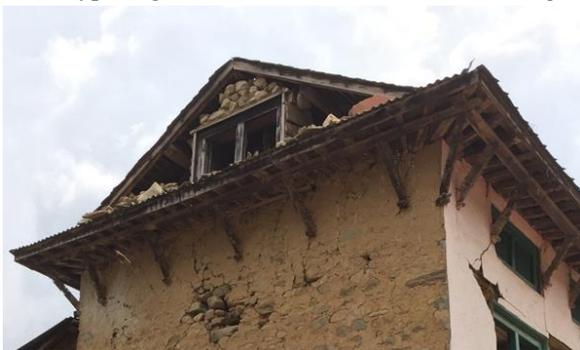
b) Gable wall collapse: The stone masonry in the short walls is typically extended up to the roof line, forming the triangular gable walls, which directly support the outermost roof trusses at each end of the house. This gable wall, although adequate for gravity loads, is unbraced and unreinforced. During the Gorkha Earthquake this unreinforced wall was prone to collapse due to the out-of-plane lateral shaking. Gable wall collapse often initiated or facilitated the subsequent collapse of the transverse walls below. A typical gable wall failure can be seen in Fig. 8.

Fig. 8. Gable wall damage after earthquake

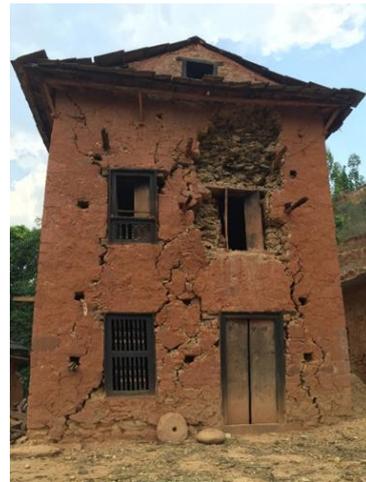
c) Short wall out-of-plane damages: There was high occurrence of damage to the short walls of SMM type buildings as shown in Fig. 9. The floor diaphragm is only connected to the short walls through the girder beam at the middle point of the walls, while it is connected to every embedded joist along the longitudinal walls, leaving the short walls significantly less braced out-of-plane than the longitudinal walls. This, in combination with the effect of the collapsing gable wall peeling away above, led to a concentration of wall out-of-plane damage observed on the short walls of the building. In addition, the wall corners did not have sufficient capacity to transfer forces from one wall

to the adjacent which also caused wall separation at the corners, leaving the short wall with even less bracing against out-of-plane loads.

Fig. 9. Short wall damage

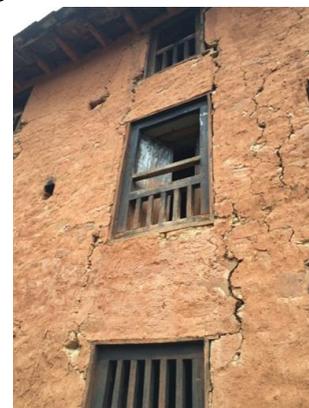
e) Diaphragm Deficiency: The floor joists are directly embedded in the walls and there is typically no element to serve as the perimeter diaphragm chord. Due to the lack of a tension-carrying chord element at the edges of the diaphragm, significant diaphragm deflection likely occurred, leading to the observed vertical cracks at the face of the walls as shown in Fig. 10.

Fig. 10. Vertical cracks observed at floor level in a typical SMM house

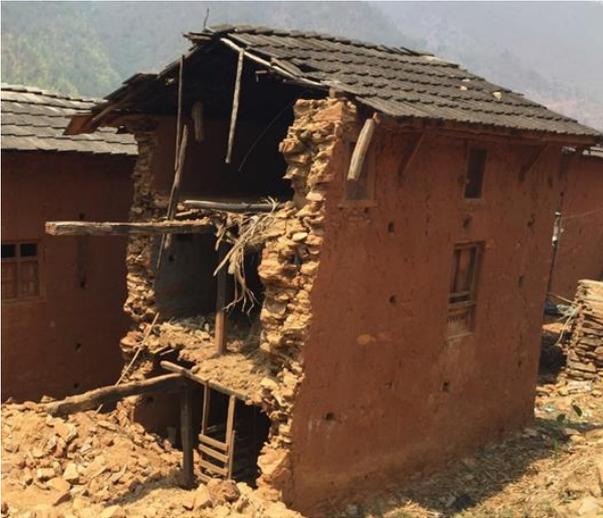
b) Timber elements: The floor is generally supported independently by wooden posts and beams. Large and long timbers are used throughout, many dating back to when high quality hardwood such as Sal wood (*Shorea Robusta*) was commonly available. The timber components are typically in good condition. Consequently these have been reused in temporary or permanent reconstruction, or salvaged and stored for future use. The current availability of timber of the same quality and size is considerably rare. The connection of the central timber girder to the independent posts supporting this beam also seem to have delayed the complete collapse of the structure despite severe damage or even collapse of some of the walls, as illustrated in Fig. 11.

Fig. 11. A damaged house in Sindhupalchowk where the entire short wall is collapsed but the house is still standing

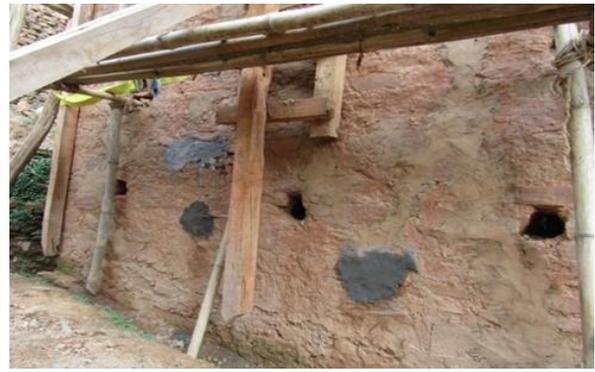
Through concrete is provided to bond the inside and the outside wythes of the SMM wall. Providing through bonding elements to interconnect the stones throughout the width of the wall helps to prevent delamination. A through bonding element of concrete and rebar is used as shown in Fig. 12; these are effective as a secure bond to the existing stones can be created. The through concrete is approximately 150mm diameter. In the type design, these are placed at a spacing of 600mm center-to-center in horizontal and vertical directions along all walls, as shown in Fig. 13.

Fig. 13. Installed through wall concrete connections

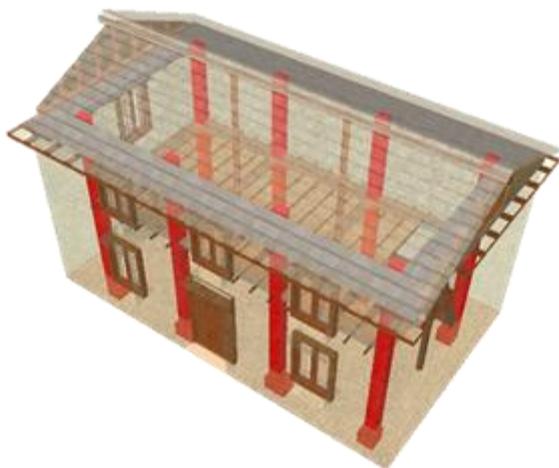
The strong backs are provided at the corners of the house and at each wall pier, as shown in Fig. 16. The corner strong backs help to inter-connect the orthogonal walls to prevent corner separation. The type design provides the option to construct the strong backs constructed out of either reinforced concrete or good quality timber.

Fig. 16. Strong backs highlighted in red

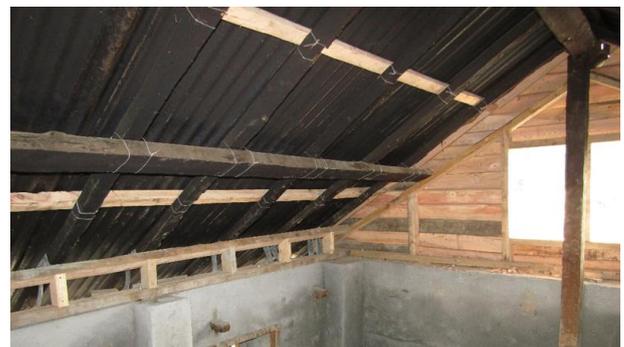
The existing timber connections are generally acceptable for gravity loads but not for wind and lateral loads. So, simple improvements in connections using galvanized iron wires and/or corrugated galvanized iron straps are provided to the roof, as shown in the photo in Fig. 19.

Fig. 19. Improvement of existing timber connections

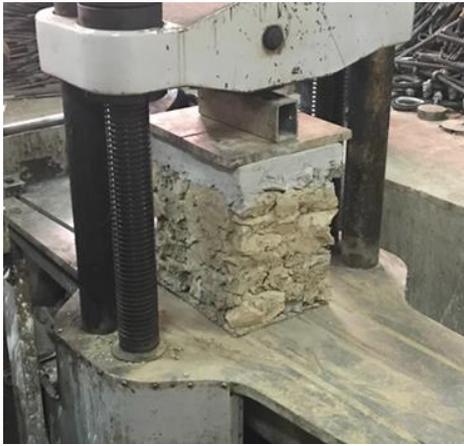
The test was carried out on a Universal Testing machine, as shown in Fig. 20. The displacement gauge was placed at the loading plate of the UTM, due to which it was only possible to observe the loading till failure and not beyond the ultimate failure point.

Fig. 20. Compressive test carried out

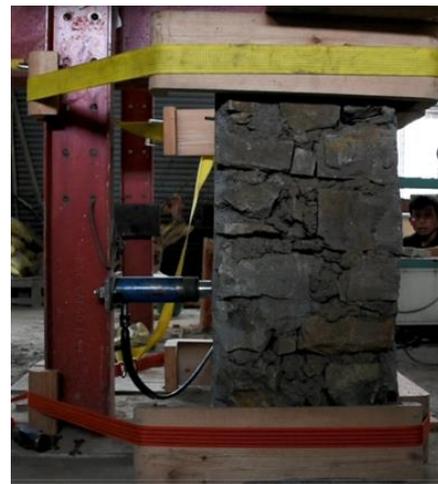
SMM wall specimens were of size 1.2m x 1.2m x 0.45m, and through concrete was inserted into each at approximately the center of the wall specimen.

The objective of the push-out test was to examine the behavior of the through concrete when pushed out of the wall. the sample wall was restrained at the top and the bottom. the through concrete was then pushed out with the help of a hydraulic plunger, as see in fig. 22 and fig. 23.

Fig. 23. dowel push out tests setup

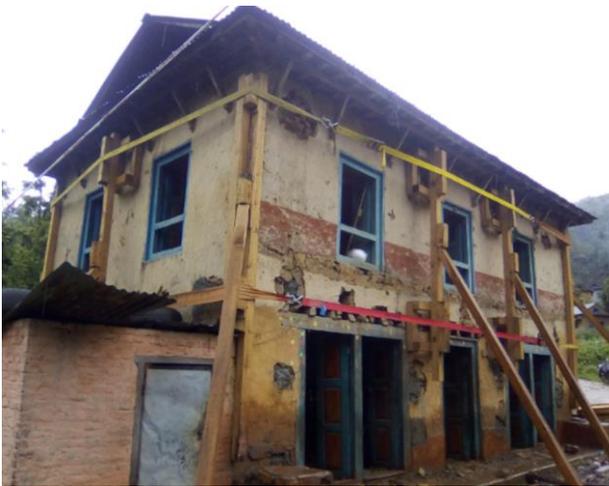
Due to these houses being damaged in the earthquake, they are very fragile and need to be adequately shored before work can commence, which can include both internal and external shoring systems as shown in Fig. 25. The availability of local timber and/ or bamboo is essential to allow the shoring process to start at the construction site. Prototype shoring designs were developed to accompany the type design.

Fig. 25. Shoring of SMM house prior to the commencing of retrofit activities

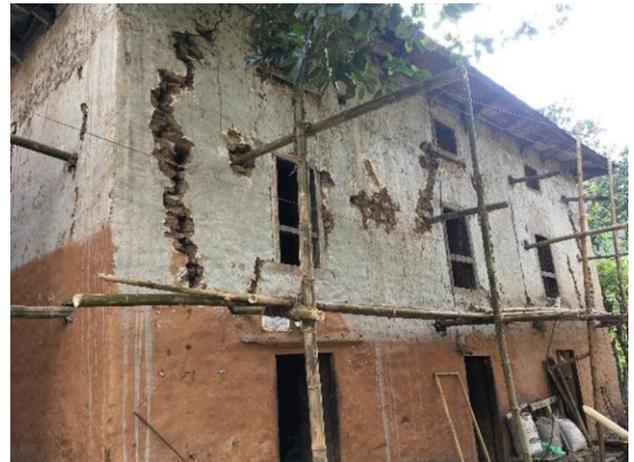
Most of the houses have mud plaster over the external and internal faces of the house, this often is cracked, like the house shown in Fig. 26, and needs to be repaired in the retrofit process. The crack repair requires stripping of mud mortar, exposing the stones (making V-notch) and grouting it with stabilized mud mortar. This crack repair process

Fig. 26. Damaged house prior to retrofitting
