**April 25, 2015 – GORKHA EARTHQUAKE, NEPAL**

**Surveyed May 5-19, 2015  
Report Released May 31, 2015**

## Build Change Post-Disaster Reconnaissance Report

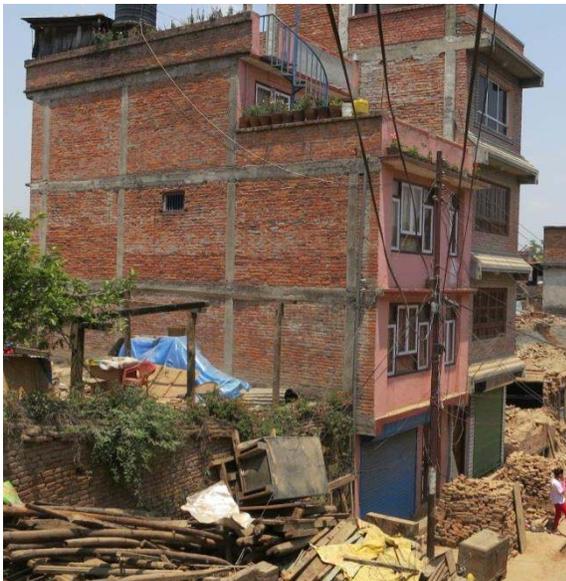
In the more urban city areas, the newer house structures are frequently constructed with reinforced concrete column and beam frames (RC frames), concrete floors and roofs, and unreinforced masonry infill (See Figures 11 and 12). For buildings which line the roads serving as main arteries to a city, the exterior elevations along the road tend to consist of open bays at the ground floor level to accommodate the storefronts of local businesses. Building height varied, typically in the range from 3-4 stories and up to 6-7 stories.

The concrete reinforcement is primarily limited to four deformed longitudinal bars in columns and beams, with widely spaced ties. There was no indication of reinforcing in any of the brick work, nor of any ties between the brick infill and the concrete columns and beams.

*Figure 11. Reinforced concrete frames with masonry infill.*

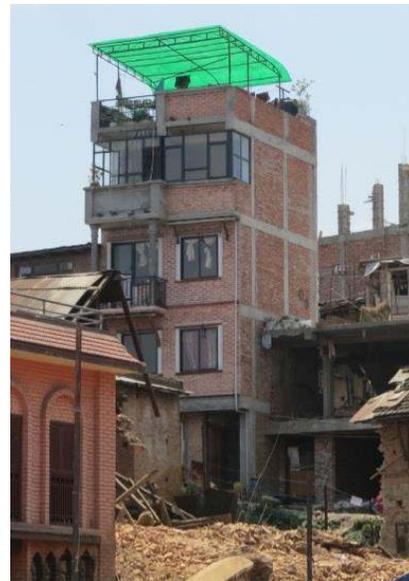
*Figure 12. Reinforced concrete frames with masonry infill.*

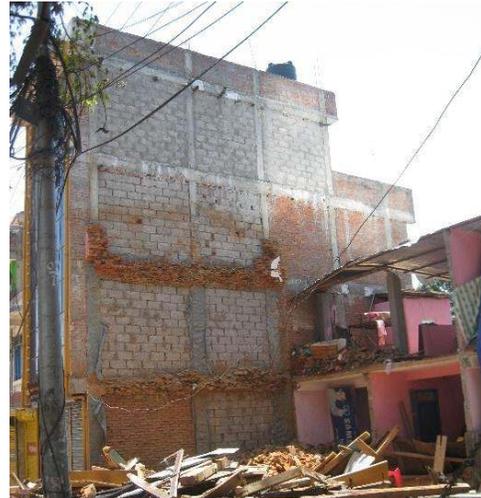
The infill thickness is typically 12" to 15" or more, and the concrete column and beam widths match the infill thickness. The majority of the infill in newer urban construction is solid clay brick. Occasional use of concrete block infill for frames was observed, particularly in areas outside of Kathmandu (See Figure 14). There is typically no concrete plinth beam at the ground level between the masonry walls and foundations. The mortar used in these buildings is most often a cement mortar. Exposed brick wall surfaces are usually plastered over.

Figure 14. Concrete block infill, Chautara.

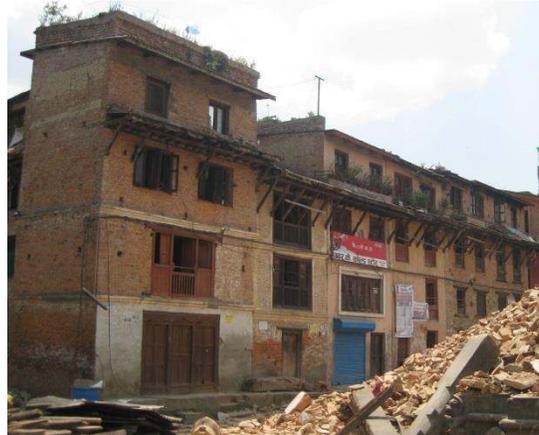
Older urban house structures utilize unconfined, unreinforced brick masonry with either wood or masonry lintels at door and window openings and wood-framed floors supporting heavy mud floor and roof slabs, or sloped wood-framed roofs or canopies with corrugated galvanized iron (CGI) or clay/stone tile finishes. The masonry wall thicknesses range from 12” to 18”. A mud mortar is found in the older buildings, and the brick walls are most often exposed, and not plastered over (See Figure 15).

Figure 15. Urban area unconfined, unreinforced masonry buildings,

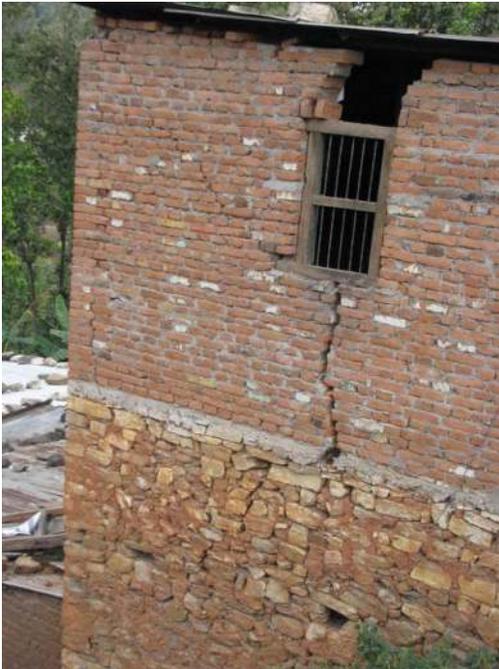
A common theme seems to be that a single level home is first built, with additional stories added as more money for further construction becomes available. Figure 16 is an example of this with

mud mortar used throughout, at both the stone and brick masonry, occurring in a hilly remote area accessible only by a narrow dirt road. Figure 17 illustrates similar mixed materials, but in the town of Zero Kilo, on a paved highway route where access is not difficult. Here, cement masonry was used at the brick walls, with a combination of cement or mud mortar at the stone masonry. Figure 18 illustrates combined brick and stone infill used at the ground floor level of a concrete frame school building. The infill at the upper levels was solely brick masonry.

*Figure 16. Brick above stone masonry, Balthali VDC.*

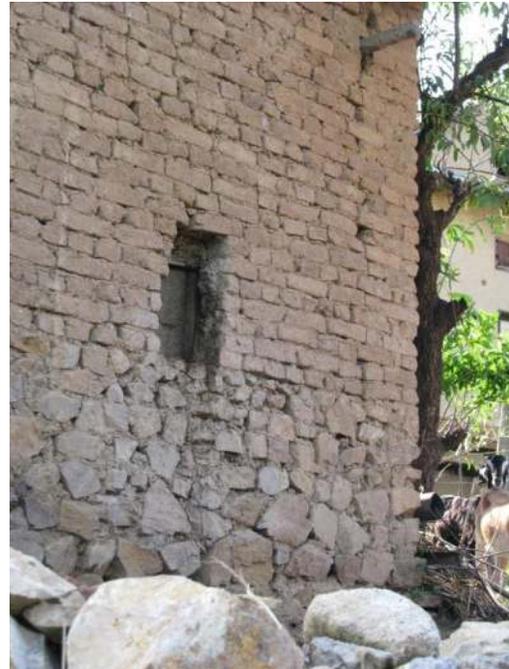
*Figure 17. Brick above stone masonry, Zero Kilo.*

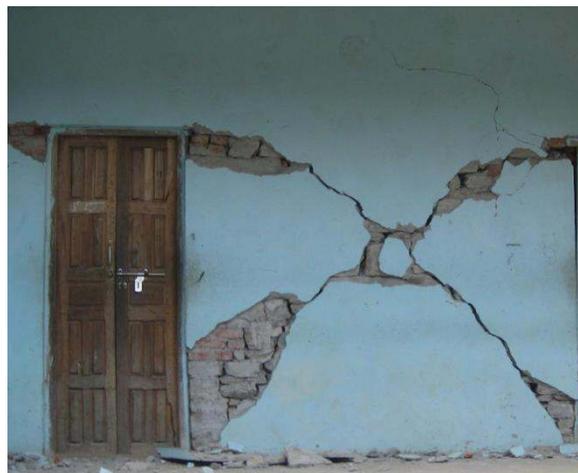
*Figure 18. Use of mixed brick and stone for infill construction, to economize costs School in Mahankal.*

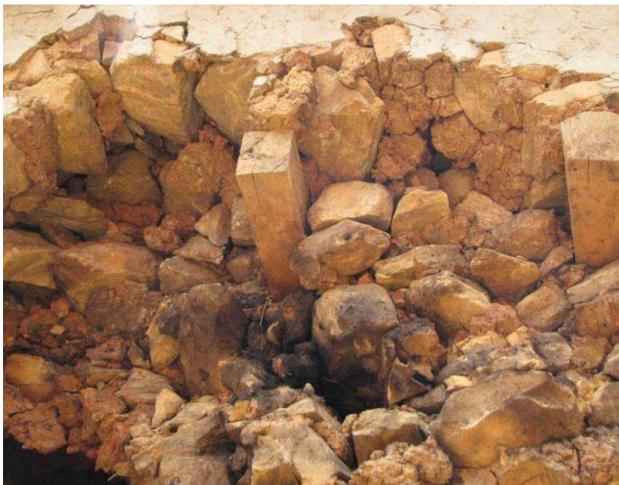
Figure 19 is an example of stone masonry. A near constant with stone masonry is the use of a mud mortar. The soil used for the mortar appears to be a clay material, reddish in color, and predominant in the local geologic landscape. Figure 20 shows a piece of mud mortar from a stone masonry wall.

*Figure 19. Random shaped stone masonry, Thula Gaun.*

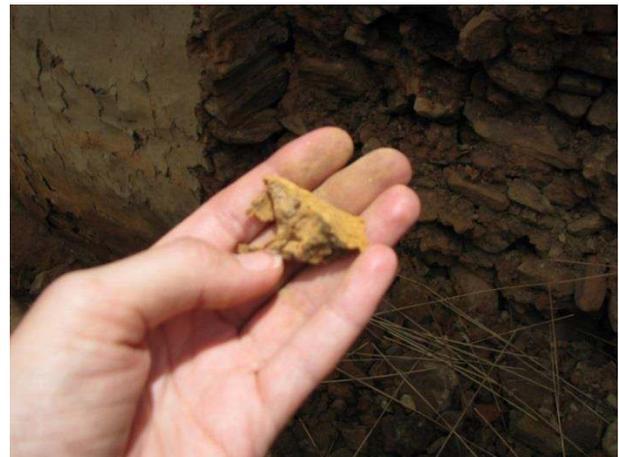
*Figure 20. Piece of mud mortar, Thula Gaun.*

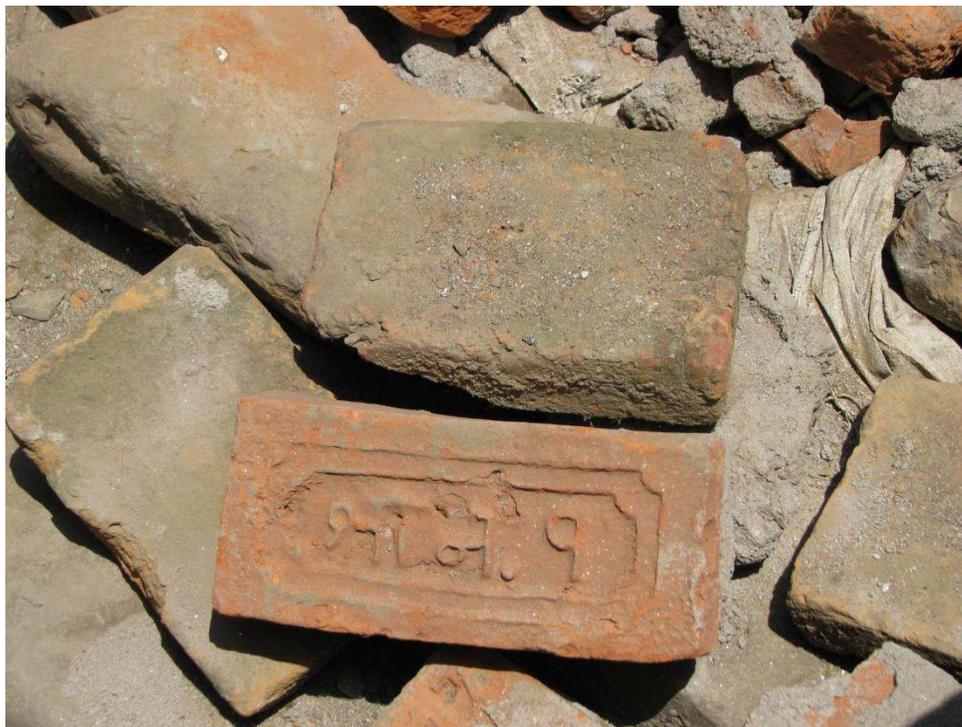
There is a noticeable difference between the brick used in newer versus older construction, which could contribute to the difference in earthquake performance. The newer bricks are taller in height, narrower in width, and longer in length than bricks from older construction. Additionally, the newer bricks usually have deformations with a brick maker's logo embossed on at least one side of the brick. Bricks from older construction tend to be flatter in shape and smooth on all sides. Figure 21 shows a side-by-side comparison of bricks from newer and older construction.

The newer bricks appear to be uniform in size and shape, regardless of manufacturer, suggesting a mechanized manufacturing process. The Nepal National Building Code (NBC) specifies a standard brick size of 240 mm x 115 mm x 57 mm. Based on bricks observed in rubble piles, where many individual bricks were still intact or clearly fractured due to overall building failure, it can be surmised that brick strength and quality of the newer bricks is not a significant contributing factor in building damage due to seismic forces. Due to the differences in types of bricks used, there does not appear to be a typical number of brick wythes in a wall.

*Figure 21. Older brick, above, compared to newer brick, below. Note brick maker's embossment on newer brick.*

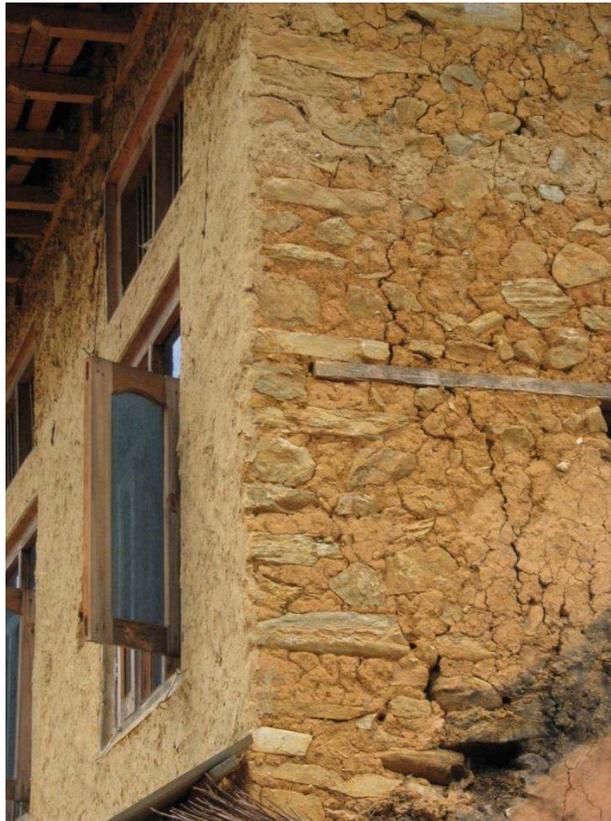
The stone work varies from randomly shaped loose stones of varying sizes, likely dug out of the hillsides, to formed stones cut from the mountainsides. Depending on location, some of the cut stonework is of small and thinner rectangular shapes, closer to brick sizes, while other cut stones are much larger and taller, approaching concrete block size. Figure 25 illustrates the variety in stone shapes and sizes used.

*Figure 25. Example of flat cut stone with random stone shapes, Thula Gaun.*

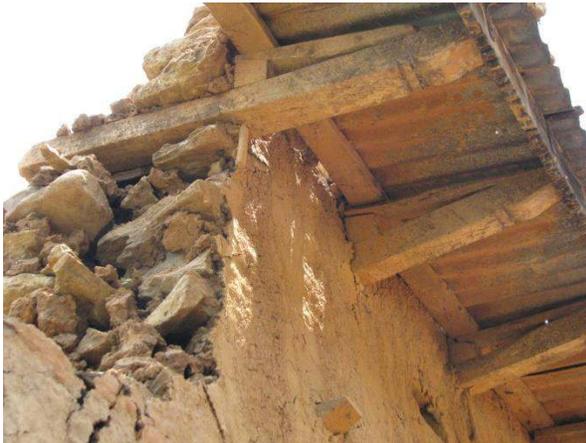
For all types of masonry where wood framed floors and roofs were used, the wood framing typically is extended into the masonry, and often through the masonry wall thickness. Unless a concrete beam-column frame was present, in which case a concrete floor or roof slab was used, the floors and roofs were typically built using wood-framed joists and rafters. At floors, a wood subfloor is placed over closely spaced floor joists. The subfloor is often bamboo or twigs, primarily serving as support for a mud slab floor layer above. These floors are typically 3"-4" thick above the subfloor. In newer construction, the subfloor is a straight-sheathed timber floor. Figures 26-29 show variations of support framing for mud floor slabs. Figure 32 shows a section at the edge of a typical mud floor installed over a more recent straight sheathed floor. There was evidence of pegs installed at overhanging roof rafters, used to anchor the sloped rafter in the masonry wall (See Figures 30 and 31). Figure 33 shows a sloped CGI (corrugated galvanized iron roof over sloped wood roof framing.

*Figure 30. Pegged roof rafters in wall, Thula Gaun.*

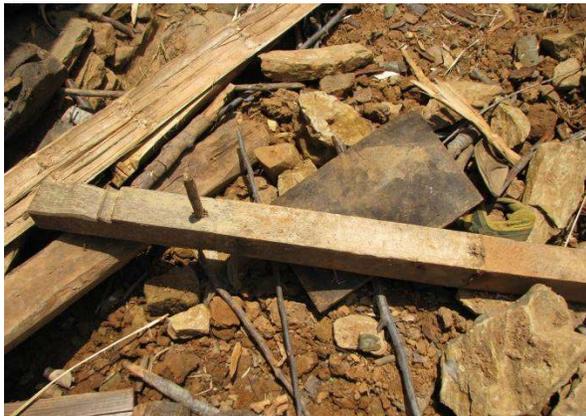
*Figure 31. Pegged rafter in rubble pile, Thula Gaun.*

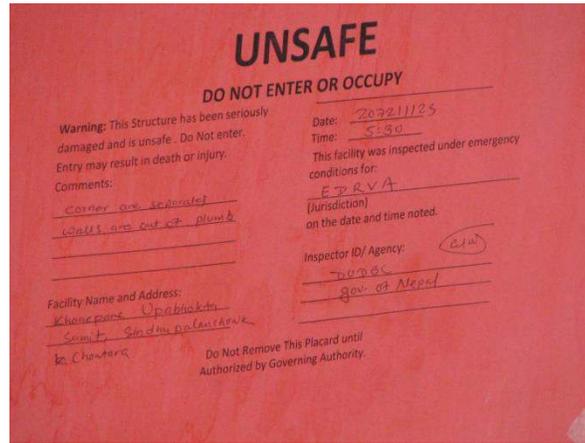
In Chautara, engineers from the Nepal Department of Urban Development and Building Construction (DUDBC) had been performing post-earthquake assessments and posting buildings with red, yellow, and green “tags” for entry. Most tagging observed was in the form of open circles spray-painted on the front walls of the buildings, usually near doorways. In one instance, a red placard was posted adjacent to the red circle. Figures 50-52 show the assessment posting circular “tags”.

Figure 52. Placard on red tagged building, Chautara.

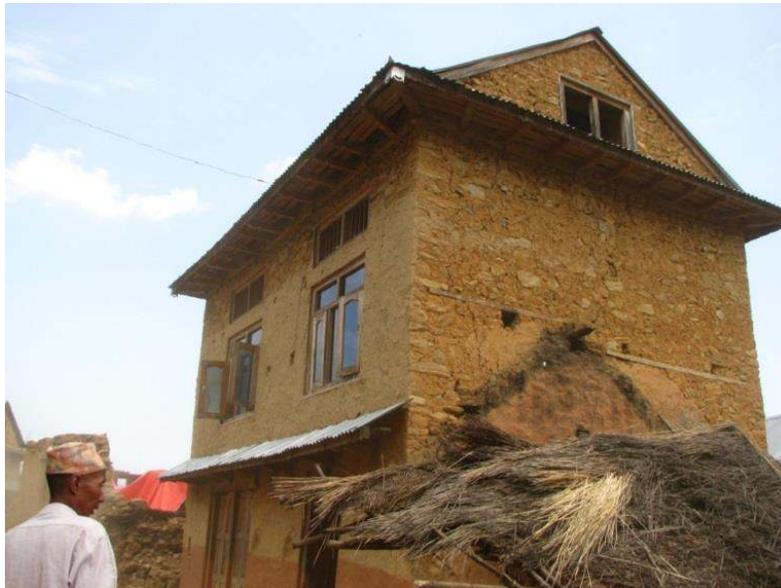
The Build Change team was in Thula Gaun, in the Balthali VDC, Ward No. 5, at the time of the M7.3 aftershock. Many homes in the village had already sustained considerable damage from the primary earthquake. During the aftershock, out-of-plane movement of the upper story stone masonry front wall was observed in one house that had sustained very little damage in the April 25th event. Given an estimated thickness of 12", observing this movement was very interesting. The house had a few small cracks in the stone masonry from the first event, but exhibited no additional damage or increase in the initial crack sizes or widths. The house had been built only 6-7 years earlier by a local builder. The upper floor had straight sheathing below the mud slab, which likely aided the house's lateral resistance by providing a resilient diaphragm at mid-height of the walls. However, prior to the aftershock, the owner had said that he wanted to tear the house down and rebuild a better, safer house.

*Figure 56. Largely undamaged house as seen in the final moments of May 12th M7.3 aftershock, Thula Gaun.*
