April 25, 2015 – GORKHA EARTHQUAKE, NEPAL

**Report Released May 31, 2015
Updated October 1, 2015**

Build Change Post-Disaster Reconnaissance Report

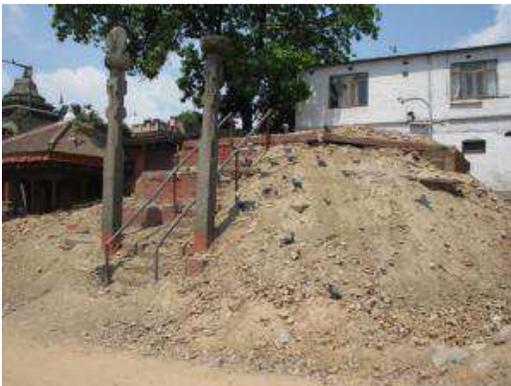
Figure 4. Destruction at UNESCO site in Kathmandu Durbar Square.

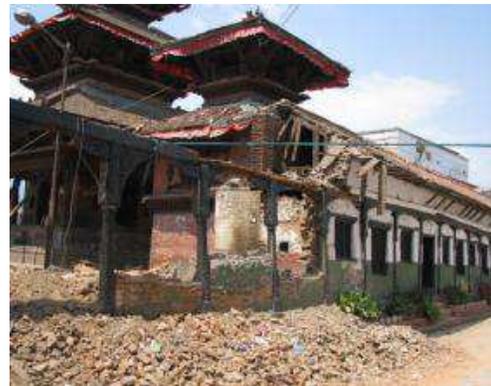
Figure 5. Destruction at UNESCO site in Kathmandu Durbar Square.

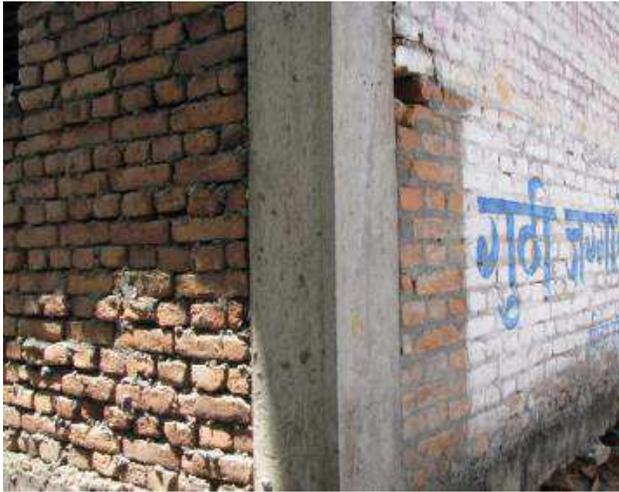
Figure 13. Note mortar finishing on exposed side wall versus mortar finish on “out of sight” back wall, Chautara.

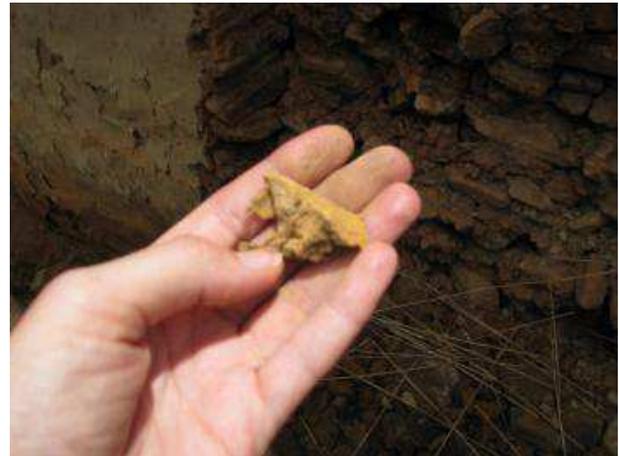
Figure 20 is an example of stone masonry. A near constant with stone masonry is the use of a mud mortar. The soil used for the mortar appears to be a clay material, reddish in color, and predominant in the local geologic landscape. Figure 21 shows a piece of mud mortar from a stone masonry wall.

Figure 21. Piece of mud mortar, Thula Gaun.

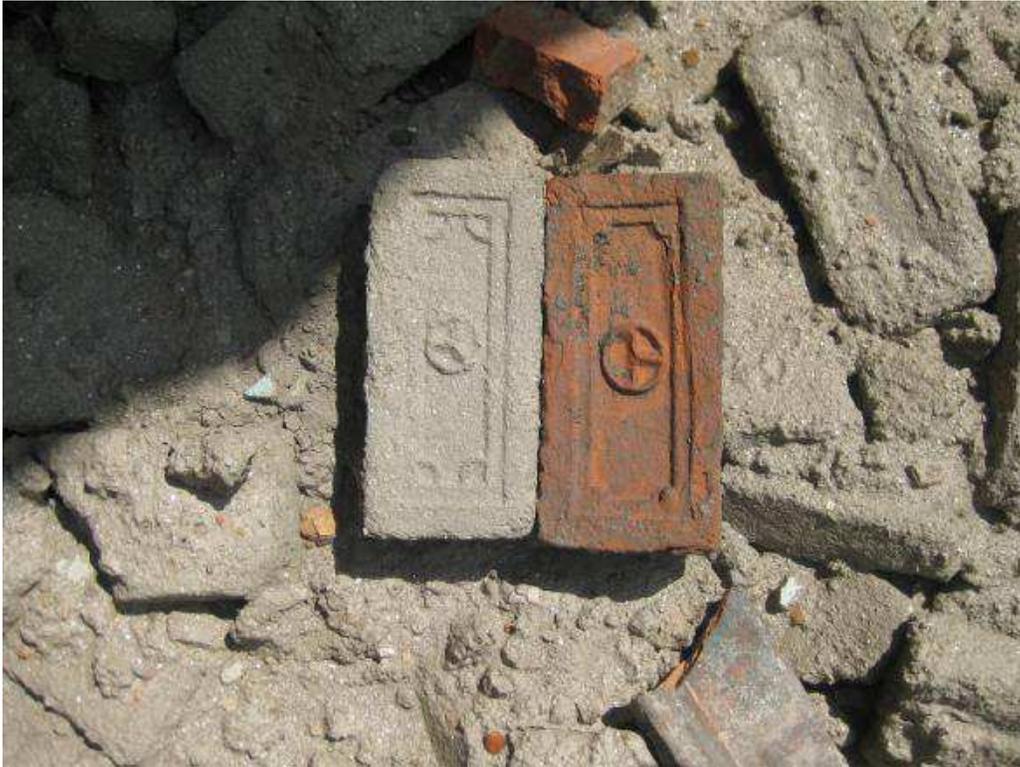
In some areas, unfired brick was used for construction, see Figure 23 and 24. As observed in Sankhu, unfired brick is typically paired with mud mortar, like adobe construction, creating a weak wall in comparison to fired brick with cement mortar.

Figure 23 Unfired brick compared to fired brick

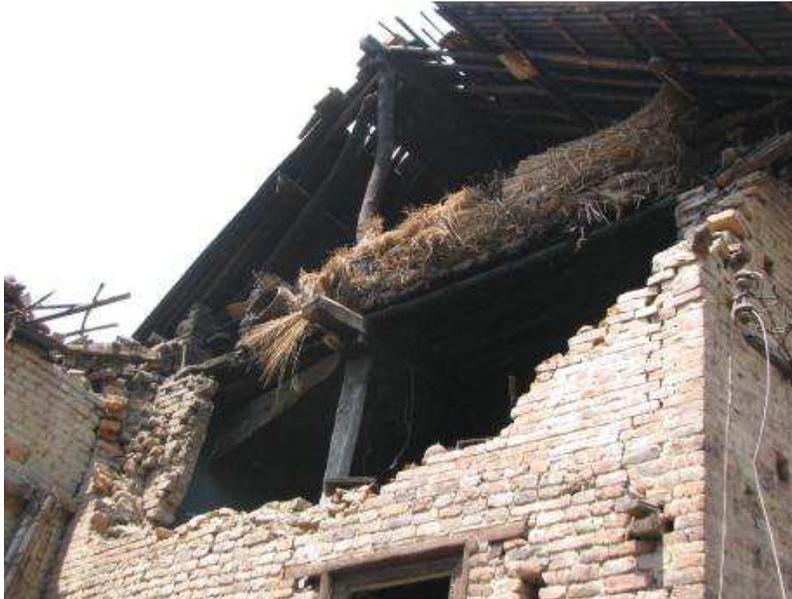
At older construction that did not utilize concrete frames, there was a substantially higher rate of failure and collapse, particularly at the wall corners and gable roof ends. There is no reinforcement tying perpendicular walls together at the corners. While the low ends of the roofs are supported by masonry walls, and the timber roof framing often runs into the wall, the gable wall ends had no ties or bracing back to the roof framing, and were frequently a source of initial collapse.

Figure 46. Collapsed end wall at gable, Bungamati.

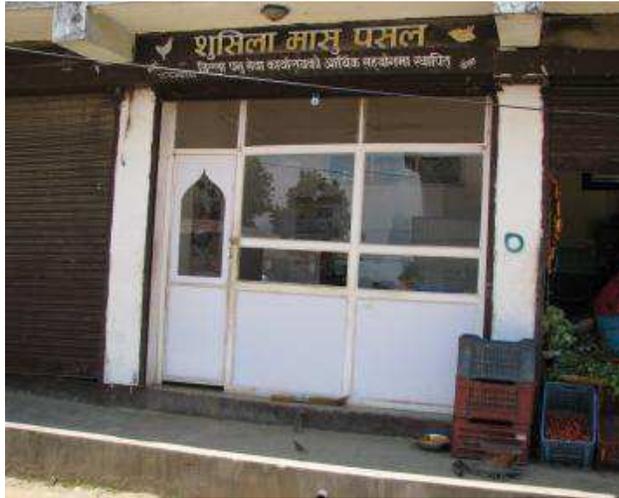
In Chautara, engineers from the Nepal Department of Urban Development and Building Construction (DUDBC) had been performing post-earthquake assessments and posting buildings with red, yellow, and green “tags” for entry. Most tagging observed was in the form of open circles spray-painted on the front walls of the buildings, usually near doorways. In one instance, a red placard was posted adjacent to the red circle. Figures 61-63 show the assessment posting circular “tags”.

Figure 61. Green tagged structure, Chautara.

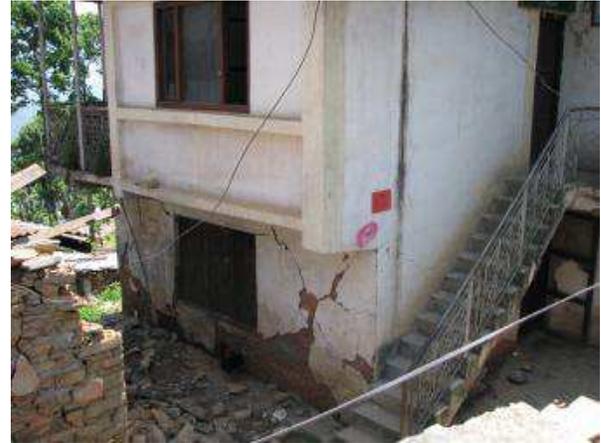
Figure 62. Red tagged structure with placard, Chautara.

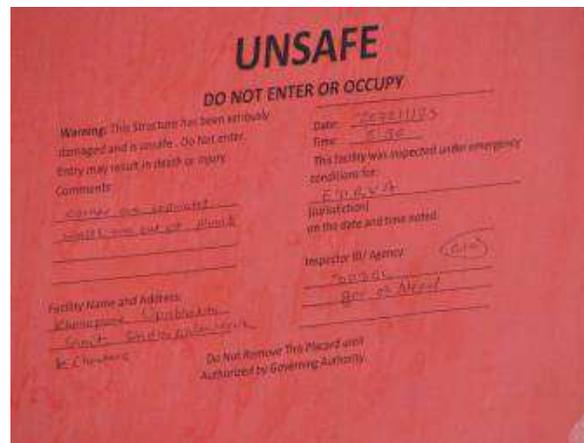
Figure 63. Placard on red tagged building, Chautara.

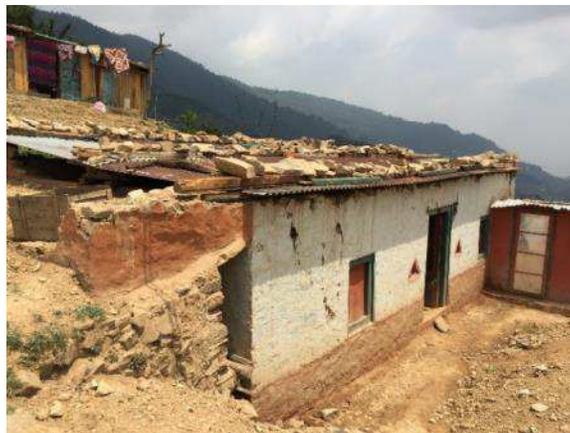
Figure 66. One of the houses in Chahal Ganeshthan Ward 9 where the upper floors were demolished and the ground floor level covered with CGI sheets.

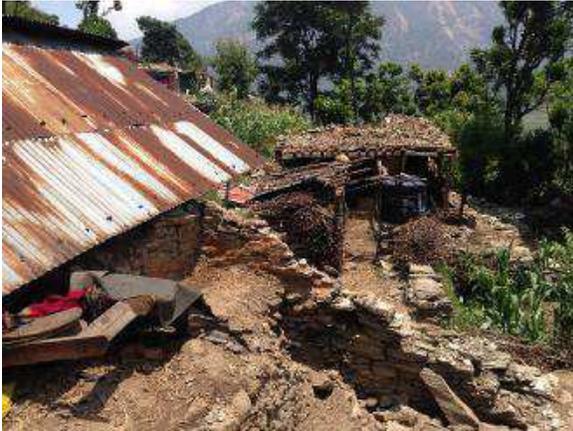
Figure 67. Collapsed houses in Ramche

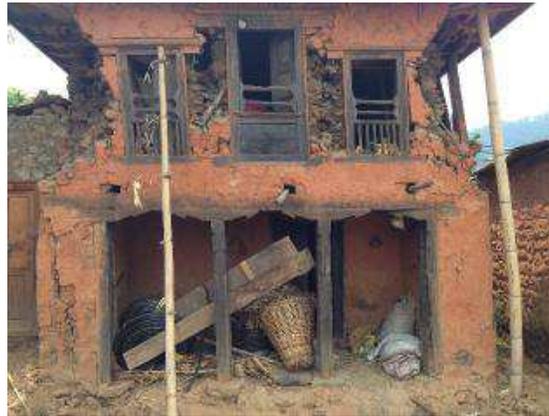
In the remote, rural hillside areas, most of house construction consists of stone masonry with mud mortar. These homes suffered the greatest amount of damage. Like unconfined brick masonry, wall corners and gable walls collapsed first. Without having even header courses to tie the width of the wall masonry together, and dried mud mortar that can be crushed to dust between fingers, the stone masonry walls disintegrated easily when subjected to the lateral earthquake forces. With the random layout nature and varying shapes and sizes of stone masonry, X-cracking was not frequently observed, or clearly visible, in these buildings.

Figure 72. House with major damage at the corners, Mahankal Chaur VDC

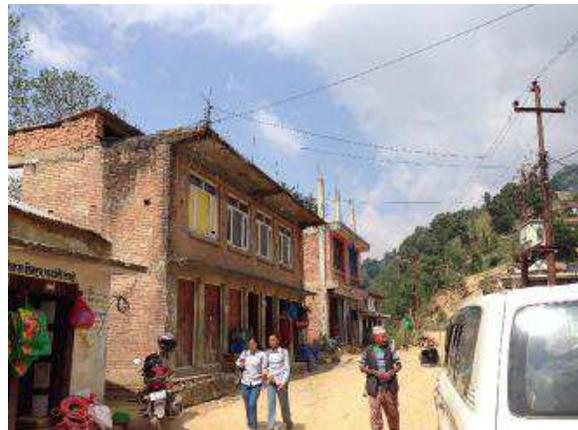
Figure 82. Concrete frame housing, Chalal Ganeshtan VDC

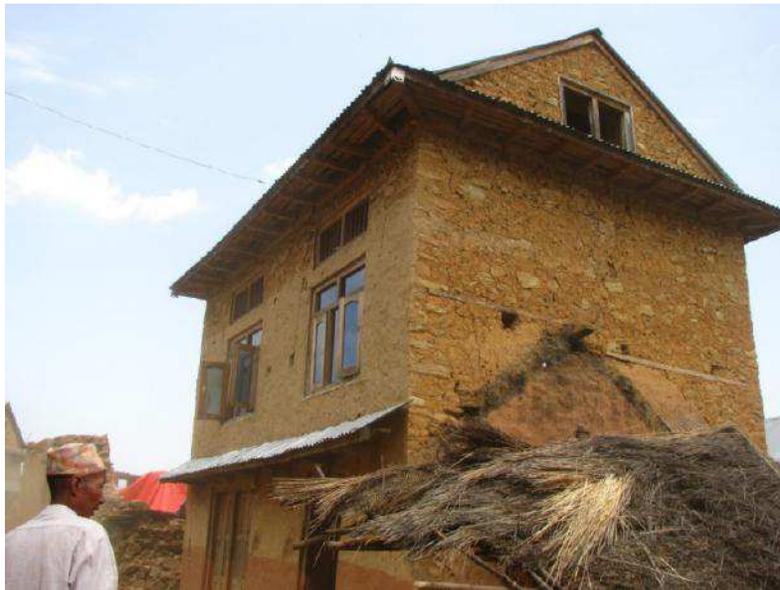
The Build Change team was in Thula Gaun, in the Balthali VDC, Ward No. 5, at the time of the M7.3 aftershock. Many homes in the village had already sustained considerable damage from the primary earthquake. During the aftershock, out-of-plane movement of the upper story stone masonry front wall was observed in one house that had sustained very little damage in the April 25th event. Given an estimated thickness of 12", observing this movement was very interesting. The house had a few small cracks in the stone masonry from the first event, but exhibited no additional damage or increase in the initial crack sizes or widths. The house had been built only 6-7 years earlier by a local builder. The upper floor had straight sheathing below the mud slab, which likely aided the house's lateral resistance by providing a resilient diaphragm at mid-height of the walls. However, prior to the aftershock, the owner had said that he wanted to tear the house down and rebuild a better, safer house.

Figure 83. Largely undamaged house as seen in the final moments of May 12th M7.3 aftershock, Thula Gaun.

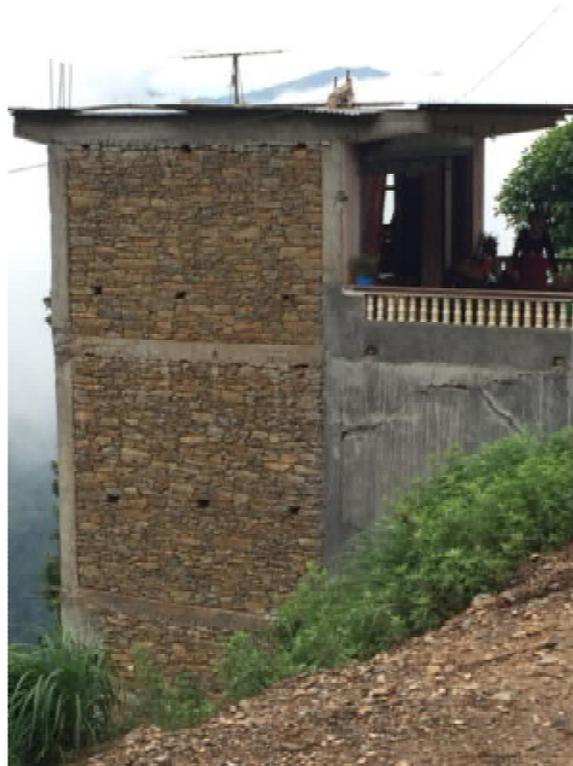
Figure 87. Reinforced concrete frame with stone and mud infill encountered in the rural area of Nuwakot.

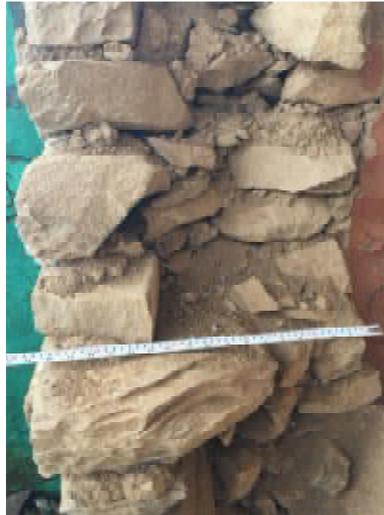
Figure 88. Wall section of a collapsed stone and mud structure, Kaule.

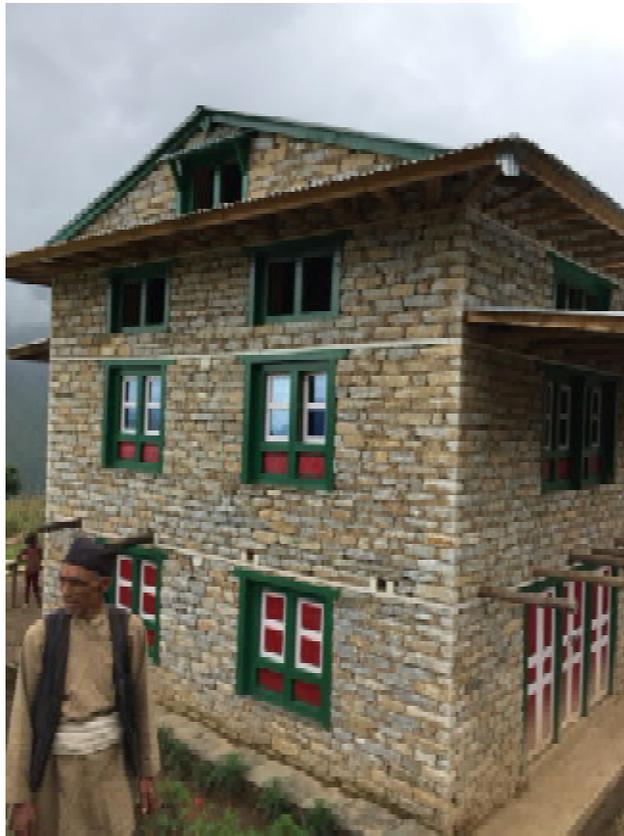
Figure 90. Exceptional stone work for stone and mud mortar building found in Chaulakharka, minimal damage

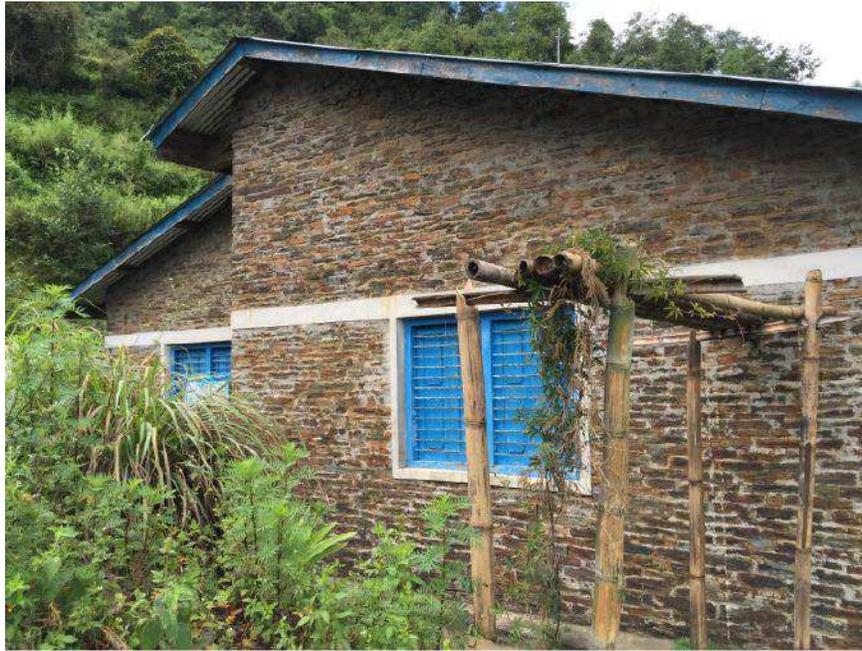
While not prevalent, the use of cement in construction in Ragani and Chaulakharka is worth noting. In Ragani a medical center built from stone masonry with cement mortar was observed and appeared to behave well during the earthquakes. Also, even though none of the stone masonry observed in Chaulakharka included cement mortar, a reinforced concrete frame building was being constructed in the village center during the time of our site visit. Encountering cement based construction in either of these VDC's was unexpected given access to the main market areas requires several hours of hiking, however these two examples of encounters with cement based construction in rural areas reinforces the notion that using construction materials other than stone and mud should not be ruled out entirely.

Figure 91. Medical center in Ragani built with stone, cement mortar, and a concrete band at the lintel level.

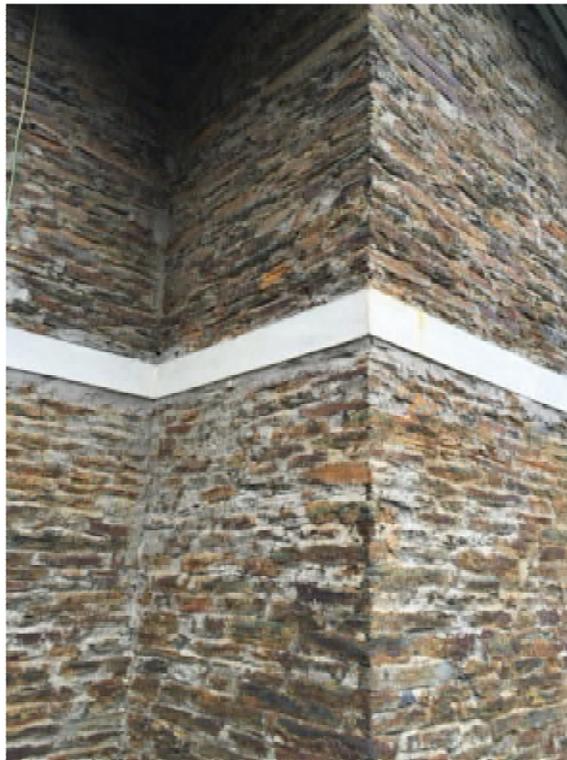
Figure 92. Stone with cement mortar and concrete band at medical center in Ragani

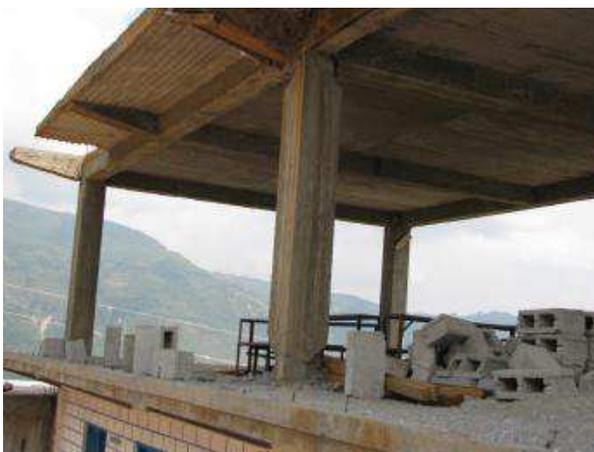
A multi-structure school in the remote village of Ichok also suffered similar damage as the Mahankal school. The older stone masonry structures had severe damage with most walls partially collapsed in the single story structures, although the steel supported and framed roof structures were still standing. Collapse of the walls appeared to be primarily due to out-of-plane failure of the unreinforced stone masonry. A newer two-story concrete frame structure was damaged primarily at the unfinished upper story. If the upper story were removed, the two lower story classrooms could be used again (See Figures 99 and 100).

Figure 99. Unfinished second story of school, Ichok.

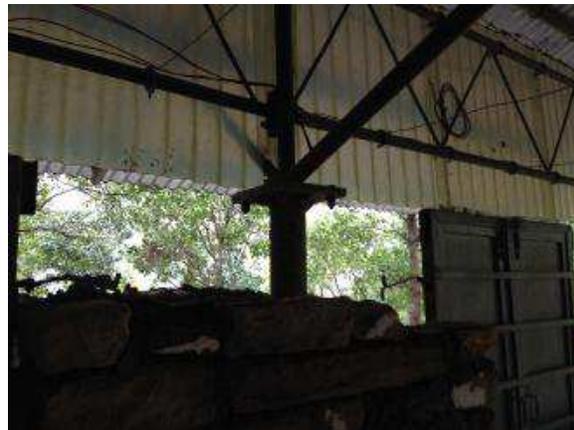
The schools that were observed in the rural villages were built with either stone masonry walls or concrete frames with brick infill. Many of the older school buildings that were observed consisted of stone masonry walls with steel truss roof framing. There was also one recently built school in Dhungharka with this same system that was constructed by builders from the village. Steel trusses observed in the field were made from either cold formed steel sections or structural steel tubing/HSS sections. In some instances the trusses were supported by steel pipe columns that were embedded inside stone masonry pilasters. Most of the school buildings that had this type of construction had damage to the stone walls, typically out of plane failures and/or delamination of the wall faces. However, in every case the roof framing remained standing.

Figure 102. School with steel framed roof and stone masonry walls, Ramche VDC

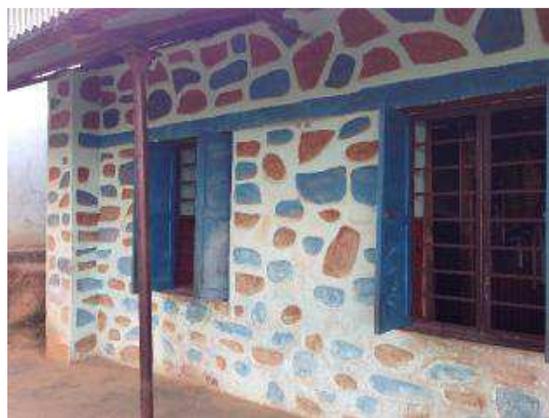
The school building in Dhungharka was constructed with a horizontal concrete band running over the top of the window and door openings. Horizontal bands are recommended in several stone masonry guidelines but this building was one of the few buildings the Build Change team found in the rural villages that had them. This building sustained no visible structural damage.

Figure 103. School in Dhungharka with a horizontal band over the windows and doors

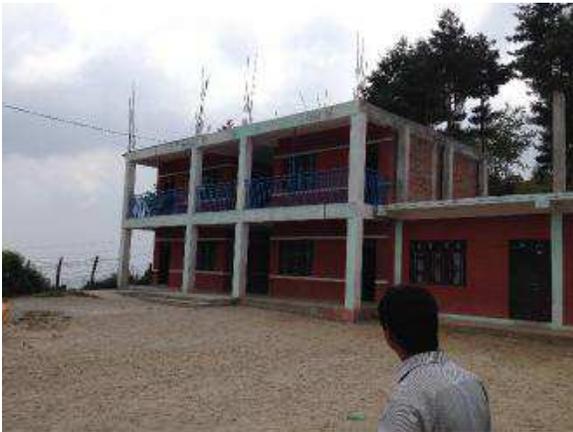
School buildings constructed with concrete frames were typically built by outside builders brought in by the government or by outside non-government aid organizations. The building in Mahankal Chaur was under construction at the time of the earthquake and did not appear to sustain damage. The fully constructed concrete frame school building in Chalal Ganeshthan also did not sustain any visible structural damage. An interesting feature of this building was that the concrete beams were poured on top of the constructed masonry walls, similar to confined masonry construction. In addition, one of the walls was infilled with stone instead of brick.

Figure 104. Concrete frame school, Chalal Ganeshthan VDC

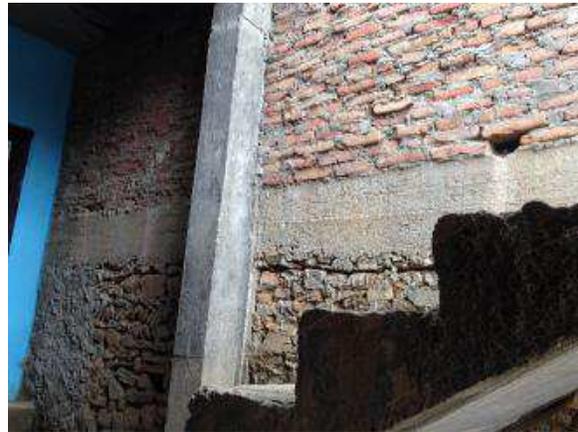
Figure 105. School with concrete frame and infill with brick and stone, with a beam poured on top, Chalal Ganeshthan VDC

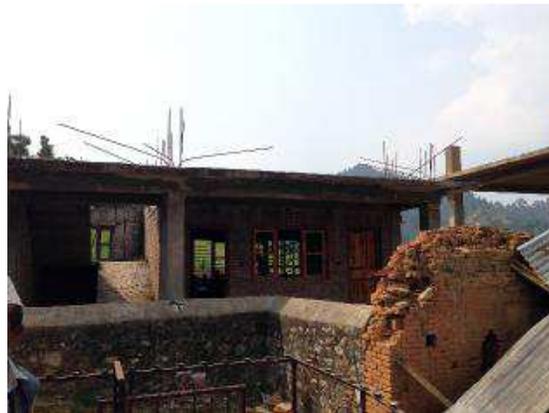
Figure 106. Concrete frame school building under construction in Mahankal Chaur

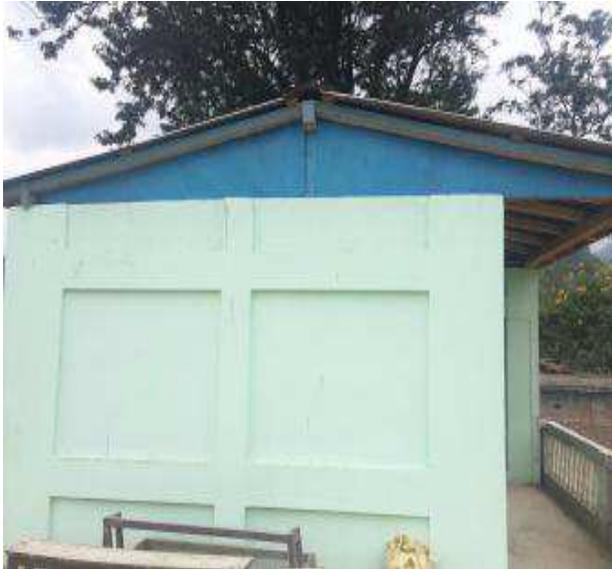
A school, in Devi Chaur VDC, of fired brick in mud mortar was retrofitted a few months before the April 25th disaster. The retrofitting was done using reinforced concrete (RC) splint and bandage. RC splint was provided at the corners and at either side of the openings and bandage was provided at the floor levels and at sill and lintel levels. The building had corrugated galvanized iron sheets with timber understructure. There were no visible cracks in the retrofitted

building whereas the building adjoining to this retrofitted structure, which was not retrofitted, was found to sustain damages to some of its walls. See Figures 107 and 108.

Figure 107. Retrofitted part of the school

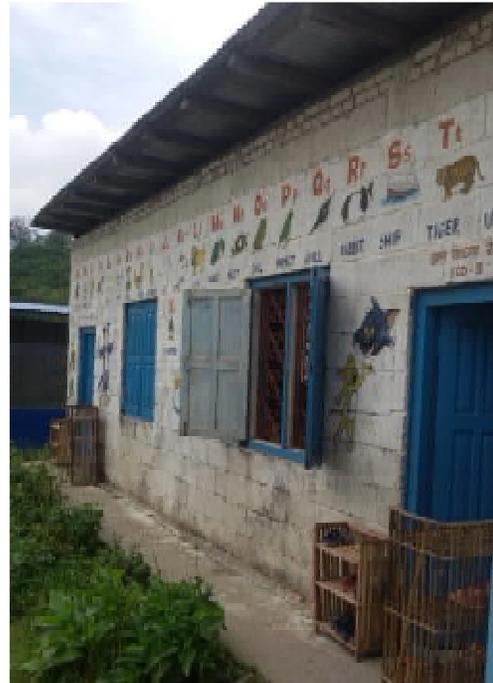
Figure 108. School building that was not retrofitted

The adjoining building was of concrete hollow blocks load bearing system with light CGI roof with timber framing. As concrete blocks are not commonly used in building construction in Nepal, the school authorities were under the impression that concrete hollow block masonry buildings could not be retrofitted. However, from other locations internationally where concrete blocks are used more commonly, there are established techniques for retrofitting this type of building.

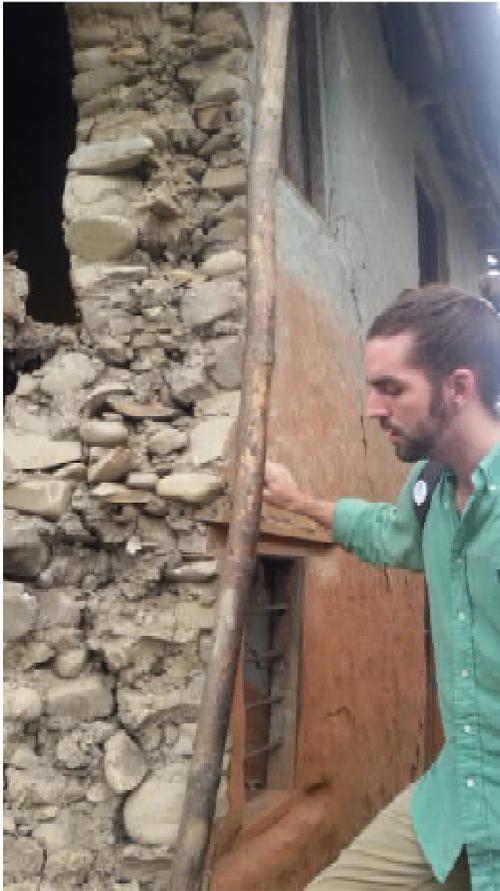
Figure 109. Partially collapsed mud in stone house

All of the buildings in the surrounding area, predominantly of stone in mud or adobe walls with timber flooring and roofing, were found to be damaged. See Figures 109 and 110.

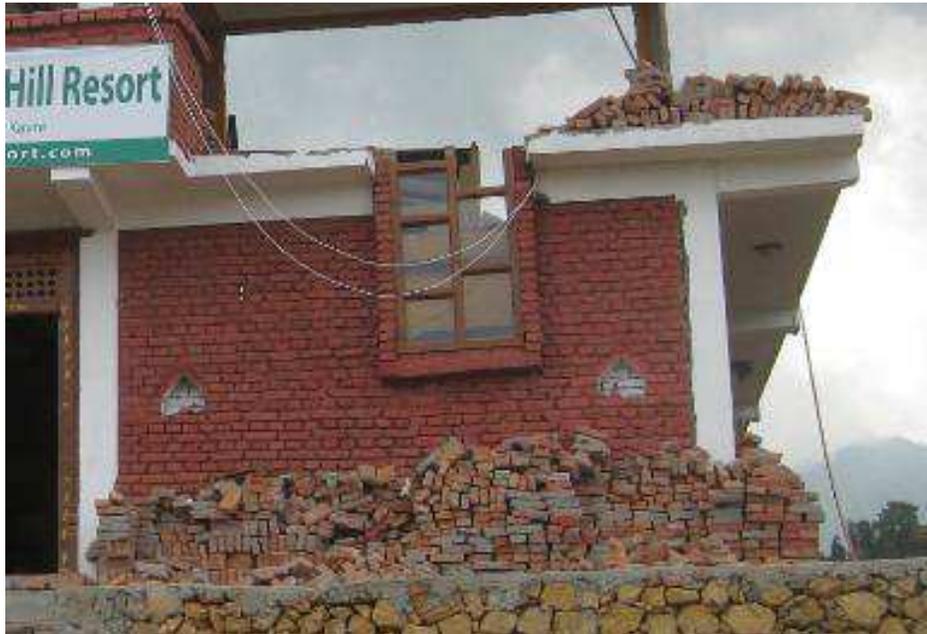
Figure 113. Construction of non-continuous, non-code complying beam at stairway of hotel structure in rural area, Thula Gaun.
