APRIL 16, 2016 - MUISNE, MANABI EARTHQUAKE, ECUADOR

Surveyed May 01-06, 2016

Build Change Post-Disaster Reconnaissance Report

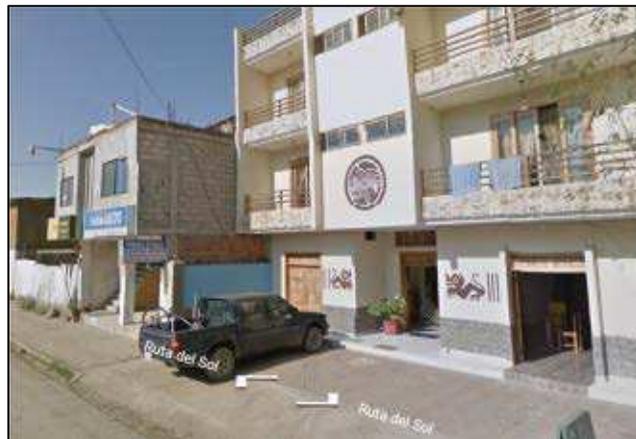
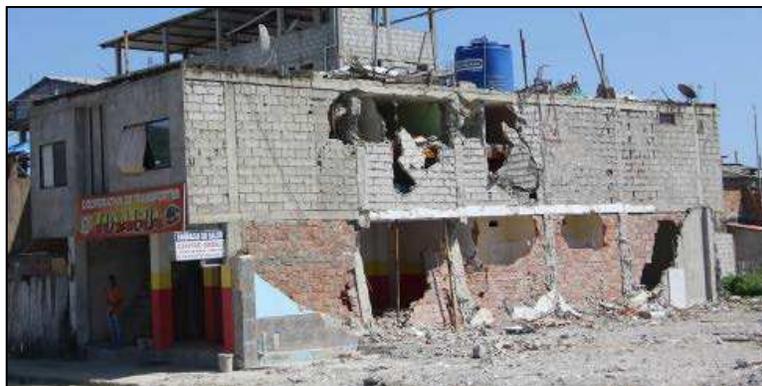
- Description:
Damages in buildings due to the adjacent building impacting it either repeatedly (pounding) (Fig. 55) or during collapse (Fig. 56). The damages were both on the exterior (cracking of frames and infill) and on the interior (in-plane cracking of walls resisting impact loads).
- Possible Causes:
Lack of seismic joint and diaphragms of adjacent buildings at different levels. Collapse of adjacent building.
- Possible measures for improvement:
Provide a seismic joint between adjacent buildings according to the expected drifts. Match the diaphragm levels between adjacent buildings where possible.

Figure 56. Adjacent building collapsed and affected this building in the mid-height of exterior walls, Canoa
