Oct 4, 2016 – Hurricane Matthew, HAITI  
Surveyed Oct 25-28, 2016  
Build Change Post-Disaster  
Reconnaissance Report

**BUILD CHANGE**

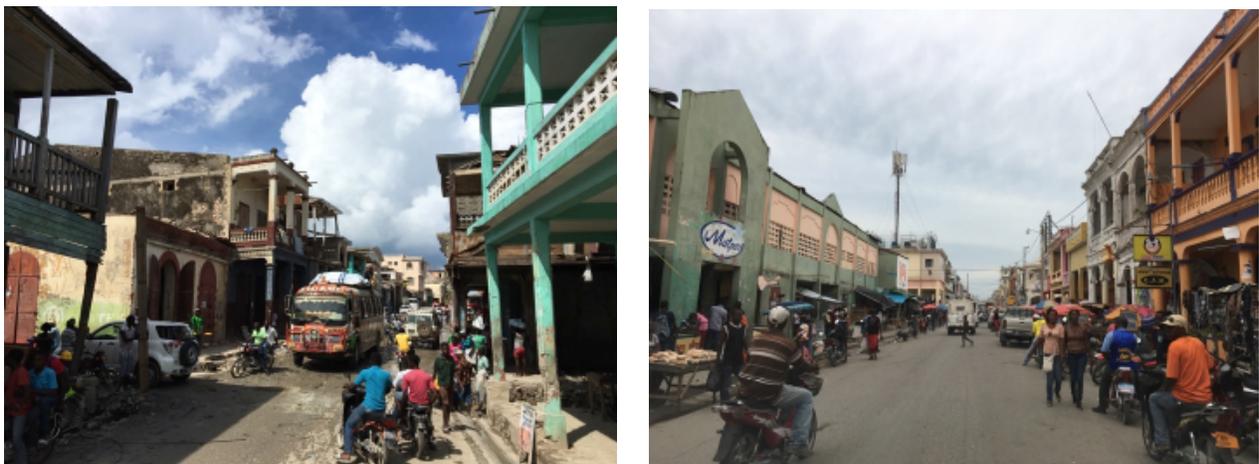
Figure 6 Left: Main road of Jérémie  
Right: City center of Les Cayes

**Type of disaster:** All the cities we visited suffered from extremely high winds. The storm surge affected the shores greatly as well. Floods due to rain greatly affected Les Cayes in the aftermath of the hurricane. Slope instability in areas on the outskirts of Jérémie was also of great concern.

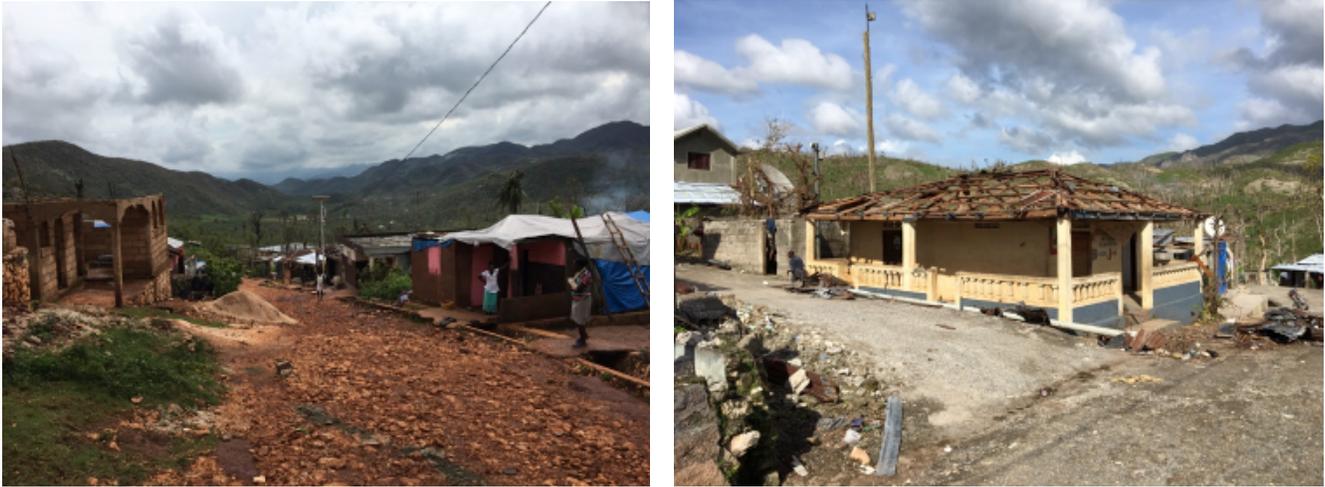
Figure 7 Left: View of Beaumont  
Right: View of Moron

**Type of disaster:** Villages in the mountains suffered from the extreme wind forces. Even though slopes can be significant in these areas, no landslide or slope instability issues were observed in the area visited. It is worth noting that these areas were covered with forest before the hurricane, which could have helped with retaining the soil.

**Roof:** The extreme winds recorded severely affected about 90% of the lightweight roofs we evaluated. The shape of the roof did not have a great impact on the extent of the damage. The main explanation for the damages appeared to commonly be due to the insufficient connections and the low quality of the metal sheets.

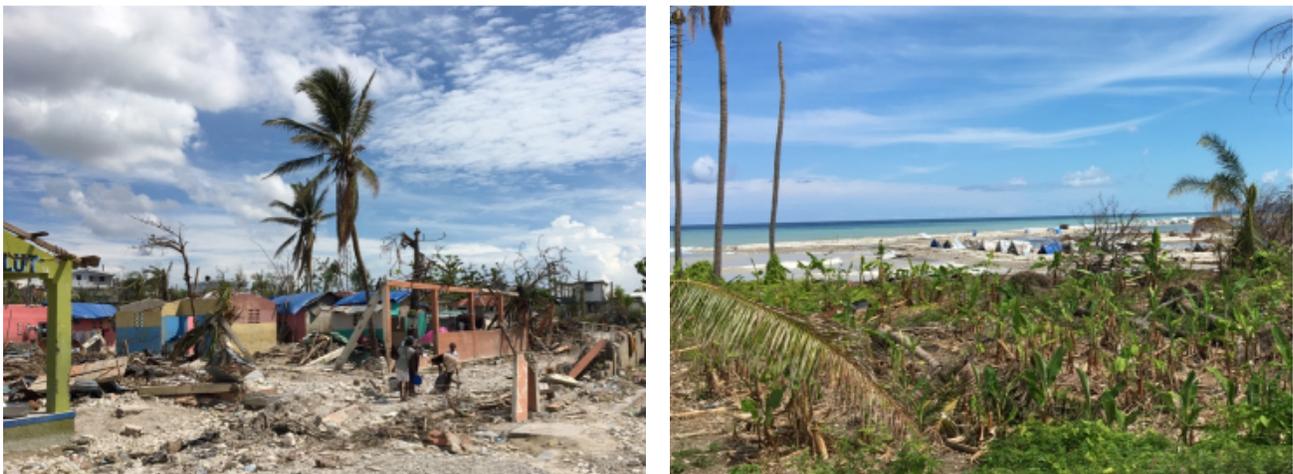
Figure 9 Left: Houses on the sea shore in Port Salut  
Right: Tents put up by fishermen who lost their houses by the sea

**Type of disaster:** Extensive damage was caused by storm surge in numerous cities and villages along the coast. Notably we visited Roseaux, Port Salut and Saint Jean du Sud. In many cases, waves damaged retaining or foundation walls causing the collapse of entire structures. Villages along the seashore were greatly affected by the storm surge; a settlement of fishermen between Jérémie and

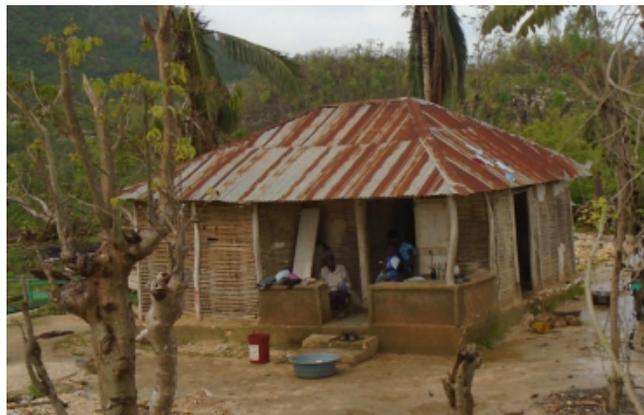
Figure 13 Wattle or Reed House

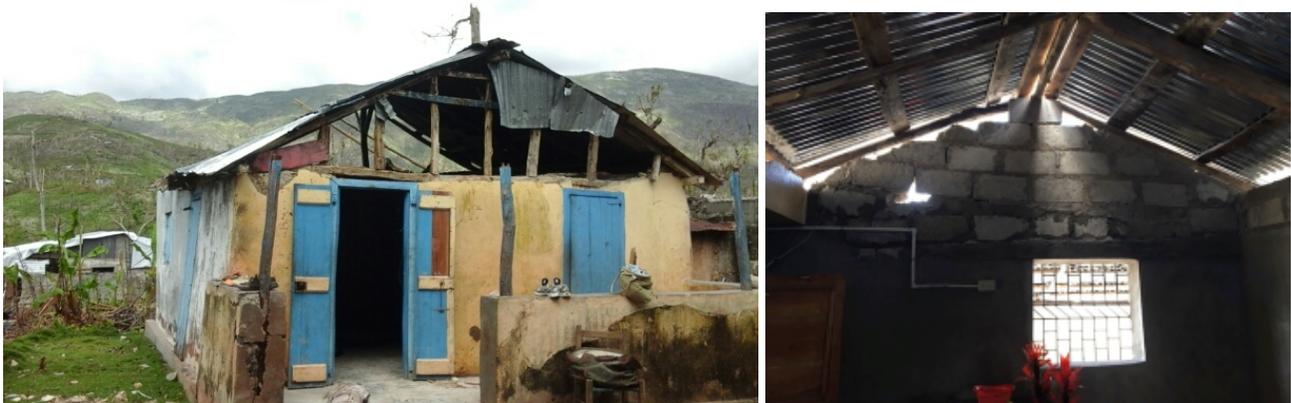
Figure 18 Left: house with a lightweight gable roof  
Right: Masonry gable wall not confined

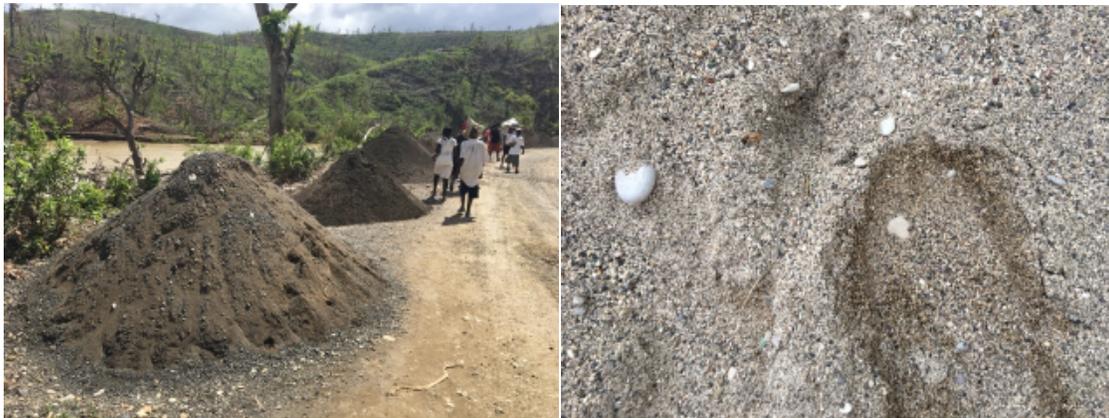
Figure 22 Left: River sand extracted from the riverbed, generally used unwashed.  
Right: Beach sand used for block manufacturing in Jérémie

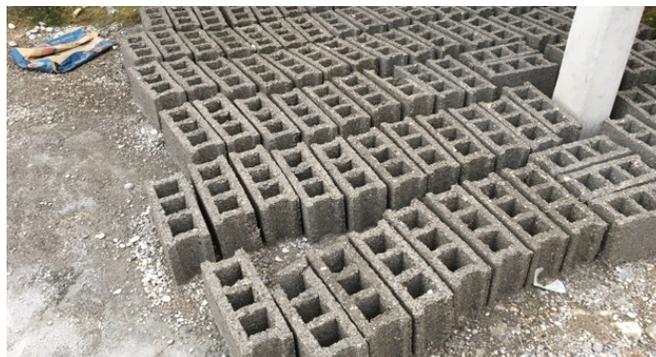
**Concrete Masonry Units, CMU:** Typically 15cmx20cmx40cm in dimension. Although no sampling and testing was performed during the visits, a visual assessment of the blocks quality was carried out. In Les Cayes, some block manufacturers are vibrating the blocks, but in the rest of the South and Grand'Anse departments, the great majority of blocks are manually made. The quality of the blocks is generally low due to use of poor quality material: unwashed sand, insufficient use of cement in the mix, and the addition of clay in the mix. The low quality was also due to a lack of training and knowledge of good manufacturing practices such as: insufficient curing, curing under the sun, and insufficient vibration.

Figure 23 Blocks curing in Jérémie

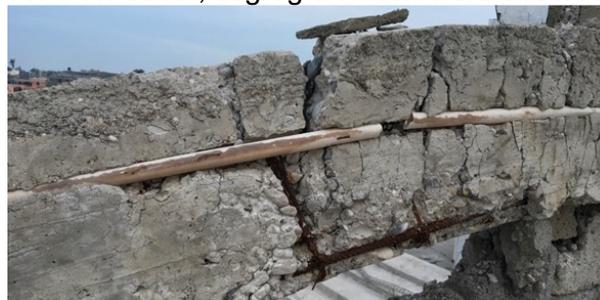
**Mortar and concrete:** Round gravel and unwashed sand is used in the concrete or mortar mix. Mud, lime and mud are also used in some villages. There is also a lack of training in the placement of the concrete and problems with concrete cover, segregation etc. were observed.

Figure 25 Reinforced concrete beam in Les Cayes

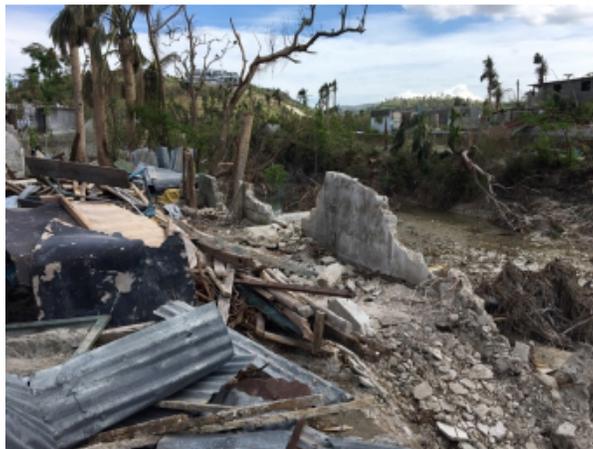
- Description:  
The Ecole Communautaire de Port-Salut was completely destroyed by a flash flood affecting the building foundation retaining wall and the building's masonry block walls.

Figure 42 Ecole Communautaire de Port-Salut located close to the ravine

- Possible Improvements:  
Building close to ravine should be avoided. An awareness campaign should be done for the population along ravines with the support of the mayor's office.

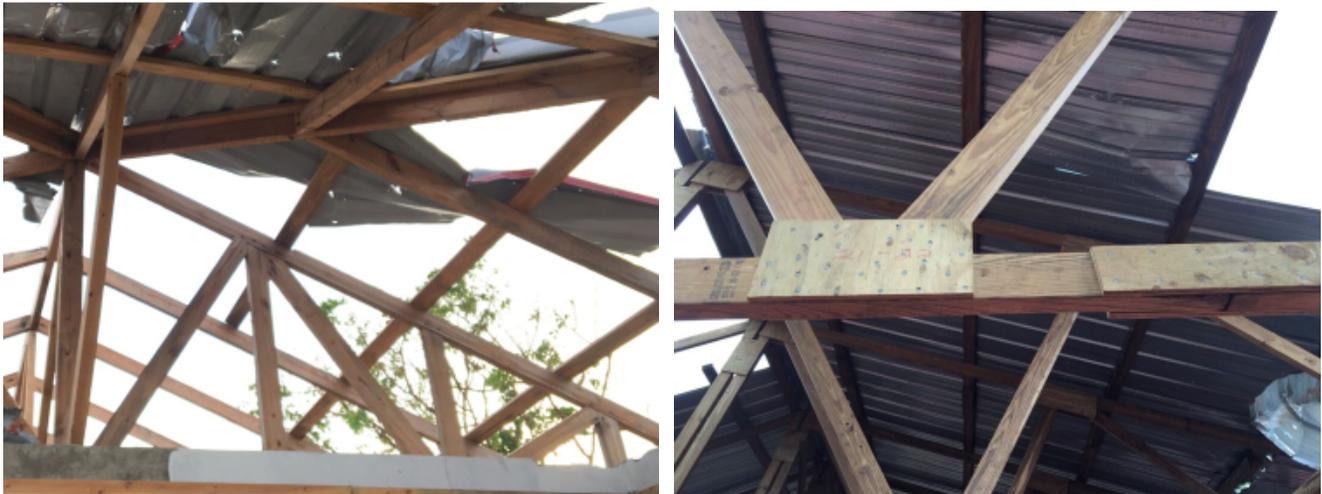
Figure 45 Left: Wood truss with simple nailed connection  
Right: Wood truss with gusset plate connection

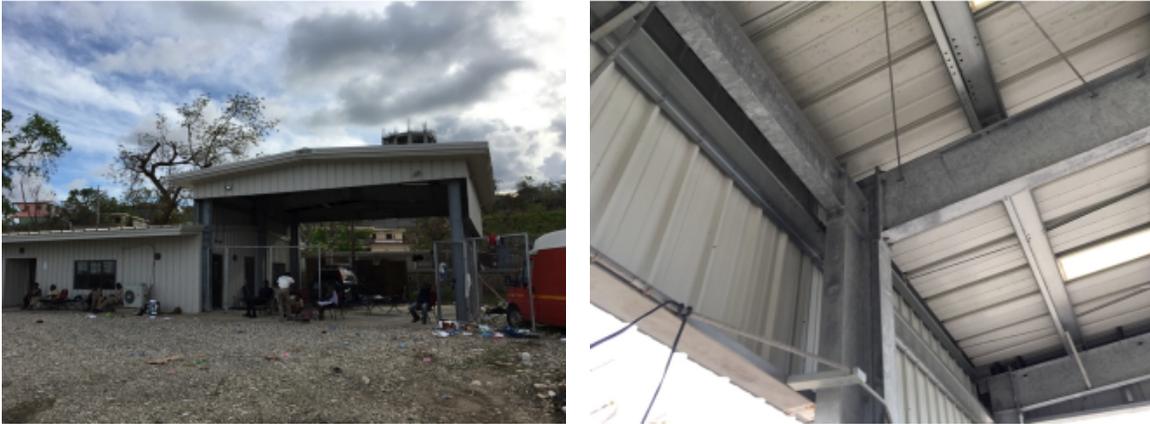
We evaluated the fire station of Jérémie, the structure did not suffer any damage.

Figure 49 Jérémie fire station

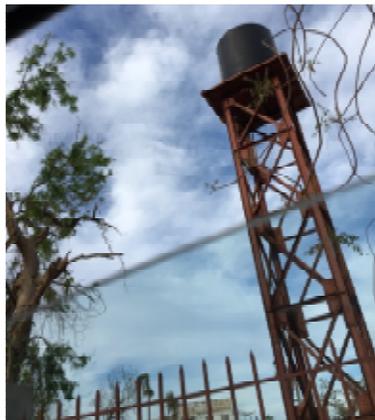
Figure 50 Undamaged steel frame water tower

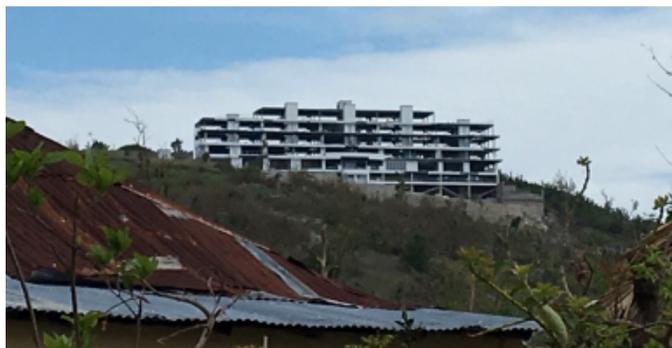
In Port Salut a new hotel made of metal frame located on the top of the mountain exposed directly to the sea suffered extensive damaged to the windows and infill but the primary structure resisted.

Figure 51 Metal frame hotel in Port Salut

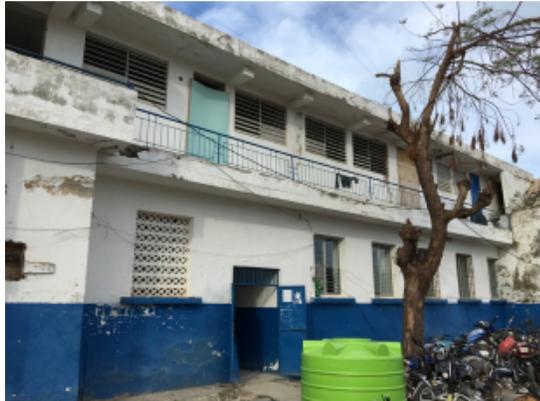
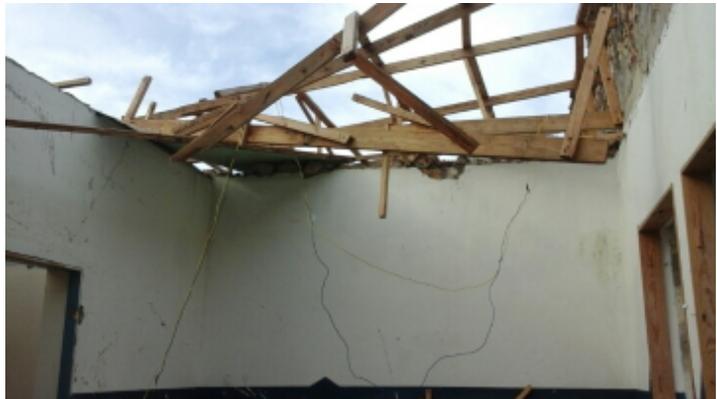
The police stations we visited suffered little damage to the wall structure. Nevertheless the lightweight roof of the Jérémie police station was blown away. The roof structure failed due to several reasons: poor connection to the reinforced concrete frame, failure of the metal sheet and failure of the some structural elements.

Figure 52 Left: Facade of Jérémie police station  
Right: Light weight roof of a part of the police station

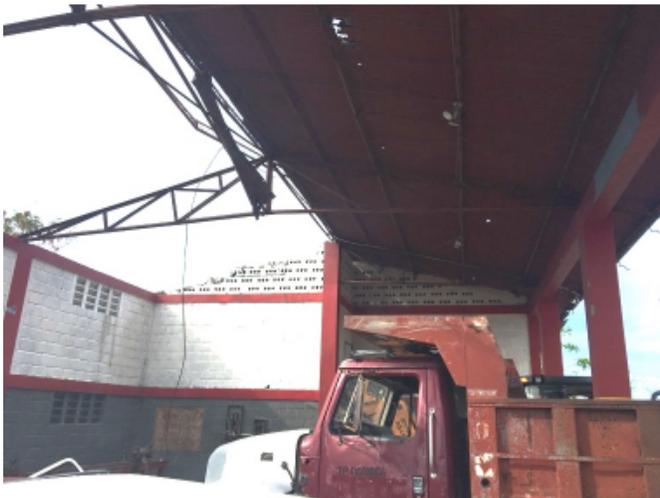
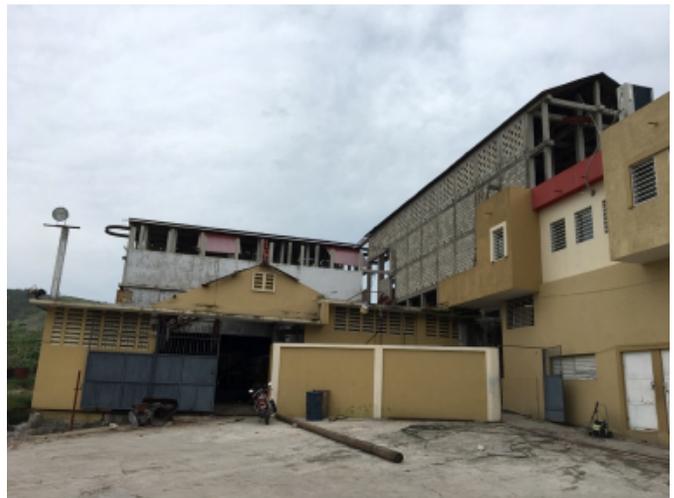
We visited a covered garage in Jérémie; the reinforced concrete frame did not suffer damage but the secondary structure of the roof failed. The top part of the gable wall was damaged too. See Figure 53. See below a reinforced concrete vetiver factory in Les Cayes that did not have structural damage, but some windows were broken.

Figure 53 Left: Covered garage in Jérémie  
Right: Undamaged reinforced concrete factory in Les Cayes

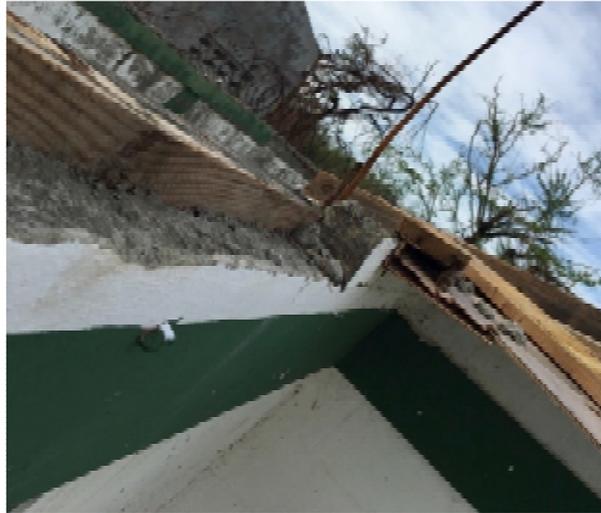
We visited offices between Roseaux and Jérémie, where the partially reinforced wall structural system resisted the hurricane well, but the lightweight wood roofs were blown away due to poor connection to the wall.

Figure 54 Wood top plate embedded in mortar to connect the roof rafters

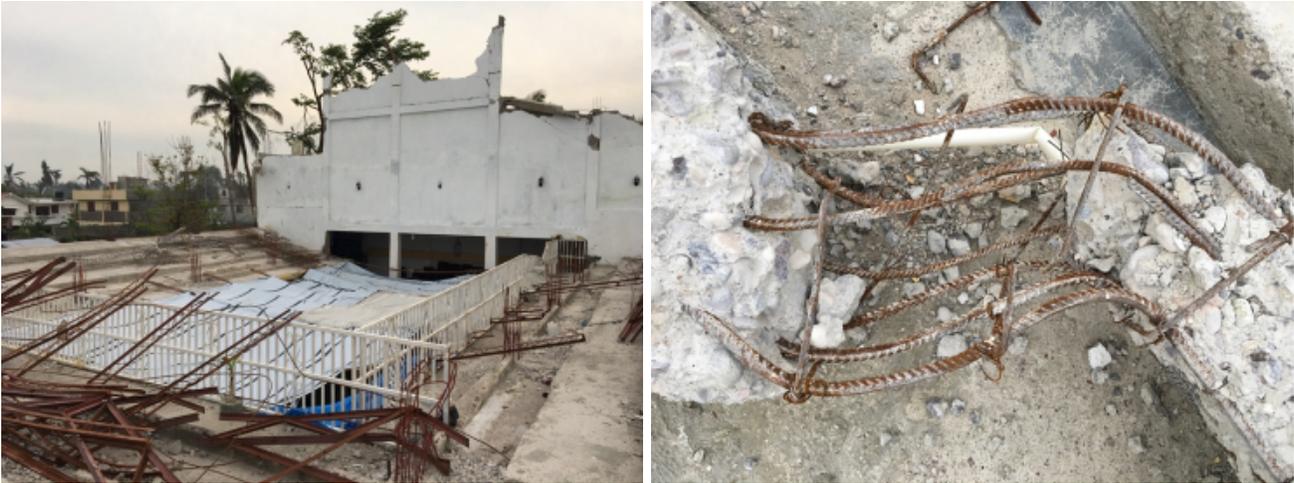
We visited a church in Les Cayes, which had a reinforced concrete (RC) structure for the level 1 and a combined steel frame and RC frame structure for the second level. The second level was completely destroyed by the hurricane winds. The concrete column failed at the base. The gable wall partially collapsed in the church. We observed very poor quality concrete (round gravel, brittle concrete) and blocks used for the structure.

Figure 56 RC and steel frame Church in Les Cayes
