**Overview**

**Housing Damage**

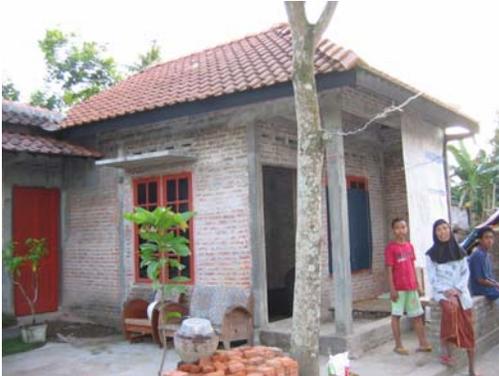
*Figure 8.* Well designed and built confined brick masonry house, edge of heavily damaged Pleret (Bantul), S7.83686° E110.41552°, IMG\_6636

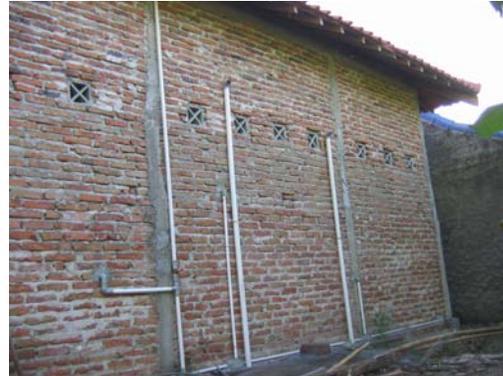
*Figure 9.* Backside of well designed and built confined brick masonry house, Bebekan Mulyodadi, Bambang Lipuro (Bantul), S7.94160°, E110.32297°, IMG\_6804

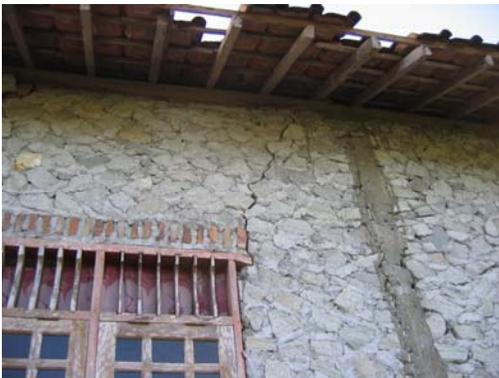
*Figure 10.* Partially confined stone masonry house with timber ring beam, Platar Somopuro, Jokonalan (Klaten), S7.75478, E110.53557, IMG\_6897

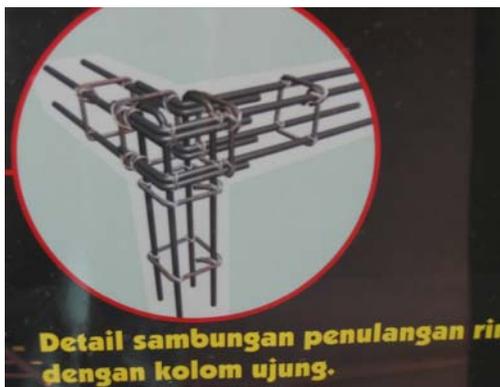
Prior to the earthquake, three houses were built in Wonokromo, Pleret (Bantul) under the supervision and direction of Prof. Sarwidi of the Center for Earthquake Engineering, Dynamic Effect, and Disaster Studies (CEEDEDS) at Universitas Islam Indonesia. These confined masonry houses used connection detailing shown in the posters distributed by CEEDEDS (Figure 11). The houses performed very well in the earthquake, with only hairline cracks, and in one case minor some damage to masonry gable wall (Figure 12).

*Figure 11.* Beam column connection detailing in posters distributed by CEEDEDS, UII, IMG\_6618

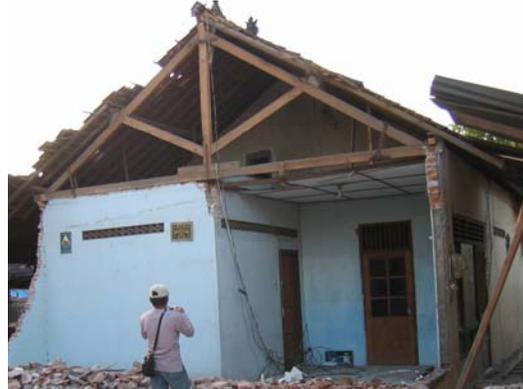
(4) Insufficient connections between walls or columns and roof. Column steel was often wrapped around a timber beam which functioned as a ring beam (Fig. 24). Timber beams were generally 8cm by 12cm and made from coconut trees or hardwood from Java and Kalimantan. Bamboo is also common for roof structures. Some older houses were a mix of structural system, in which part of the roof load was carried by timber posts infilled with masonry. A typical timber truss is shown in Fig. 25.

*Figure 25.* Typical timber truss with steel plates reinforcing the joints, Kasongan, Kasihan (Bantul), S7.84512° E110.33534° IMG\_6831.

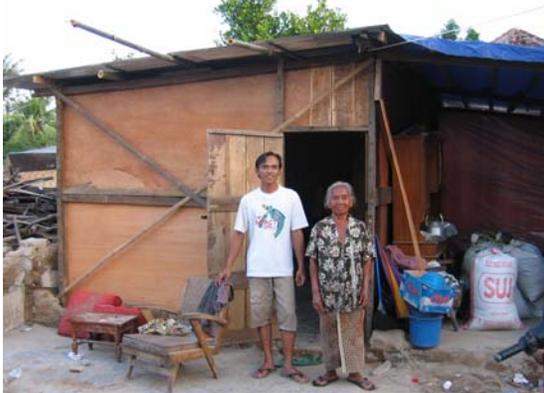
Tents were distributed in some areas, as were hammers, shovels and other tools to support debris clearing and recycling. Many families with destroyed houses have already rebuilt transitional one or two-room shelters on the foundation of their destroyed house (Fig. 29 and 30). Transitional shelters use a mix of recycled timber, bamboo, and window and door frames, and new plastic tarps, plywood and corrugated galvanized iron sheets. Also, many families were continuing to live in houses that were damaged beyond repair and vulnerable to collapse in aftershocks.

Figure 29. Transitional house in Pleret (Bantul),  
S7.83686° E110.41552°, IMG\_6646

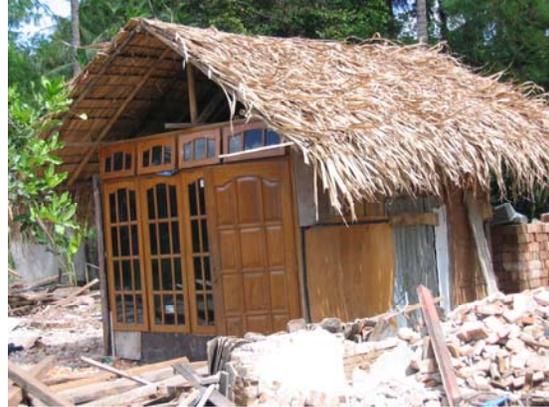
Figure 30. Transitional house in Pleret (Bantul)  
IMG\_6727
