**April 25, 2015 – GORKHA EARTHQUAKE, NEPAL**

**Surveyed May 5-19, 2015  
May 31, 2015**

## Build Change Post-Disaster Reconnaissance Report

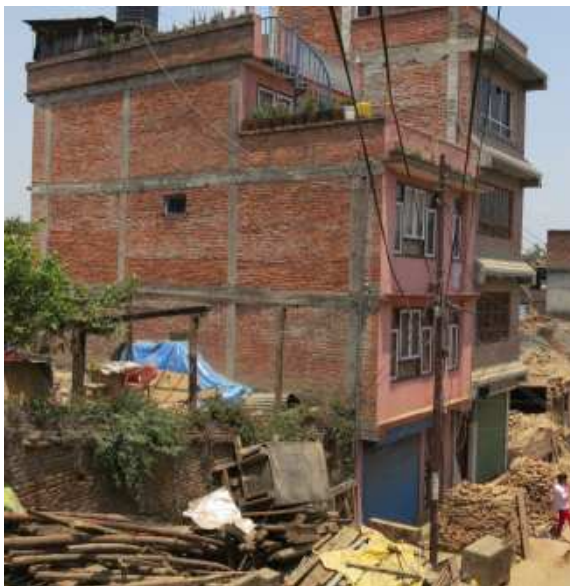
The concrete reinforcement is primarily limited to four deformed longitudinal bars in columns and beams, with widely spaced ties. There was no indication of reinforcing in any of the brick work, nor of any ties between the brick infill and the concrete columns and beams.

*Figure 11. Reinforced concrete frames with masonry infill.*

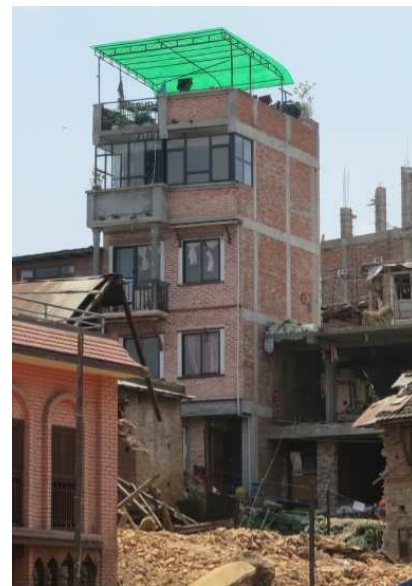
*Figure 12. Reinforced concrete frames with masonry infill.*

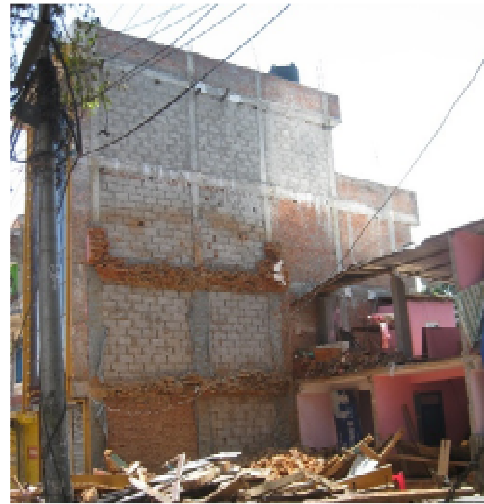
*Figure 14. Concrete block infill, Chautara.*

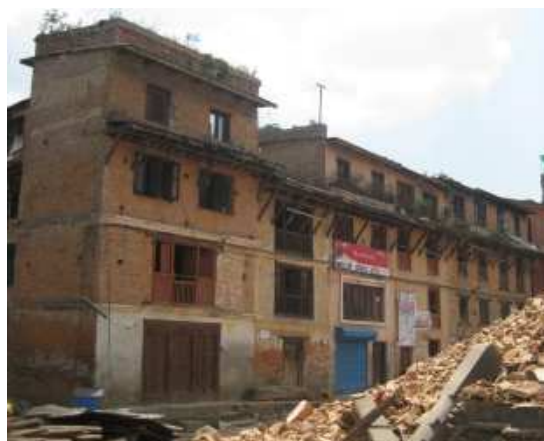
Older urban house structures utilize unconfined, unreinforced brick masonry with either wood or masonry lintels at door and window openings and wood-framed floors supporting heavy mud floor and roof slabs, or sloped wood-framed roofs or canopies with corrugated galvanized iron (CGI) or clay/stone tile finishes. The masonry wall thicknesses range from 12” to 18”. A mud mortar is found in the older buildings, and the brick walls are most often exposed, and not plastered over (See Figure 15).

Figure 15. Urban area unconfined, unreinforced masonry buildings,

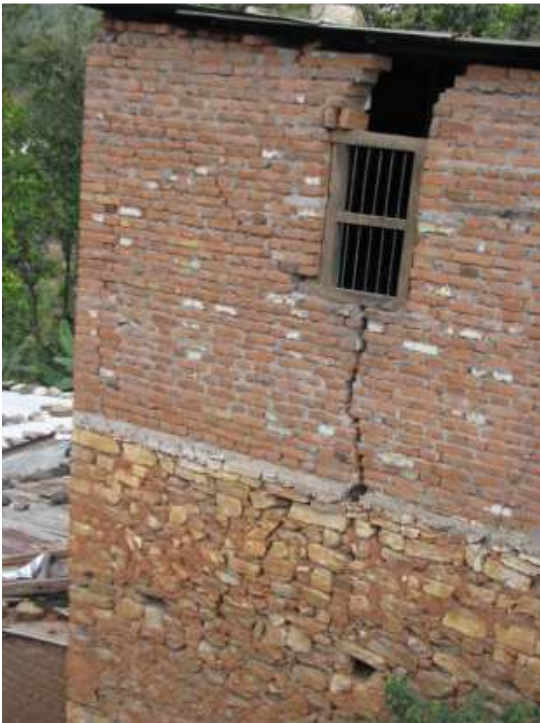
A common theme seems to be that a single level home is first built, with additional stories added as more money for further construction becomes available. Figure 16 is an example of this with mud mortar used throughout, at both the stone and brick masonry, occurring in a hilly remote area accessible only by a narrow dirt road. Figure 17 illustrates similar mixed materials, but in the town of Zero Kilo, on a paved highway route where access is not difficult. Here, cement masonry was used at the brick walls, with a combination of cement or mud mortar at the stone masonry. Figure 18 illustrates combined brick and stone infill used at the ground floor level of a concrete frame school building. The infill at the upper levels was solely brick masonry.

*Figure 16. Brick above stone masonry, Balthali VDC.*

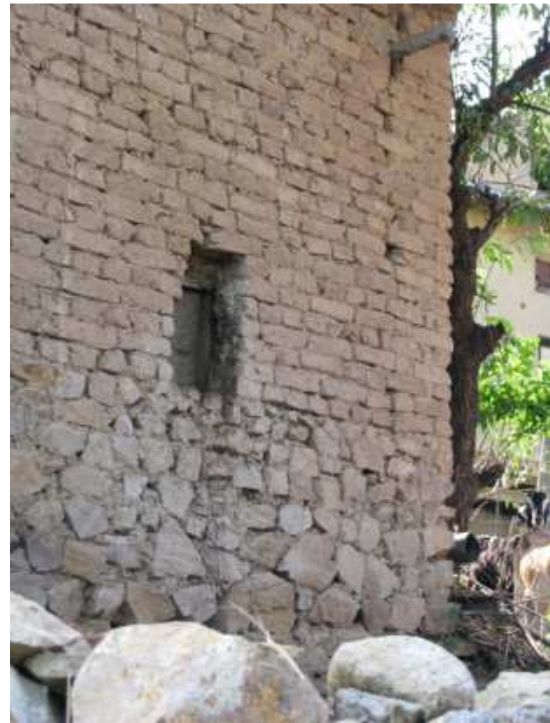
*Figure 17. Brick above stone masonry, Zero Kilo.*

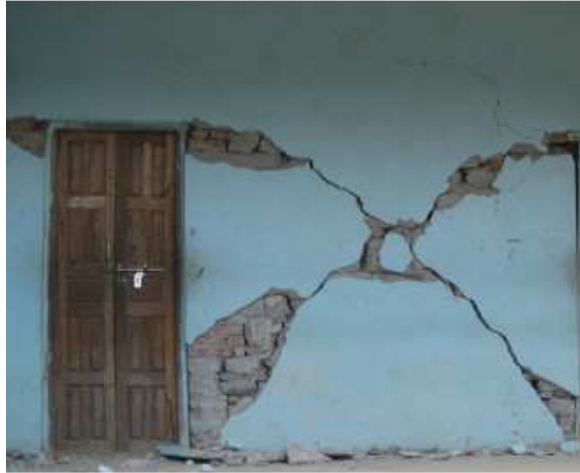
*Figure 18. Use of mixed brick and stone for infill construction, to economize costs School in Mahankal.*

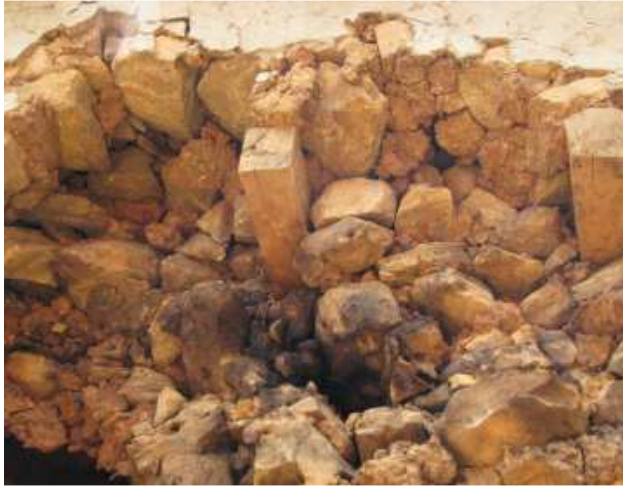
Figure 19 is an example of stone masonry. A near constant with stone masonry is the use of a mud mortar. The soil used for the mortar appears to be a clay material, reddish in color, and predominant in the local geologic landscape. Figure 20 shows a piece of mud mortar from a stone masonry wall.

*Figure 19. Random shaped stone masonry, Thula Gaun.*

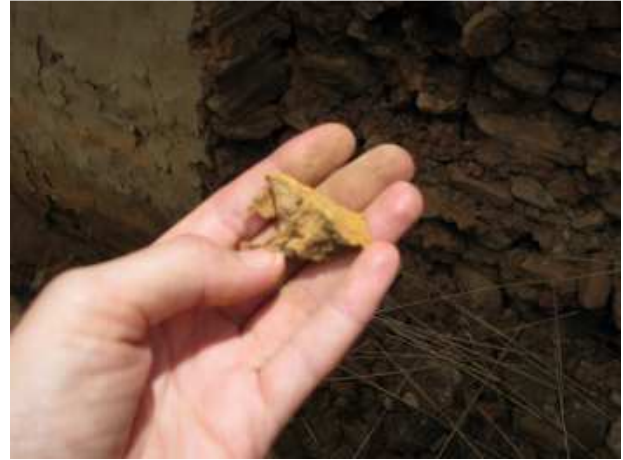
*Figure 20. Piece of mud mortar, Thula Gaun.*

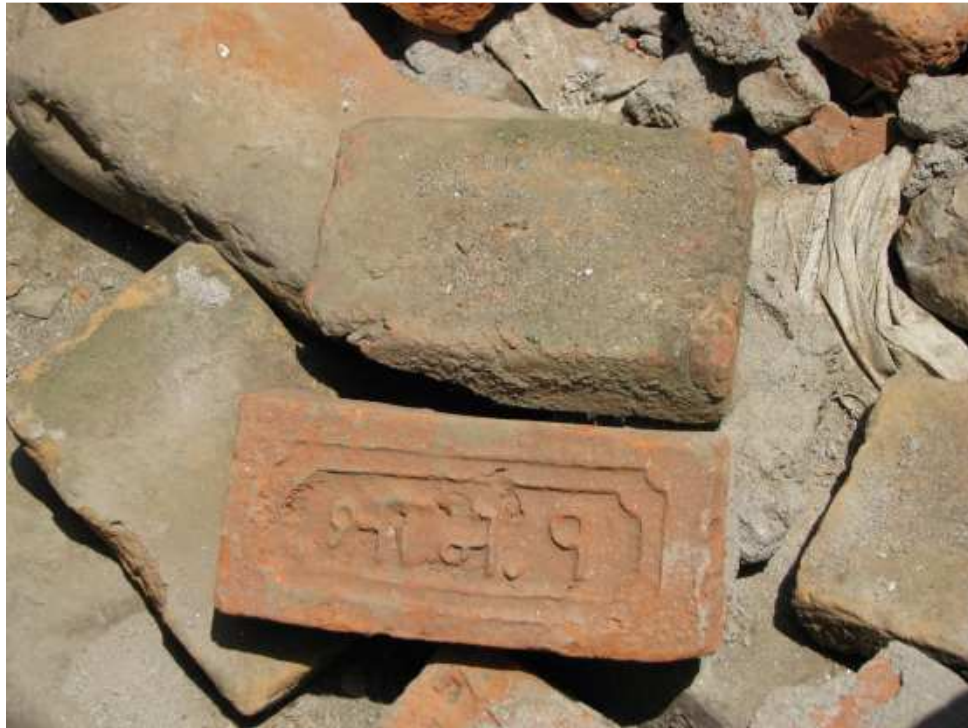
There is a noticeable difference between the brick used in newer versus older construction, which could contribute to the difference in earthquake performance. The newer bricks are taller in height, narrower in width, and longer in length than bricks from older construction. Additionally, the newer bricks usually have deformations with a brick maker's logo embossed on at least one side of the brick. Bricks from older construction tend to be flatter in shape and smooth on all sides. Figure 21 shows a side-by-side comparison of bricks from newer and older construction.

*Figure 21. Older brick, above, compared to newer brick, below. Note brick maker's embossment on newer brick.*

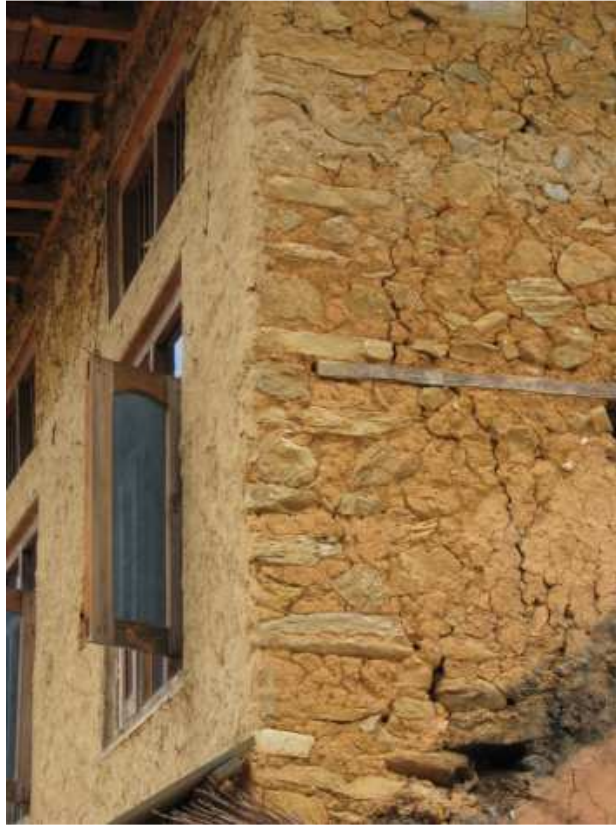
The stone work varies from randomly shaped loose stones of varying sizes, likely dug out of the hillsides, to formed stones cut from the mountainsides. Depending on location, some of the cut stonework is of small and thinner rectangular shapes, closer to brick sizes, while other cut stones are much larger and taller, approaching concrete block size. Figure 25 illustrates the variety in stone shapes and sizes used.

*Figure 25. Example of flat cut stone with random stone shapes, Thula Gaun.*

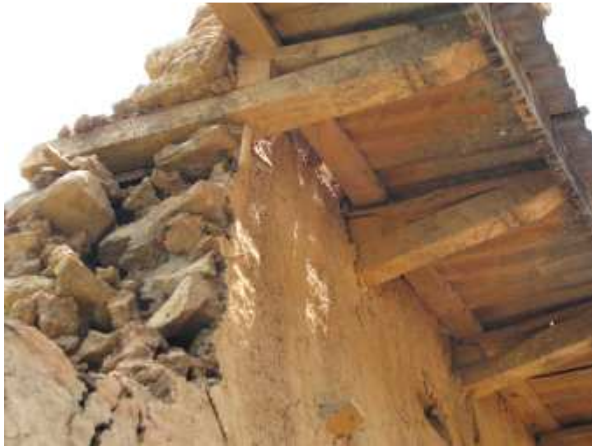
*Figure 30. Pegged roof rafters in wall, Thula Gaun.*

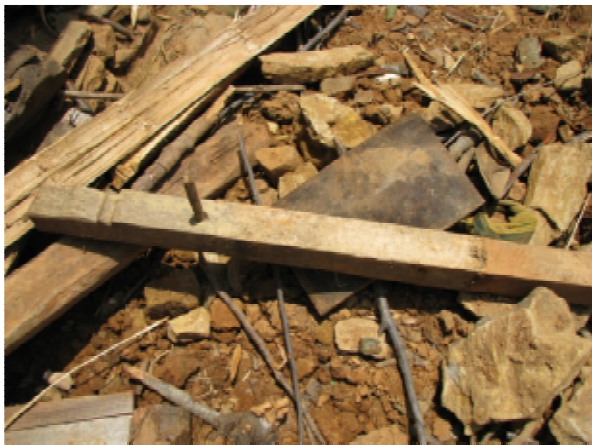
*Figure 31. Pegged rafter in rubble pile, Thula Gaun.*

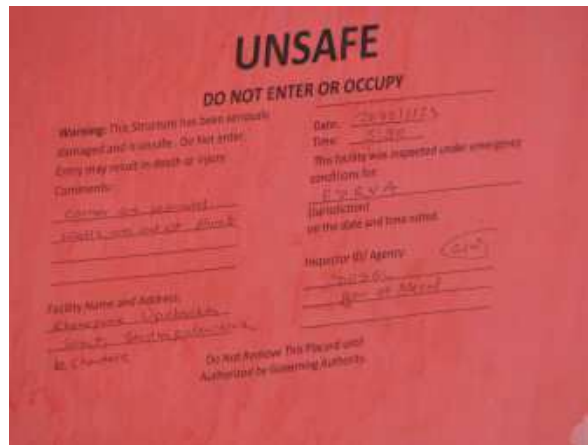
In Chautara, engineers from the Nepal Department of Urban Development and Building Construction (DUDBC) had been performing post-earthquake assessments and posting buildings with red, yellow, and green “tags” for entry. Most tagging observed was in the form of open circles spray-painted on the front walls of the buildings, usually near doorways. In one instance, a red placard was posted adjacent to the red circle. Figures 50-52 show the assessment posting circular “tags”.

Figure 52. Placard on red tagged building, Chautara.

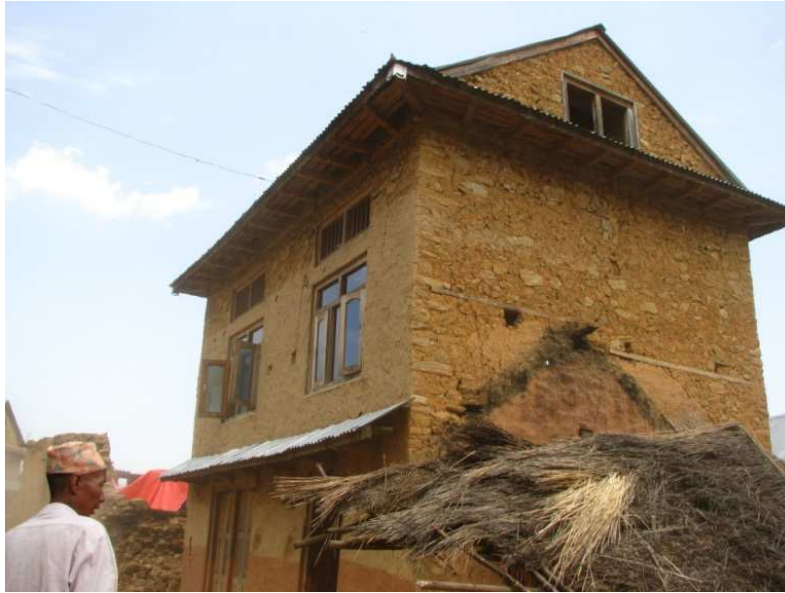
The Build Change team was in Thula Gaun, in the Balthali VDC, Ward No. 5, at the time of the M7.3 aftershock. Many homes in the village had already sustained considerable damage from the primary earthquake. During the aftershock, out-of-plane movement of the upper story stone masonry front wall was observed in one house that had sustained very little damage in the April 25th event. Given an estimated thickness of 12", observing this movement was very interesting. The house had a few small cracks in the stone masonry from the first event, but exhibited no additional damage or increase in the initial crack sizes or widths. The house had been built only 6-7 years earlier by a local builder. The upper floor had straight sheathing below the mud slab, which likely aided the house's lateral resistance by providing a resilient diaphragm at mid-height of the walls. However, prior to the aftershock, the owner had said that he wanted to tear the house down and rebuild a better, safer house.

*Figure 56. Largely undamaged house as seen in the final moments of May 12th M7.3 aftershock, Thula Gaun.*
