# Typhoon Odette: Needs Assessment in Bohol

# Initial Needs Assessment: Loboc, Bohol

# Initial Needs Assessment: Inabanga, Bohol

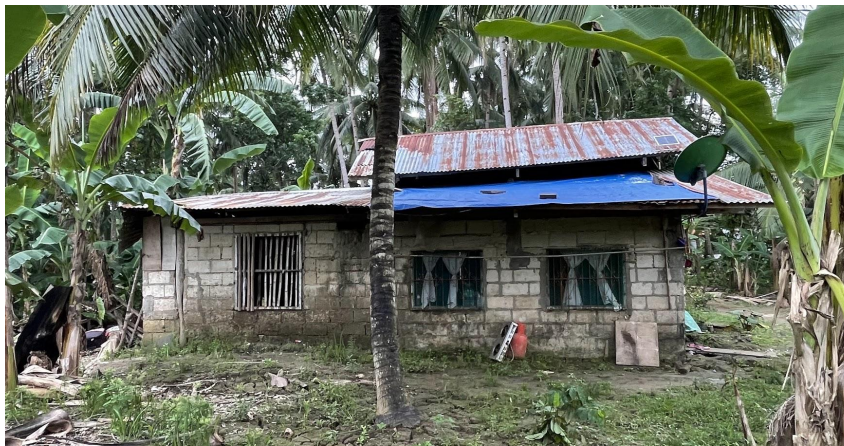
## Partially Damaged Houses:

**Brgy. Ugpong:** 33 Houses

(Estimated Cost: PhP 2.64 Million)

**Brgy. Valladolid:** 82 Houses

(Estimated Cost: PhP 6.56 Million)

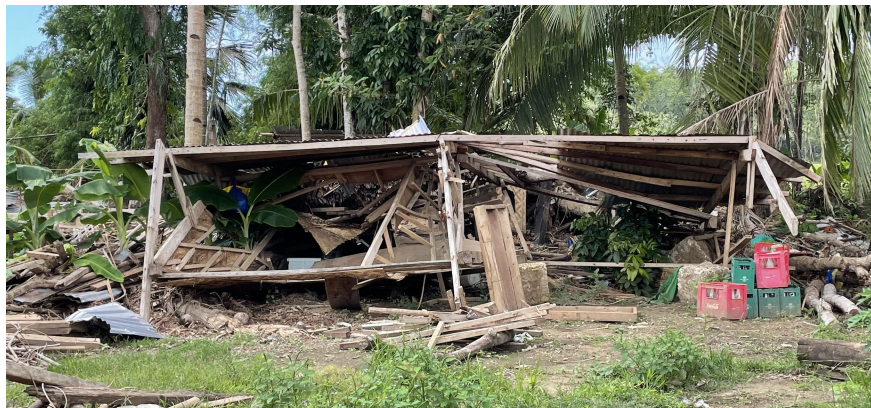
## Fully Damaged Houses:

**Brgy. Ugpong:** 19 Houses

(Estimated Cost: PhP 3.8 Million)

**Brgy. Valladolid:** 25 Houses

(Estimated Cost: PhP 5 Million)

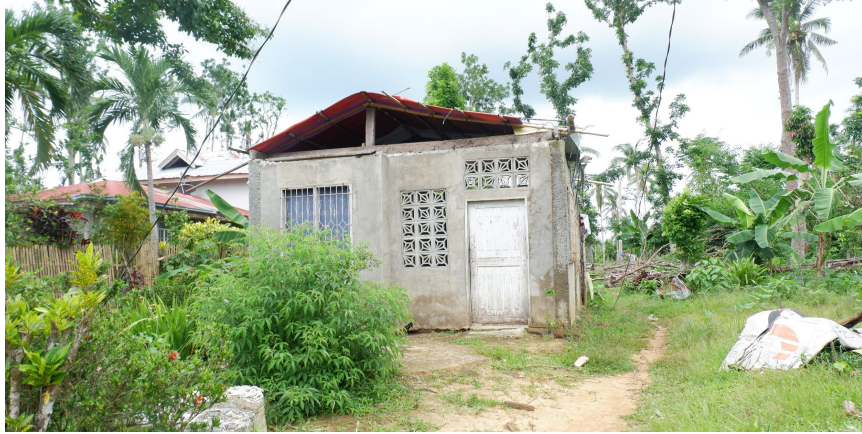
## Partially Damaged Houses:

**Sitio Bacayan, Barangay Badiang:**

3 Houses

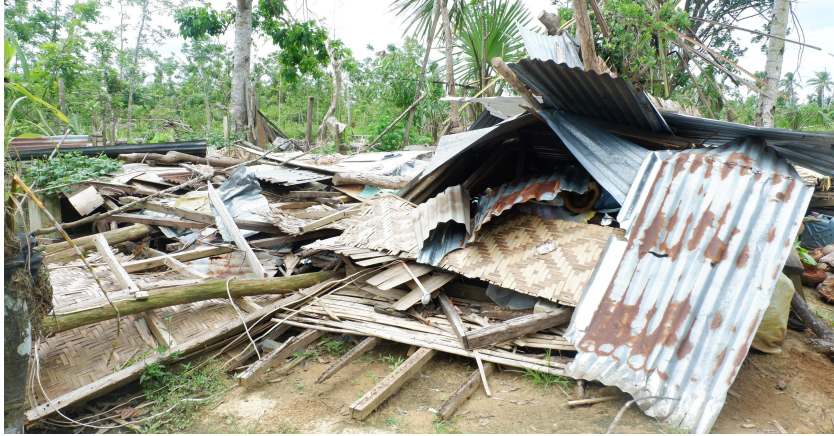
## Fully Damaged Houses:

**Sitio Bacayan, Barangay Badiang :**

49 Houses
