## **EARTHQUAKE RECONNAISSANCE REPORT 4 – 7 September 2018, LOMBOK - INDONESIA**

**Submitted: 12 October 2018**

This report was prepared by Build Change Design Engineer Laura Masmia Putri and Indonesia Program Manager Mediatrich Triani N. with support from the other reconnaissance team member, Elwahyudi, Technical Supervisor.

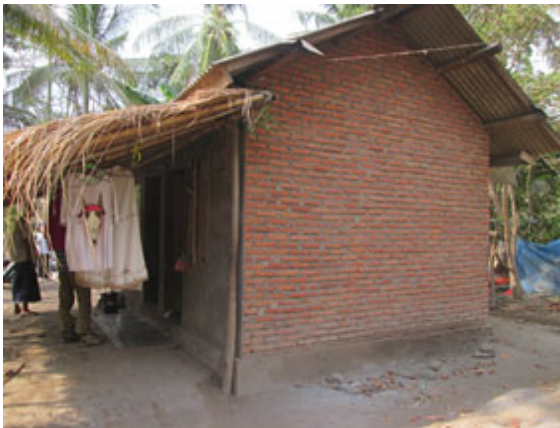
**Figure 4.** Typical unreinforced clay brick masonry house with open gable roof

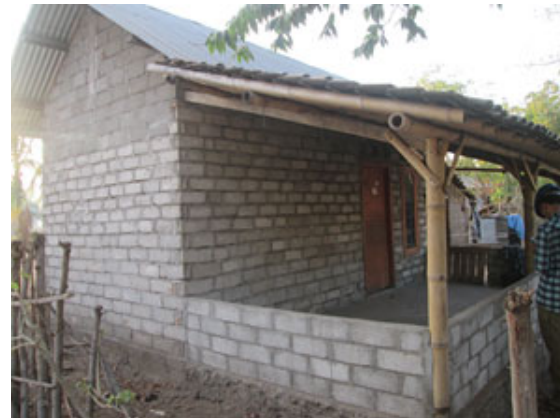
**Figure 5.** Typical unreinforced concrete block masonry house with open gable roof

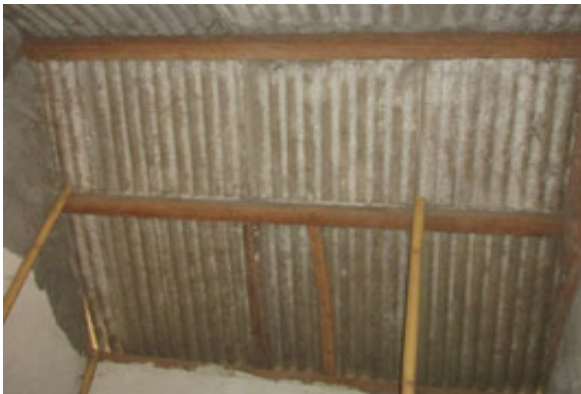
**Figure 8.** Roofing without trusses

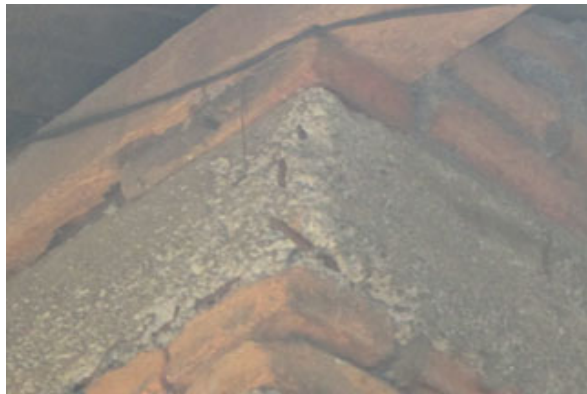
In a few cases, a reinforced concrete beam was provided at the top of the walls, despite the absence of reinforced concrete columns (See **Figure 9**). However, in most cases, there was no connection provided between masonry walls and roof framing.

**Figure 9.** Reinforced concrete beams were provided despite the absence of reinforced concrete columns

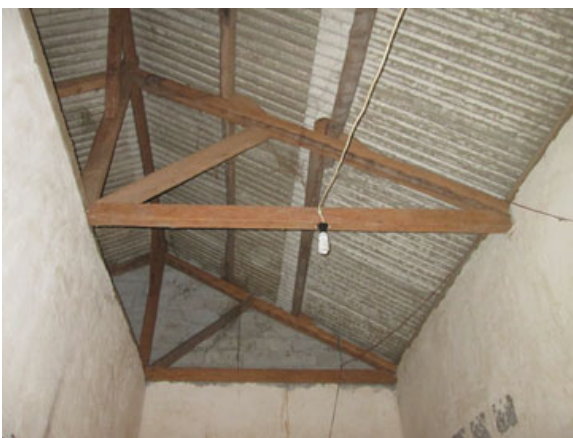
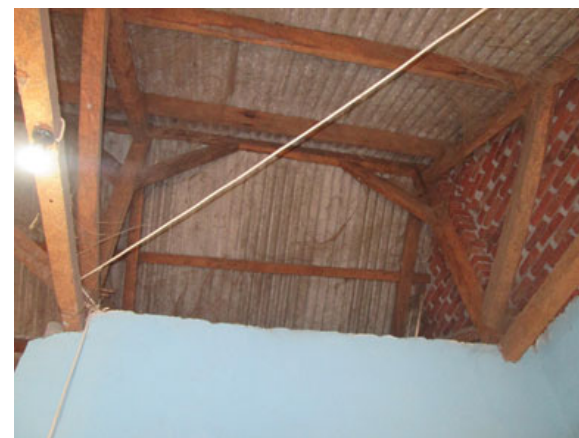
Open gable, hip (see **Figure 6**) and cross hip (see **Figure 7**) were the most common roof types encountered, with a few houses having a single-slope roof. Most of the houses inspected were provided with roof trusses every 2.5m - 4m. In some cases, purlins sat directly on top of the unreinforced masonry walls in lieu of truss-framing (see **Figure 8**). In other cases, the roof truss was connected to the top of the wall by smooth rebars (6mm - 8mm diameter) embedded into the URM walls. The roof truss or rafters were usually of good quality timber (of Grade II or I). Bracing between roof trusses was absent as shown in **Figure 10**.

**Figure 10.** Typical roof trusses when present

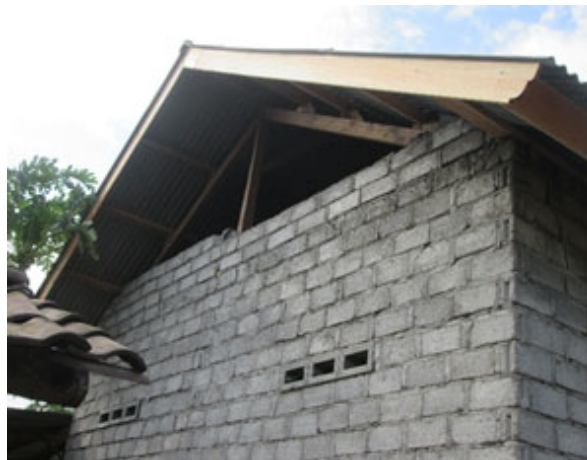
**Figure 17.** Gable OOP collapse

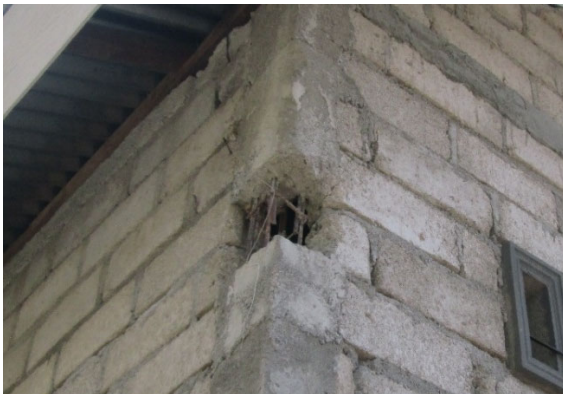
**Figure 20.** Longitudinal concrete reinforcement with four smooth rebar

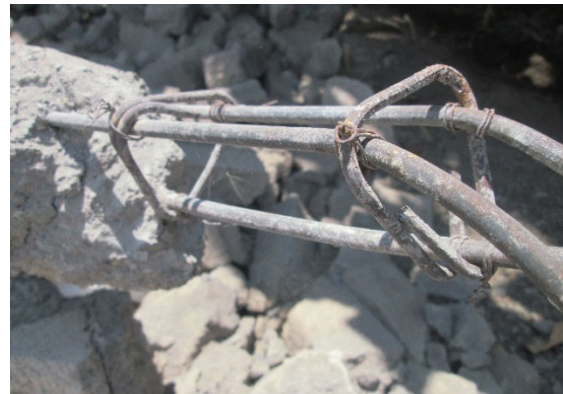
**Figure 21.** Longitudinal concrete reinforcement with three smooth rebar

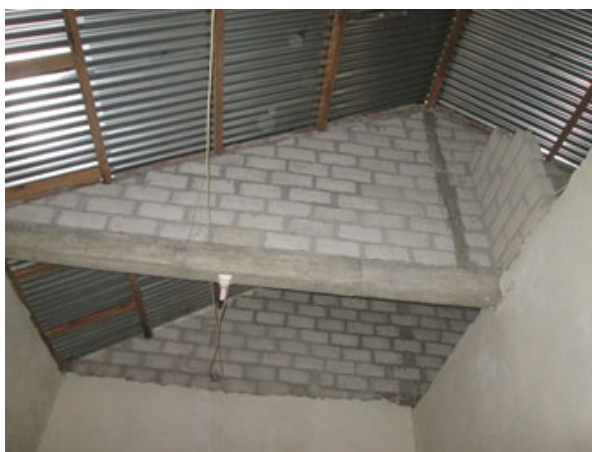
**Figure 26.** Partial confined masonry as the replacement of timber roof truss

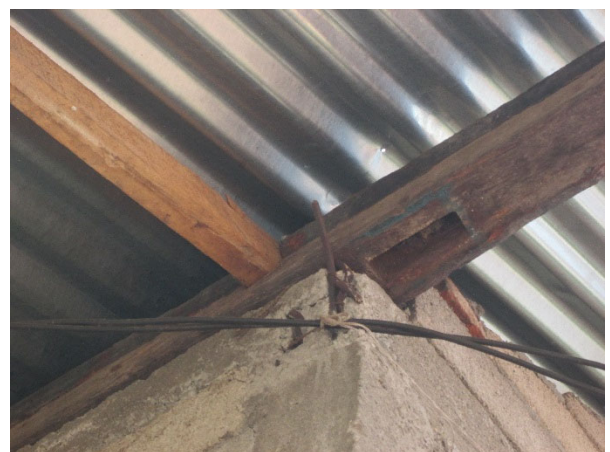
The roof is supported with timber and covered by metal sheets or clay tiles (see **Figure 24** and **Figure 25**). Unusual yet common practice to use timber frame confined masonry as roof support was encountered in few houses (See **Figure 26**). The roof is typically connected to the walls by protruded longitudinal rebar from columns that are bent around the rafter (see **Figure 27**).

**Figure 27.** Protruding rebar as connector between ties and roof timber

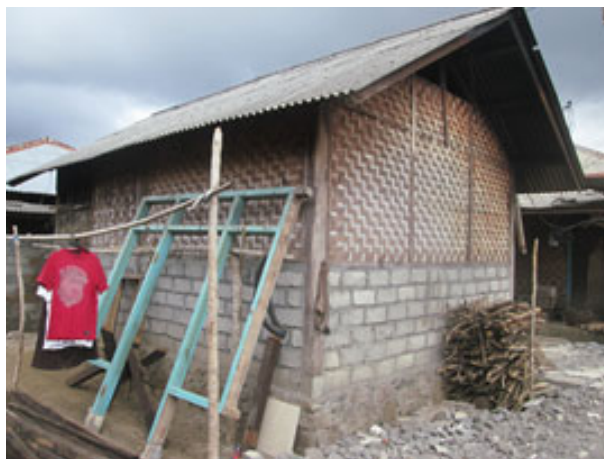
Timber frame houses are the most common type of housing structure in Sembalun Sub-district, especially in Sajang Village. The walls were usually 2.5m - 3m tall. The bottom 1m were made out of masonry: concrete block or bricks. The upper half of the walls were made of timber or bamboo panels (See **Figure 32**). In some cases, the infill extended to the top of wall (see **Figure 33**). The masonry infills were poorly connected to the timber posts. Generally, the wall frames were not braced, but knee bracing in corners was present in several cases. There was rarely a plinth beam present and connections between the timber posts and the footing were minimum, if not absent.

**Figure 32.** Timber frame with masonry skirt

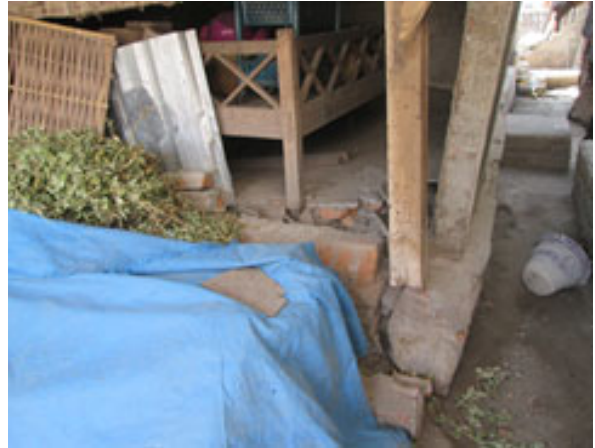
**Figure 35.** Shifting of timber post

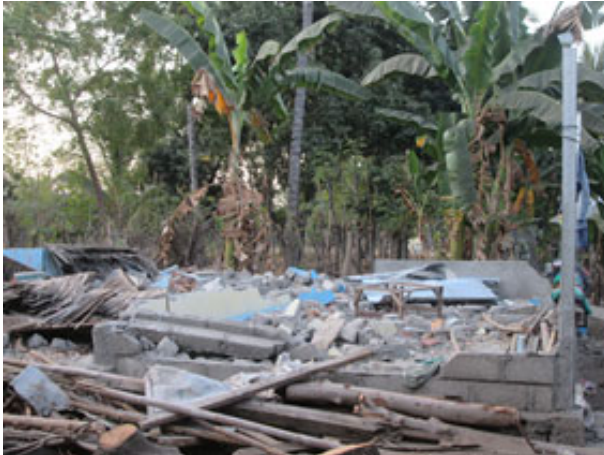
A few unusual construction practices were encountered in Akar-akar Village, Bayan Sub-district. In one case, lightweight steel was used for the main frame of the house (see **Figure 46**). Even though the house was already demolished by homeowner, the lightweight steel seemed to not be able to resist either the gravity loads or the lateral loads due to the earthquakes. In another case, bamboo was used as concrete reinforcement for a house that was estimated to be reinforced concrete frame with masonry infill or confined masonry (see **Figure 47**). The bamboo was also proven to be too weak and crushed due to the earthquake.

**Figure 46.** Lightweight steel frame with masonry infill

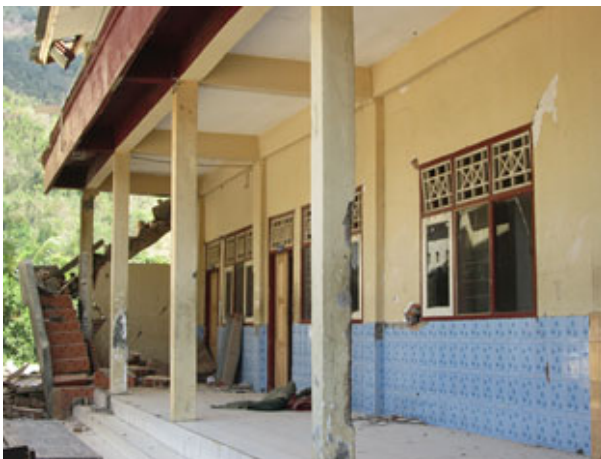
For one-story school buildings, the column and beams dimensions ranged from 13cmx13cm to 20cmx20cm. For two-story buildings, the column and beams were 20cmx30cm. For both one and two-story buildings, the columns were provided every 2.5m - 4m (see **Figure 52**), and the wall spans ranged from 7m to 12m. Mostly, a single building consisted of one to four adjacent classrooms at 7mx7m to 8mx8m. The openings typically took approximately 50% of the wall panels area and more than 80% of wall panels length. Typically for multi-classrooms buildings, the interior wall panels were made of full masonry wall without openings, yet some of interior transverse walls were made of removable wood planks to create larger rooms that can be used during meetings or special events. The exterior transverse wall panels were either made of solid masonry or masonry with small openings.

**Figure 52.** Columns were provided every 2.5m - 4m length

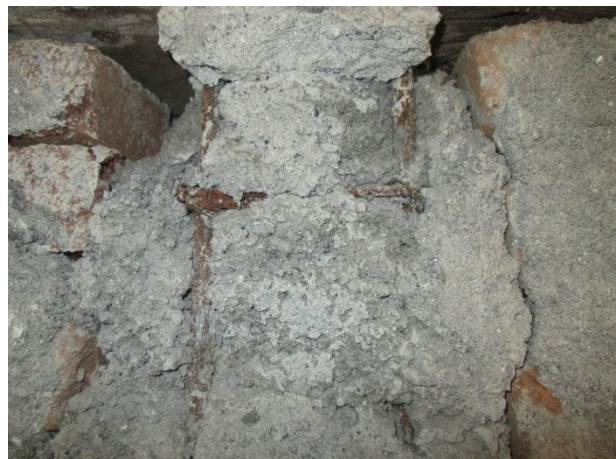
The concrete of columns ranged from poor to fine quality. Poor concrete composition and mixing process were evident (see **Figure 53**). The concrete frames were reinforced with smooth rebar with diameter of 8mm, 10mm and 12mm in the longitudinal direction and 6mm - 8mm in the transversal direction. The stirrups were placed every 20 cm or more in most cases, though rarely a spacing of 15cm was encountered (see **Figure 54**, **Figure 55** and **Figure 56**).

**Figure 53.** Concrete of one school building

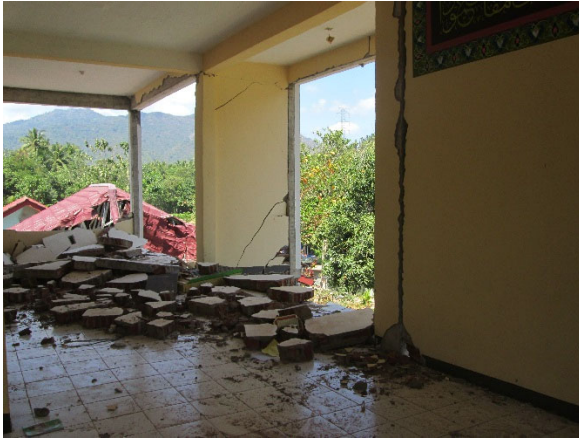
**Figure 68.** Total OOP collapse of wall panel

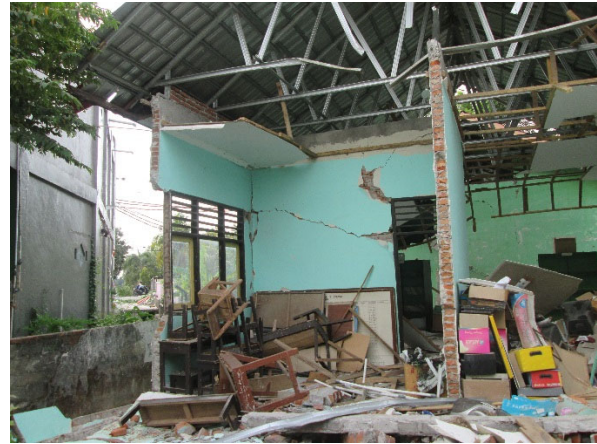
**Figure 69.** OOP collapse of masonry gable

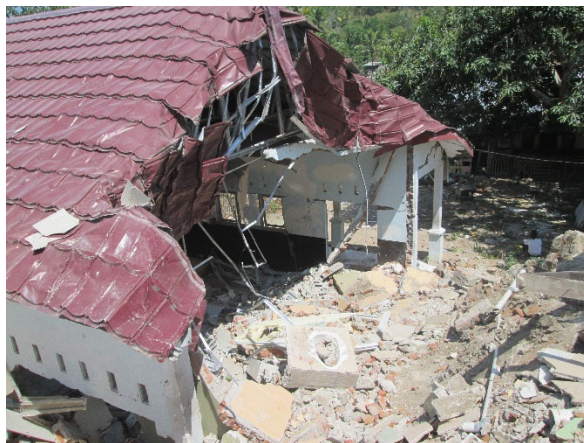
**Figure 70.** A building impacted by the falling walls/gables that collapsed OOP of two-story building nearby
