EARTHQUAKE AND TSUNAMI RECONNAISSANCE REPORT
31 October 2018 - 8 November 2018, PALU - INDONESIA

Submitted: December 2018

This report was prepared by Build Change Design Engineer Laura Masmia Putri and Volunteer Sam Adiputra, with support from Technical Supervisor Elwahyudi and IMR Officer Ridzki Rachman M.S.

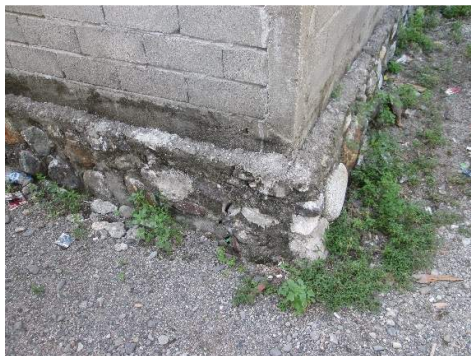
(a) A house with stone foundation with plinth beam

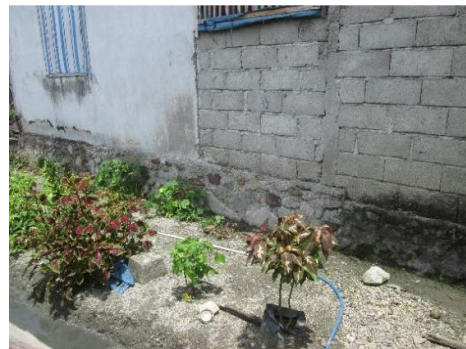
(b) A house with stone foundation without plinth beam

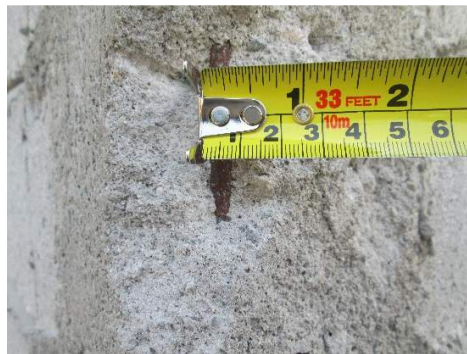
Figure 31. Smooth longitudinal rebar Ø6mm

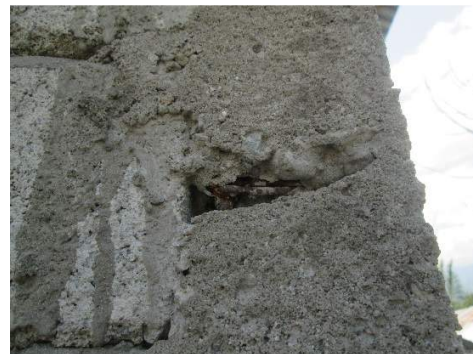
Figure 32. Stirrup of smooth rebar Ø4mm

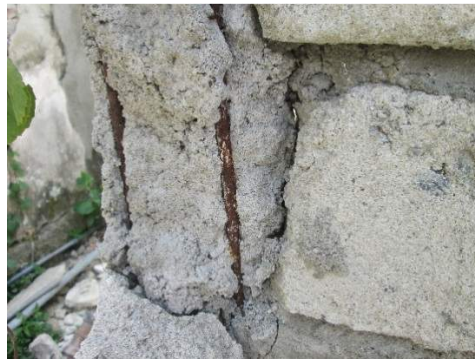
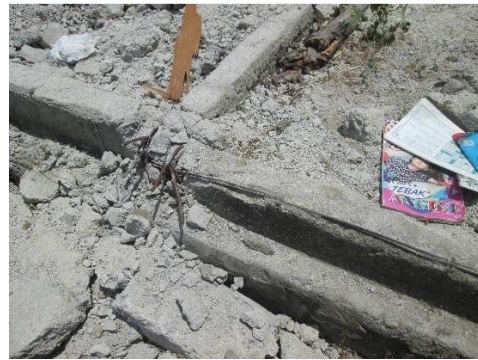
Figure 44. Poor confining element

The confining concrete elements were usually of poor quality, with compressive strength of less than 10 MPa using a rebound hammer test (see Figure 44). Insufficient

(a) poor quality of concrete column

(b) poor quality of concrete plinth beam

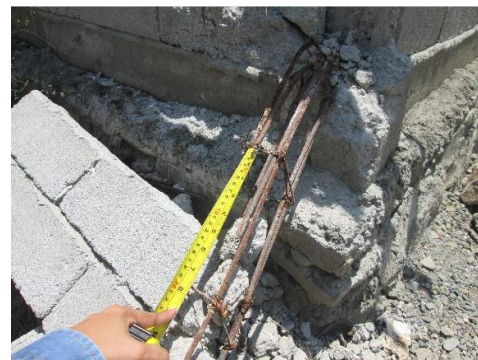
Figure 45. Insufficient concrete cover (exposed rebar), stirrup was provided every 20 - 40cm

concrete cover and exposed rebar was common to encounter (see Figure 45), causing the rebar to be rusted and fragile (Figure 46). Typically stirrups were only provided every 20cm – 40cm (Figure 45). The connection between each confining element was usually insufficient (see Figure 47). Minimum or no overlapping was provided between confining elements.

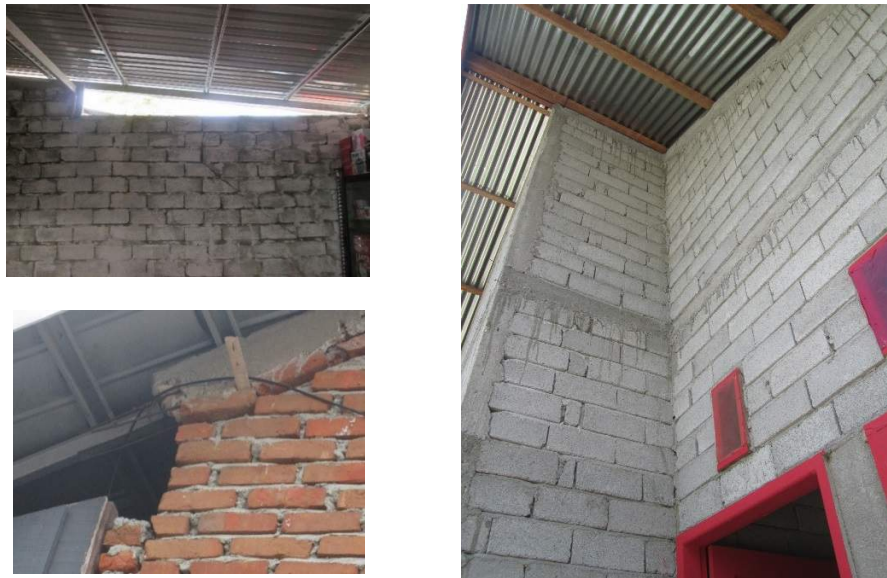
Figure 48. Absence of ring beam or columns at wall intersection

At several houses, the confining elements, such as the columns and beams, were absent (see Figure 48). Usually, masonry around openings were not confined (see Figure 49). At some houses, masonry was laid poorly, especially around openings (Figure 50).

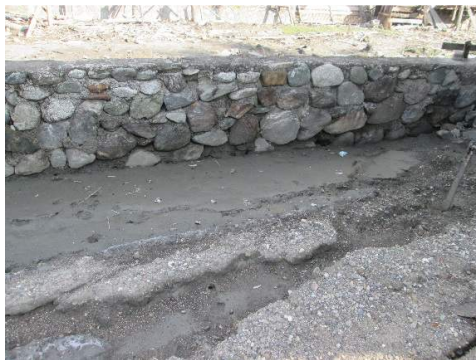
Figure 51. Poor location, sandy and muddy soil, near river, high liquefaction potential

Several houses that were built in Donggala area were built on top of muddy, sandy and loose soil (Figure 51) with high liquefaction potential, leading to partial settlement of houses to be common (Figure 52). Some parts of the house, such as the kitchen, toilets or storage were sometimes of a different type of structure, such as timber frame with masonry infill or timber frame with wood plank (see Figure 53), causing a significant difference in building response and performance during the earthquakes.

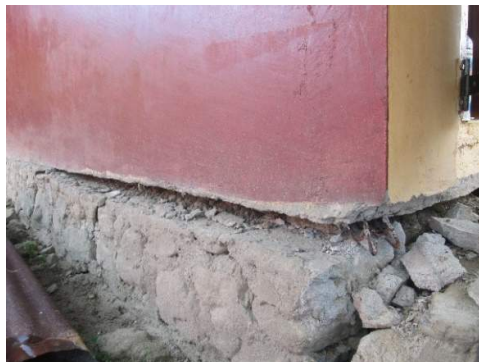
Figure 55. Separation between plinth beam and foundation

Cracks in the foundation was very common to encounter due to ground settlement at these sites and poor mortar quality, which lacked cement (see Figure 54). The cracks that were caused by partial settlement also led to damage to other structural elements such as columns, plinth beams and walls. Separation between the plinth beam and foundation was encountered, showing the absence of a connection between the plinth beam and stone foundation (see Figure 55).

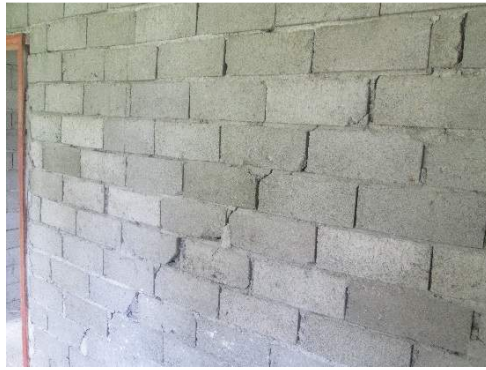
Figure 63. Diagonal stair-step cracks on wall

Partial or complete out-of-plane collapse (see Figure 60) of slim-slender walls, diagonal cracks around openings (see Figure 61) caused mainly due to the absence of confining elements, and flexural vertical cracks at mid-length of walls (see Figure 62) were common. Stair-step diagonal cracks that showed the poor quality of mortar were also prevalent (see Figure 63). Damage to non-structural components such as floors were found in most houses (see Figure 64), while damage to ceiling (Figure 65) only happened to heavily damaged or collapsed buildings (Figure 66).

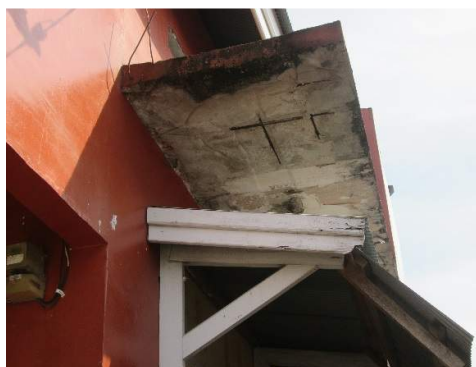
Figure 76. Concrete slab canopy with insufficient concrete cover

Some deficiencies encountered for this house type were the insufficient concrete cover at concrete slab canopy (see Figure 76). Some concrete frames appeared to be reinforced using one smooth rebar Ø8mm only (see Figure 77).

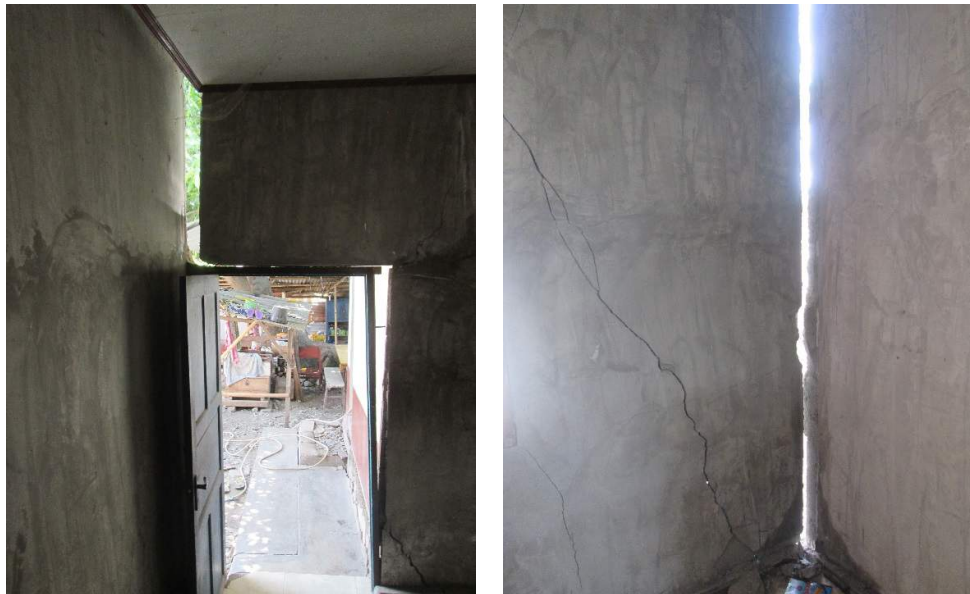
The most common damages are separation between RCF elements (see Figure 78), separation between RCF and masonry infill (see Figure 79), splitting columns (see Figure 80), diagonal cracks around openings (see Figure 81), out-of-plane (OOP) collapse of masonry infill (see Figure 82), leaned walls (see Figure 83), cracks on floor (see Figure 84) and damage and fall of ceilings (see Figure 85).

Figure 79. Separation between RCF and masonry infill

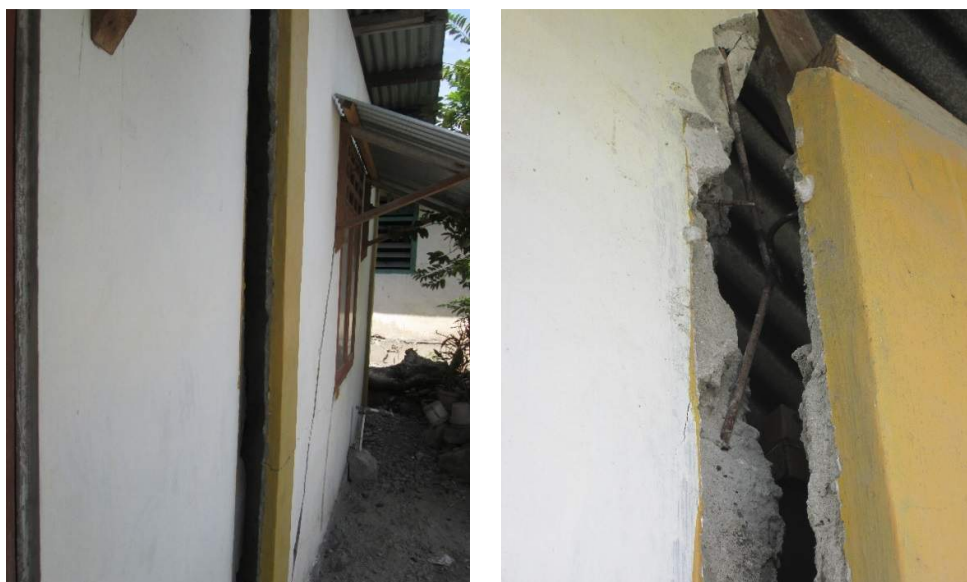
Figure 80. Splitting of column

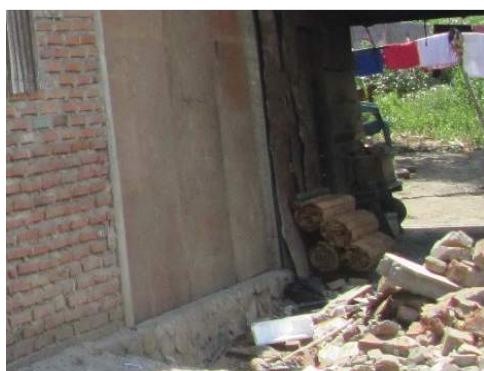
Figure 82. OOP collapse of masonry infill

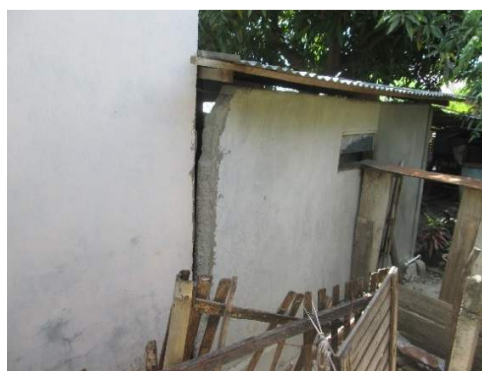
Figure 83. Leaned masonry infill

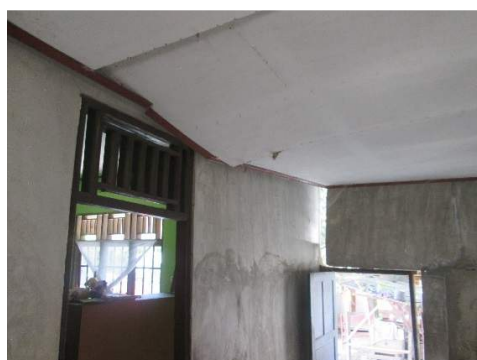
Figure 85. Damage in ceilings

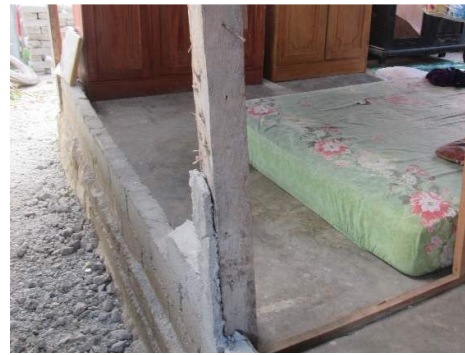
The quality of timber structure was varied from Grade I (see Figure 103) to Grade III (see Figure 104). In some cases, a deteriorated timber frame and roof truss were encountered because most of timber structural (and non-structural) elements were not protected (see Figure 105).

Figure 104. Timber structure of Grade III or lower

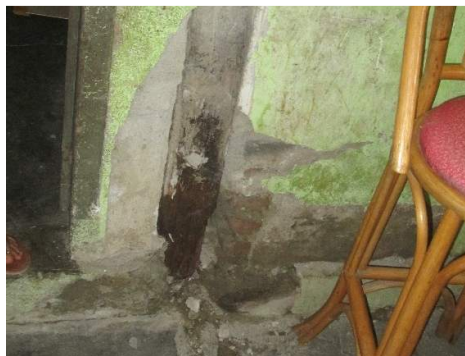
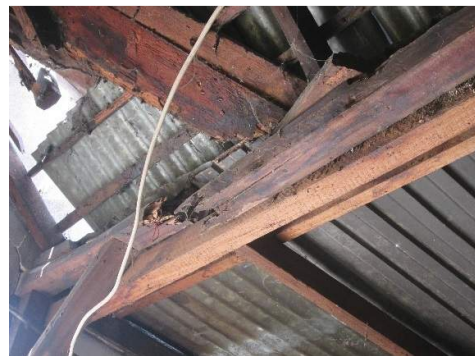
Figure 105. Deteriorated timber frames that were not protected

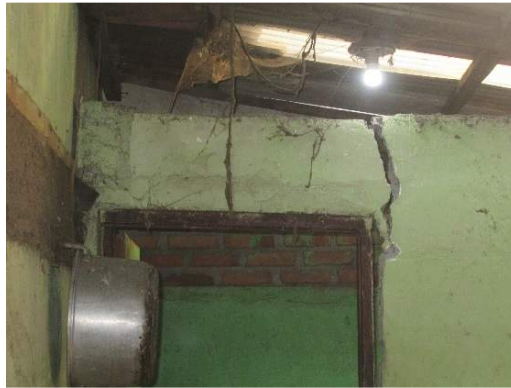
At most cases, all of the masonry was confined by sill plates, but in several cases, the sill plate was absent (see Figure 106). Knee bracing at the corner of timber frame was sometimes provided (see Figure 107), but mostly, knee bracing was absent (see Figure 108). At most houses visited, nails with various length and sizes were used as connector between heavy infill and timber frame (see Figure 109). At one house with cast-in-situ concrete infill, barbed wire, aside from nails, was used to connect the timber

Figure 106. Absence of sill plates at the top of masonry

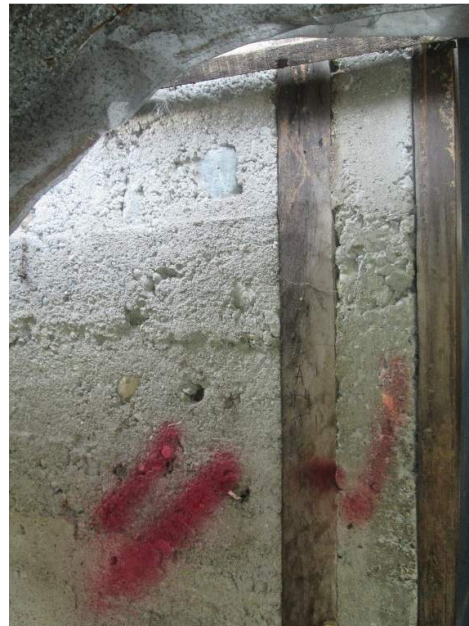
Figure 108. Post without knee bracing

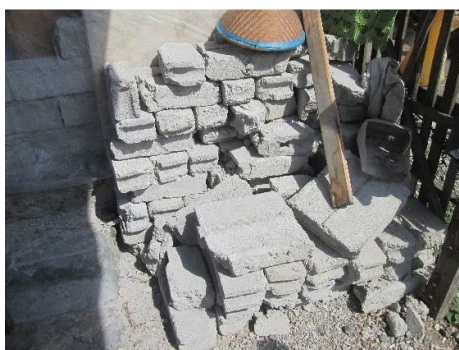
The quality of masonry infill varied. Most of the concrete blocks were of poor quality and easily scratched using bare hand (see Figure 112). The clay brick was relatively better compared to concrete block overall, but weak unburnt bricks were also quite common to encounter (see Figure 113). The cast-in-situ concrete infill quality varied

Figure 112. Typical concrete block of poor quality

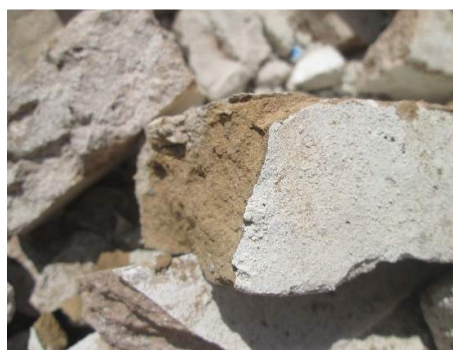
Figure 113. Under burnt clay brick used for a collapsed house

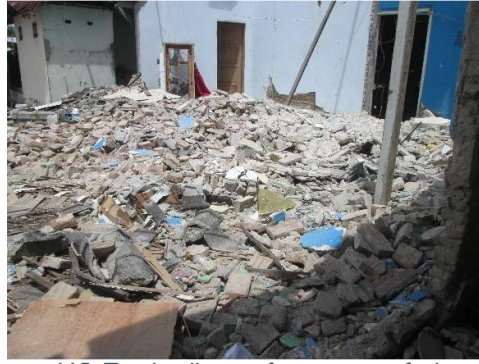
The most common damages encountered were total collapse of some part of the house (see Figure 115), OOP collapse of heavy infill while the timber frame remained undamaged (see Figure 116), diagonal cracks on heavy infill around openings (see Figure 117), separation between heavy infill and timber frames (see Figure 118), cracks of heavy infill at the corner of wall panel (see Figure 119), sliding cracks on heavy infill (see Figure 120), toe crushing and horizontal cracks of infill (see Figure 121), stepped cracks (see Figure 122), flexural vertical cracks on heavy infill (see Figure 123), vertical splitting of heavy infill (see Figure 124), cracks on foundation due to the poor quality of mortar (see Figure 125), dislocation of posts due to poor connection to other adjoining structures (see Figure 126), leaned walls because the timber frame could not support the heavy infill (see Figure 127), and cracks on concrete floor (see Figure 128).

Figure 115. Total collapse of some part of a house

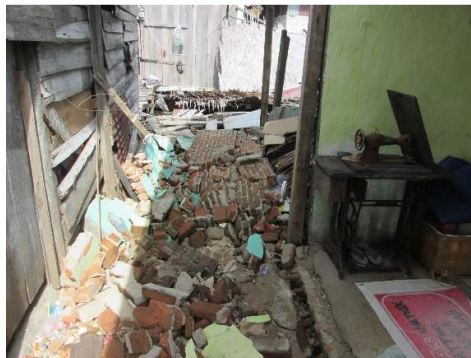
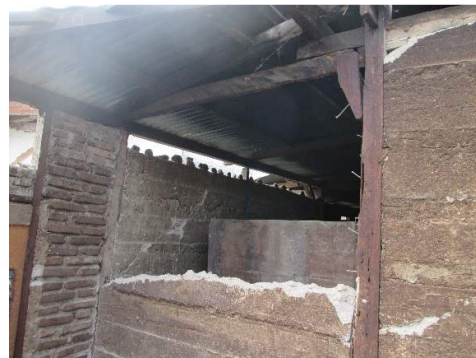
Figure 116. OOP collapse of heavy infill

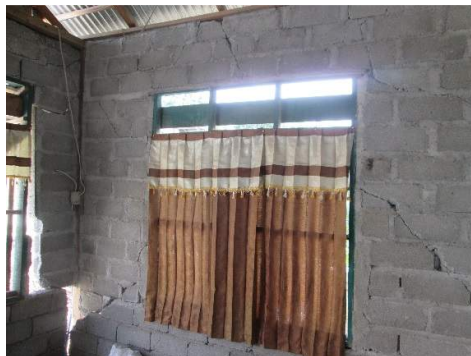
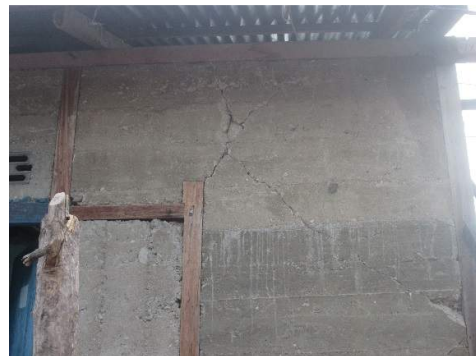
Figure 117. Diagonal cracks around openings

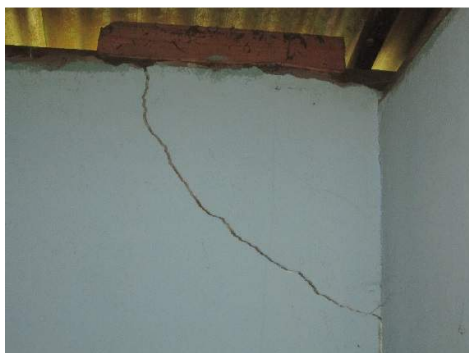
Figure 119. Cracks of heavy infill at wall corner

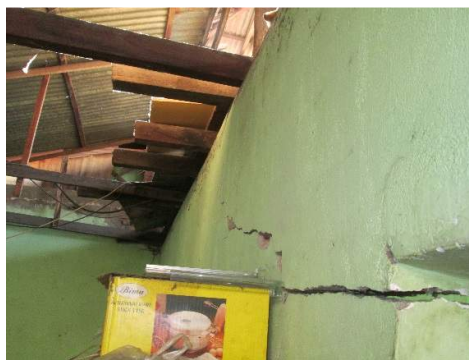
Figure 120. Sliding cracks of masonry infill

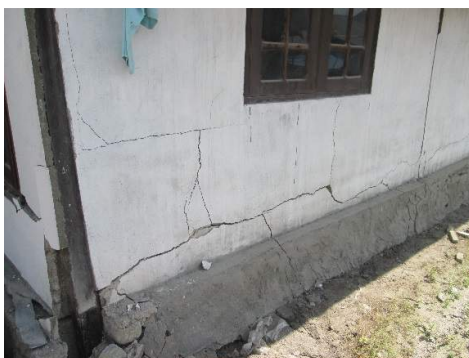
Figure 121. Toe crushing, and horizontal cracks on heavy infill

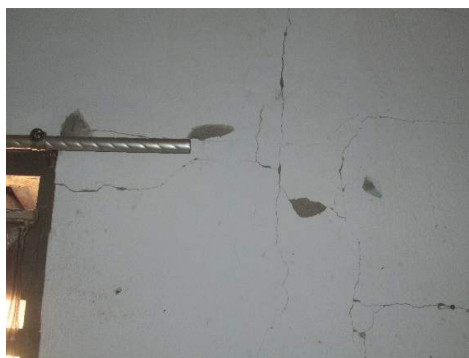
Figure 122. Stepped cracks at heavy infill

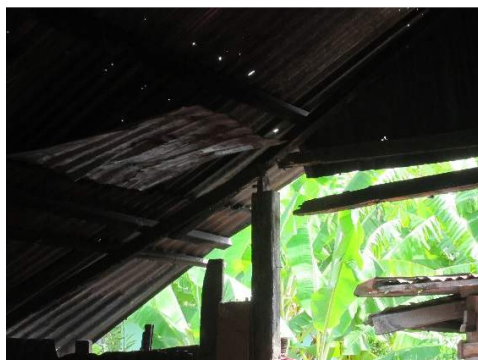
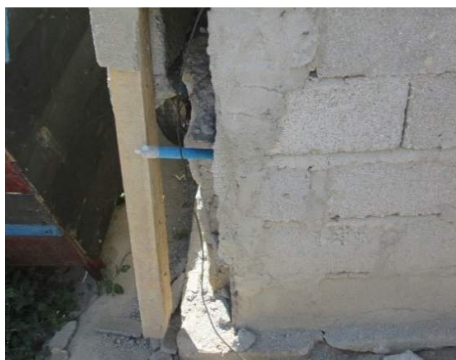
Figure 126. Dislocation of (a) sill plate and (b) timber post that were not well-connected to foundation

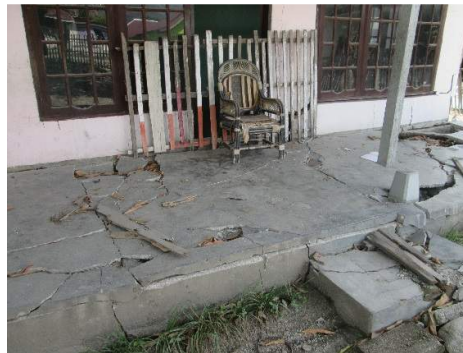
Figure 128. Cracks on concrete floor

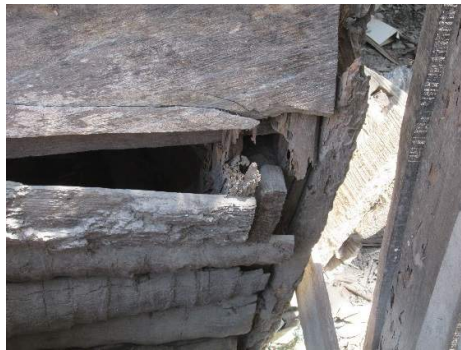
Most of the houses (64%) only suffered minor damage or no damage despite the poor quality of timber and poor connection between timber structures (see Figure I45). Moderate and severe damage observed was mostly due to the deterioration of timber main structural elements (see Figure I46) and tilted structure due to soft story mechanism for raised house (see Figure I47). Cracks on the concrete floor was prevalent (see Figure I48).

Figure 146. Damage due to deteriorated timber

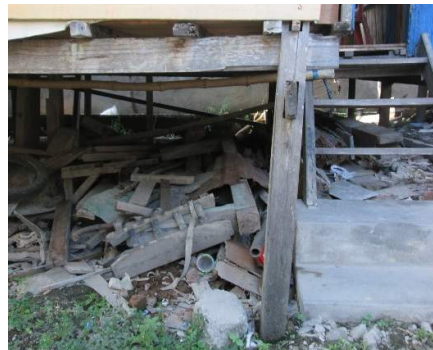
Figure 147. Soft-story failure for raised timber house

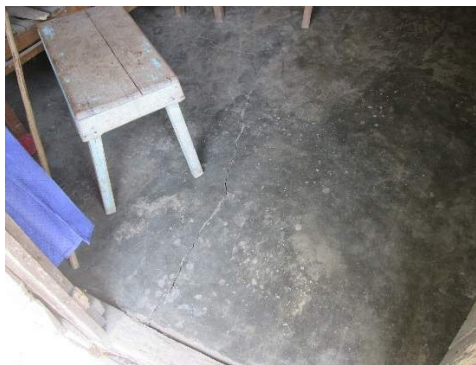
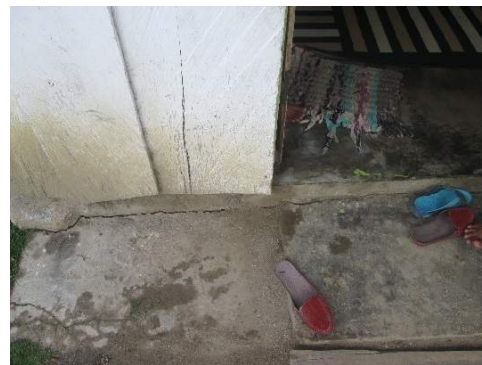
Figure 148. Crack on concrete floor

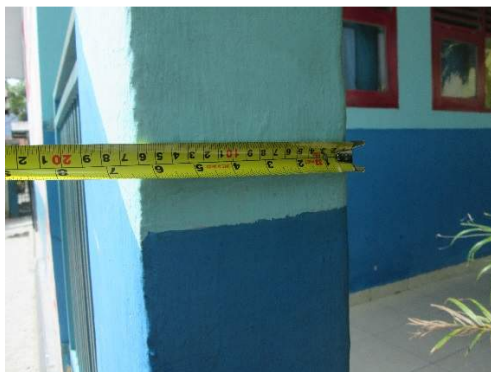
Figure 165. Column of 15cmx15cm

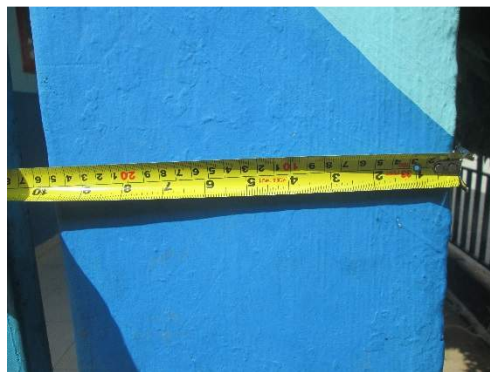
Figure 166. Column of 15cmx25cm

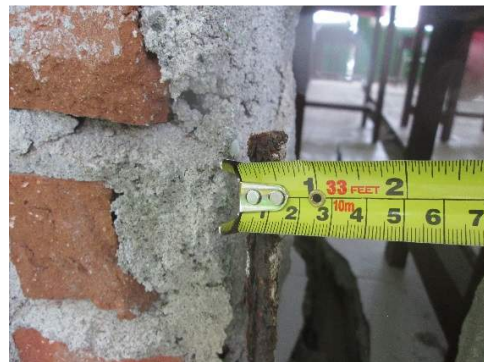
Figure 172. Column with smooth longitudinal rebar $\varnothing 10\text{cm}$

The material quality of columns, beams and confining elements varied from poor to good. One-story and old school buildings usually had a very low compressive strength (see Figure 174) and this concrete was easily broken using bare hands. However, two-story and newer school buildings had higher compressive strength. Rebound hammer test showed that these school buildings had compressive strength of around 17 MPa to 32 MPa (see Figure 175). Concrete of old school buildings usually lacked in cement (see Figure 176) and was not well-compacted (see Figure 177). The exposed reinforcing rebar was usually badly rusted and fragile (see Figure 178). This was due to thin concrete cover (see Figure 180) or in some cases, when the concrete cover was excessive (Figure 181), the rusted rebar might be caused by the lack of cement allowing moisture and oxygen to easily penetrate into the RCF and allow the oxidation process to take place and cause rust. From all RCF that was exposed so that the reinforcing could be evaluated, none of them that had sufficient seismic detailing (see Figure 182).

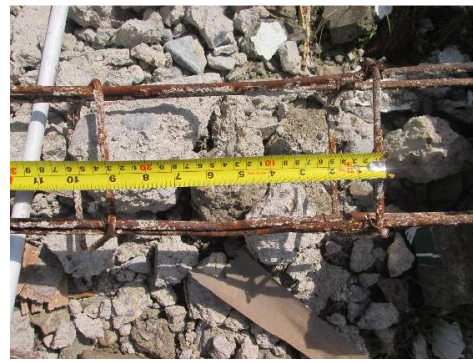
Figure 173. Column with stirrup of smooth rebar $\varnothing 4\text{mm}$ every 23cm

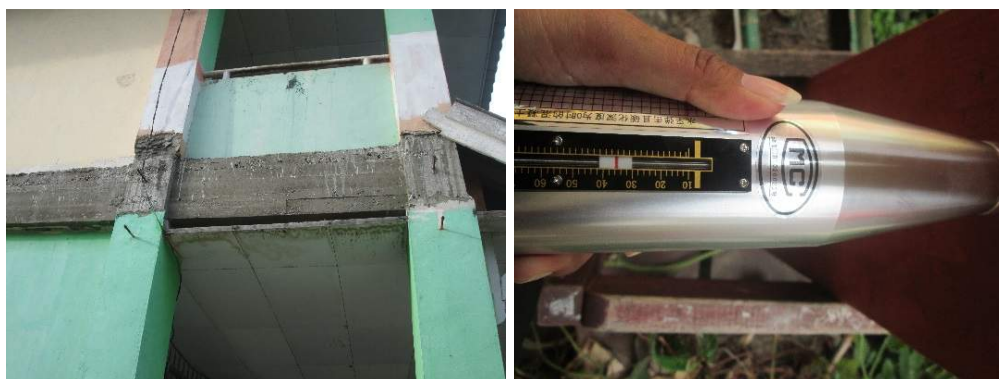
Figure 175. New and two-story school buildings had relatively high compressive strength

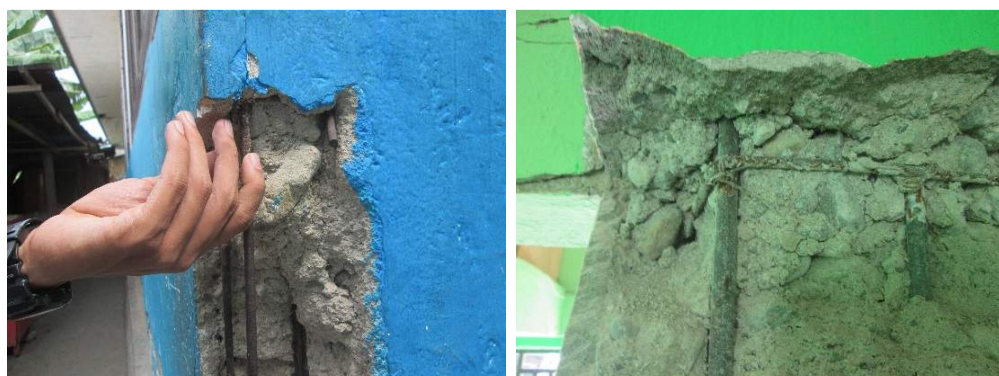
Figure 176. Concrete lacking in cement

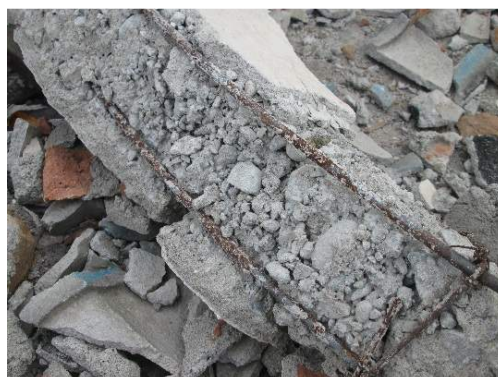
Figure 177. Concrete that was not well-compacted

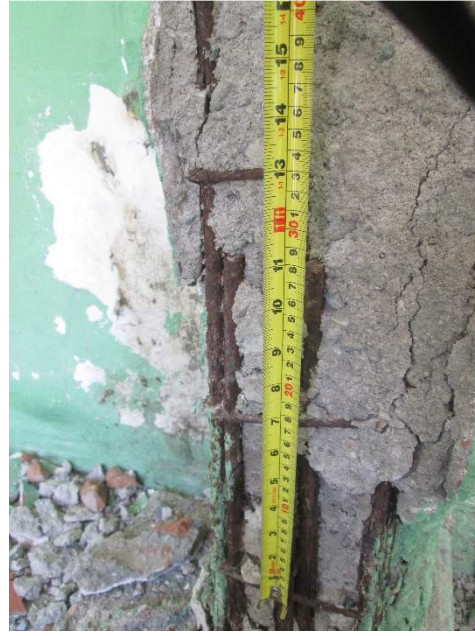
Figure 179. Smooth rebar Ø6mm every 18cm

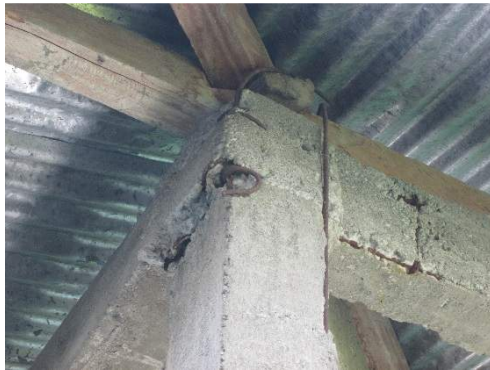
Figure 180. Thin concrete cover

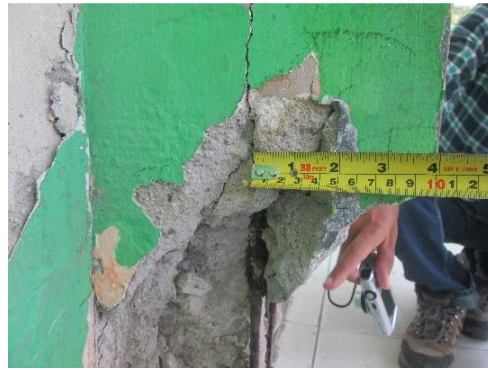
Figure 181. Excessive concrete cover (10cm)

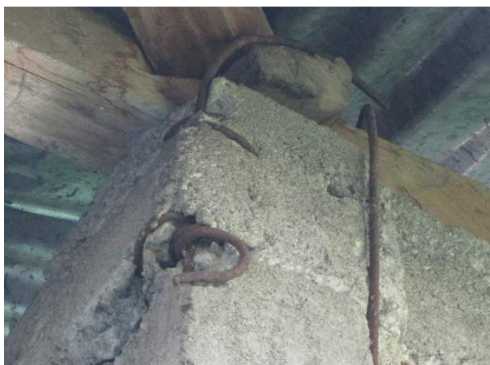
Figure 182. Poor seismic detailing

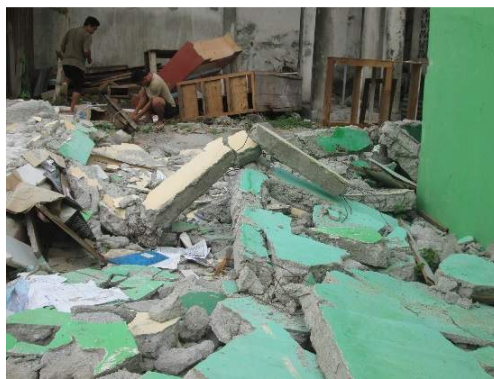
Building collapse was common for one-story older buildings (see Figure 185). For new two-story buildings, collapse was due to soft-story mechanism (see Figure 186). For buildings that remained standing, the most common damage encountered to structural RC columns was crushing at joints (see Figure 187), splitting cracks (see Figure 188), cracks due to corrosion of rebar (see Figure 189), diagonal cracks (see Figure 190), horizontal cracks (see Figure 191), bending (see Figure 194), and cracks due to captive column mechanism (see Figure 195). For beams, the most common damage encountered was shear cracks (see Figure 192), diagonal cracks that probably caused by corrosion rebar (see Figure 193),

Figure 185. Total collapsed of old, one-story school building

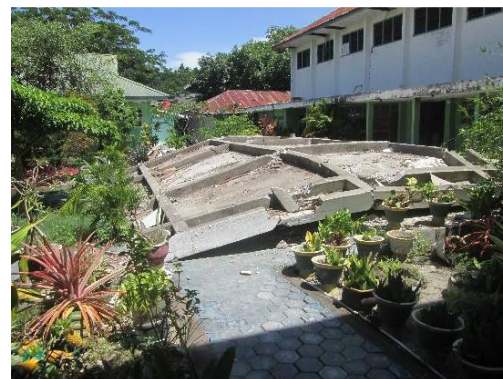
Figure 186. Total collapsed of new school building due to soft-story mechanism

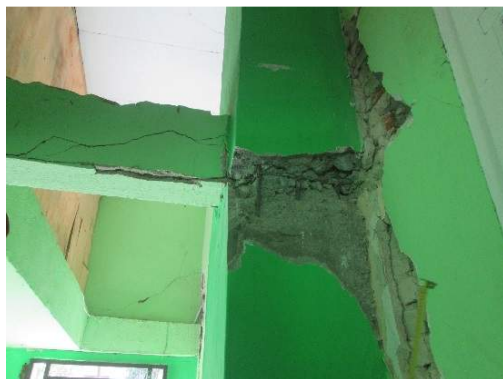
Figure 187. Concrete crushed at joints

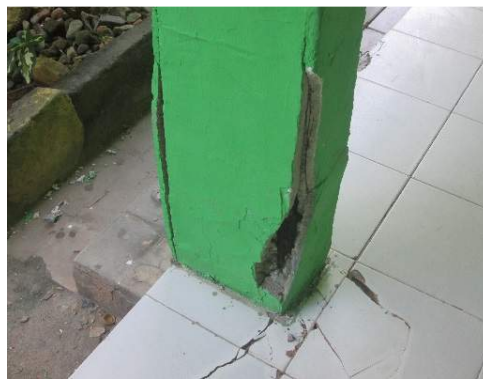
Figure 188. Splitting crack

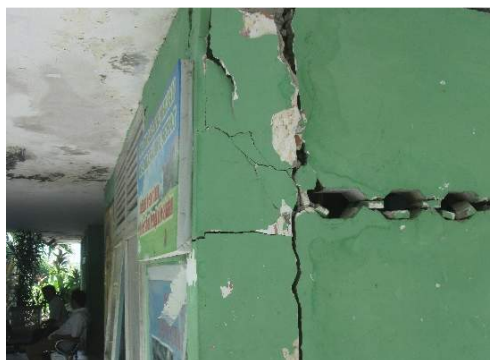
Figure 191. Horizontal cracks on columns

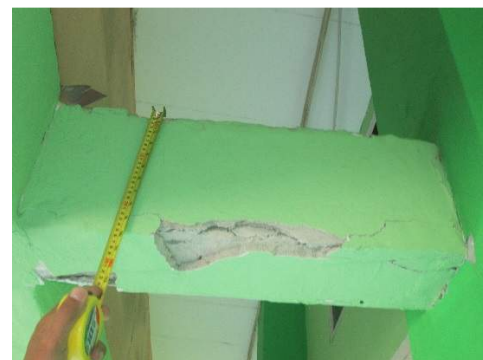
Figure 192. Shear cracks on beams

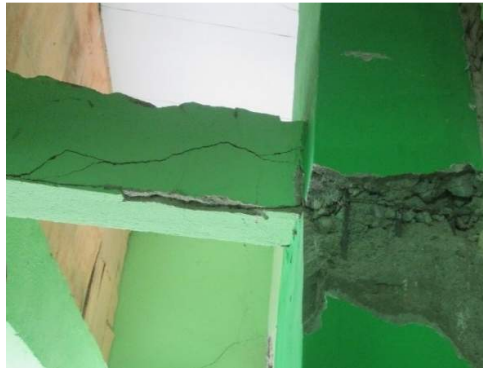
Figure 193. Diagonal cracks on beams

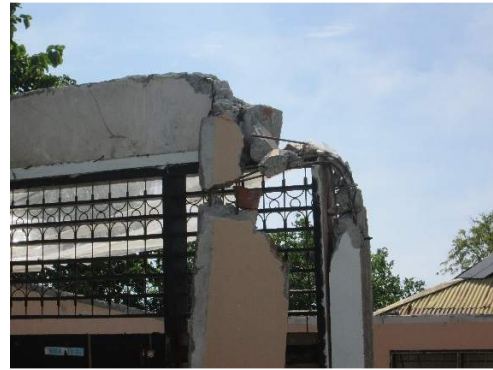
Figure 194. Bending column

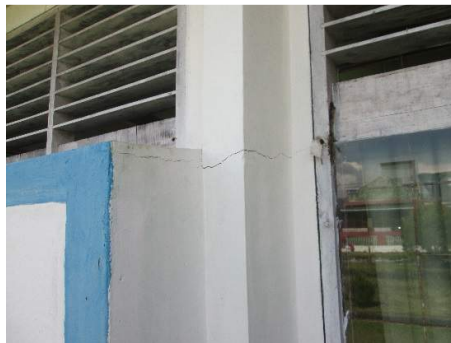
Figure 195. Cracks due to captive column mechanism

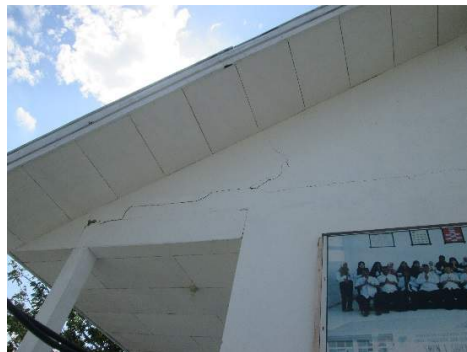
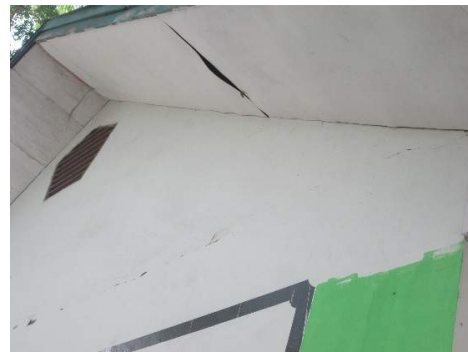
For walls, the most common damage encountered was cracks on the heavy gable (see Figure 198), OOP collapse of masonry gables (see Figure 199), OOP collapse of walls (see Figure 200 to Figure 201), diagonal cracks at wall around openings (see Figure 202), separation between confining elements and masonry walls (see Figure 203), and vertical cracks on wall (Figure 204). For walls without openings, diagonal cracks were also observed due to long and slender walls (see Figure 205).

Figure 198. Cracks on heavy gable

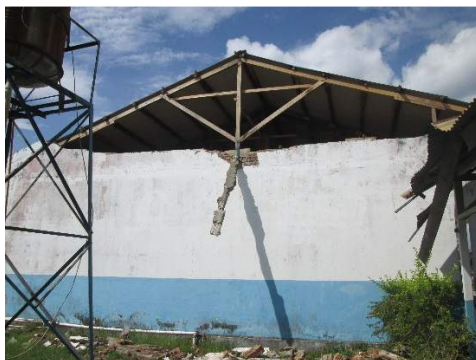
Figure 199. OOP Collapse of masonry gable

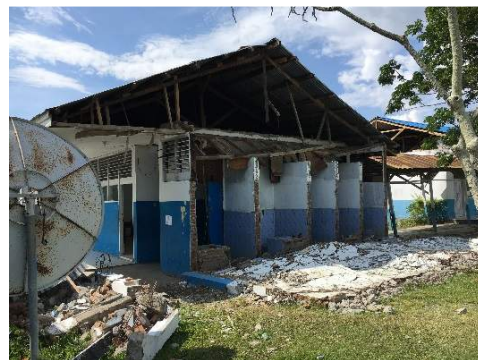
Figure 200. OOP Collapse of wall panel

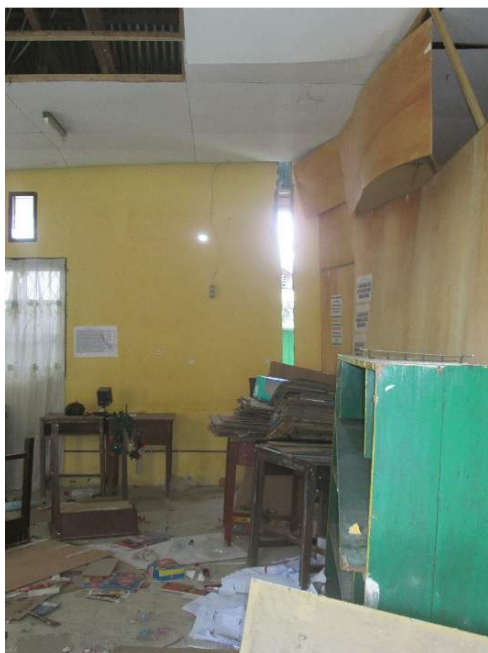
Figure 201. OOP Collapse of masonry wall

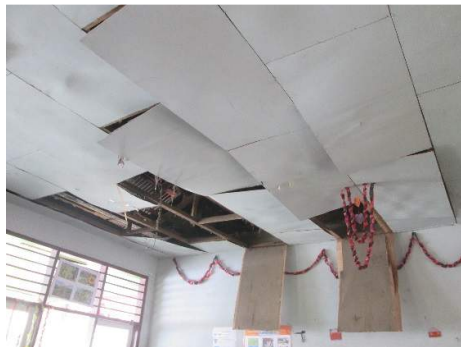
Cracks on foundation either due to poor mortar quality, ground settlement or ground cracking were also common (see Figure 206). Damage to concrete floors (see Figure 207), falling ceilings and damage to roof covering (see Figure 208), and damage doors and windows (see Figure 209) were also prevalent. Significant ground settlements that caused the floor to be uneven were also observed (see Figure 210). Some school's fences were collapsed (see Figure 212).

Figure 208. Damage and falling ceiling and roof covering

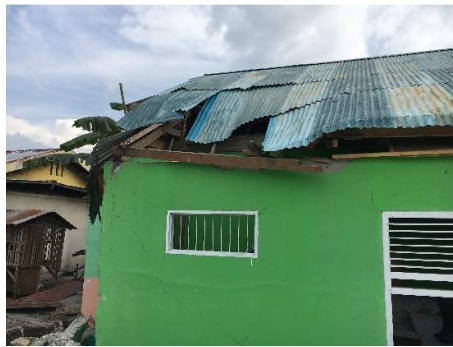
Figure 209. Damage to doors and windows

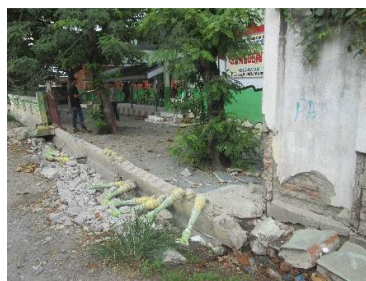
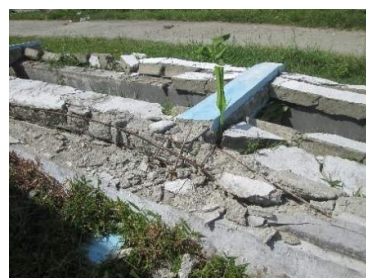
Figure 212. OOP Collapse of masonry fences

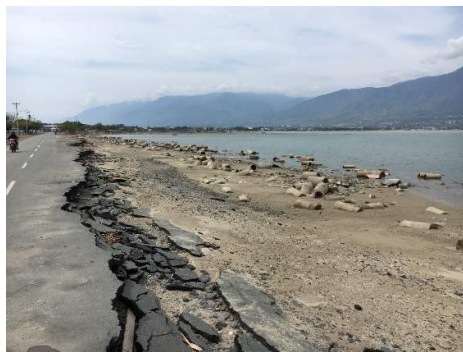
Near the coastline, the foundation of the road was eroded by the earthquake and subsequent tsunami, causing lateral spreading and partial collapse of the road into the bay. This was seen extensively both in Palu coastline (Figure 214) and Kampung Muara in the city of Dongala (Figure 215). In the mountainous region, several landslides and rockfall that occur due to the intense ground shaking caused temporary blocking of access to several villages.

Figure 214. Part of the road eroded into the bay due to earthquake and tsunami

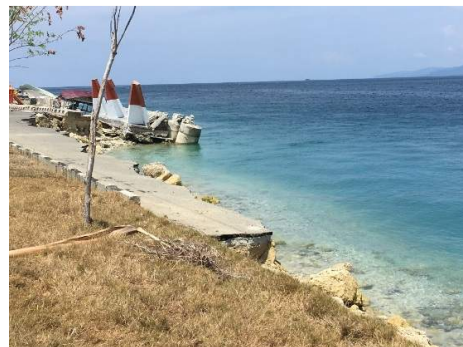
Figure 215. Road collapse into the bay due to foundation failure in Dongala city

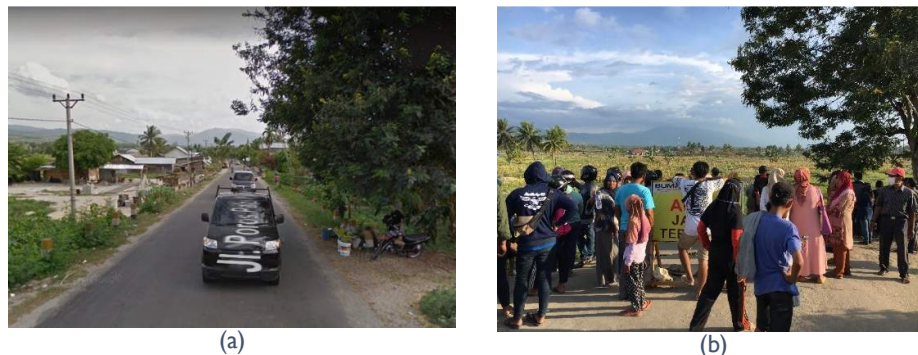
In the four villages where severe liquefaction occurred (Balaroa, Petobo, Jono Oge, and Sibalaya), roadways were destroyed long with the villages by the mudflow. Figure 216 shows the aftermath of the liquefaction in the village of Petobo, with damage to the main road that runs through it. Figure 217 shows the before and after of the view from the bridge, at one end of the liquefaction zone in Jono Oge. The before view was taken from Google Maps street view, while the after view was taken during the visit. The roadway that connects the two-end point has been taken by the flow a few kilometers downstream.

Figure 217. (a) Before and (b) After picture of the village of Jono oge due to the liquefaction*

*Note the same tree at the right side of the picture. The houses and road has been swept away downstream along with the liquefaction.

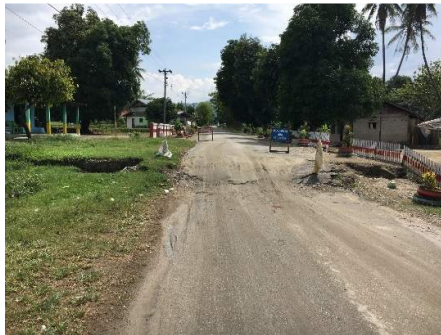
In the Sigi district, uplift and cracking of the ground was still observable, one month after the earthquake event. In the only main artery road that connects Palu with Kulawi, the road was uplifted approximately 50 cm (20 inches) on one side (see Figure 218). Pipelines buried underneath the ground are visibly bent (see Figure 219). There was a major separation crack on the ground, with its width measured at 50 cm (20 inches), and depth of crack about 1 meter (40 inches). This measurement is taken one month after the event, which means the crack was probably deeper during the

Figure 218. Uplift of the ground of approximately 50cm

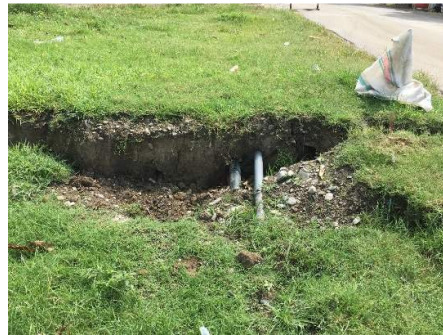
Figure 219. Bent pipelines exposed due to uplift

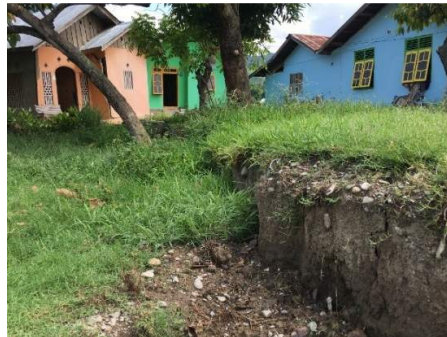
earthquake. This ground lifting causes significant damage to the structures that rest along the crack line. (see Figure 220)

Figure 220. Ground uplift causes significant damage to the houses along its path

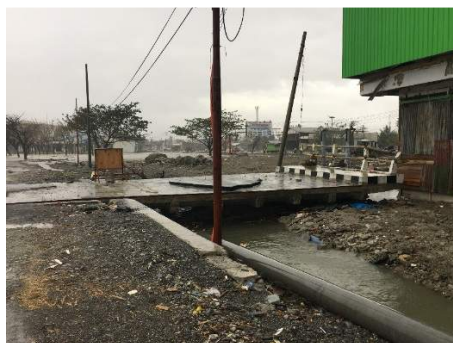
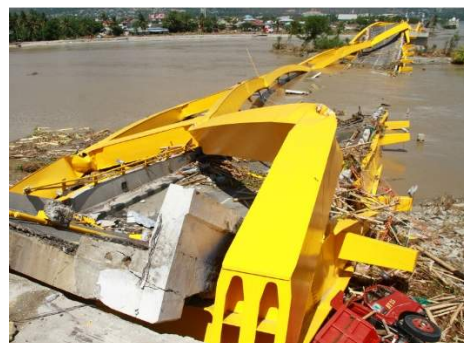
One of the short overpasses near the coastline was pushed approximately 8 meters away by the tsunami (Figure 221). The earthquake also caused the collapse of renowned Palu Bridge IV, which cuts down one of the main between from West Palu to East Palu (Figure 222). A bridge in Parigi Moutong was fractured due to the settlement of piers at its mid-span (see Figure 225).

Figure 221. A short bridge overpass near the Palu coastline was swept and shifted 8 meters inland due to the tsunami

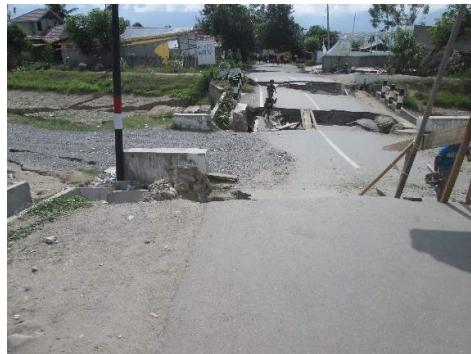
Figure 223. Bended bridges in Oti villages

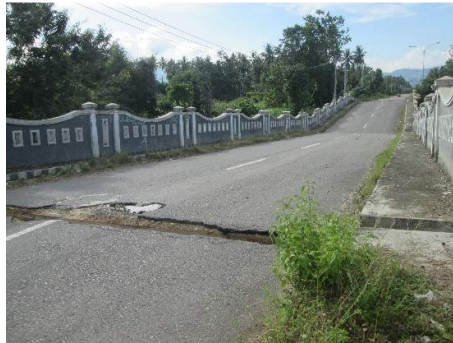
Figure 224. Damaged bridge in Petobo village

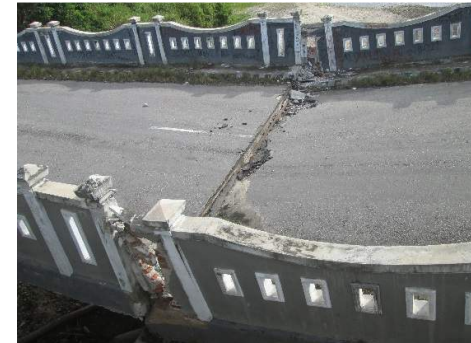
Figure 225. Damaged bridge in Parigi Muotong

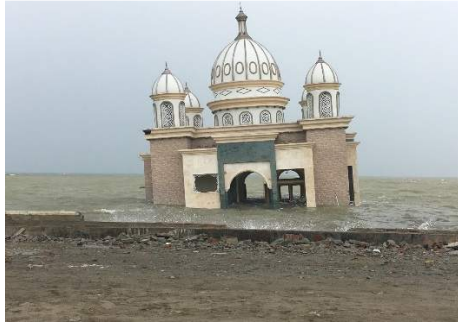
One mosque was located at the Palu coastline, and had fallen off its foundation due to the earthquake and tsunami (see Figure 227). Masjid Agung, the largest mosque in the city of Palu (see Figure 228), also observed substantial nonstructural wall damage and some column damage, potentially due to captive column condition. Non-structural walls and tiles had fallen off the structure due to shaking. The mosque and its surrounding courts were still used as evacuation site during the time of the visit. Partial collapse and significant cracking are also observed in some of the churches visited in Palu (see Figure 229).

Figure 227. A mosque near Palu coastline

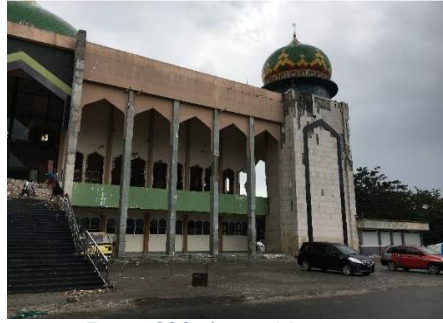
Figure 228. Agung Mosque

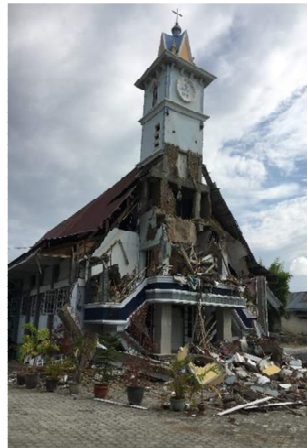
Figure 229. Damaged churches in Palu

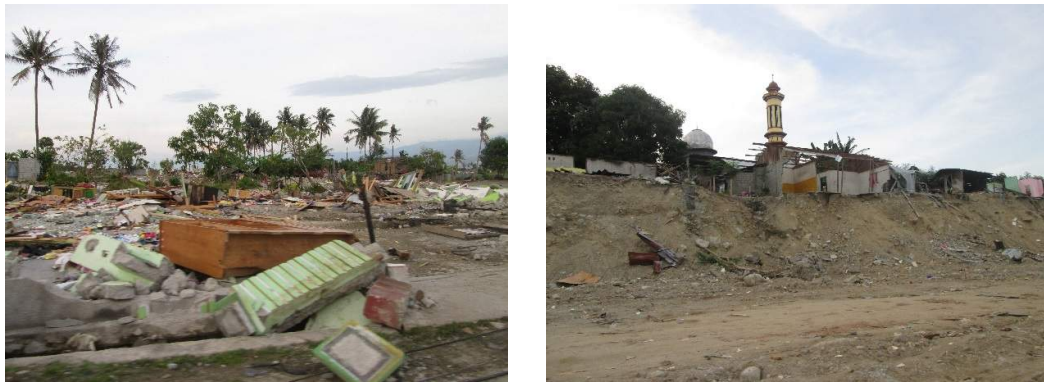
Four villages (Balaroa and Petobo in Palu city, Biromaru and Sibalaya in Sigi district) experienced severe liquefaction where houses, streets, and other structures were completely destroyed by the liquefied soil flows. Most buildings were buried under the liquefied soil while the remaining ones were either collapsed/severely damaged (due to settlement of up to 5 meters, large cracks and lateral spreading of soil) or half-buried by the moving soil (see Figure 231 - Figure 234).

Satellite image of Balaroa village (a) before and (b) after liquefaction

Figure 231. Balaroa village, significantly affected by liquefaction

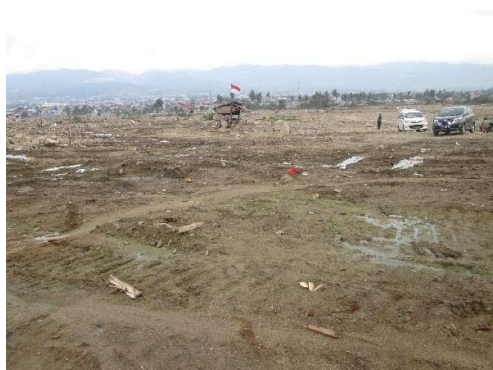
Based on the observation, it was found that the soil in the four villages were either peat or sand, with shallow ground water level. Water was easily observed in all areas in these villages even though it was not in rainy season.

(d) Water emerged in Balaroa, showing shallow ground water level

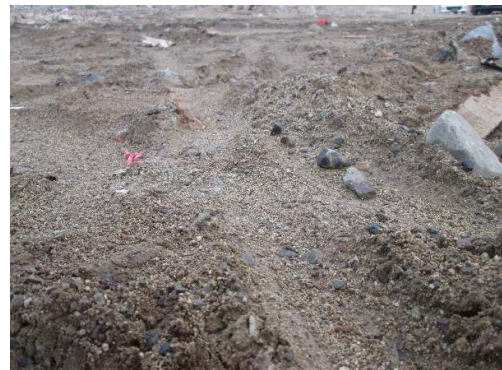
(e) Typical sandy and loose soil in Balaroa

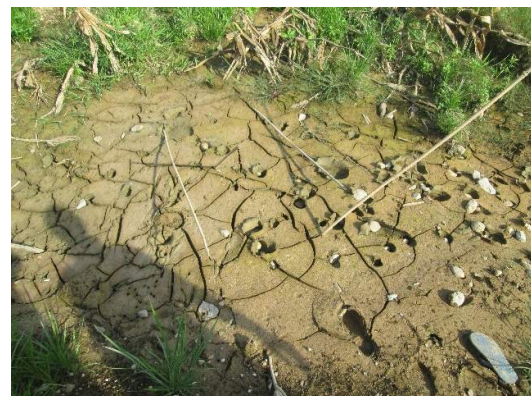
(d) Soft peat soil dominated Biromaru village

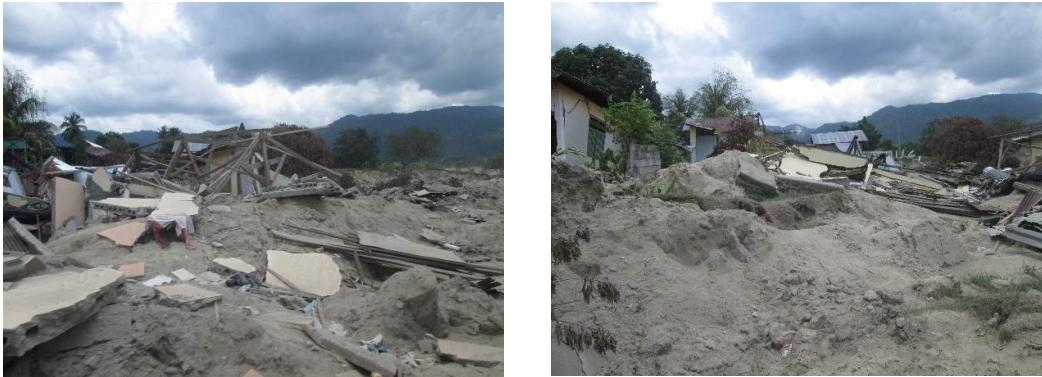
(a) The remaining buildings in Sibalaya village after liquefaction

Figure 234. Sibalaya village that was affected by liquefaction

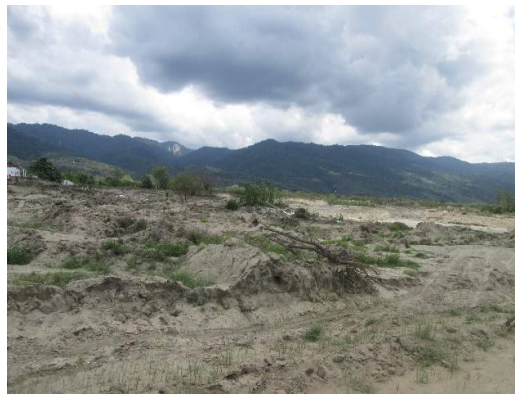
(b) Sandy soil in Sibalaya village
